**CONSERVATION PROBLEMS OF HISTORICAL CHURCHES IN
ELAZIĞ: SURP SIMON CHURCH**

**IN PARTIAL FULFILLMENT OF THE REQUIREMENTS
FOR THE DEGREE OF MASTER OF SCIENCE
IN ARCHITECTURE DEPARTMENT**

**GAZİ UNIVERSITY
GRADUATE SCHOOL OF NATURAL AND APPLIED SCIENCES**

DECEMBER 2023

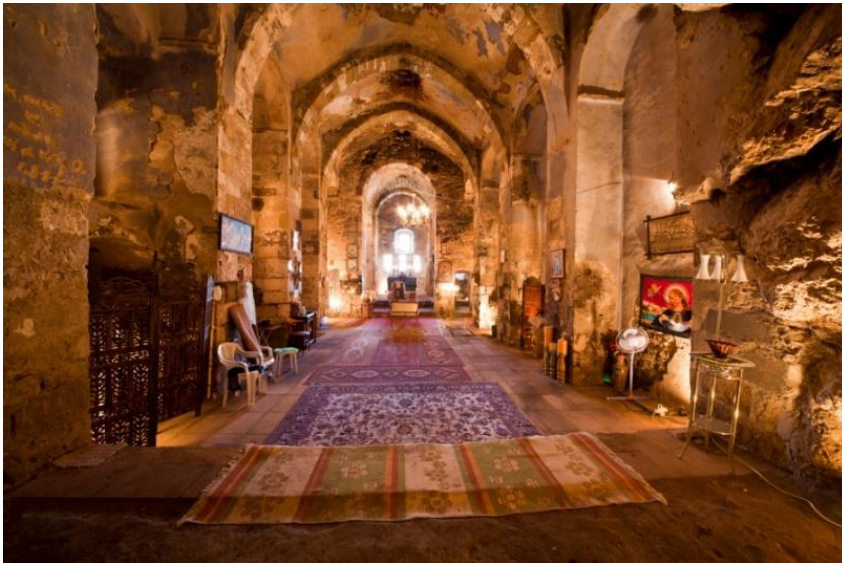
Figure 3.7. Interior of the Virgin Mary Church (Source: <https://harput.web.tr/harputun-tarihi-eserleri/harputdaki-kiliseler/meryem-ana-kilisesi/>, Access Date: 18.10.2023)

The exterior of the church is exceptionally well-preserved and remains in excellent condition. Conversely, the interior floor has incurred significant damage, and the church's inscriptions have been entirely obliterated (Figure 3.7). Notably, the naos, bema, and pastaforium cells are still intact, while the narthex extending towards the north has not survived to the present day (Çakmak, 2006).

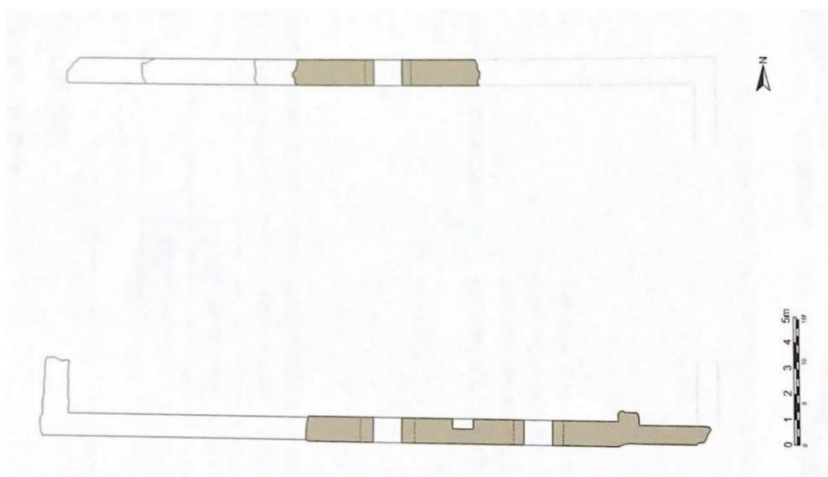
Figure 3.10. Plan Survey of Surp Hagop Church (Source: EACHAR, 2018)

From the remaining walls of the structure, it is evident that the church had a rectangular plan. The partially standing north-south walls are constructed from rubble stone (Figure 3.10). Traces of the foundation of the east wall are still observable. The north wall includes a wide arched entrance on the lower level and an arched window on the upper level. The south wall exhibits two arched openings on the lower level and three arched windows on the upper level. The roof covering of the building has been entirely lost. The foundation of the west wall is also absent.

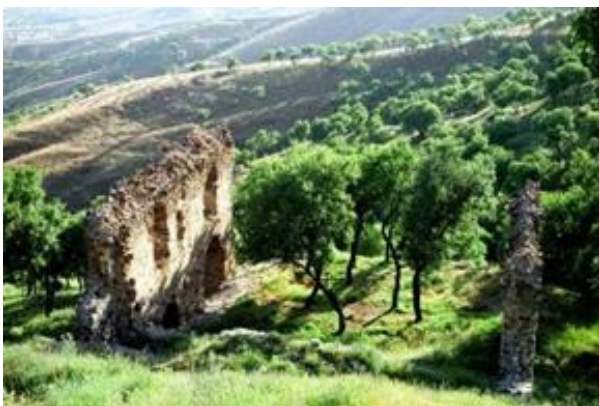
Figure 3.12. General View Surp Hagop Church (Source: <https://harput.web.tr/harputun-tarihi-eserleri/harputdaki-kiliseler/surp-hagop-kilisesi/>, Access Date: 10.09.2023)

Currently, the church stands near the residential area to the west of the main road, situated on a sloping terrain below the road level. Only a small portion of the walls still stand, and the north wall has collapsed more than the south wall. The walls have suffered from severe deterioration and corrosion.

The remaining part of the church, much of which has collapsed, is vulnerable to human and natural destruction (Figure 3.11-3.12). Since the north and south walls are not connected to each other, their structural balance is fragile and there is a risk of complete collapse.

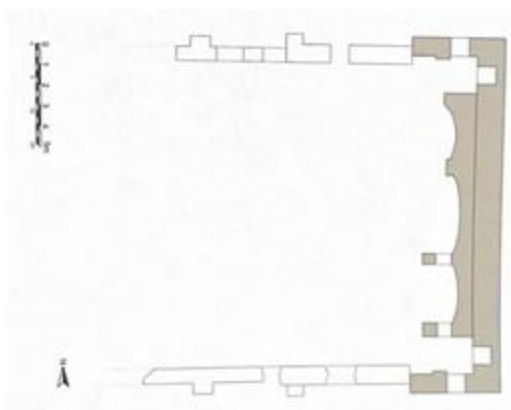
Figure 3.14. Kızıl Church Plan (Source: EACHAR, 2018)

The walls of the rectangular church are built with rubble stones. The western wall was completely destroyed and most of the north-south walls were demolished. The east wall is standing. The upper cover is completely destroyed.

The surviving part of the church, a large part of which has been demolished, measures approximately 15×18 meters. Church has three apses, two side cells are quite small and close to square (Figure 3.14). There are indications that it may have had five naves. It is an original example of Armenian church architecture. The outer length of the east wall is 18 meters, the surviving part of the north wall is measured to be about 11 meters, and with the traces on the ground, it is observed that it continues for about 15 meters. The wall thickness is 90 centimeters in the side cells (north and south walls) and 70 centimeters in other parts (EACHAR, 2018).

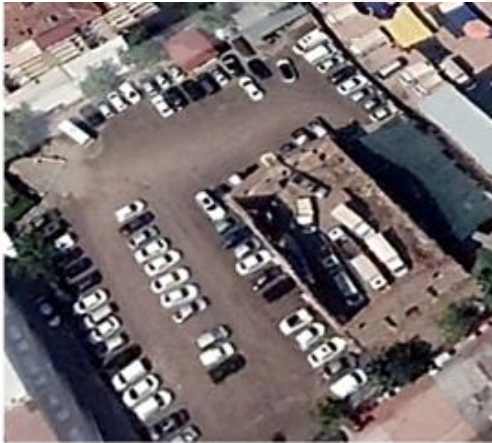
Figure 3.20. Situation of the Church in August 2021 (Google Earth Pro)

Inventory documents indicate that the church has 2 storeys and there is a staircase in front of the apse on the eastern façade. However, neither the staircase, the floor nor the apse arch have survived to the present day. The fact that the upper cover and other elements of the building

have disappeared has made the building more open to external influences. In addition to the fact that the church is completely open to external influences, the additions and subtractions made in order to be used for different functions have also caused deterioration in the church. For example, today it is used as a parking lot and vehicles are parked inside the body walls of the church, causing deterioration on the entrance door. One of the reasons why the floor of the building has not survived to the present day is the constant entry of vehicles into the church (Figure 3.20). Another factor that threatens the extinction of the Armenian Protestant Church is the earthquake factor. The area where the building is located is very close to the “Eastern Anatolian Fault Line”, one of Türkiye’s active fault lines. There are also cracks in the walls and deterioration on the walls due to vandalism.

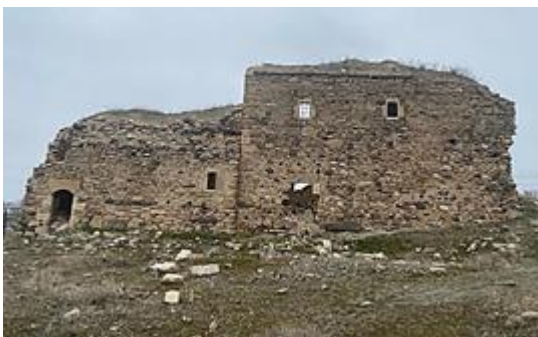
Figure 3.24. Elevation Difference of the Surp Kevork Church (Author's Archive, 2023)

The jamatun section opens to the exterior via a single door in the southwest room. The lime plaster on the interior walls is adorned with painted decorations. It can be deduced from the trace on the ascending body wall and the difference in roof heights that the church structure comprises two distinct units (Figure 3.24).

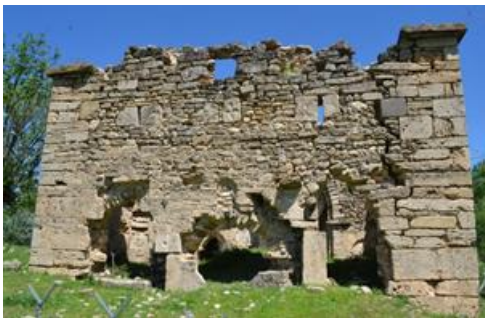
Figure 3.29. Ekinözü Church West Facade General View (Çapkur, 2023)

According to the priest Natanyan, who was sent to the region in 1878, the village of Ekinözü had 180 households and 1436 inhabitants, while the Armenian population in 1914 was recorded as 1648 (207 households). According to Natanyan, there were two imposing masonry Armenian churches in the region, one of which must have been the Keğahayyats Surp Asdvadsadzin (Virgin Mary) Monastery, and the other was the Surp Gatoğige (Ekinözü) Church (Bardizaksi et al. 2010, 121). The church is a masonry building with a rectangular plan (Figure 3.28-3.29).

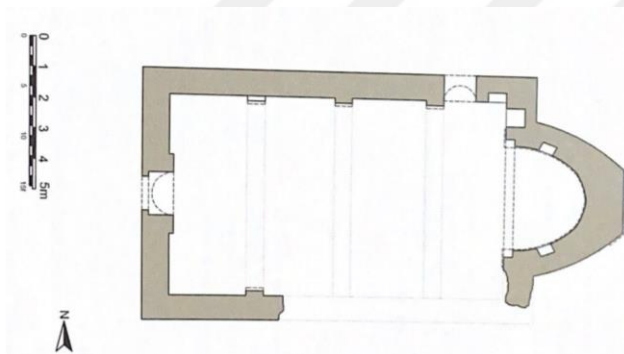
Figure 3.30. Plan of Ekinözü Church (EACHAR, 2018)

The church consists of a rectangular plan and a single space with a half-dome apse, measuring approximately 12.75×9.30 meters (Figure 3.30). On both sides of the apse, there are rectangular vaulted cells with arched entrances. Arches resting on circular columns protruding from the side walls support the vaulted upper cover. There is an arched entrance in the center of the north wall with arched windows beside it. The walls of the masonry structure are constructed using cut stone. In the center of the east wall, there is a half-domed apse (EACHAR, 2018). On the north and south walls of the main space, there are two recessed columns formed by circular projections from the wall. The column heights are approximately 1.70 meters. When examining the exterior, you can observe the windows of the two side cells on the east façade. On the two corners of the west wall, the upper-end or floor-level moldings are preserved. The central axis of the entrance has an arched entrance and arched windows on both sides. It is evident that the exterior walls are unplastered.

Despite some collapses, the plan scheme remains sufficiently legible. The floor level cannot be observed. Except for the partial dome and arches over the apse, there is no information available on the upper cover. The church faces significant structural problems on almost all of its walls. There is substantial material loss on all walls, along with serious structural cracks starting from the upper part of the arches and extending upward on the walls. There are structural cracks and separations at the joints of the wall, material losses in the doors and windows, and cracks in the lintels of the west wall windows. Issues related to vegetation on the upper cover of the apse and the presence of microorganism formations, which are commonly found in the stone material, have been observed. The church is also highly vulnerable to human and natural damage (EACHAR, 2018).

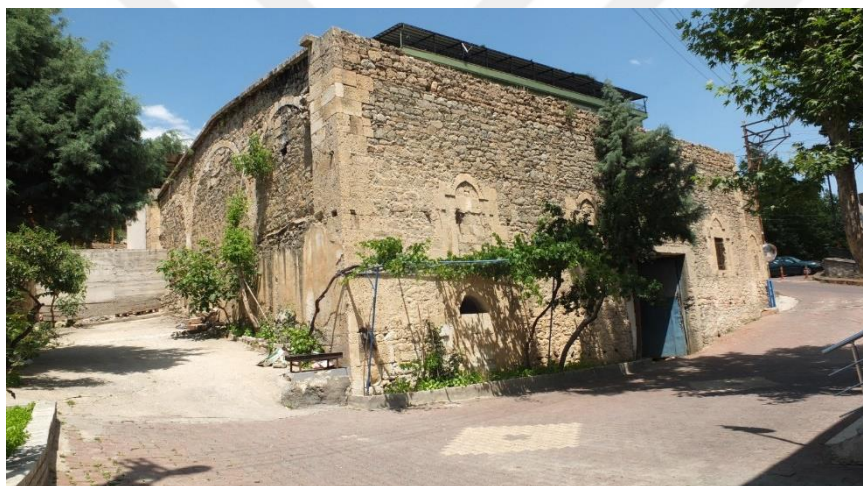
Figure 3.32. General View of Toma Church (Source: <https://elazighaberkent.com/meryem-ana-kilisesi-turizme-kazandiriliyor/> , Access Date: 05.11.2023)

The church has largely preserved its structural integrity, but there are some deterioration and conservation issues due to years of disuse. The deterioration of the building is described in the EACHAR as follows:

“There is a row of shops adjacent to the north wall of the church. The main entrance door and west windows on the west façade are below the elevated road level and have been closed. On the south façade of the building, a 3.5-meter wide door was opened for use in later periods. The floor levels cannot be observed precisely due to the interventions. There are serious material deterioration due to moisture throughout the building. Saltation problems caused by cement-based plaster are observed. The frescoes have been destroyed and only a few traces of them can

be observed. The roof is covered with grass. The church, which was used as a warehouse and garage by the municipality in the past, is currently empty”.

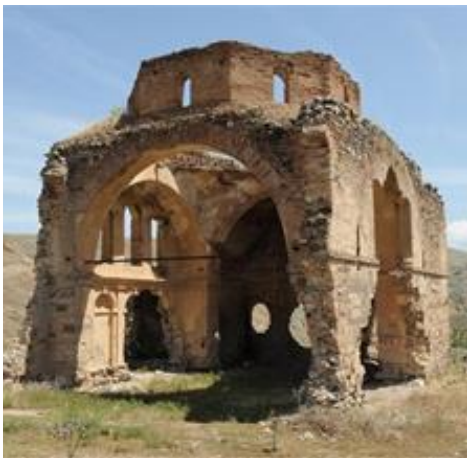
Figure 3.36. General View of Surp Lusavoriç Church (Source: <https://tr.pinterest.com/pin/420242208969026242/>, Access Date: 05.11.2023)

The part on the south wall of the building with upper and lower floor window openings has been demolished. The lower floor openings cannot be read on the south wall, while the upper floor windows are preserved. The west wall is completely destroyed. On the west wall, the wall remains of the north and south walls can be observed. The protruding apse is partially destroyed (Figure 3.36). Although the wall of the apse is preserved, there are large-scale holes. Only the octagonal dome cover and the windows on the octagonal dome cover have been preserved and the dome has completely collapsed. In the interior, the plaster, writings and drawings on the walls have been severely destroyed. Material losses, corrosion and moisture-related problems are observed.

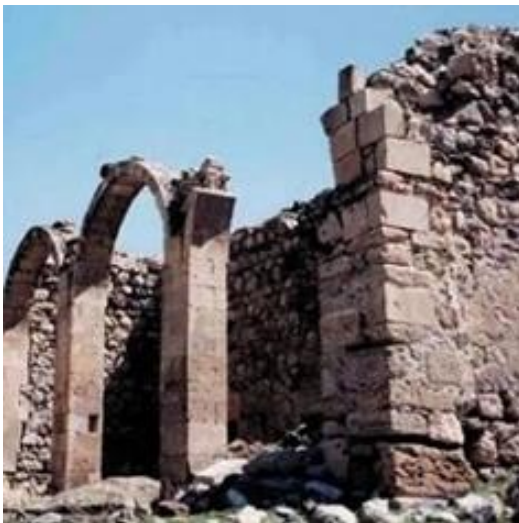
Figure 3.38. General View of Kindik Church (Source: <https://mapio.net/pic/p-8537099/>, Access Date: 25.10.2023)

The semi-open space walls on the east and west sides of the church have been partially preserved, but the vaulted upper cover has collapsed (Figure 3.38). Additionally, the south wall and most of the west walls inside the building are completely destroyed. All of the walls exhibit structural cracks, severe collapses, material losses, and stone discharges. Furthermore, the entire floor is covered with rubble. The church is located to the north of Kindik Rock in a remote and inaccessible location, reachable only via a narrow pathway. Despite its historical significance, the church has suffered extensive damage, rendering it vulnerable to destruction from both natural and human factors.

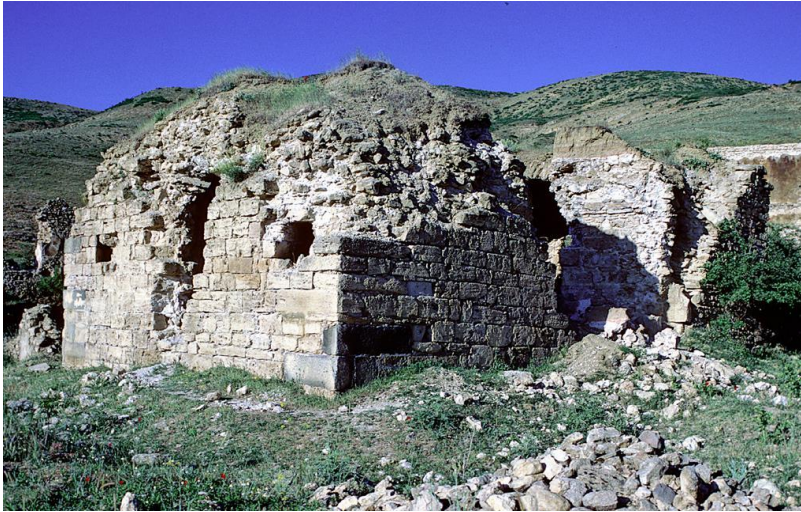
Figure 3.40. General View of Kovancılar Church (Source: <https://www.collectif2015.org/tr/100Monuments/Le-monastere-de-la-Sainte-Mere-de-Dieu-a-la-Delectable-Vue/>, Access Date: 05.11.2023)

The walls of the monastery are still standing but do not provide information about the general structure (Figure 3.40). The plan of the church is approximately recognizable. There are significant structural problems in the monastery walls and the church as a whole. The entire wall texture and the stones close to the ground are melting due to the moisture rising from the ground. In other parts, there is significant loss of material and weathering of the stones. The building is structurally at risk due to the collapse of many parts (EACHAR, 2018).

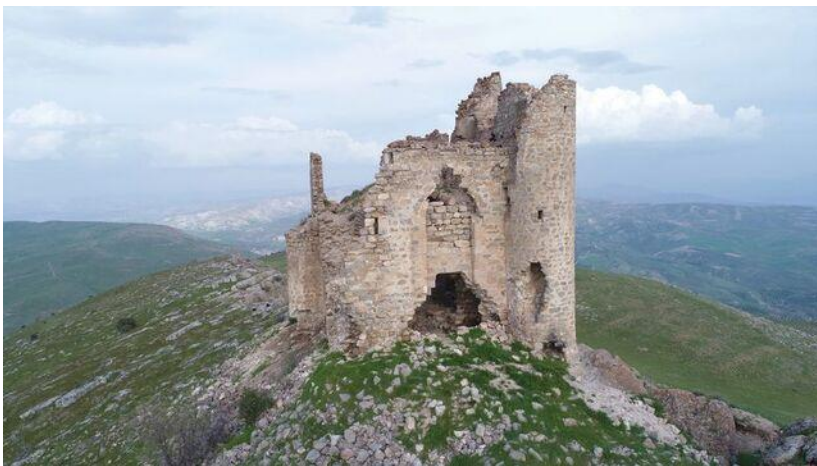
Figure 3.42. Muşar Mountain Church (Mor Ahrun Monastery) (Source: <https://www.haberturk.com/mar-ahron-manastiri-koruma-altina-aliniyor-2544673>, Access Date: 08.10.2023).

This monumental castle-church structure is in a state of partial ruin. The roof covering over the upper floors and the narthex is missing. A large part of the vault, many parts of the towers and body walls are holed, ruined and destroyed. There are large pits on the floor of the church and the podium of the apse has been completely destroyed.

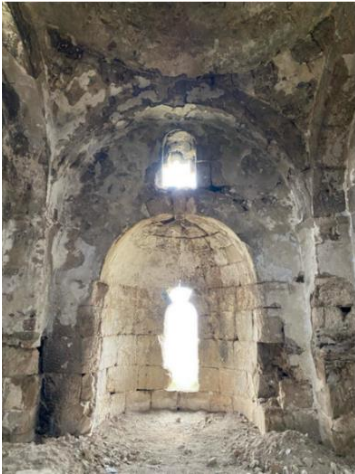
Figure 4.5. Apse of the Church (Source: Author's Archive, February 2023)

The apse on the east side of the church is in the shape of a semicircle with a radius of 1.42 m. There is a arched window in the apse and the walls are built with cut stone. But the keystone of this arched window does not exist today. The upper cover of the naos is a dome. The dome height from the center is 7.43 meters. The outer surface of the dome is conical. The load of this dome is transferred to the floor through the pendentives located at the corners. The windows on the pulley of the dome provide natural light to the interior. The parts protruding outward from the clover plan are covered with half domes that are lower than the central space. The vaulted central passage on the west side of the naos connects the naos to the jamatun section. (Figure 4.6).

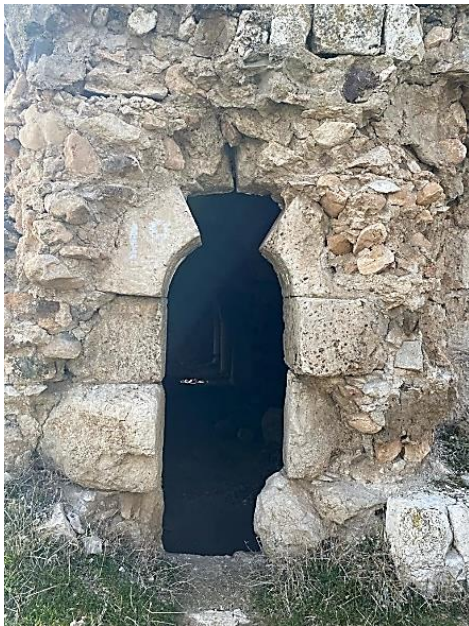
The northern facade of the church has material loss on the rubble stone section. There is also material loss on the western facade, but this damage is not perceptible from the interior. Breakages and dislocations are present in the cut stones, rubble stones, and thin-cut stones on the facades of the structure. The keystone of the arched window on the eastern facade has disappeared (Figure 4.22).

Figure 4.22. Arched Entrance Door on the Eastern Facade (Author's Archive, 2023)

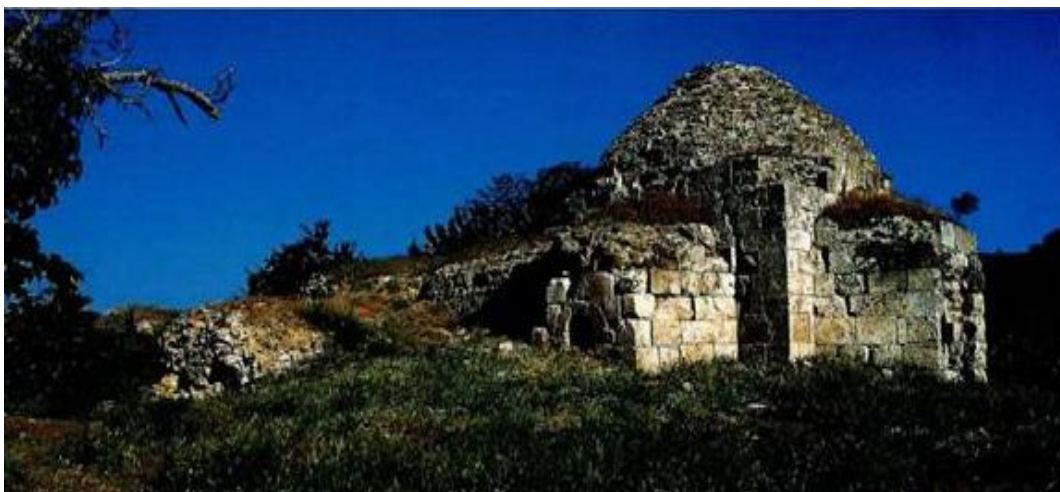
Upon examining the photograph shared by Thierry, who visited the church in 2010, it is observed that the cut stones forming the apse walls are in quite good condition (Figure 4.24).

Figure 4.24. Surp Simon Church in 2010 (Thierry, 2010)

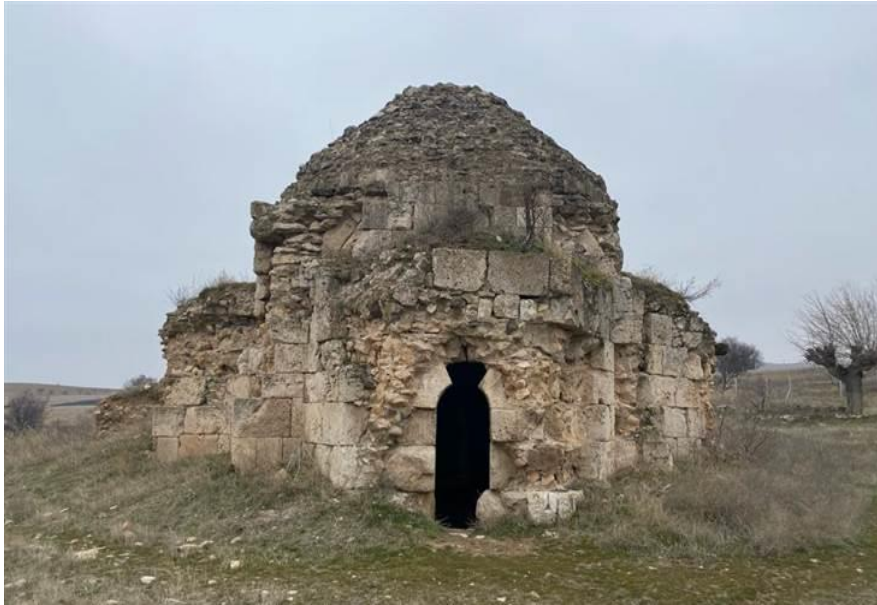
While the cut stones appear to be in quite good condition in 2010, the cut stones on the exterior facade of the eastern side, where the apse is located, have deteriorated by 2023 (Figure 4.25).

Figure 4.25. East Facade of the Church (Author's Archive, 2023)

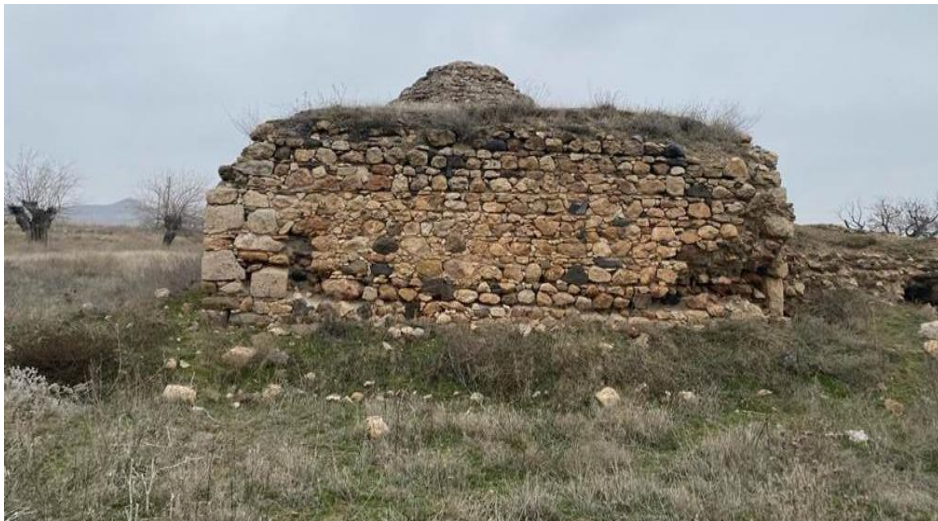
While there is material loss on the wall forming the western facade of the structure, this loss is not visible on the interior facade (Figure 4.26).

Figure 4.26. West Facade of the Church (Author's Archive, 2023)

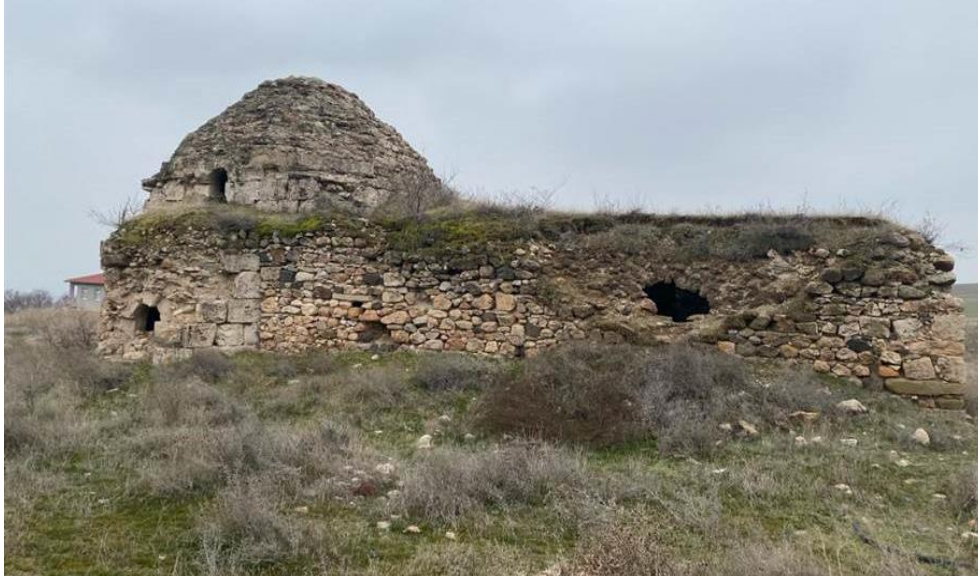
The ground level has significantly risen on the southern facade of the church, and there are also accumulations of soil on the top covering of the church. There are material losses on the northern facade of the church, and these material losses can also be observed in the interior (Figure 4.27).

Figure 4.27. North Facade of the Church (Author's Archive, 2023)

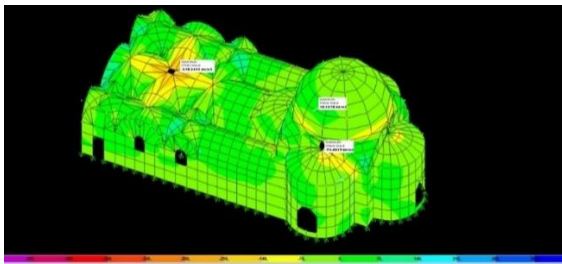
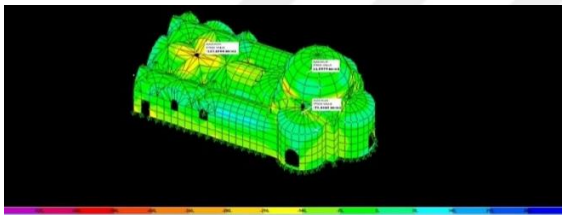
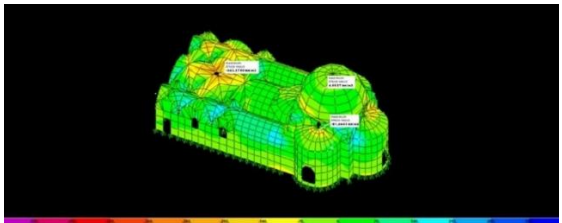
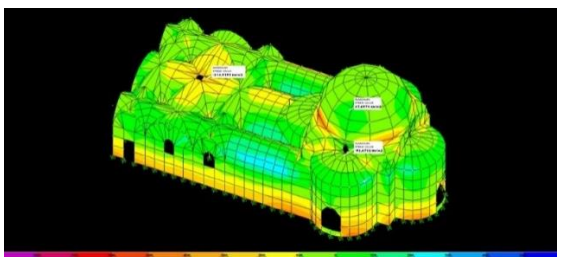
Under the earthquake load in the Y direction, tensile stresses occur in the cross vaults in the jamatun, the upper covers of the pastoforions, and the upper covers of the half domes. In the naos, compression stresses occur on the parts where the dome meets the pendentives and on the skylight of the jamatun. On the east façade, tensile stresses occur in the 1-1 direction on the apse arch and pendentives (Figure 4.38-Figure 4.41) Tensile stress was also observed in the cross vaults of the jamatun. The fact that the displacement values in the y direction are higher than those in the x direction shows that the church is more vulnerable to earthquakes in this direction. Maximum stresses of the openings of the church is given in Table 4.5.

was determined that stress accumulations occurred on the upper parts of the vaults in the jamatun section and on the northern wall of the jamatun. In the naos section, sensitivities were observed at the points where the main dome connects with the pendentives. The building has a very rigid behavior in general. Although the identified weaknesses do not threaten the structural integrity of the building for the time being, considering the seismicity of the Elazığ region, it is important to make the necessary reinforcements. According to the structural analysis, the reason why the church shows better structural behavior compared to other churches is its architectural difference from other churches. In the Surp Simon Church, which was built with the masonry construction technique; the lightness of the structure, the roof covering form used, the wall thicknesses, the ability of the domes to transfer their loads to the ground properly, the composition of building elements such as arch-vault-dome and the smaller size of the church compared to other churches are the main factors of the preservation of the structural integrity of this church today. Legal documents on the preservation, maintenance and restoration of historical buildings set out some basic principles. In line with these principles, the Surp Simon Church was documented with sensitivity. In addition, the structural behavior of the building was determined before a possible threat was encountered by making use of modern technologies. For this reason, the results of the study provide information on which considerations should be taken into account during the restoration phase of the church. Considering the current situation of the church, it is thought that the deterioration and damages seen in the structure can be eliminated with the minimum intervention principle determined in the regulations. Surp Simon Church, which has an important place in the cultural heritage of Elazığ province, needs to be conserved and passed on to future generations. The current conservation problems of the church are the soil layer accumulated on the upper cover, the uncertainty of the boundaries of the land where the church is located, the traces of writing and paint seen in the interior and the deficiencies in the flooring, which can be easily solved. The fact that the church shows a very rigid behavior structurally suggests that the church can be included in daily life with minimum intervention. In conclusion, as a part of the cultural diversity and heritage of Anatolia, which is home to many cultures, the evaluation of the church discussed in this thesis from a comprehensive perspective has contributed to the inventory of the building. It is important to transfer historical buildings, especially those under earthquake risk, to future generations through multidisciplinary studies. In future research, it is necessary to develop detailed restoration proposals in order to re-functionalize such buildings and bring them to the society.
