**UNIVERSITY OF GAZIANTEP  
GRADUATE SCHOOL OF  
NATURAL & APPLIED SCIENCES**

**REHABILITATION OF HEATED AND DAMAGED  
MEDIUM STRENGTH SELF COMPACTING STEEL FIBER  
REINFORCED CONCRETE CORBELS**

**M. SC. THESIS  
IN  
CIVIL ENGINEERING**

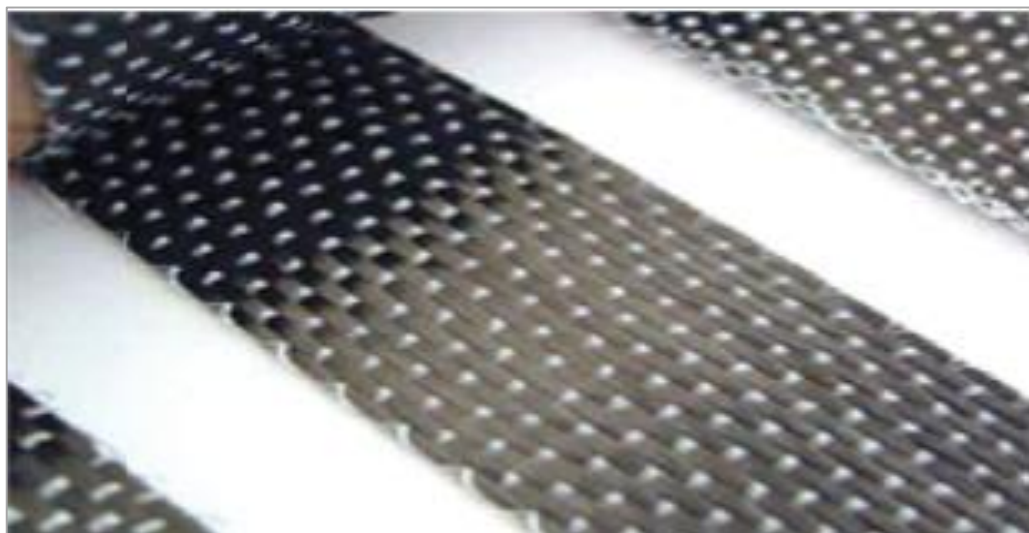
Carbon fibers are anisotropic in nature which is produced at 1300°C. The advantages of carbon fibers can be summarized as; High strength, excellent creep level, resistance to chemical effects, low conductivity, low density and high elastic modulus. Carbon fibers are expensive and anisotropic materials and it has a low compression strength these are the weak sides of carbon fibers (Sultan, 2012). Figure .1 shows the typical carbon fiber polymer.

**Figure 2.1** Typical Carbon Fiber Polymer (CFRP)

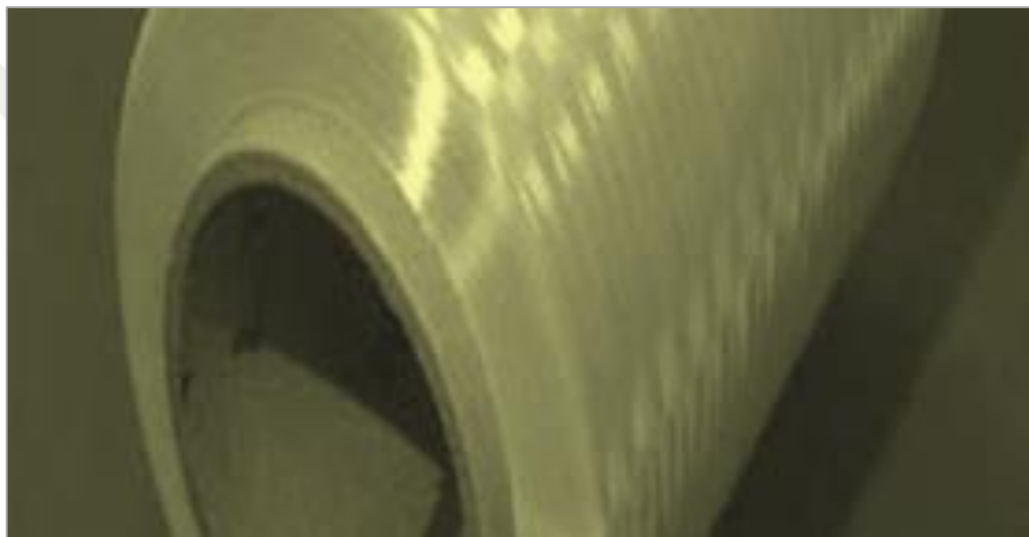
Aramid fibers widespread known as a Kevlar fiber in the markets. The structure of aramid fiber is anisotropic in nature and usually are yellow in colors. Aramid fibers are more expensive than glass, moderate stiffness, and good in tension application (Cables and tendons) but lower strength in compression. Aramids have high tensile strength, high stiffness, high modulus and low weight and density. Impact-resistant structure can be produced from aramids. There are five classes Kevlar with the different engineering properties. Kevlar-29, Kevlar-49, Kevlar- 100, Kevlar-119, Kevlar-129 (Günaşlan et al, 2014). Figure 2.2 present typical aramid fibers

**Figure 2.2** Typical Aramid Fibers Polymer (AFRP)

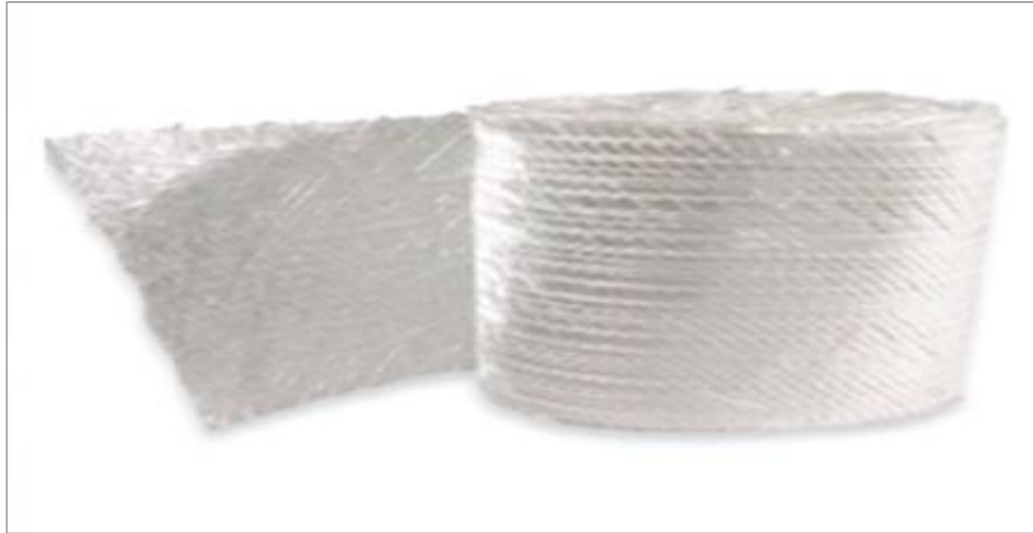
Glass fibers are isotropic in nature and most widely used filament. Common types of glass fibers are E-Glass, S-Glass and C-Glass. The characteristic properties of glass fiber are: High strength, low cost, good water resistance and resistance to chemicals (Zhang, 2010). Figure 2.3 shows the typical glass fibers (GFRP)

**Figure 2.3** Typical Glass Fibers Polymer (GFRP)

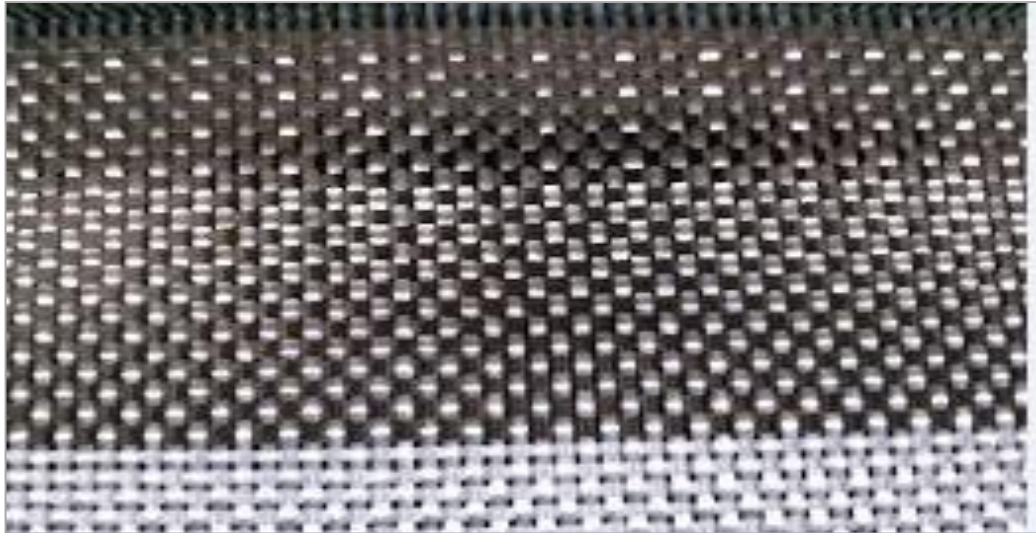
The price of fibers made from basalt is higher than those made of E-glass, but less than S-glass, aramid or carbon fiber and as worldwide production increases, its cost of production should reduce further (Jamshaid and Mishra, 2015). Figure 2.4 show the typical basalt fibers (BFRP).

**Figure 2.4** Typical Basalt Fibers Reinforced Polymer (BFRP)

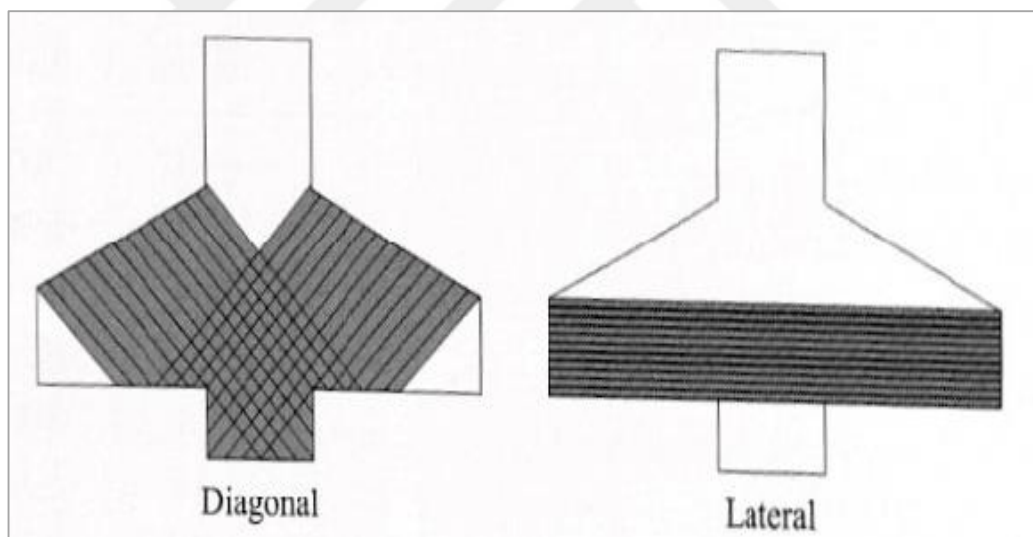
Ozden and Atalay (2011), investigated the strength and post-peak performance of reinforced concrete corbels strengthened with GFRP overlays. In the experiment 24 specimens were tested to failure under quasi-static gravity loading. The parameters studied were the strength of concrete, the shear span to depth ratio,  $a_v/d$ , the main reinforcement, and the GFRP layers and orientation, the GFRP wrapping configurations are shown in Figure 2.5.

**Figure 2.5** GFRP wrapping configurations

Test results concluded that GFRP wrapping with 45 degrees' fiber orientation (diagonal) was more effective than lateral wrapping. The level of tension steel strain on the onset of failure depends on the type and number of GFRP layers and the tension reinforcement ratio. The results also revealed that the level of strengthening with GFRP wrapping ranges from (40-200) %, depending on the reinforcement ratio,  $A_v/d$  ratio and the orientation and number of GFRP layers used.

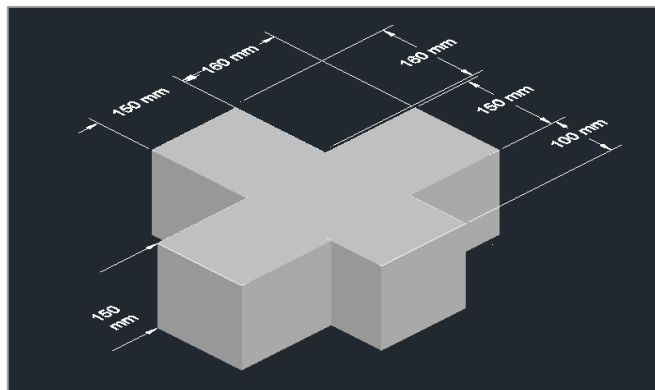
The width of the corbels is 150 mm. Both columns and corbels have the same cross section (150 × 150 mm). The stubs of the column are extended by 160 mm from above and 100 mm from below the corbels. Figure 3.1 shows the dimensions of the corbel.

**Figure 3.1** Dimensions of the corbel. (Mohammed A. KAMIL 2016)

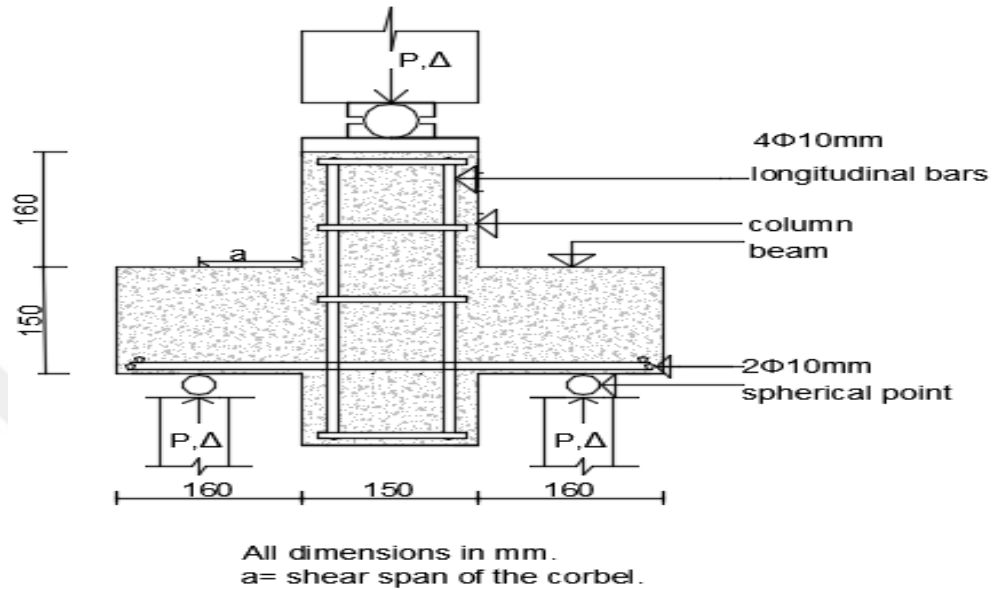
The column was reinforced with four vertical bars (10mm in diameter) and 4 stirrup reinforcement had been provided in the form of closed ties at a spacing of 90 mm. The main tension reinforcement of the corbel consisted of two 10mm diameter steel bars. Figure 3.2 shows the details of the reinforcements.

**Figure 3.2** Reinforcement details of the corbel

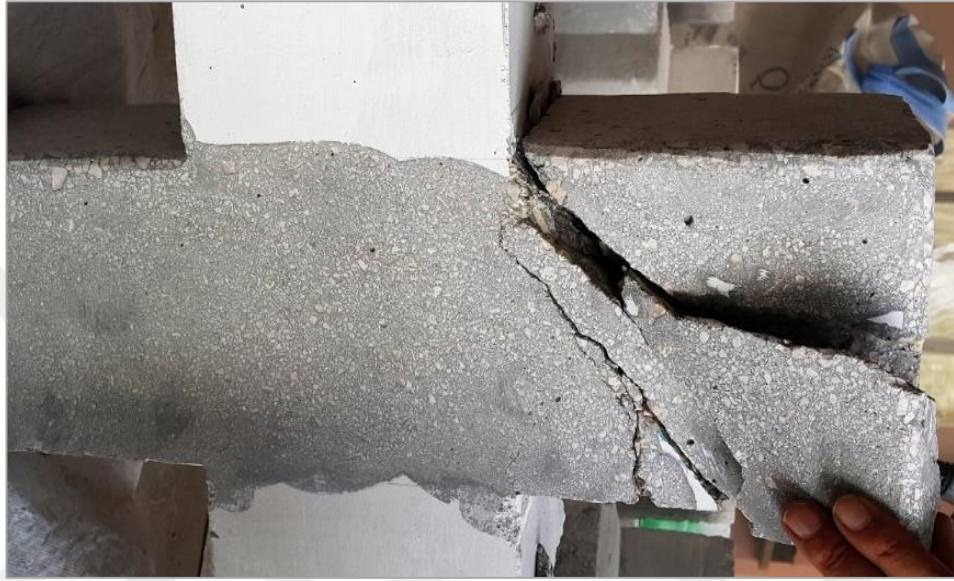
Proper preparation of the concrete surface can affect the behavior of concrete members which strengthened or repaired with FRP systems. However, some of the corbels were damaged extremely as shown in Figure 3.3, while some others were not damaged so much (see Fig. 3.4). Therefore, proper and appropriate surface preparation is required for both of them.

**Figure 3.3** High damaged corbel

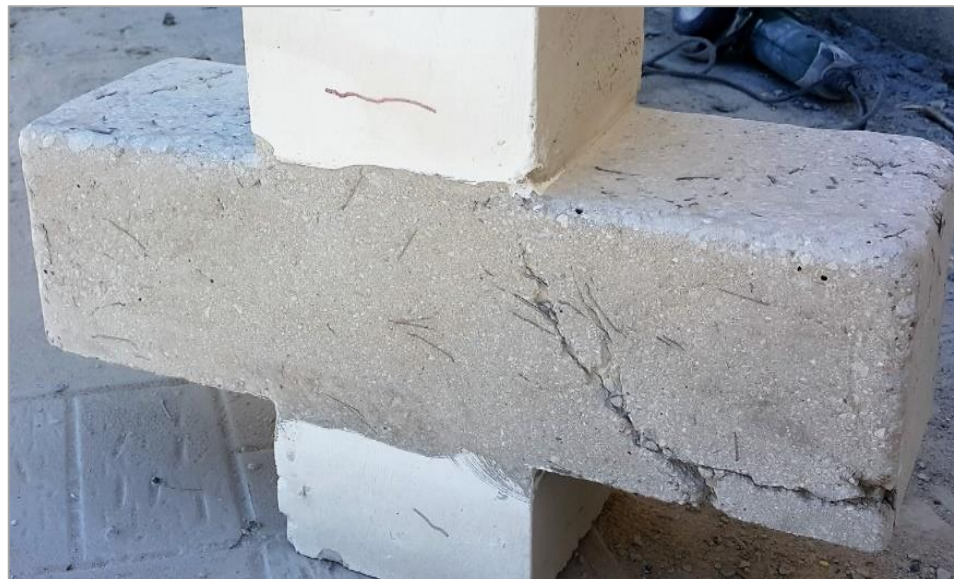
**Figure 3.4** Low damaged corbel

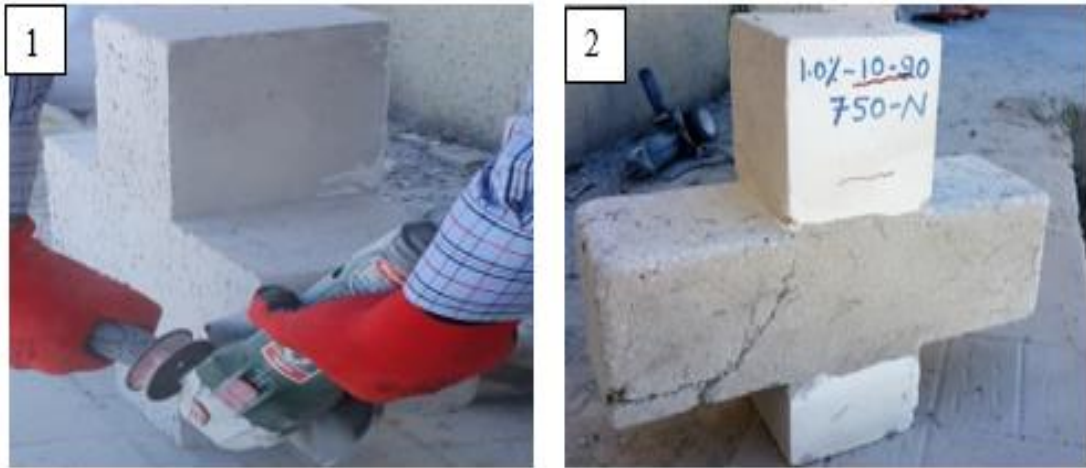
Surface grinding process was carried out by grinder machine which was used to clean the surface of corbels. The top four corners of each corbel's beam were rounded to reduce the decrease in strength, to prevent stress concentrations on them and to avoid tearing in basalt fabric (see Fig. 3.5).

**Figure 3.5** Surface grinding process

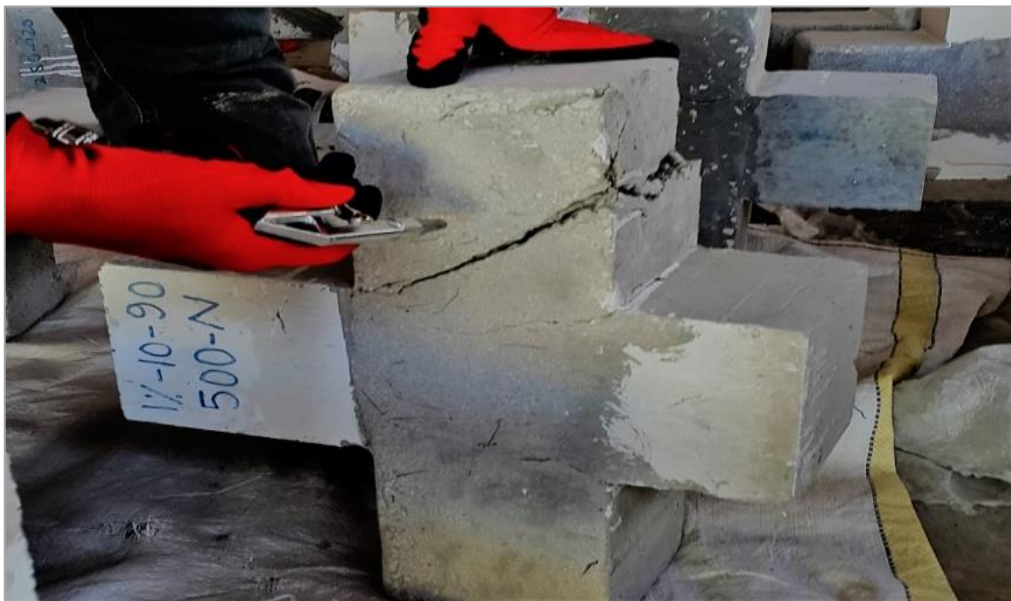
Before the gluing of basalt fiber fabric, the air compressor was used to remove any loose concrete particles or dust on the surface (see Fig. 3.6).

**Figure 3.6** Using air compressor for removing loose particles

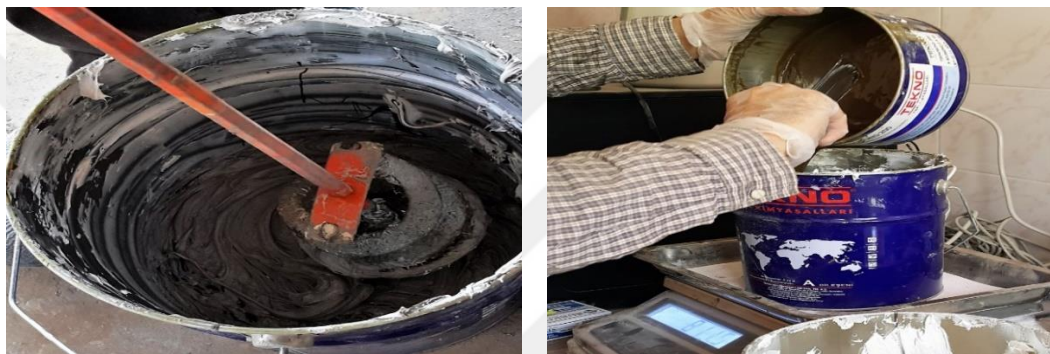
The high viscosity epoxy was used for substituting the loosening parts from damaged corbels, which is shown in Fig. 3.7, A and B components of the epoxy were mixed in a ratio of 1:1 by weight. A mechanical mixer with 500 RPM was used for mixing the components in a container until a gray color and consistency are achieved (at least 3 minutes).

**Figure 3.7** Mixing of high viscosity epoxy

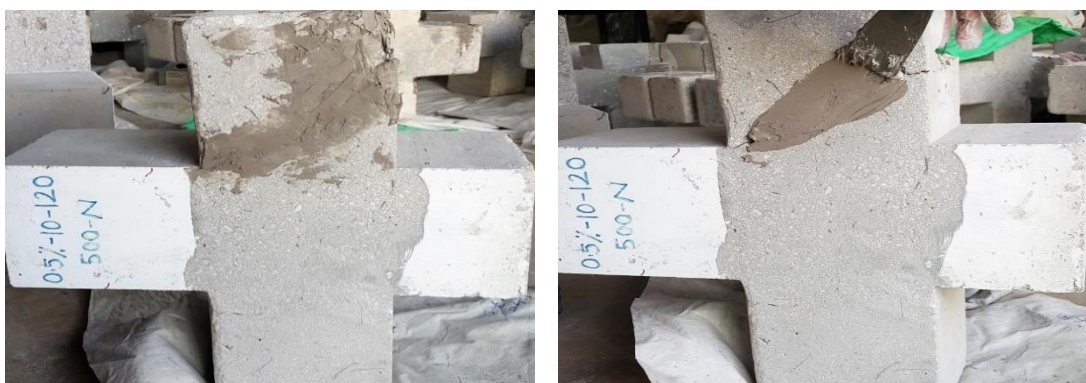
The high viscosity epoxy was also used for filling the big cracks to prevent the leakage of low viscosity resin from the cracks (see Figure 3.8).

**Figure 3.8** Filling the side cracks with high viscosity epoxy

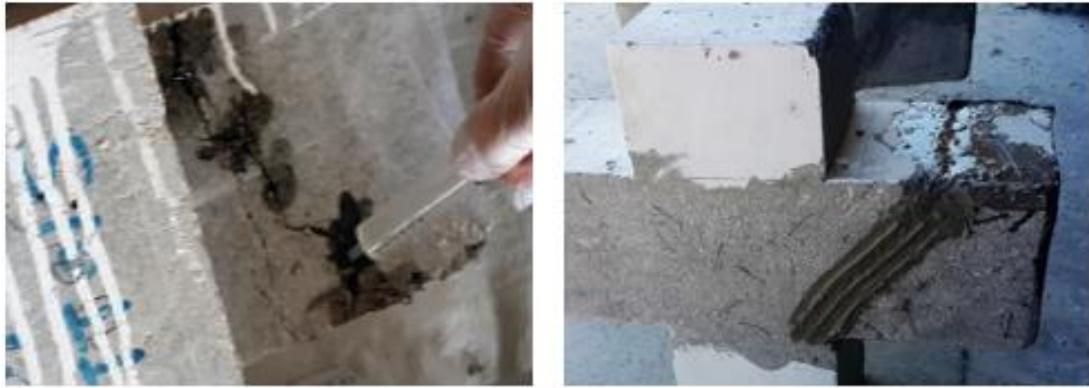
The crack repair epoxy was mixed according to the technical advice which contained in the adhesive data sheets. When the epoxy was injected into the corbels, the cracks

and voids were filled with it. In injection technique, machine was not used and penetration of the epoxy only depended on gravity (see Fig. 3.9).

**Figure 3.9** Crack repair epoxy(Sikadur-52) injection

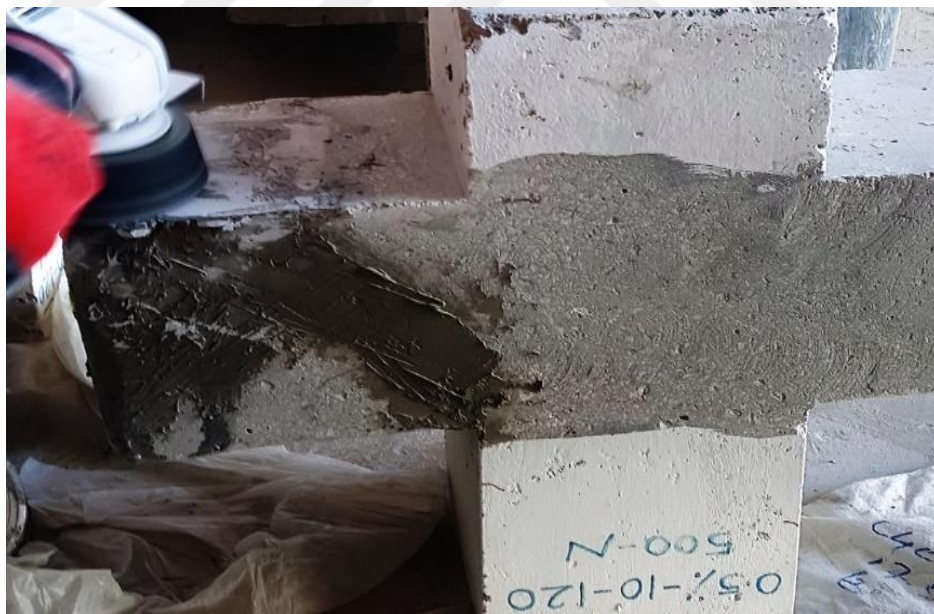
After injection process, the corbels were left for 7 days for curing of the epoxy (obtainment of the target strength of the epoxy). Then grinder machine was used to level the bottom surface of the corbel beams (see Fig. 3.10) in order to provide the appropriate setup on the testing machine.

**Figure 3.10** Grinding after injection

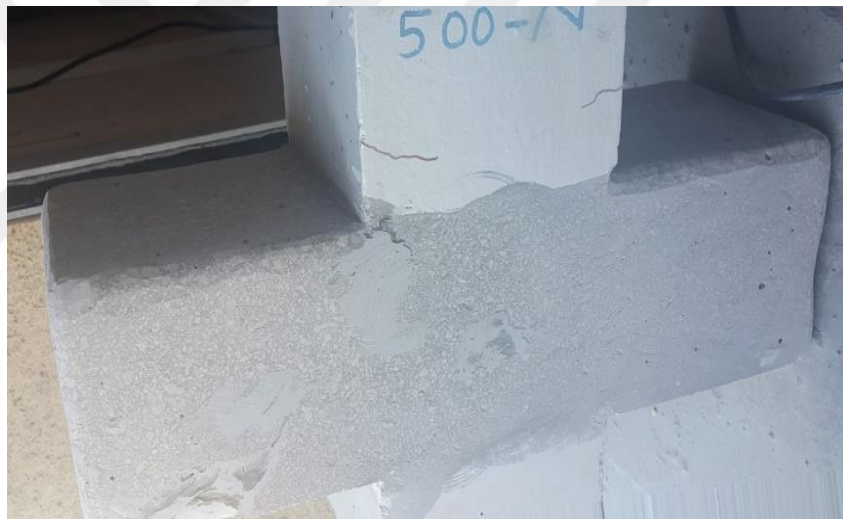
In this method, all of the corbels were subjected to the injection method before gluing the basalt fiber fabric on surface of them. The performance of externally bonded FRP can be affected by delamination or fiber crushing of FRP if the crack width is 0.3 mm or higher. Therefore, epoxy can be injected into those cracks that are wider than 0.3mm. Minor cracks require resin sealing or injection to avoid corrosion of the steel reinforcement exists in the damaged concrete members. However, for detailed methods and surface preparation of concrete, relevant criteria and guidelines can be used (ACI Committee 440, 2002). The surface of corbels became rough due to application of epoxy 200 and Sikadur-52 injection on them. Therefore, grinder machine was used to make corbel surfaces smooth and to avoid any delamination between basalt fiber fabric and the concrete surface, as shown in Figure 3.11.

**Figure 3.11** Surface preparation before gluing the basalt fiber

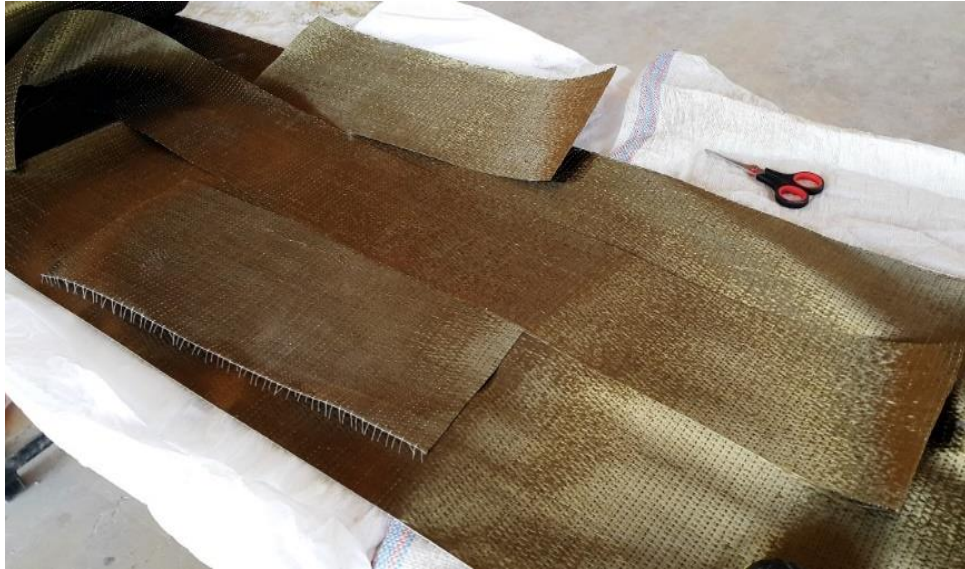
Three strips of basalt fiber fabric were cut in specific dimensions for all corbel specimens (see Figure 3.12). The epoxy hardener and resin were mixed by an electric drill machine according to TEKNOBOND 300 product data sheet. Then the basalt fabric was saturated with the epoxy (see Fig. 3.13),

**Figure 3.12** Basalt fiber strips

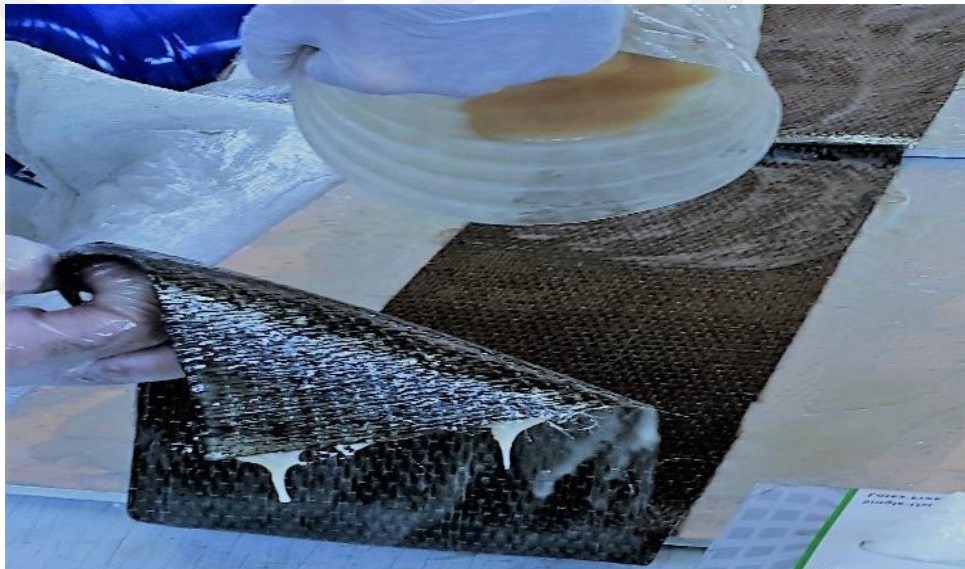
**Figure 3.13** Saturated basalt fiber with low epoxy

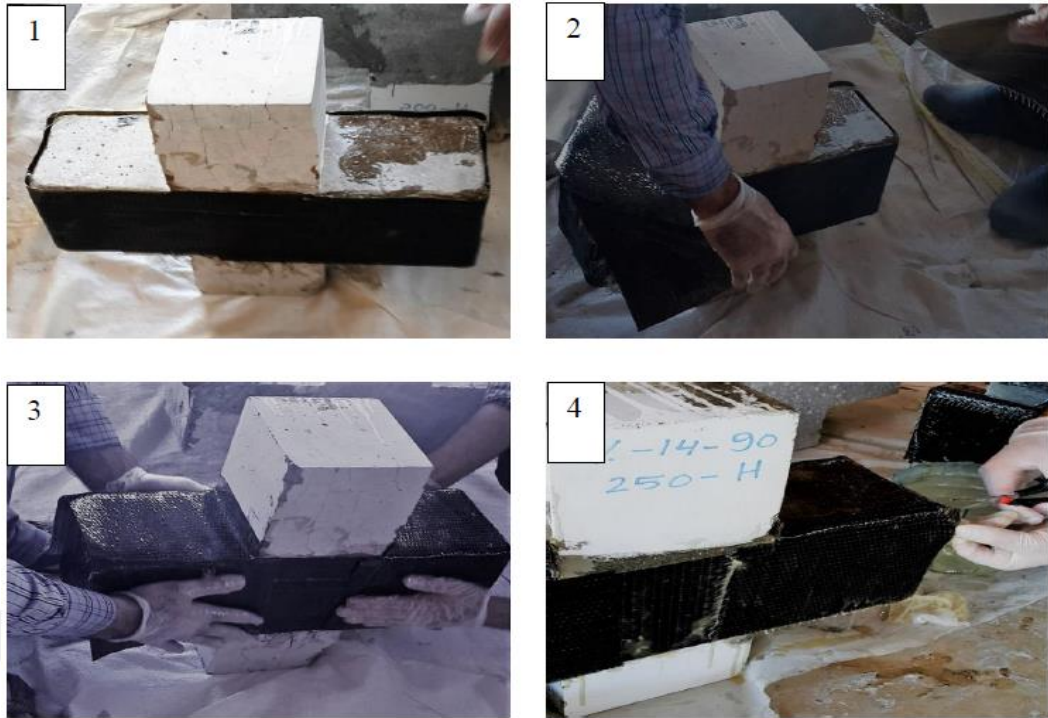
To resist vertical and horizontal stresses the saturated basalt fiber fabrics were glued bi-directionally on the corbels. The fibers were aligned parallel to the axial stresses in a layer, and another layer was wrapped transversally. Afterwards, trowel was used to eliminate air voids and to achieve perfect adhesion between the fabric and surface (see Fig. 3.14)

**Figure 3.14** Configuration steps of bonding surface and applying the Basalt Fiber

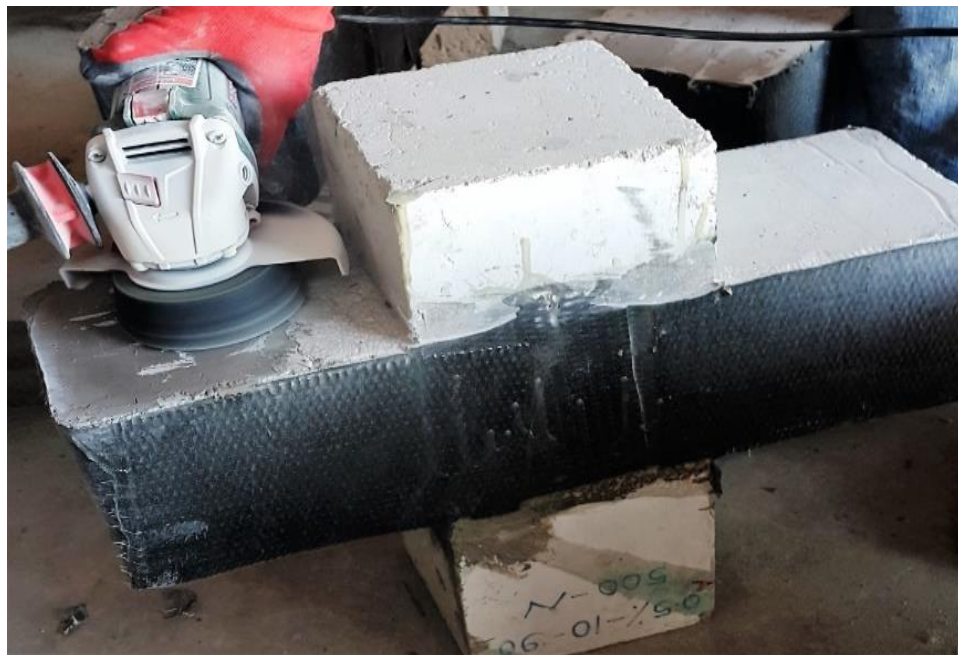
At last, grinder machine was used again for levelling of corbels' bottom surface to provide successful simultaneous load transfer mechanism up to both of supports, Figure 3.15

**Figure 3.15** Grinding after covering of basalt fiber

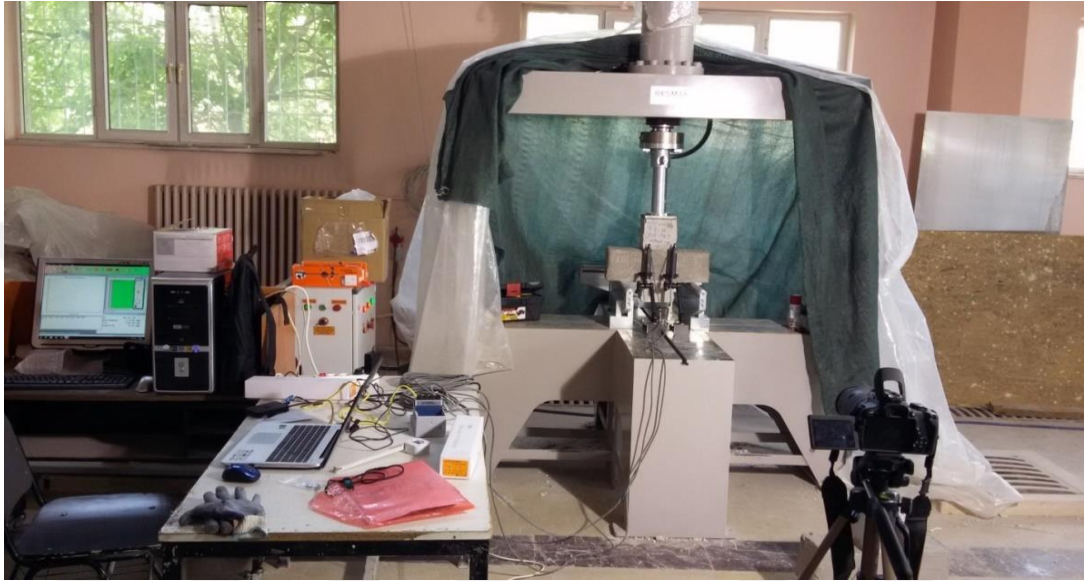
All of the corbels were tested before and after the rehabilitation process under vertical loads. As shown in Figure 3.16, a testing machine with capacity of 500 kN was used to perform loading tests and the load was applied at the top of the column. The machine was operated in displacement controlled mode with the rate of 0.4 mm/min, and the data were recorded at every 0.2 s.

**Figure 3.16** Corbel Specimen Setup.

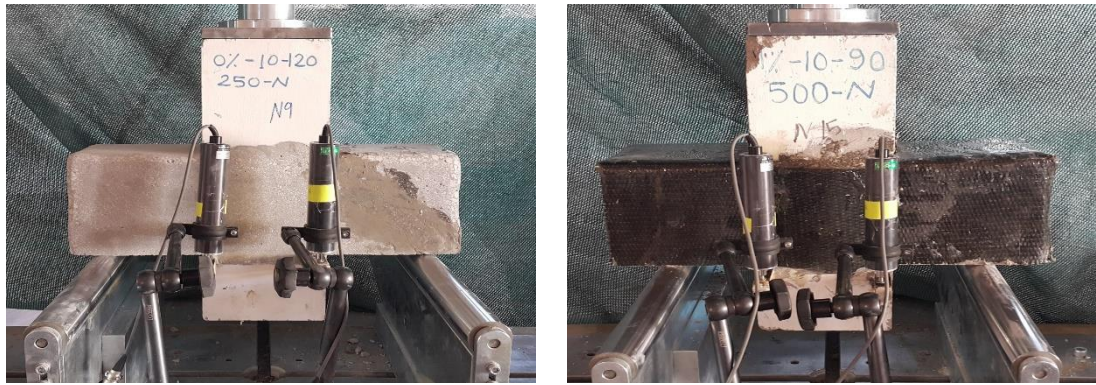
The deflection was measured using two linear variable displacement transducers (LVDT). These LVDTs were placed at two opposite sides of the corbel-column junction at the tension side of the beams. The corbel specimens were supported on two supports; with one side on a steel roller, whereas the other side was supported on a steel hinge allowing free rotation, but preventing translation in both horizontal and vertical directions. These supports were at a distance ( $a$ ) from face of the column as shown in Figure 3.17. The deflection ( $\Delta$ ) value was obtained as average values of two LVDT readings (for each specimen). Results of loads and deflections with respect to time were recorded in computer to extract load-deflection curves of the specimens. The load was transferred from the loading frame to the corbel by the 15 mm thickness loading plate. Loading plate was produced from a transmission steel to transfer the load effectively and continuously until failure.

**Figure 3.17** Injected and covered corbels with two LVDTs on the testing machine

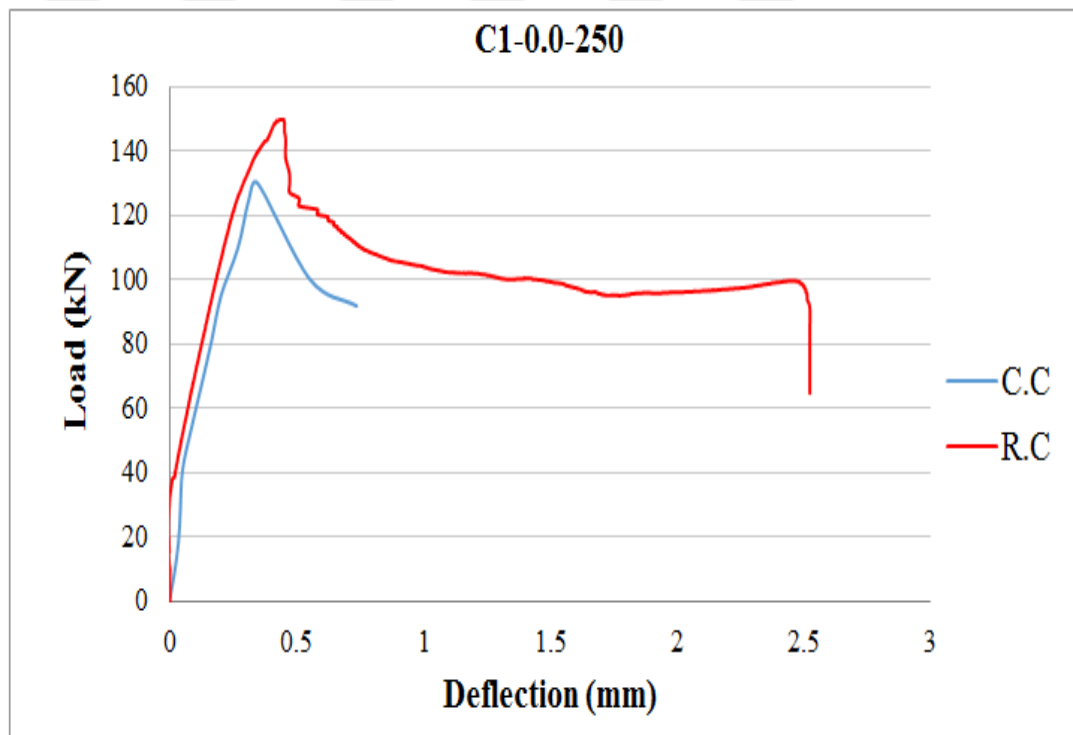
The specimen's ultimate load capacity was 130 kN. The shear failure occurred in the right beam of the corbel, and also very small micro cracks appeared in the right side as shown in Figure 4.2. Whereas the corbel was repaired by only epoxy injection, the load capacity increased in a great amount which was 1.15 of its initial value. After repairing, the mode of failure was the same with the first failure mode which was shear failure as shown in Figure 4.3. As it is shown in the load-deflection curve in Figure 4.1, the deflection at maximum load of the corbel was equal to 0.34 mm before repairing and increased to 0.44mm after rehabilitation. From the curve of R.C (Rehabilitated Corbel), it can be noted that the load capacity reached to its peak value of 150 kN, and the load directly drops to 122 kN due to the development of first cracks. After that, the load gradually decreases to 100 kN until the displacement of 2.5mm at which the corbel collapsed.

**Figure 4.1** Load-displacement curve of specimen (C1-0.0-250)

This corbel which was reinforced with two  $\phi 10$ mm steel bars for the main reinforcement, and was produced from medium strength self-compacted concrete with compressive strength of 50MPa, was prepared without steel fiber. After  $28 \pm 1$  day of water curing process, the specimen was placed in an electrical furnace and the temperature was increased by a rate of  $5^\circ\text{C}/\text{min}$  till the required temperature of  $250^\circ\text{C}$  was obtained. The corbel was maintained in the desired temperature for 1 hour. After cooling, the corbel having the shear span of 120mm was subjected to a vertical load.

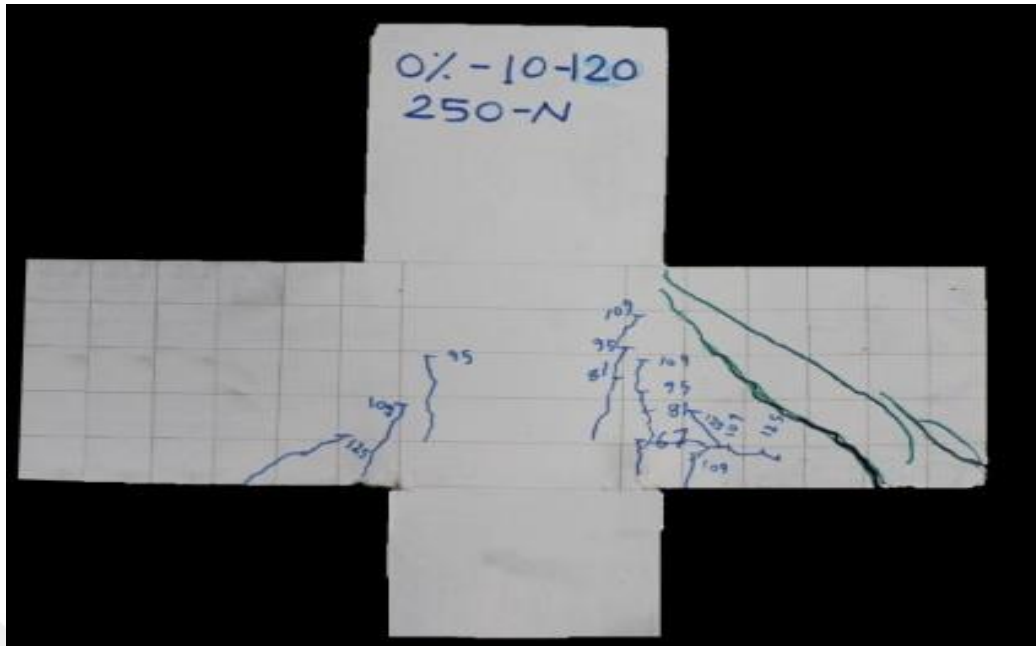
**Figure 4.2** Specimen (C1-0.0-250) failure before repairing

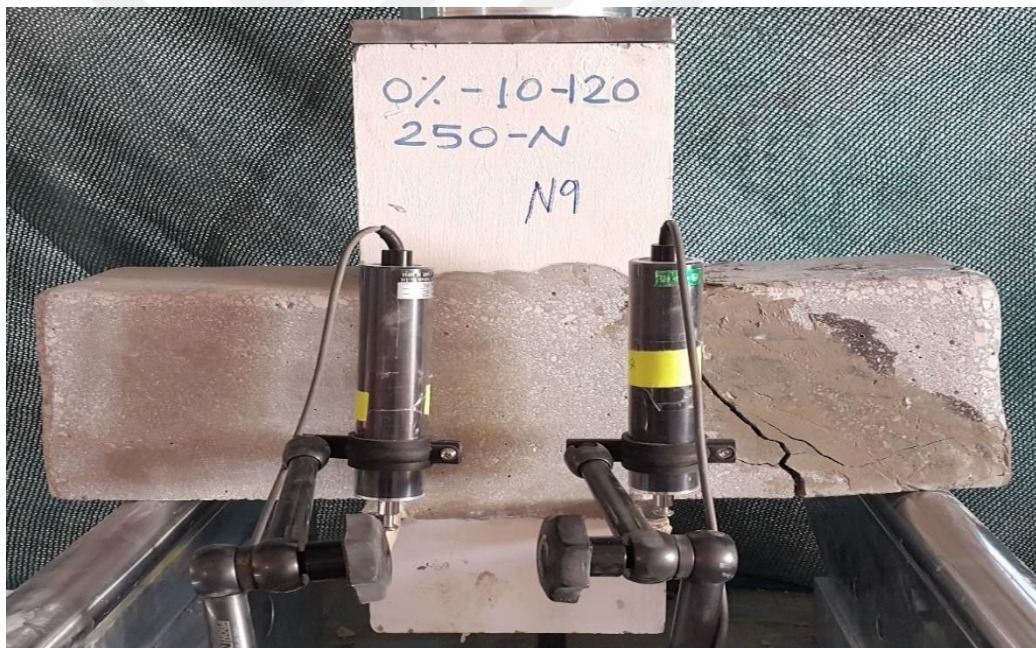
**Figure 4.3** Specimen (C1-0.0-250 ) failure after repairing

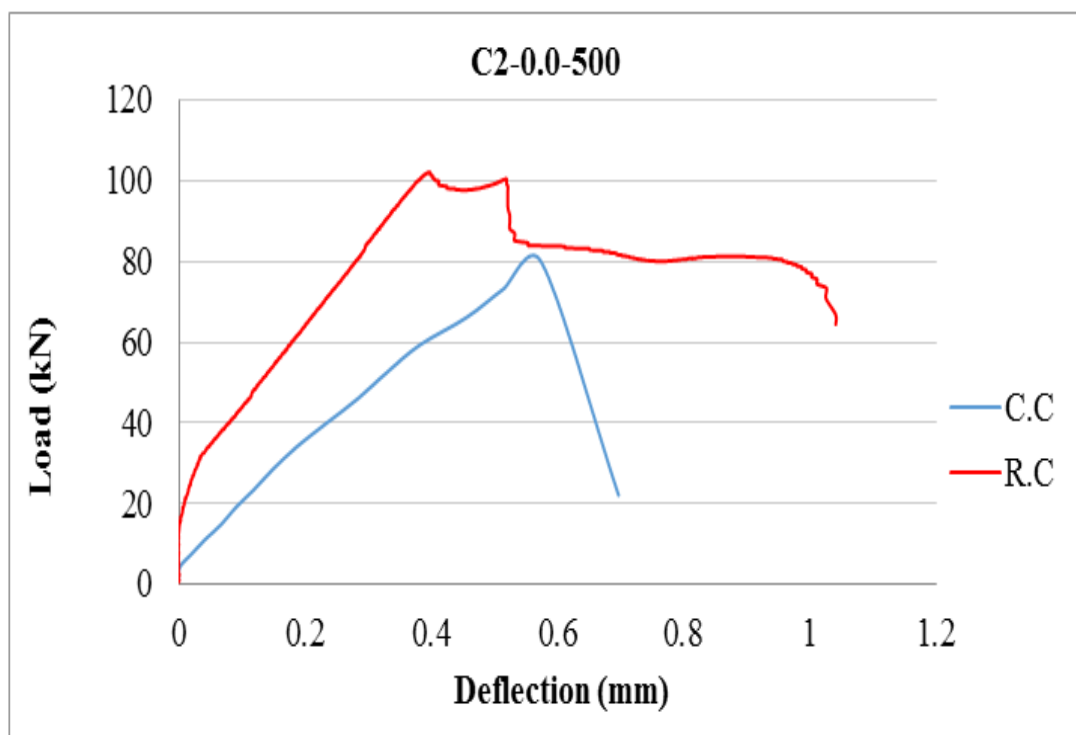
As shown from load-deflection curve of the specimen Figure4.4, the deflection at maximum load of the corbel is equal to 0.57mm before repairing and decreased to 0.40mm after rehabilitation. In the displacement of 0.52mm the R.C load dropped down for 82 kN, and the loading continued in a small rate of decrement until it collapsed in 1.04mm.

**Figure 4.4** Load-displacement curve of specimen (C2-0.0-500)

This specimen was exposed to the elevated temperature of 500°C and the corbel has the same reinforcement details and shear span with specimen of C1-0.0-250. The ultimate load capacity before rehabilitation was 80 kN with diagonal splitting failure mode in the left side, and a few number of micro cracks on the right side as well, (see Figure4.5). The specimen was repaired by epoxy injection only in order to investigate the effectiveness of restoring the capacity after rehabilitation. The results showed an extremely high improvement in the capacity of the corbel after repairing, where the rate of increasing was 1.28 of the initial value. In other words, absence or lower number of micro cracks provides the corbel to be stronger when only epoxy injection is used for repairing of it. After rehabilitation, the peak load increased to 102 kN with the same failure pattern as shown in figure 4.6. The new diagonal splitting failure crack occurred near the old one on the same side.

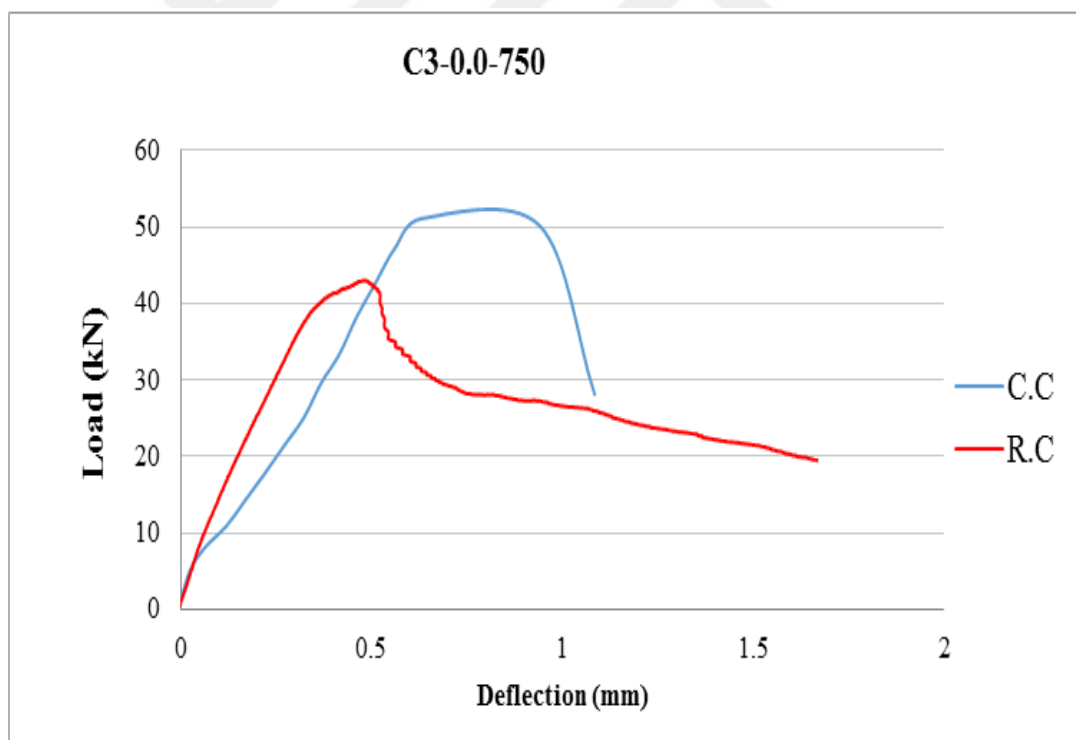
**Figure 4.7** Load-displacement curve of specimen (C3-0.0-750)

It can be noted from the load-deflection curve Figure 4.7, at displacement of 0.53mm the R.C load is dropped rapidly. After that, the load gradually decreased until collapse occurred at displacement of 1.66mm.

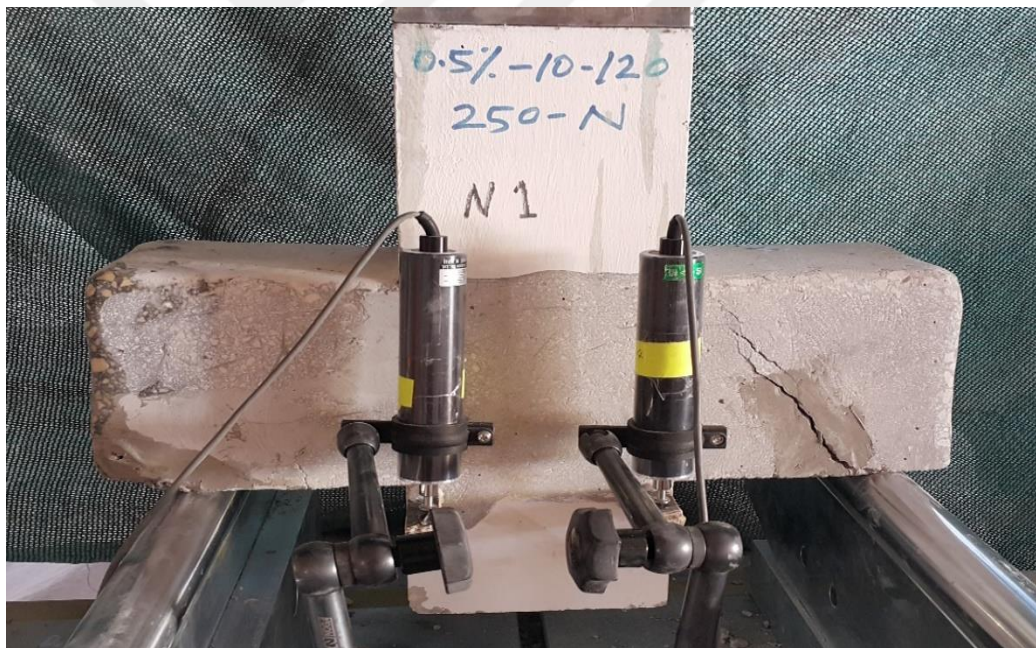
**Figure 4.12** Specimen (C4-0.5-250 ) after repairing

After epoxy injection was used to repair the damaged corbel, 0.67 of its original load capacity was restored. It can be seen from Figure 4.12, that the failure is apparent on the right beam of the corbel, the side which was neither totally damaged nor perfectly injected due to high presence of micro cracks. Transfer of the failure indicates that the corbel did not fail on the repaired corbel side. Consequently, the rehabilitation process succeeded. As shown from load-deflection curve in Figure 4.10, the displacement at maximum load after repairing is equal to 0.70mm, and the load decreases gradually after peak load due to the existence of steel fiber.

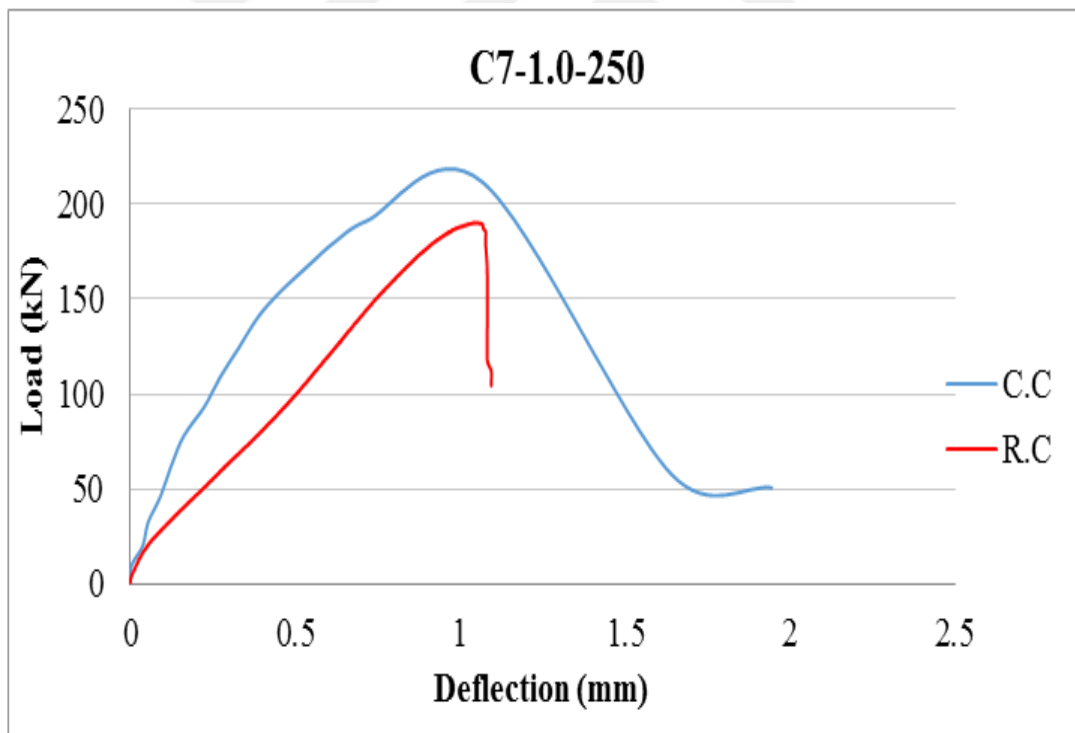
**Figure 4.19** Load-displacement curve of specimen (C7-1.0-250)

Figure 4.19 shows corbel displacements before and after rehabilitation that equal to 1.06mm and 1.05mm at maximum load respectively. It can be noted that when the corbel reaches its peak capacity, the load directly drops due to the shear failure.

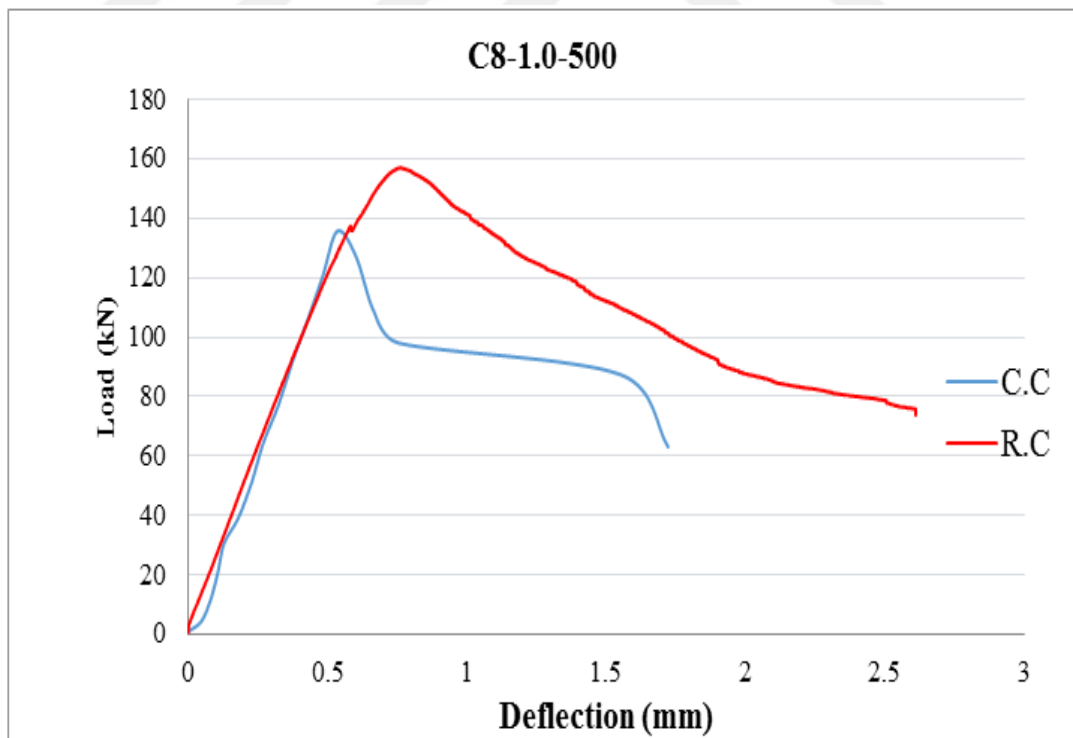
**Figure 4.22** Load-displacement curve of specimen (C8-1.0-500)

The deflection of the corbel at maximum load before repairing is equal to 0.53mm and increased to 0.76mm after rehabilitation. Presence of 1.0% of steel fiber in the corbels' concrete mix affects the load drop as shown in figure 4.22, in which the corbel gradually comes to colapse at 2.62mm after reaching to its peak capacity.

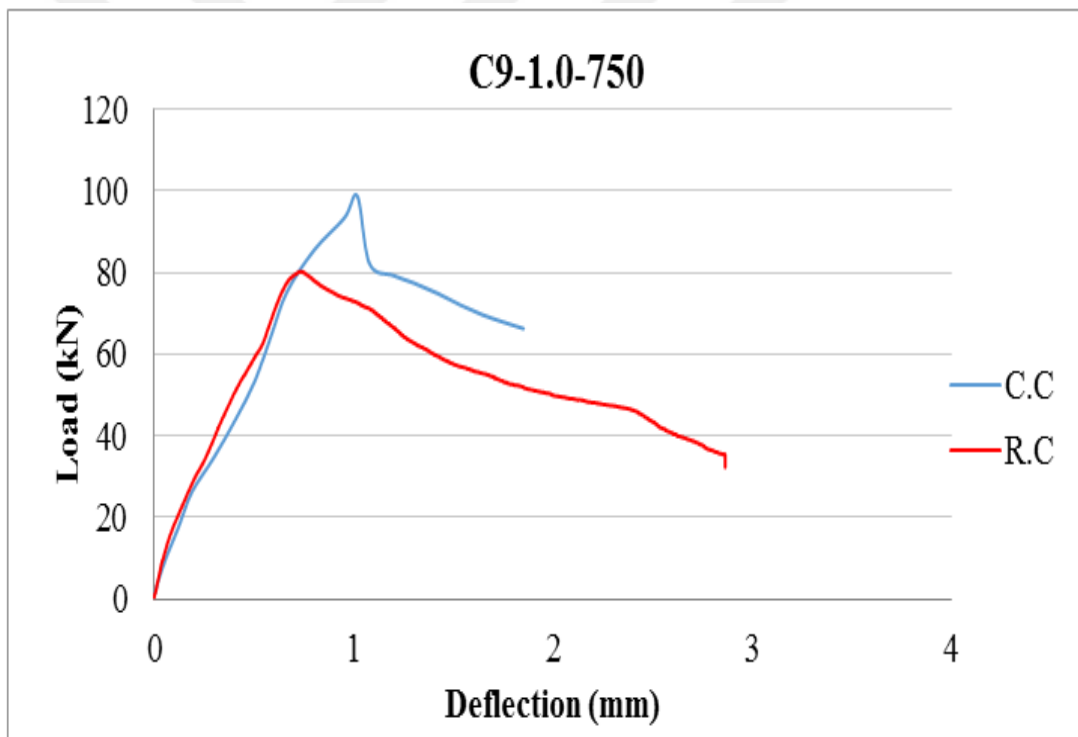
**Figure 4.25** Load-displacement curve of specimen (C9-1.0-750)

As it can be noted from the load-deflection curve in Fig. 4.25 that after at displacement of 0.73mm the load on R.C drops gradually from 80 kN to 35 kN. The drop is due to propagation of cracks and its gradual nature is due to the existence of steel fiber.
