**UNIVERSITY OF GAZIANTEP  
GRADUATE SCHOOL OF  
NATURAL & APPLIED SCIENCES**

**REHABILITATION OF HEATED AND DAMAGED  
MEDIUM STRENGTH SELF COMPACTING STEEL FIBER  
REINFORCED CONCRETE CORBELS**

**M. SC. THESIS  
IN  
CIVIL ENGINEERING**

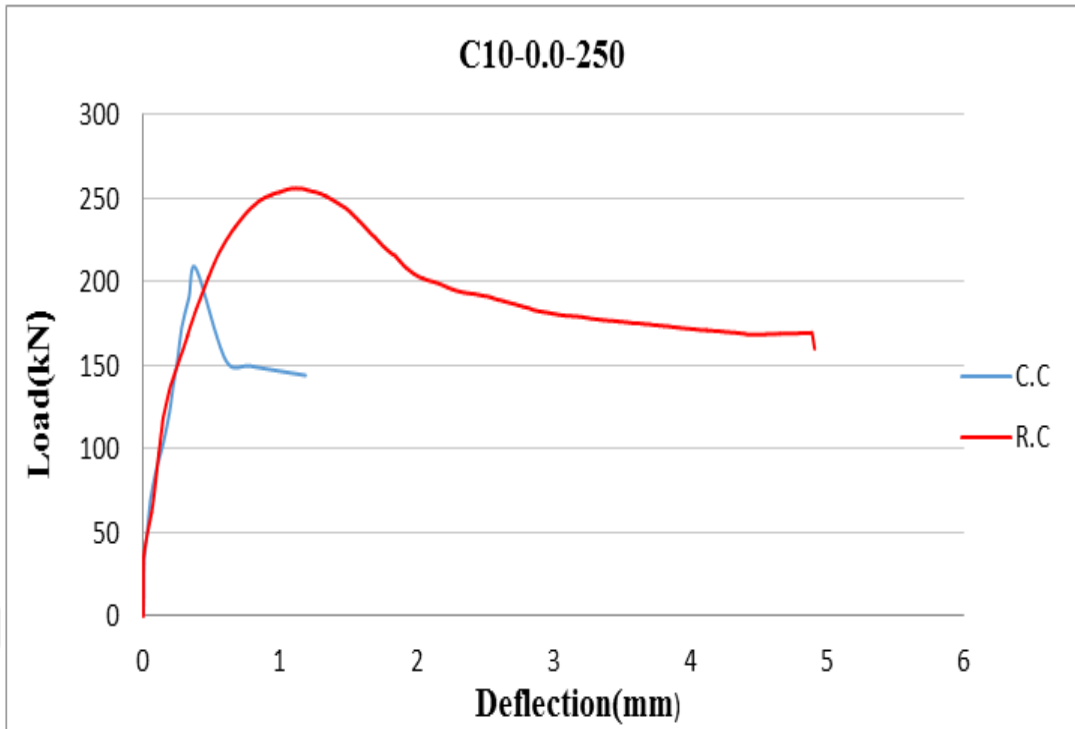
**Figure 4.28** Load-displacement curve of specimen (C10-0.0-250)

As it is shown in load-deflection curve (Fig. 4.28) that the maximum displacement of the control corbel C.C before repairing is equal to 1.18mm and increased to 4.89mm after strengthening. From the figure it can be noted that before strengthening, the ultimate load capacity is 208 kN with corresponding displacement of 0.38mm. The corbel failed because of shear failure. After strengthening, the load capacity increases to 256 kN with corresponding displacement of 1.11mm. The load remains constant for a while and drops with a smaller slope until failure that leads to ductile behavior after repairing and strengthening.

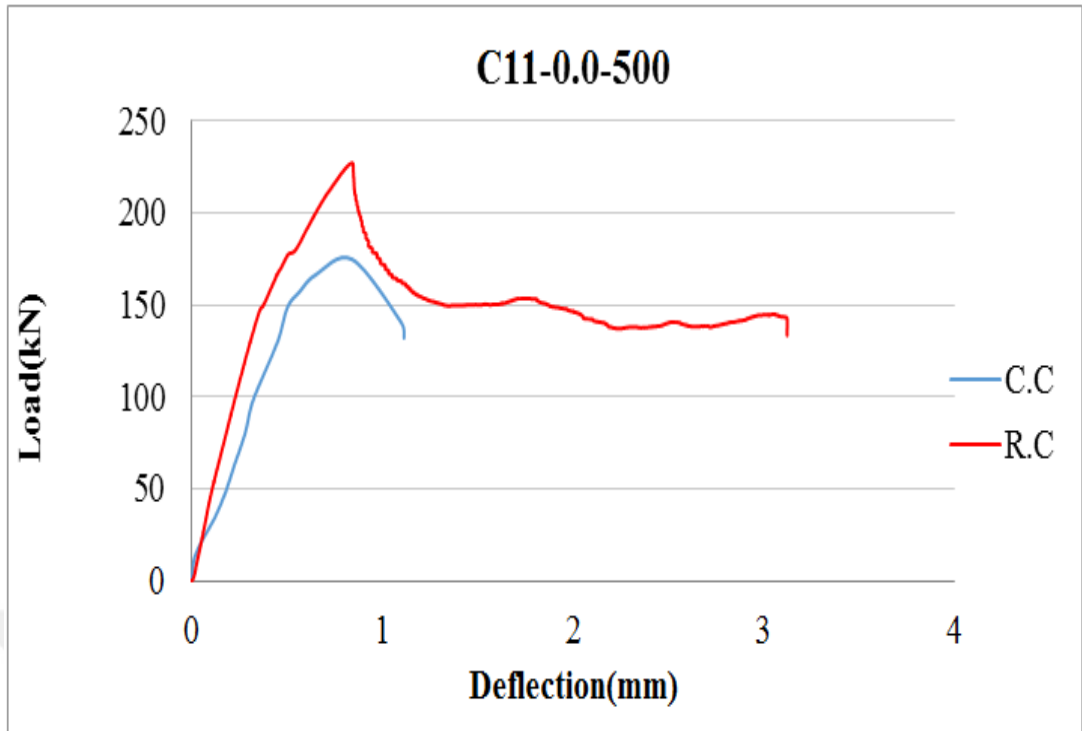
Figure 4.31 Load-displacement curve of specimen (C11-0.0-500)

As it is shown from load-deflection curve (Fig. 4.31) that the maximum deflection of the corbel before repairing is equal to 1.11mm, while it increases to 3.12mm after rehabilitation. It means that ductile behavior is achieved in addition to increase in load capacity after rehabilitation.

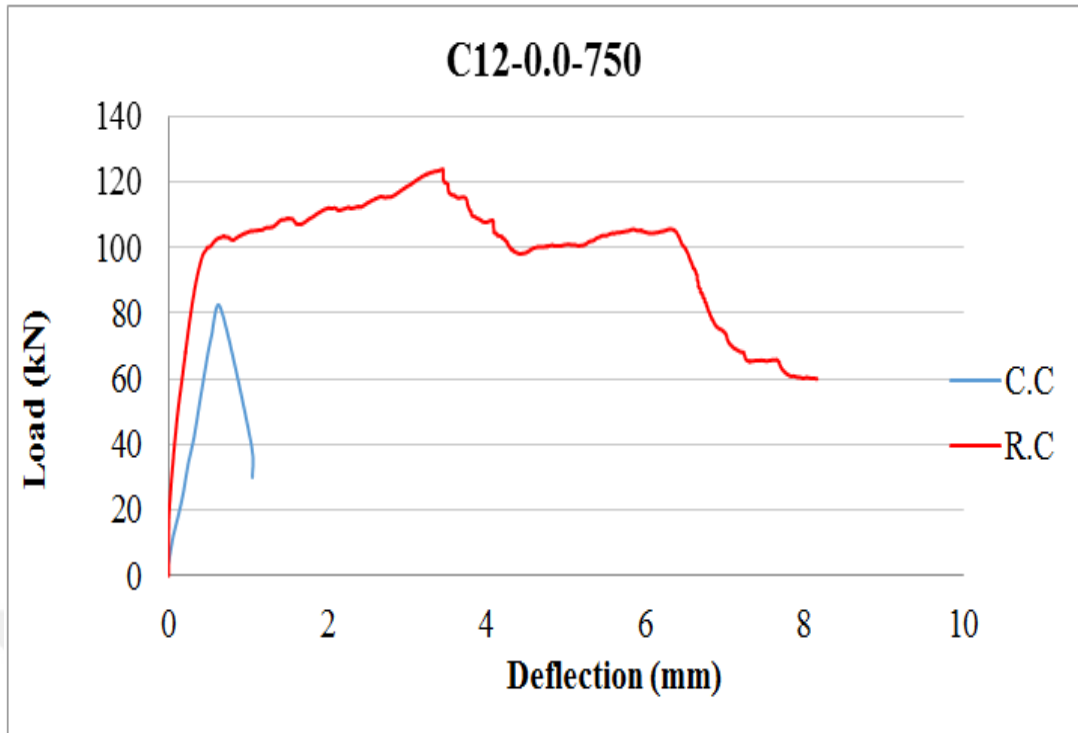
**Figure 4.34** Load-displacement curve of specimen (C12-0.0-750)

It is shown in the Figure 4.34 that the displacement is equal to 0.65mm at maximum load before rehabilitation and after strengthening it increased to 3.45mm. It can be noted that the load does not drop directly and the corbel becomes more ductile due to basalt fiber fabric, and the maximum deflection increased to 8 mm from 1.05mm.

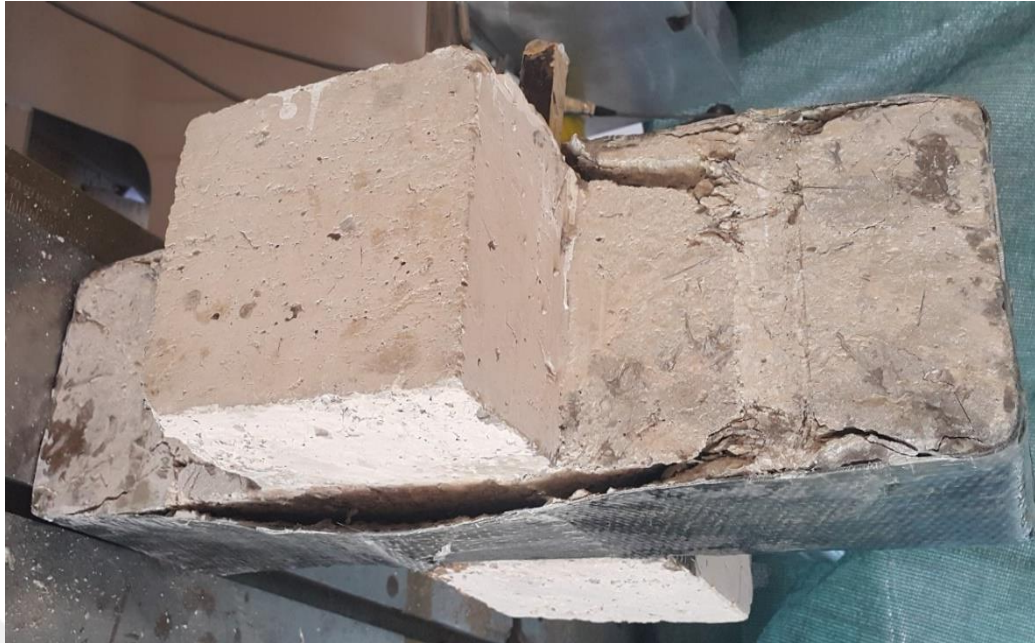
**Figure 4.36** Specimen (C12-0.0-750 ) de-bonding failure after strengthening  
**C13-0.5-250:**

After rehabilitation the peak load capacity increased to 124 kN with the same failure pattern as previous corbel (see Fig.4.36). De-bonding failure because of difference in the strength between basalt fiber which was placed as two layers in two directions and the adhesive resin.

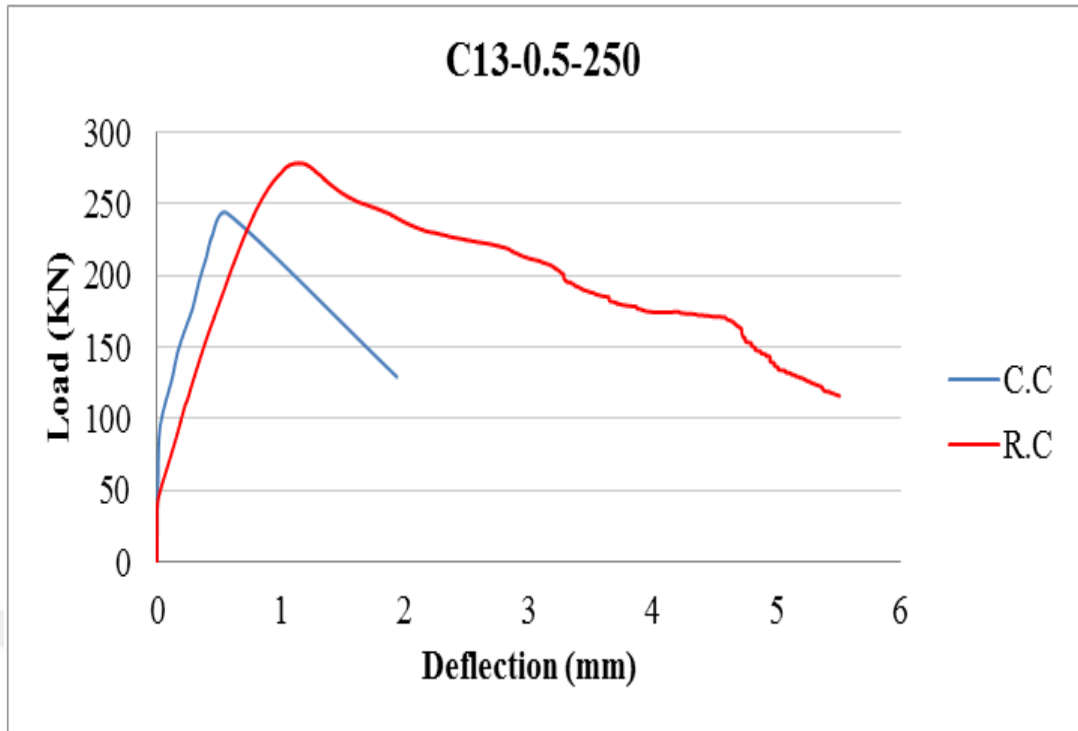
Figure 4.37 Load-displacement curve of specimen (C13-0.5-250)

The load–displacement response of the specimen is shown in Fig. 4.37. Maximum displacement rises from 1.9 mm to 5.5mm. It is obvious from the trend of the curve that ductility increases after strengthening. Furthermore, deflection at maximum load is increased from 0.56 mm to 1.13 mm after strengthening. The post-peak (descending) part of the load-deflection curve indicates that load decreases gradually depending on the presence of steel fiber (SF) and basalt fiber fabric.

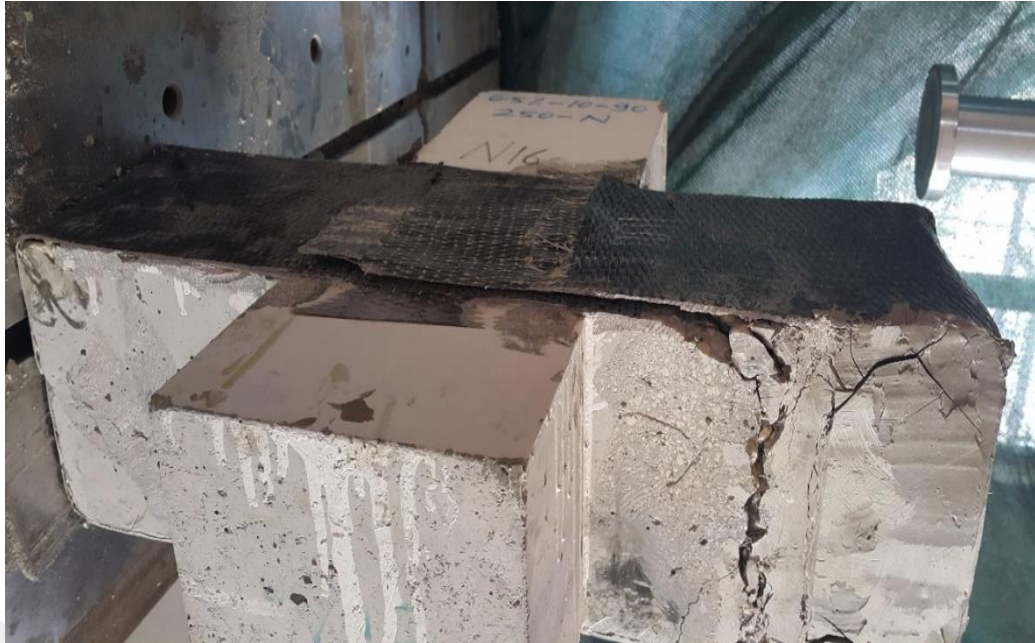
**Figure 4.39** Specimen (C13-0.5-250) de-bonding failure after strengthening  
**C14-0.5-500:**

After the corbel had been repaired with epoxy injection and it had been strengthened with basalt fiber fabric, load capacity increased as the amount of 14% of its original value. After strengthening, the ultimate load capacity increased to 247 kN. Separation of basalt, de-bonding failure, was occurred as shown in Fig. 4.39.

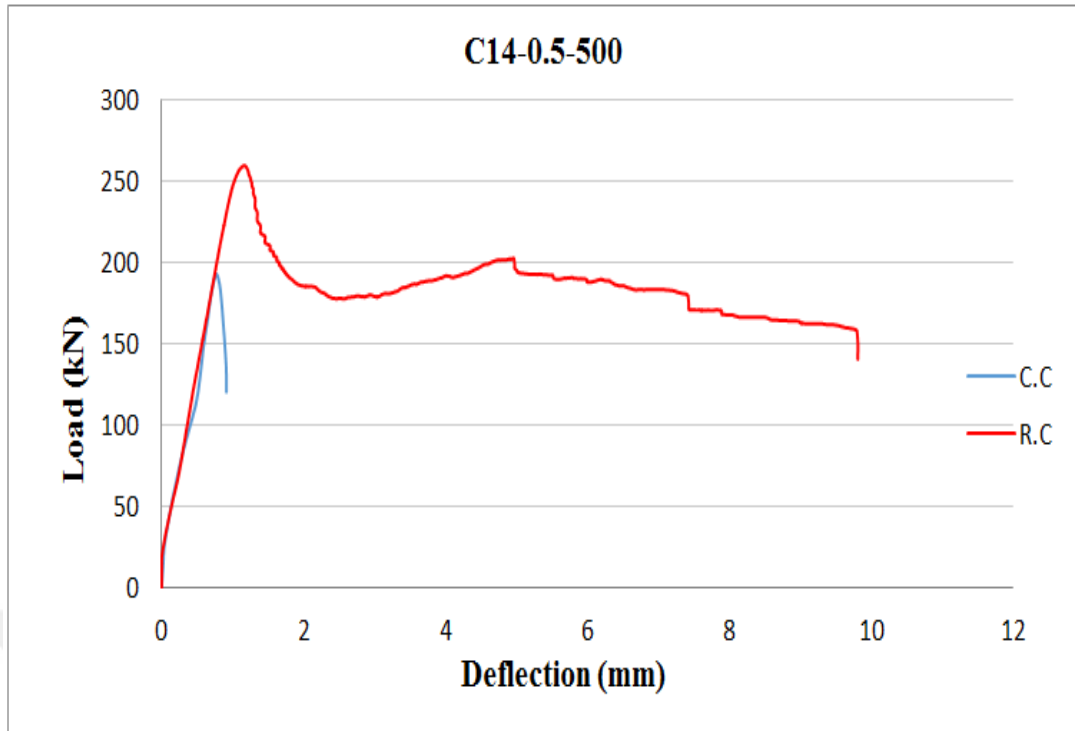
**Figure 4.40** Load-displacement curve of specimen (C14-0.5-500)

The damaged corbel was repaired with epoxy injection and was strengthened by externally wrapped basalt fiber fabric. After strengthening, the corbel was tested with the same loading condition and shear span with previous control corbel. The ultimate capacity of the specimen increased to 260 kN with corresponding displacement of 1.15mm and the same failure (de-bonding) occurred (see Fig.4.42). The maximum displacements of the specimen before and after strengthening are equal to 0.91mm and 9.81mm, respectively (see Fig. 4.40). The increase of the maximum displacement as shown in the curve indicates the remarkable improvement in the ductility after strengthening.

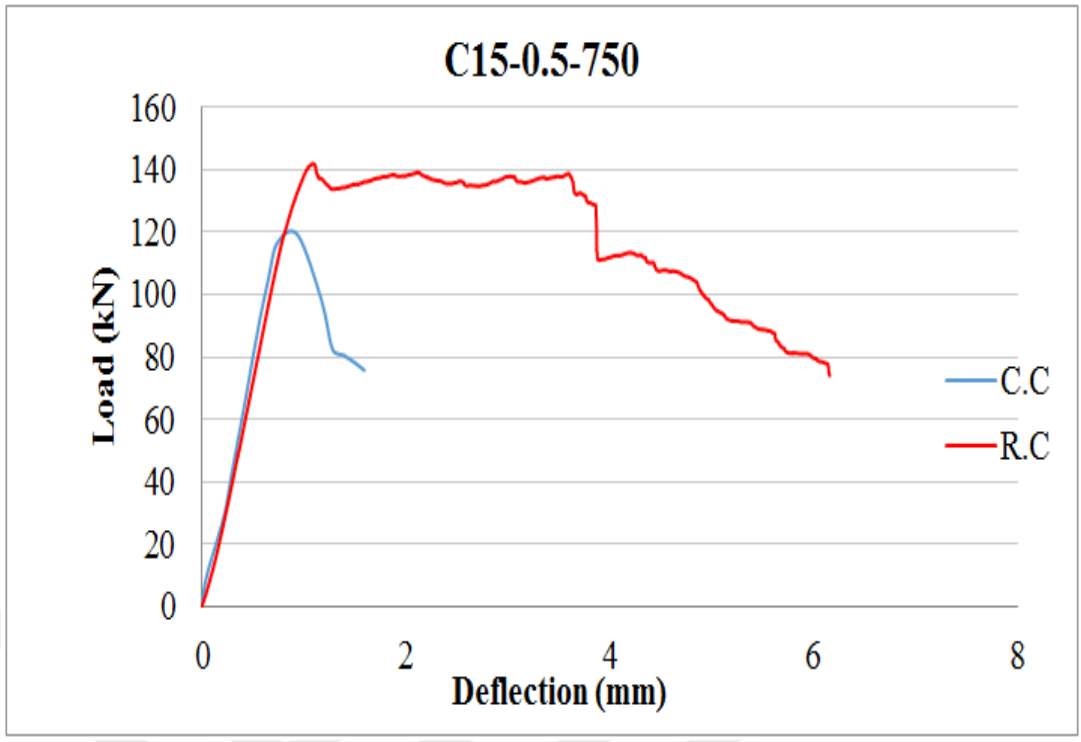
Figure 4.43 Load-displacement curve of specimen (C15-0.5-750)

This corbel was exposed to very high temperature of  $750^{\circ}\text{C}$ . In addition to main reinforcement the concrete was reinforced with 0.5% steel fiber. The corbel was loaded vertically with shear span of 90 mm. The first hairline crack appeared at load of 80 kN on the left side of the specimen and other cracks formed at load of 105 kN on the other side of the specimen (see Figure4.44). When the load reached to 119 kN, shear failure occurred on the left side of the specimen with corresponding displacement of 0.93 mm (see Figure4.43). The maximum displacement of the sample was 1.59 mm.

After crack repair material had been injected into the corbel and the corbel had been strengthened with basalt fiber fabric, the specimen was loaded vertically. The ultimate capacity increased in amount of 19% of the original value. The failure mode of the specimen, after strengthening, was de-bonding failure and the ultimate load capacity increased to 142 kN. The maximum displacement increases to 6.15 mm and thus the specimen's behavior becomes more ductile as shown from Fig. 4.43.

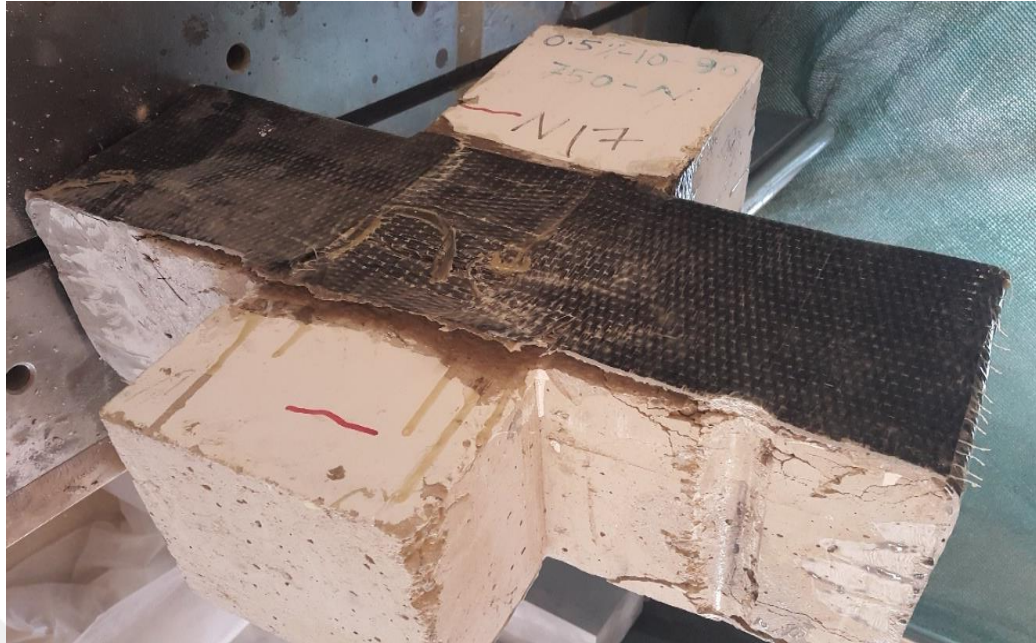
**Figure 4.45** Specimen (C15-0.5-750 ) de-bonding failure after strengthening

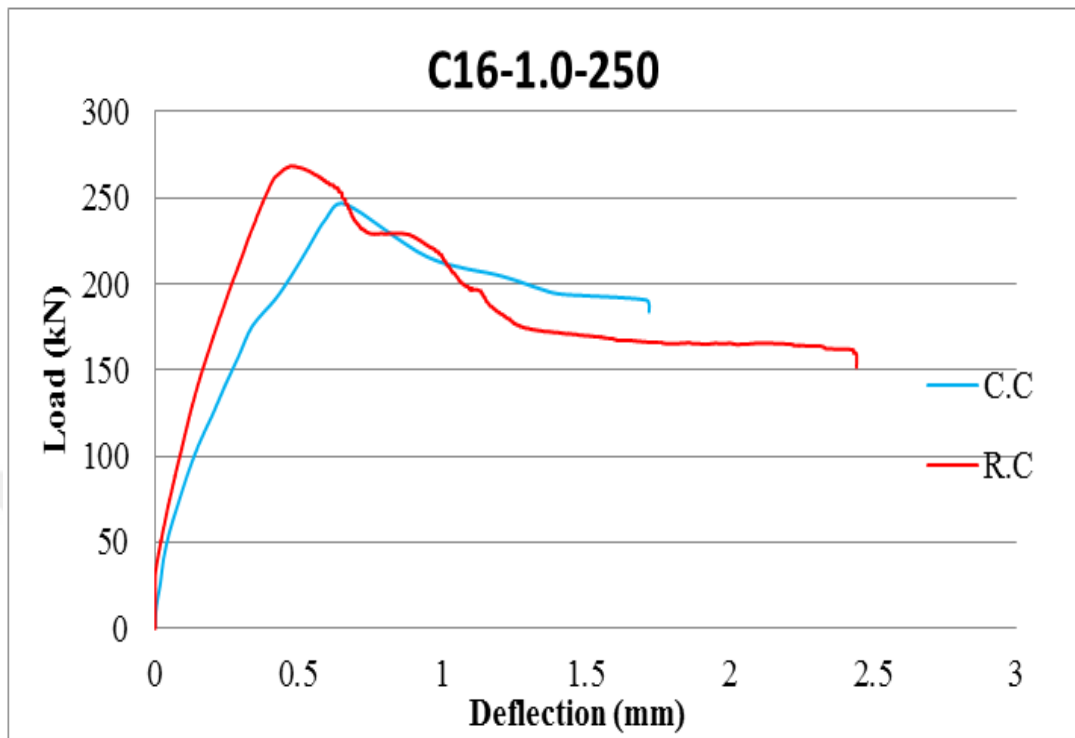
Figure 4.46 Load-displacement curve of specimen (C16-1.0-250)

This specimen had been maintained in an electrical furnace with temperature degree of 250°C. The corbels' concrete mix contained 1.0% of steel fiber as volume, the shear span to depth ratio ( $a/h$ ) was 0.6 (the shear span was 90mm). The sample had been damaged by vertical loading. The first crack was observed as flexural crack at load of 106 kN on the left side. When the load reached to 141 kN the cracks were appeared on both sides of the corbel, (see Fig. 4.47). The cracks were followed by a shear crack at the load of 221 kN on the left side of corbel. The corbel reached to its ultimate capacity of 247 kN at displacement of 0.66 mm, and also the total displacement of the corbel was 1.71mm.

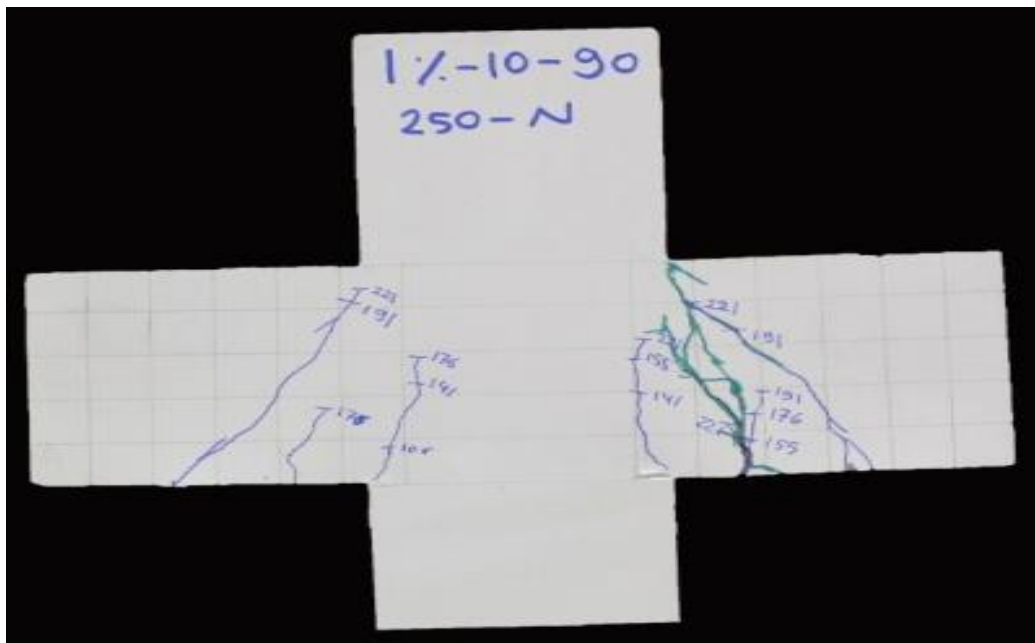
Figure 4.47 Specimen (C16-1.0-250) failure before strengthening

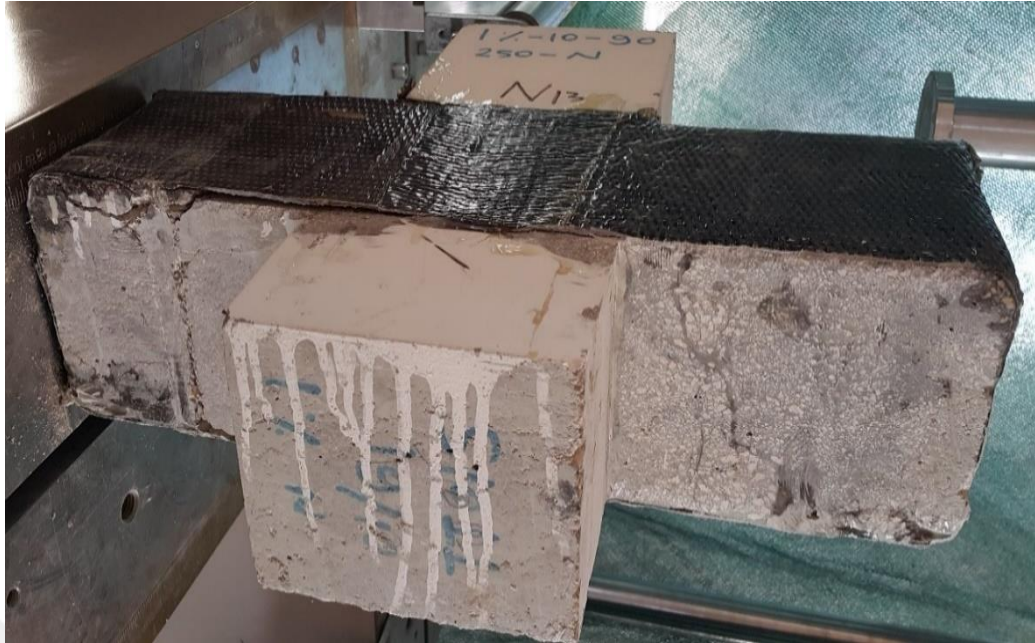
**Figure 4.48** Specimen (C16-1.0-250 ) de-bonding failure after strengthening  
**C17-1.0-500:**

After failure of the corbel, it was repaired with epoxy injection and was externally strengthened with basalt fiber. After strengthening, the ultimate capacity of the corbel was 268 kN, which means the load increased in amount of 0.09% of its initial value. The existence of high number of micro cracks had negative effect on increasing the load capacity after strengthening. However, the corbel was not exposed to very high temperature as some of other corbels. Like previous rehabilitated and strengthened corbels, the specimen's failure mode was de-bonding, as shown from Fig. 4.48. Even though the corbel's displacement at maximum load decreased, it can be noted from

Fig. 4.48 that the basalt fabric makes the corbel more ductile by increasing the total displacement from 1.72mm to 2.44mm.

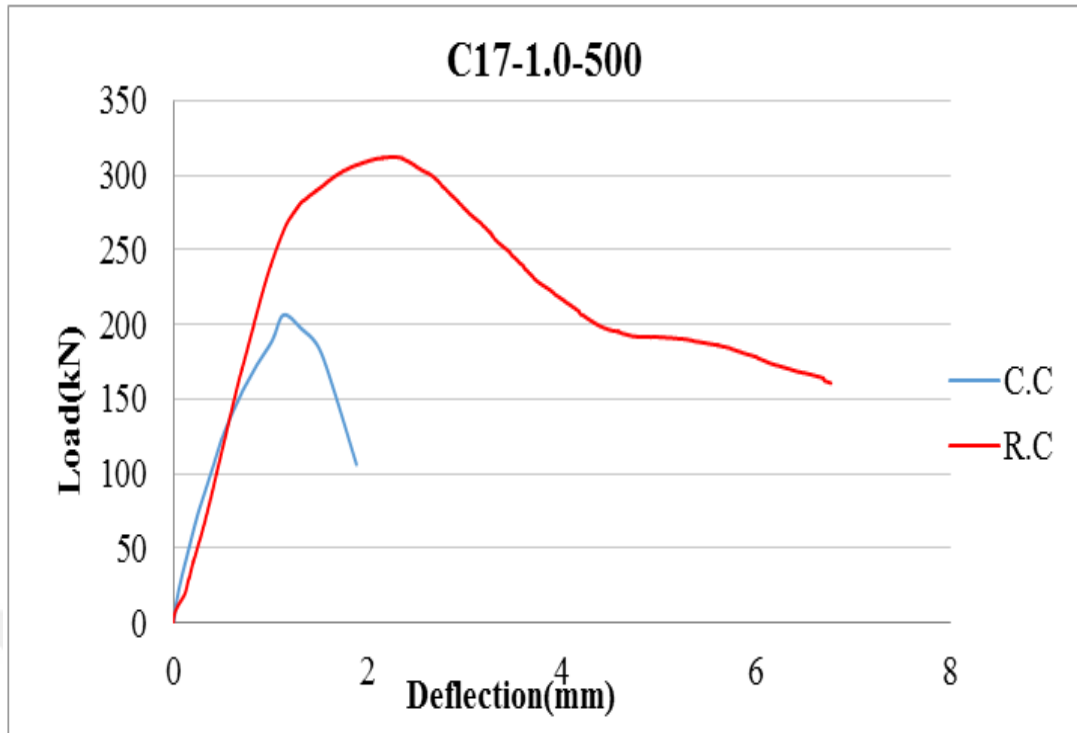
**Figure 4.49** Load-displacement curve of specimen (C17-1.0-500)

It can be concluded from the load-deflection response of the specimen (see Fig. 4.49) that the maximum deflection of the corbel before repairing is equal to 1.88 mm and increased to 6.70 mm after strengthened with basalt fiber. In that way, ductility increase in the corbel is illustrated by the rise in the maximum displacement.

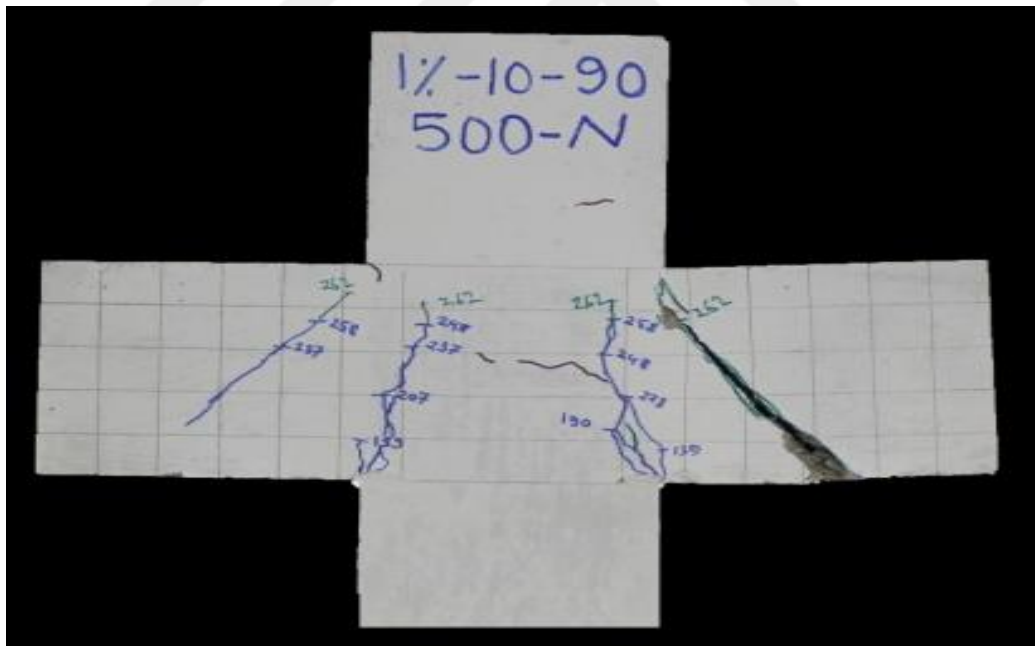
**Figure 4.50** Specimen (C17-1.0-500) failure before strengthening

This corbel has same reinforcement details with C16-1.0-250 whose shear span is 90mm, and the specimen was exposed to elevated temperature of 500°C. The ultimate load capacity before rehabilitation was 207 kN with shear failure on the right side (see Fig. 4.50). After failure, the specimen was rehabilitated with crack repair material and was externally strengthened with basalt fiber. The result showed a great improvement in the capacity of corbel after strengthening that the capacity increased to 1.51 times of the original value. The strengthening increased the peak load capacity to 313 kN. After the load arrived to 281 kN, separation between the fiber and corbel's surface occurred (see Fig. 4.51), which indicates that the failure existed due to de-bonding.

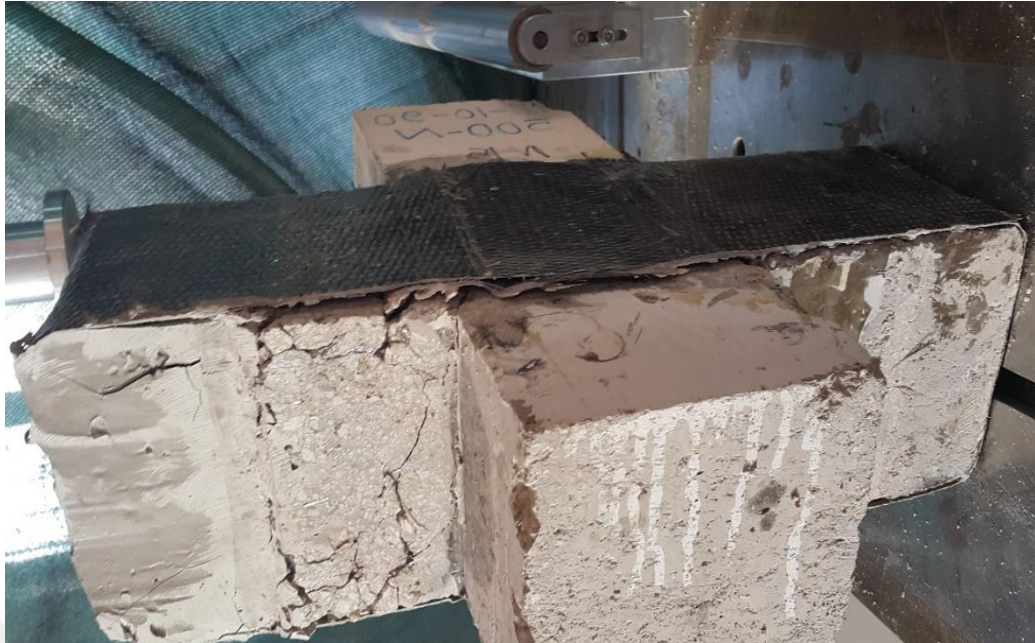
**Figure 4.51** Specimen (C17-1.0-500 ) de-bonding failure after strengthening

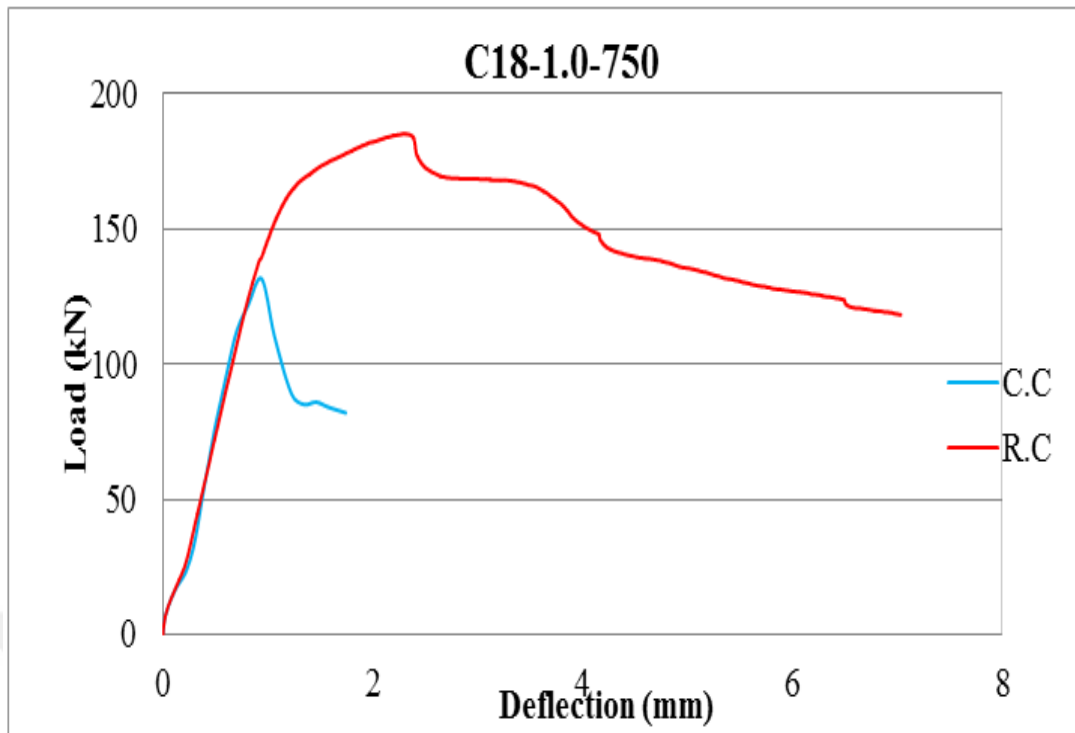
Figure 4.52 Load-displacement curve of specimen (C18-1.0-750)

After rehabilitation and strengthening process, the specimen was loaded vertically with same shear span value. The ultimate load capacity, after strengthening, reached to 185 kN with displacement of 2.29mm. Moreover, the load increased in amount of 40% of its original value. The mode of failure was De-bonding, which was occurred due to separation between the basalt fiber and concrete surface (see Fig. 4.54). The sample becomes more ductile since the maximum displacement increases to 7mm, as shown from Figure4.52.

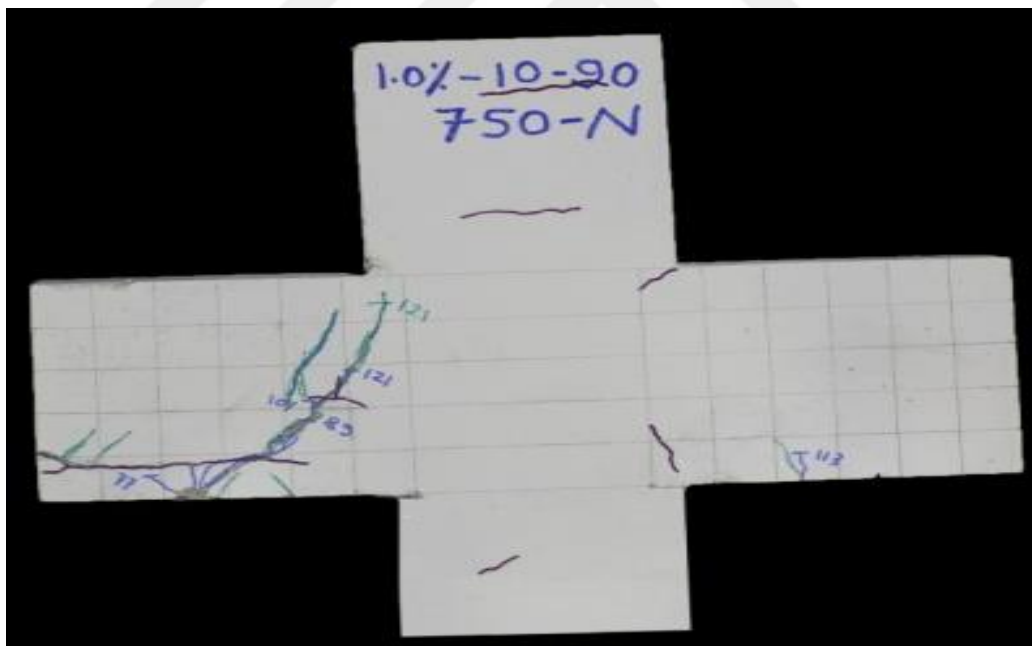
Figure 4.53 Specimen (C18-1.0-750) failure before strengthening

This specimen was reinforced with the same amount of steel fiber as the previous specimen which is 1.0% as volume. This specimen was exposed to high temperature of 750°C. The corbel was loaded vertically with shear span of 90mm. The first hairline crack appeared at load of 71 kN on the left side of the specimen, it was followed by another crack at load of 113 kN on the other side of the specimen (see Fig. 4.53). The corbel's maximum load was 132kN with displacement of 0.94mm.

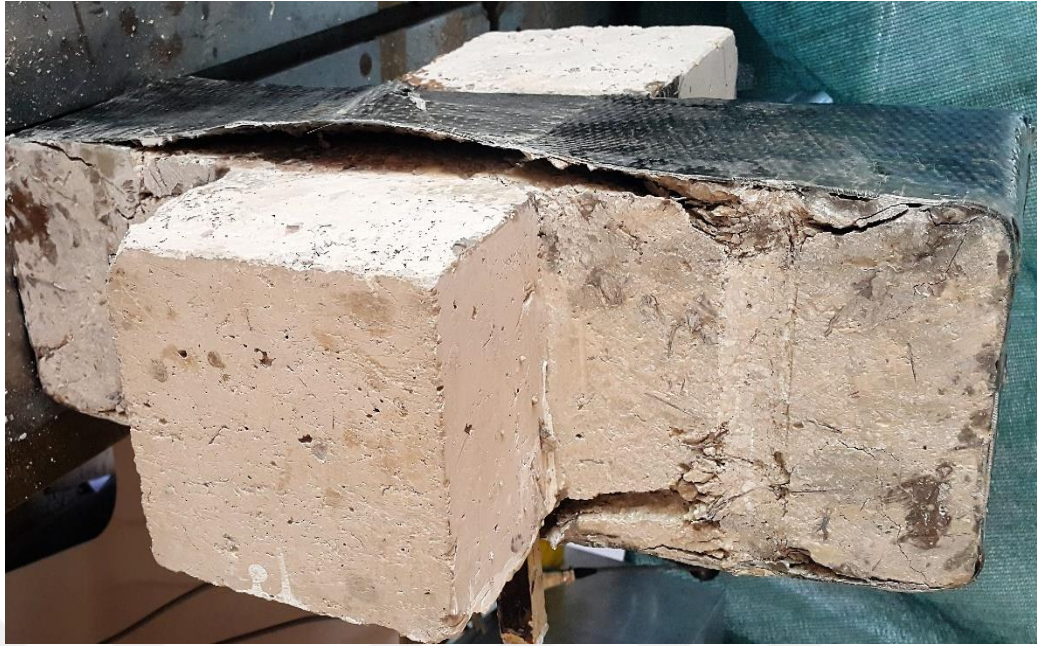
**Figure 4.54** Specimen (C18-1.0-750 ) de-bonding failure after strengthening
