ASSESSING THE IMPACT OF CHANGES ON VALUES DURING THE  
TRANSFORMATION OF TRADITIONAL HOUSES INTO HOTELS: THE  
CASE OF TARAKLI

IN PARTIAL FULFILLMENT OF THE REQUIREMENTS  
FOR  
THE DEGREE OF MASTER OF SCIENCE  
IN  
CONSERVATION OF CULTURAL HERITAGE IN ARCHITECTURE

APRIL 2024

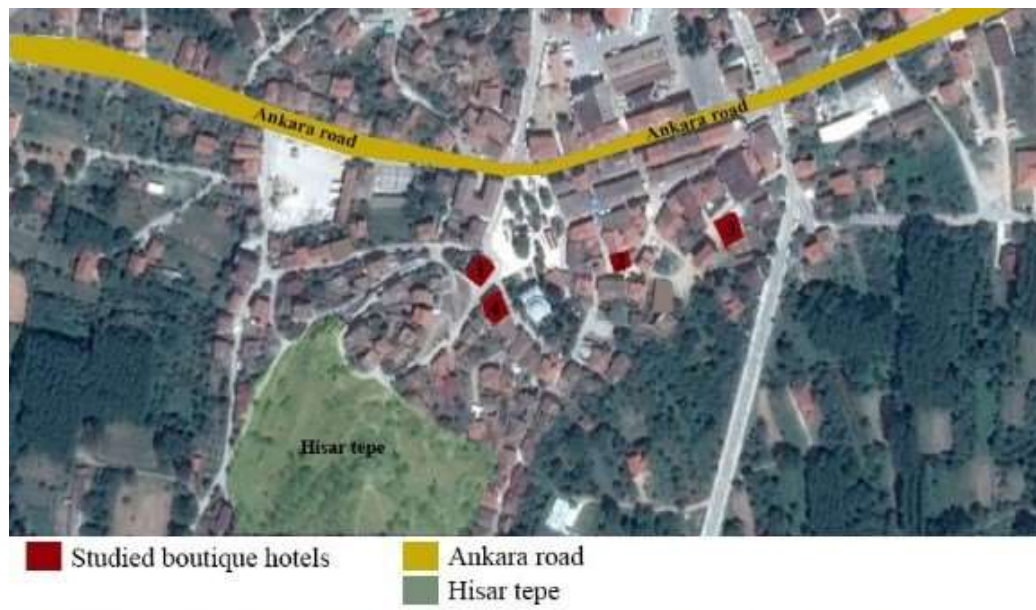
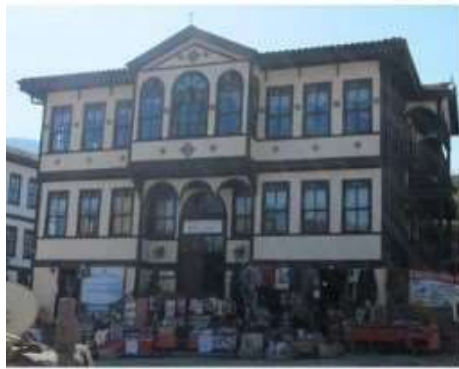
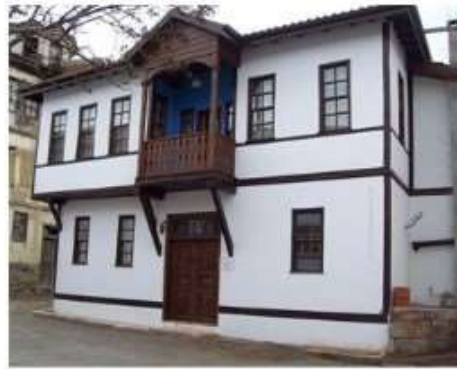
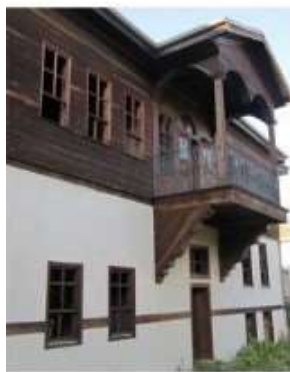
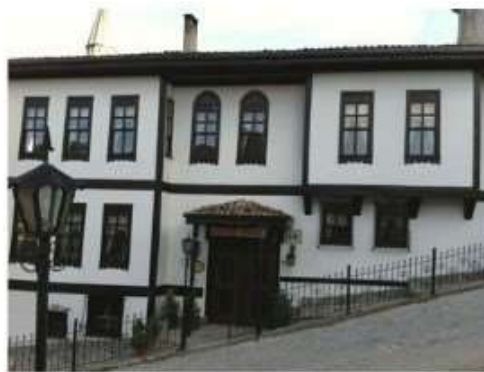
Figure 1.2. Location of studied traditional houses which were transformed to hotels  
(Author, 2023)

1.Kadirler house

2.Abdi İbrahim house

3.Hacı Rifatlar house

4. Çakırlar house

For this purpose, field studies were completed in Taraklı. Field studies were implemented on October, 2013 and June, 2016. This study is based on data from 2013 and 2016. Further studies can be completed to analyze the recent status of the town. The town of Taraklı in Sakarya is a traditional settlement with its traditional houses and historic tissue. In Taraklı, many traditional houses have been adapted to contemporary conditions as hotel, restaurant, shop and etc. There are totally six transformed hotels in Taraklı. One of them was reconstructed and another one was not available (not be able to enter) during the study. In this regard, four traditional houses which were transformed into hotels were chosen for the study. Their names are Kadirler house, Abdi İbrahim house, Çakırlar house and hacı Rıfatlar House (Figure 1.2).

**Hacı Rıfatlar House:** Hacı Rıfatlar house locates in Ulucamii quarter, Santral street. It locates very close to traditional houses such as fenerli house, Abdi İbrahim house and other traditional houses and it also locates close to Göynük stream. Its original function was house but it was transformed and it is used as a guest house & hotel. It has three floors and a mezzanine floor (ground floor and two floors).

**Çakırlar House:** Çakırlar house locates on sloped topography. The building was constructed with three floors. It has main entrance on north facade. Ground floor has its entrance on west facade. It has no any garden. Its roof type is hipped. It has three floors (ground floor and two floors).

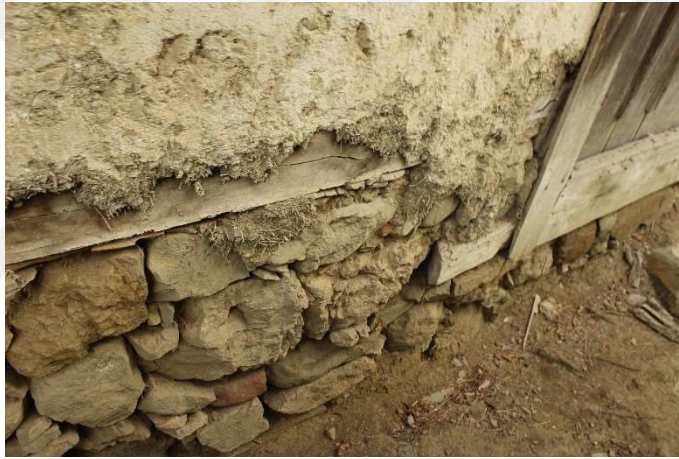
Figure 2.12. Stone foundation of Ezancılar house (Author, 2016)

**Stone:** Stone was used as a second material for Taraklı houses. It was generally chosen for constructing the foundation and ground floors because stone prevents dampness on the ground of the building (Figure 2.12). In addition, it is an appropriate material for transition through timber and mudbrick but stone was not a popular construction material as timber in this region because it was hard to find stone in nearby areas. Furthermore, quarrying and transporting stone expenses were hard to overcome (Özyer, 2008). Rubblestone for the foundation, and Kayran for garden walls and pavements were chosen as construction material. Ground floor walls were raised through 80-120 cm height. On the other hand, if the house is located on a sloped topography, a stone wall can be constructed at one-floor height to provide resistance against dampness and other issues of ground. (Özyer, 2008).

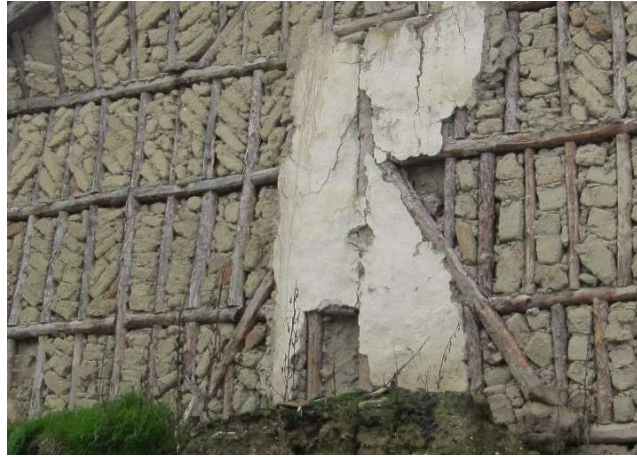
Figure 2.13. Mudbrick detail as a construction material from unnamed house in Taraklı (Author, 2016)

**Mudbrick:** It had significance in the Taraklı region as a construction material. Especially for the houses that were constructed on plain topography. Lots of houses were designed as timber-framed structures and their structures were infilled with mudbrick (Figure 2.13). Ingredients of mudbrick were water, clayey earth, and straw. Although the dimension of mudbrick change, the most common sizes was 10x12x20 cm, and 10x15x20 cm but for masonry walls, it changed to 10x15x30 cm or 10x20x30 cm according to a cross section of timber posts (Özyer, 2008).

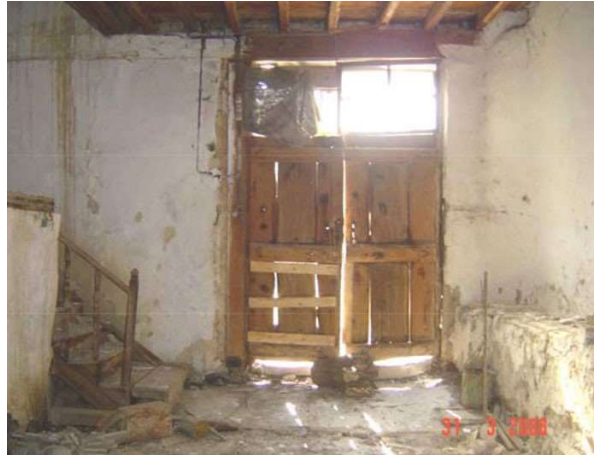
**Hayat & Taşlık:** It provides circulation on the ground floor (Davulcu, 2009). When the flooring is covered with stone, it is called taşlık (Figure 2.17) Hayat or taşlık can be divided into different spaces like storage, dam, barn, and garage and it can also called işlik to provide production area (Çetin, 2006). Hayat includes a big fireplace for the preparation of food for the winter seasons. It is also lightened by small, loopholed openings (Çetin, 2006).

Figure 2.17. Taşlık of Hacı Rıfatlar konağı before its transformation (Özkan, 2008, p.103)

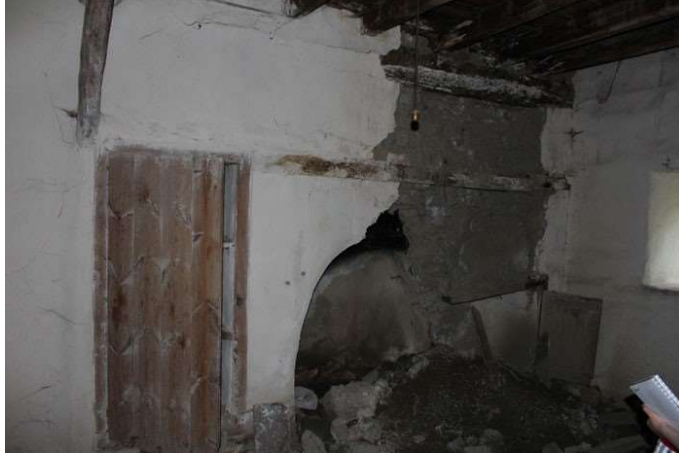
**Kitchen:** On the ground floors, If there is no barn or hayloft then it is possible to say that there are spaces like a kitchen (Figure 2.18) and bathroom (Özkan, 2008). The kitchen might be located on the first floor (Özkan, 2008).

Figure 2.18. Kitchen of Ezancılar konağı (Author, 2016)

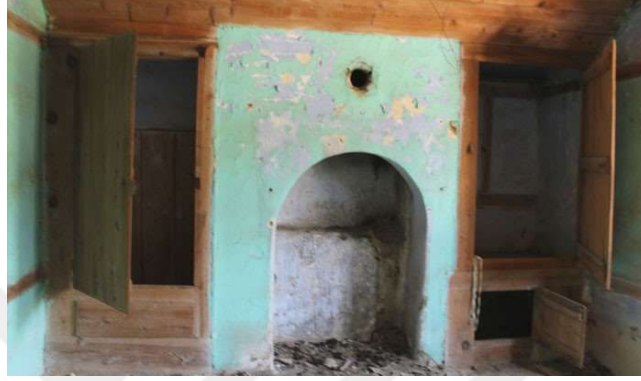
**Room:** Room entrances can be divided into two one of them is 45 degrees sloped or plain. It can be said that rooms have 4m. width and 4m. depth and they own also a fireplace, cupboards, and sedir, too (Figure 2.20). The walls are covered with bağdadi plaster in pastel colors. A few examples of wall decoration can be found. Room doors have a single wing (Özkan, 2008).

Figure 2.20. Gusülhane (at left side of fireplace) , fireplace and closet (at right side of fireplace) view of the room, Haşmet Doğru house (Author, 2016)

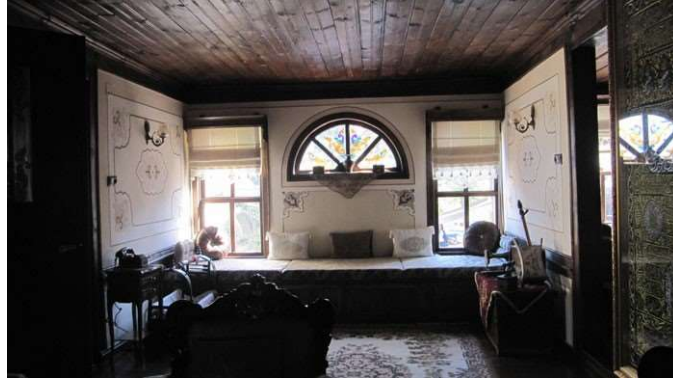
**Window:** To provide better lighting conditions, lots of windows were opened during construction. Windows are divided into different groups such as flat and vaulted lintels. The most known flat lintel has two stable partitions at the top and middle and is openable below. Newer dwellings have flat lintel with two partitions and it is formed by two guillotine covers. Windows with arched lintels are used to emphasize significant places such as the eyvan and sofa. The design of the arched lintel is close to a window with three partitions but it has both two and three partitions (Özkan, 2008).

Figure 2.22. Eyvan window of Kadirler konağı after its transformation (Author, 2013)

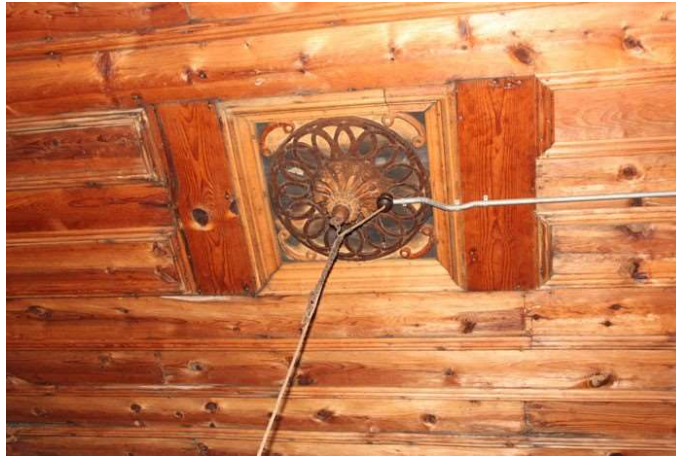
**Ceiling:** Although wooden ornament was not used on interior door wings, yüklük and closet doors, it was used for ceiling of traditional houses with ‘çitakari technique’ by closing holes between woods on ceiling with laths. Besides, ceiling woods can be nailed to ceiling as parallel or cross to wall and different geometric forms were applied (Çetin, 2006). Ceiling panels were not applied on corridors and service areas but ceiling panels with ornamentation and paint can be seen in living units generally (Özyer, 2008).

Figure 2.23. Ceiling ornament of 2.nd floor sofa, Ezancılar house (Author, 2016)

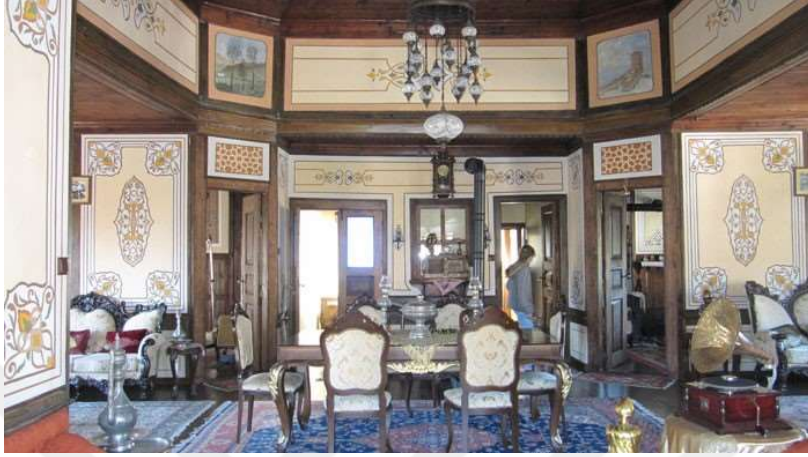
**Walls:** Walls are usually ordinary and colored. Kalemîşi ornament (Figure 2.24) can be rarely seen in Sakarya houses but in two different forms on plaster and wood material (Çetin, 2006).

Figure 2.24. Kalemîşi ornamentation on wall of 2.nd floor sofa of Kadirler house after its transformation (Author, 2013)

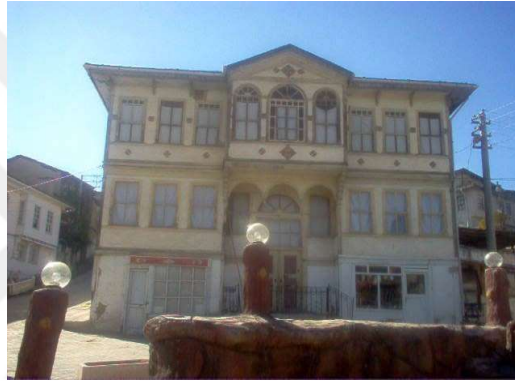
Figure 3.4. Pre-intervention view of Kadirler house, east facade (taken from the Taraklı Municipality, 2013)

The east facade of the Kadirler house (Figure 3.4) has a staircase that is reached by a one-way concrete staircase with iron railings. There are shop entrances with wooden glass windows and single-winged doors at the right and left sides of the staircase. Door and window frames are painted with oil paint. Swelling and cracks are visible on the paint. The ground floor was plastered and painted. Cracking, swelling, and flaking have been detected on plaster. The first floor has eight rectangular, wooden framed, and painted windows and one arched window on top of the entrance. Arched, timber decorations emphasized the main entrance.

Deteriorations were inspected on doors and windows. The first floor was plastered and painted. Cracking, swelling, and flaking have been detected on plaster. On the first floor, there are a total of 9 original, 6 rectangular, and 3 arched wooden windows. It is emphasized by a cantilever. The second floor was plastered and painted. Cracking, swelling, and flaking have been detected on plaster.

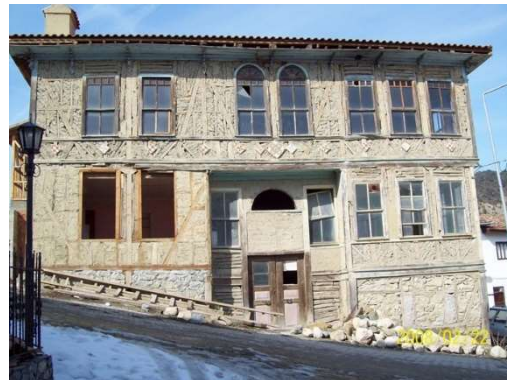
Figure 3.5. Pre-intervention view of Kadirler house, south facade (taken from the Taraklı Municipality, 2013)

The south facade of the Kadirler house (Figure 3.5) has an original double-winged wooden door that provides the entrance on this floor. On the second floor, It has two rectangular, wooden framed windows and an arched window on top of it. It also has five, rectangular, wooden framed windows. On the first floor, it has five rectangular windows and two arched windows. Floors were plastered and painted. Cracking, swelling, and flaking have been detected in plaster.

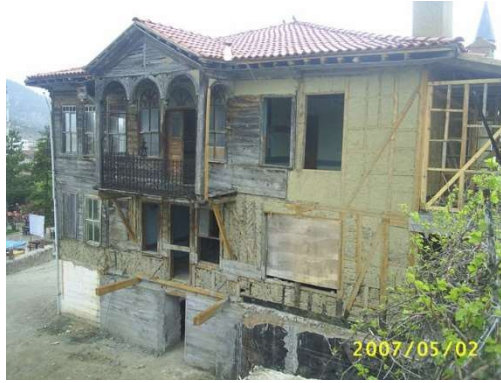
Figure 3.6. Pre-intervention view of Kadirler house, north facade (taken from the Taraklı Municipality, 2013)

The north facade of the Kadirler house (Figure 3.6) had an additional structure on the ground floor which covered a large part of the ground floor. On this floor, one wooden door was detected. The walls of the additional building were plaster and painted. Cracking, insect infestation, discoloration, etc. on windows, door frames, and distortions have been detected. On the first floor, there were four original wooden windows, two wooden toilet windows, and one original single-winged wooden door. Two of the windows are half covered with bricks. The walls were covered with plaster and painted. Cracking, insect infestation, discoloration, etc. on windows, door frames, and distortions have been detected. On the second floor, there are a total of five original wooden windows, three rectangular and two arched, one wooden toilet window, and one original double-winged wooden balcony door. The walls were covered with plaster and painted. Cracking, insect infestation, discoloration, etc. on windows, door frames, and distortions have been detected on this floor, too.

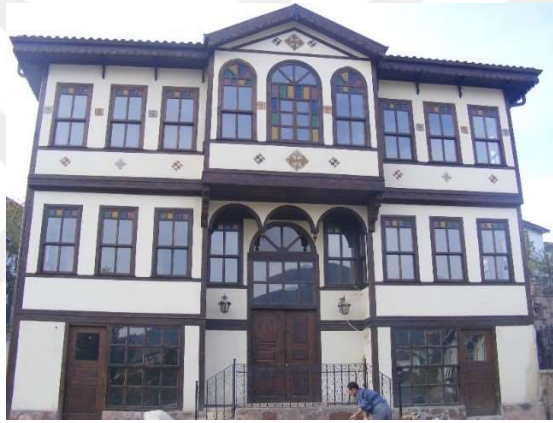
Figure 3.11. Post-intervention view of Kadirler house, east facade (Author, 2013)

The east facade (Figure 3.11) was emphasized by the cantilever. The main entrance door was also emphasized by a cantilever and raised by a staircase which has two directions. The main entrance has an arched window on top of it. The cantilever also has an arched windows. Other windows of the front facade are rectangular. The east facade has a main entrance and it has also two other entrances that open through the shop areas. The second floor was ornamented by ceramic tiles that were located below the windows and on top of the triangular face of the cantilever. The ending points of floors were defined with horizontal and wooden lines on the front facade.

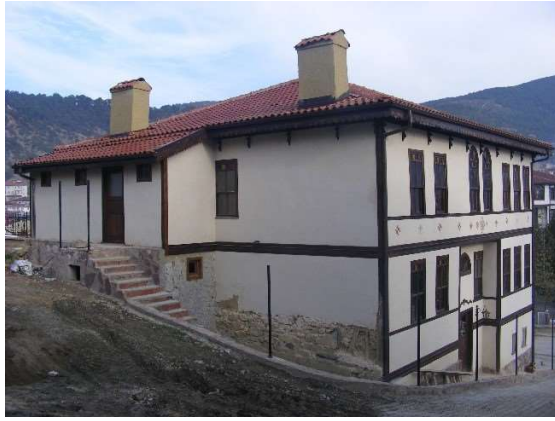
Figure 3.13. Post-intervention view of Kadirler house, west facade (Author, 2013)

The west facade (Figure 3.13) has an addition with a door that opens to the street by a stone staircase at the back side and three little windows on top of it. The first floor also has a single, rectangular window with colored glass on its top. The finishing of the second floor is plaster but the first floor was made out of plaster. The ending point of the floor was defined with horizontal and wooden lines.

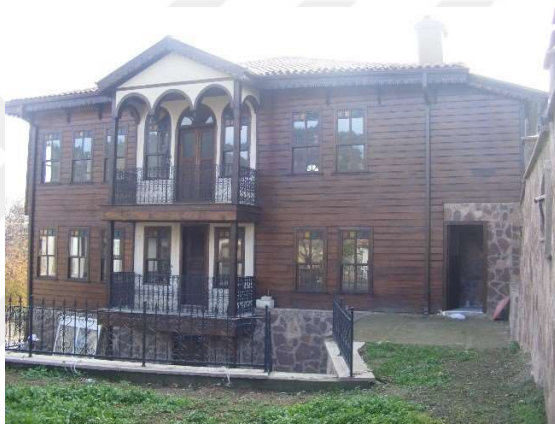
Figure 3.14. Post-intervention view of Kadirler house, north facade (Author, 2013)

The north facade (Figure 3.14) has a vertical axis at the middle of the facade which contains door openings on each floor. The ground floor opens to a garden with a wooden door. The door is the only opening on the ground floor on the right side of the house. The surface of the ground floor is stone. The first floor has a balcony entrance and one window on each side of the balcony entrance. The floor has five windows with colored glass on their tops. Three of them are located on the left side of the balcony, and two of them are located right side of the balcony. The second floor has a balcony with a door and two windows on each side of the door. The balcony of the second floor was emphasized by arched windows and doors with colored glasses on their tops. It also has an arched and triangular roof on it. The

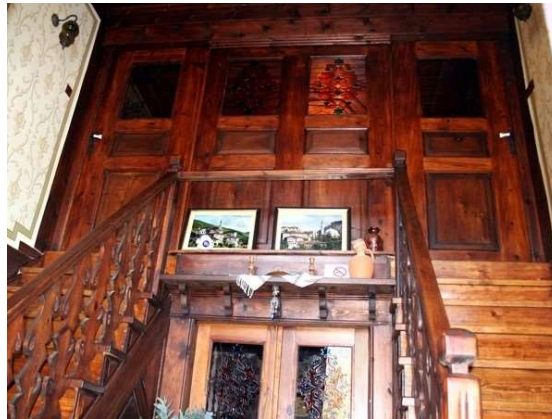
The room GPOI05 is an entrance area (Figure 3.16) and it has two wooden staircases both at the right and left sides. In between the staircases, there is a double-sided door that opens through room GPOI01. In space GPOI05, the floor is covered with ceramic tiles. Its ceiling material is wood. The walls are covered with kalemîşi works

Figure 3.16. Entrance space of Kadirler house, GPOI05 (Author, 2013)

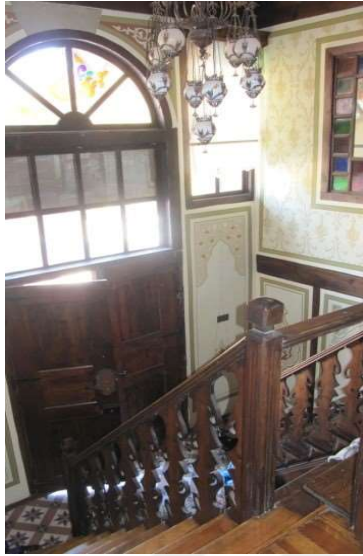
Figure 3.17. Interior entrance of Kadirler house, GPOI05 (Author, 2013)

of art (Figure 3.17). The entrance area is illuminated by two colored windows on the upper right and left side and windows which were decorated and colored with figures on the upper side of the entrance door.

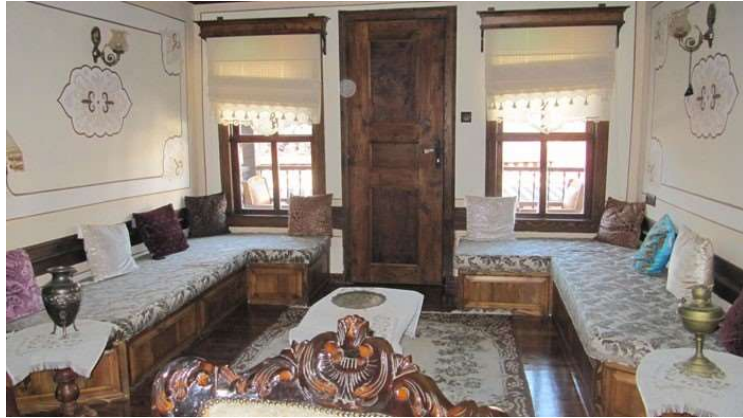
Figure 3.20. Eyvan of Kadirler house at first floor (Author, 2013)

The first floor (Figure 3.18) has a main space, called FPOI07. It is a sofa (Figure 3.19). The sofa space opens to FPOI01, FPOI04, FPOI05 and FPOI06 rooms. It also opens to wet spaces which are numbered as FPOI02 and FPOI03. Rooms have eyvan (Figure 3.20) spaces in between them. The sofa has a balcony on the south facade. Two staircases that come from the ground floor open to the sofa on the first floor on the eastern side. A staircase that rises from the first floor to the ground floor is located on the western side of the sofa. The sofa was pulled in and emphasized on the northern and eastern sides. It also has built-in seating units that are called sedir. The floor and the ceiling are wooden. The walls are covered with kalemişi.

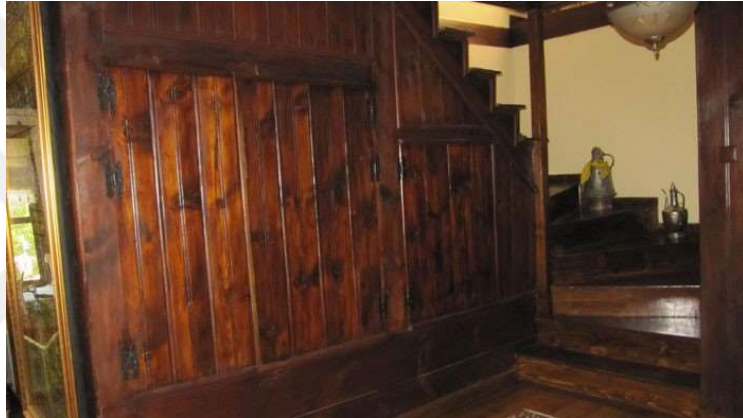
Figure 3.21. Built-in closet under staircase at first floor (Author, 2013)

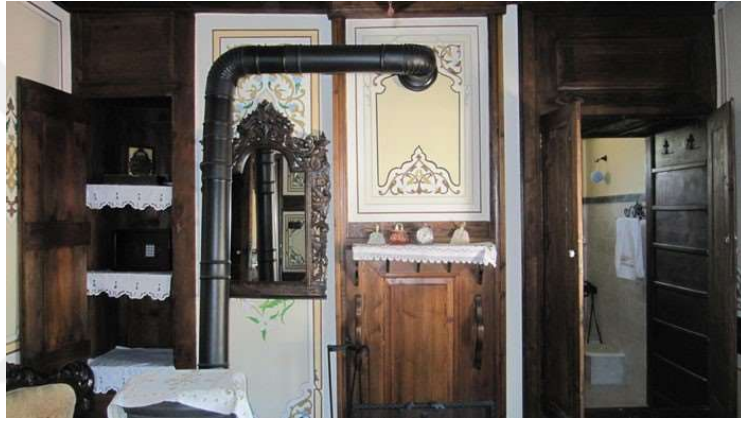
Figure 3.24. Closet, fireplace and gusülhanes' current condition (Author, 2013)

Room SPOI04 has a wooden closet, a fireplace, a niche, and a bathroom. It has a wooden door and windows. The flooring and ceiling are wooden. The walls are decorated with Kalemîşi.

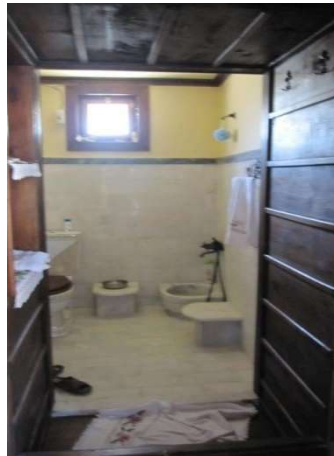
Figure 3.25. Current view of gusülhane and wet space addition (Author, 2013)

The space SPOI02 has a door that opens directly to the street. The SPOI02 is designed as a bathroom.

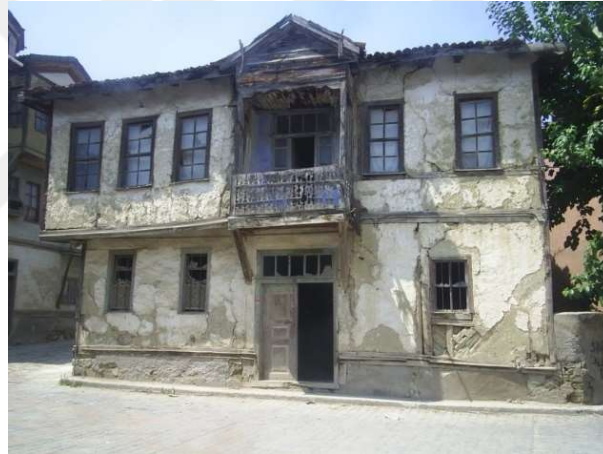
Figure 3.28. Pre intervention south facade view of Abdi İbrahim house (taken from the Taraklı Municipality, 2013)

The south facade of the Abdi İbrahim house (Figure 3.28), has a double-winged, rectangular-shaped, wooden entrance door with a little, five rectangular glasses on top of it. The main door has two rectangular windows on its left side and one rectangular window on the right side on the ground floor. The first floor has a cantilever and a balcony. The balcony has a door with little glass frames. There are also five rectangular windows. On this facade, all of the window and door frames are wooden. The balcony has a wooden covering, too. Its balustrade is also wooden. The construction style of this facade is timber-framed mudbrick. The wall is plastered and painted. Cracking, swelling, and flaking have been detected in plaster. There are cracks and lots of materials on the wall. Most of the windows on the ground floor were broken. Wooden parts were also damaged.

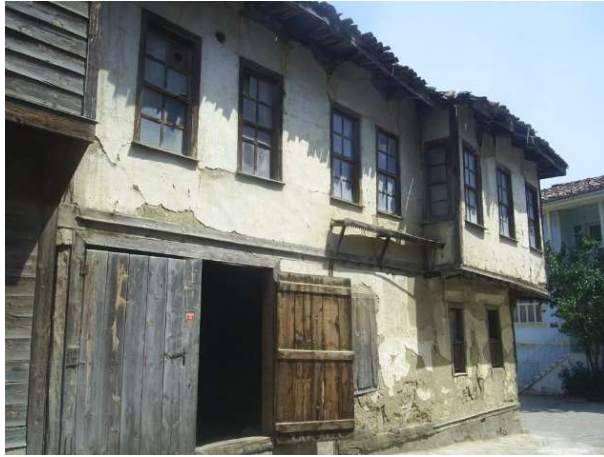
Figure 3.29. Pre intervention east facade view of Abdi İbrahim house (taken from the Taraklı Municipality, 2013)

The east facade (Figure 3.29) of the Abdi İbrahim house has a large double-winged, wooden door. It has a rectangular, window with a wooden covering and two rectangular windows on its right side on the ground floor. There are five rectangular windows on the first floor. The construction style of this facade is timber-framed mudbrick. The wall is plastered and painted. Cracking, swelling, and flaking have been detected in plaster. There are cracks and loss of materials on the wall. Most of the windows on the ground floor were broken. Wooden parts were also damaged.

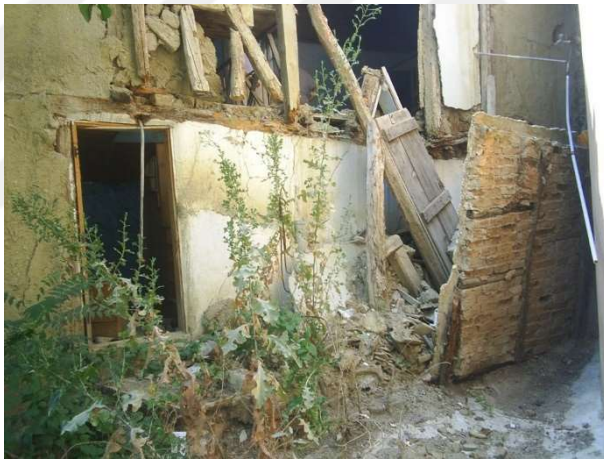
Figure 3.30. Pre intervention west facade view of Abdi İbrahim house (taken from the Taraklı Municipality, 2013)

The west facade (Figure 3.30) of the Abdi İbrahim house has a small window on the ground floor which serves to the taşlık. It has four windows. Two of them serve to the wet spaces. One of them serves to the Sofa. The other one serves to the room FPRI04 on the first floor. Cracking, swelling, and flaking have been detected in plaster. Most part of this facade was harmed. GPRI03 and FPRI03 were demolished. Some part of the FPRI02 was also demolished.

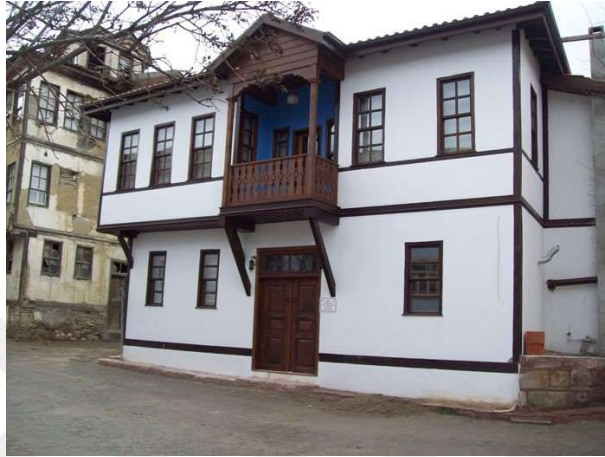
Figure 3.33. South facade of Abdi İbrahim house (taken from the Taraklı Municipality, 2016)

The south facade of the Abdi İbrahim house (Figure 3.33) includes the main entrance door. The door is wooden and has small glasses on top of it. The entrance door has three, rectangular windows with a wooden frame on the ground floor. The main entrance was emphasized by a balcony with a gable roof on the first floor. The balcony was covered with wooden material. The balcony has a door and four windows on the right and left sides of it. There are also five rectangular windows on the first floor. The South west part of the first floor was cantilevered towards the street with three windows. The walls are plastered and painted to the white color. Floor and opening finishings were defined by vertical, timber lines.

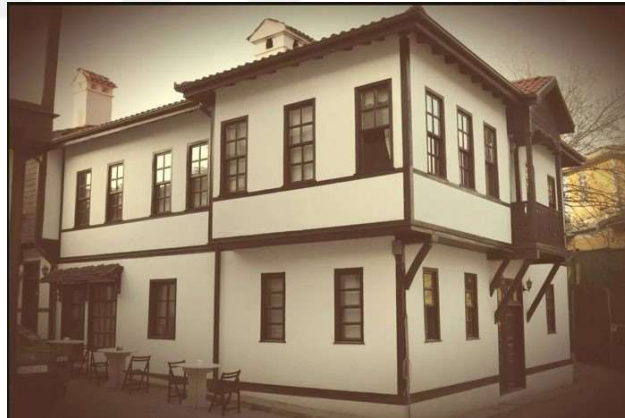
Figure 3.34. West facade of Abdi İbrahim house (taken from the Taraklı Municipality, 2016)

The west facade of the Abdi İbrahim house (Figure 3.34) includes a secondary entrance and a large window on its right side. The facade has three rectangular, windows on the ground floor. There are seven rectangular windows on the first floor. The construction material of window frames is wood. The Southwest part of the first floor was cantilevered towards the street with three windows. The walls are plastered and painted to the white color. Floor and opening finishings were defined by vertical, timber lines.

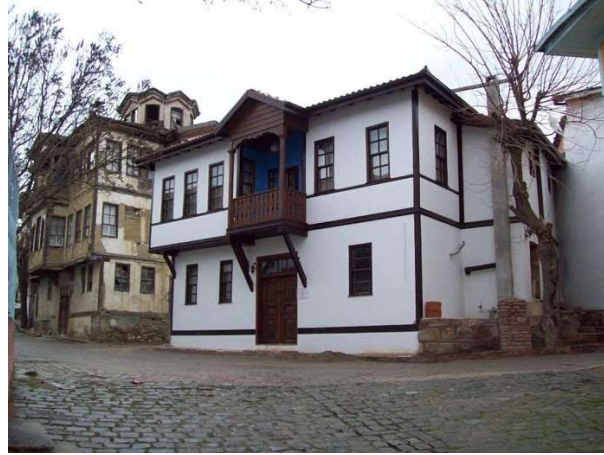
Figure 3.35. : South and east facades of Abdi İbrahim house (taken from the Taraklı Municipality, 2016)

East facade of the Abdi Ibrahim house (Figure 3.35) has rectangular, guillotine window for corner room at first floor. It also includes small openings for the purpose of ventilating wet spaces. Wet spaces were cantilevered towards small garden as mass addition.

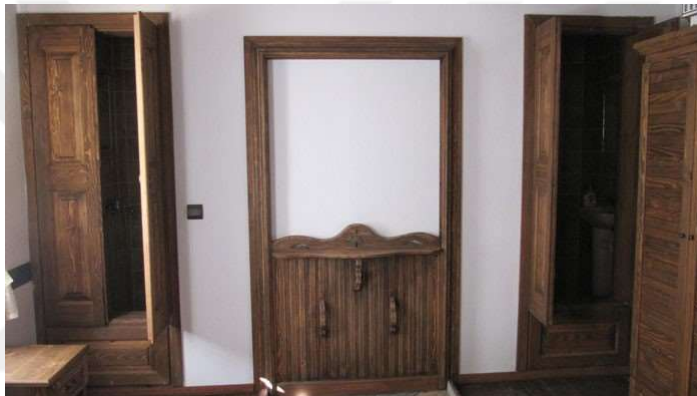
Figure 3.39. Closets of bathroom and wc in a bedroom of ground floor, GPOI07 (Author, 2016)

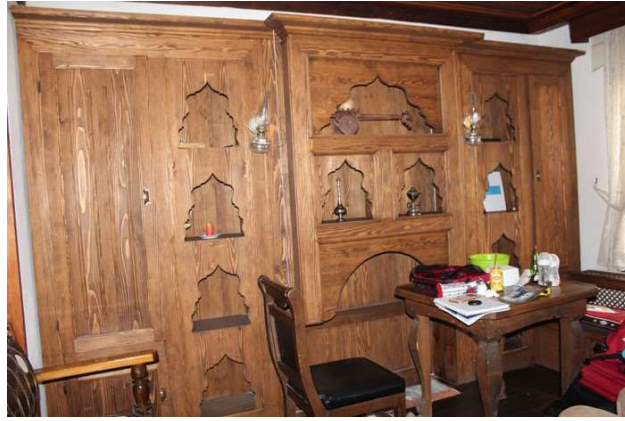
Figure 3.41. Fireplace and closets on lobby, GPOI08 (Author, 2016)

The post intervention ground floor plan of Abdi Ibrahim house (Figure 3.36) has main entrances from the south and east facades. The room GPOI01 is an entrance space with a door and a window on the right side of it. GPOI08 is a lobby area (Figure 3.41). It has a fireplace and storage on the right and left sides of the fireplace. It has a window and a wooden staircase with two steps. The GPOI07 is a bedroom (Figure 3.38), (Figure 3.39) and (Figure 3.40) that has a door, four windows, wooden staircase with two steps. It also has a fireplace and bath on the left side of the fireplace and wc on the right side of the same fireplace. GPOI06 is an entrance space that opens through the GPOI02. It is used as a dining room (Figure 3.42). GPOI02 has a wooden staircase and two WC areas behind the staircase. GPOI04 has an exit door which opens to the street. GPOI05 is a kitchen. The rooms GPOI01, GPOI02, GPOI06, GPOI07, and GPOI08 have wooden flooring and ceiling. The room GPOI02 has a stone flooring and wood ceiling. Their walls are covered with plaster and painted to the white color. Floor and wall covering materials of the GPOI03, GPOI04, and GPOI05 spaces were changed with new materials (ceramic tiles). New types of fixtures were added to these spaces. GPOI03 has a door and a small window. GPOI04 has two doors. GPOI05 has a door and a window.

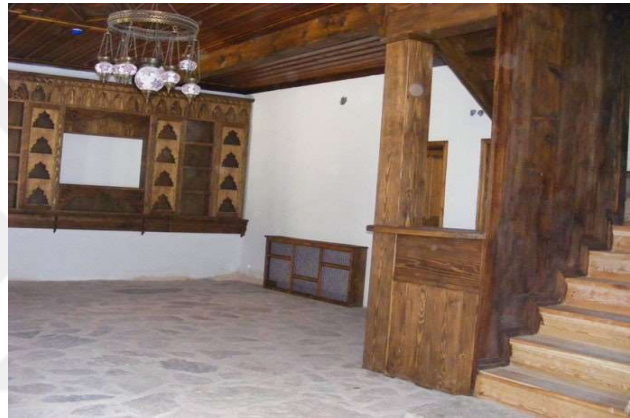
Figure 3.42. Dining room and information desk under staircase, GPOI08 (taken from the Taraklı Municipality, 2016)

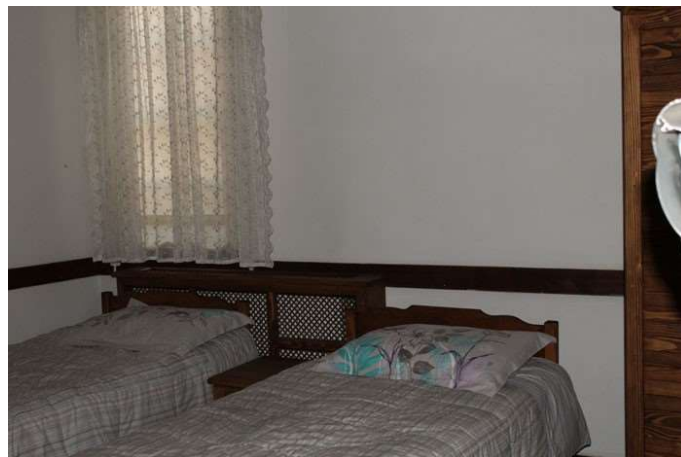
Figure 3.45. Post intervention view of the room in first floor, FPOI04 (Author, 2016)

The post intervention first floor plan of Abdi Ibrahim House (Figure 3.44) has a hall named FPOI08 (Figure 3.47). It has a wooden staircase. The ceiling and flooring were covered with wood material. FPOI08 opens to the FPOI01, FPOI04 (Figure 3.45), FPOI07, FPOI09 and FPOI10. They are used as a bedroom for the guests. FPOI01 has a door, two windows, and a niche. It also has a bathroom. Its door, window frames, ceiling, and flooring are wooden. FPOI02 is covered with ceramic tile. Brand new materials were used as a fixture (Figure 3.46). FPOI04 has a door, window, and a niche. It also has a bathroom. Its door, window frames, ceiling, and flooring are wooden. FPOI03 is covered with ceramic tile. Brand new materials were used as a fixture. FPOI07 has a door, three windows, and a niche. It also has a bathroom. Its door, window frames, ceiling, and flooring are wooden. FPOI06 is covered with ceramic tile. FPOI09 has a door and eight windows. During the study, it cannot be entered into FPOI09 because it was locked. It was drawn according to the description of the owners. It cannot be entered into FPOI10, too. FPOI05 is a bathroom. It is covered with ceramic tile. Brand new materials were used as a fixture. All of the walls were plastered and painted white color.

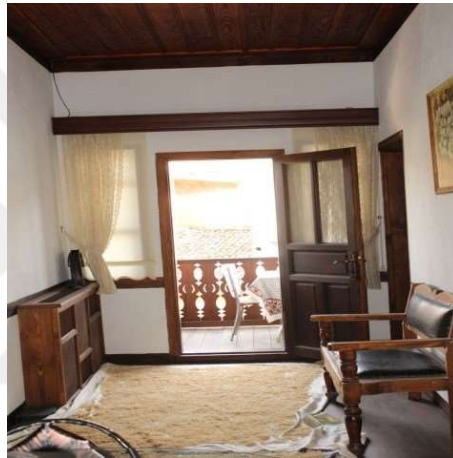
Figure 3.47. Post-intervention view of hall, FPOI08 (Author, 2016)

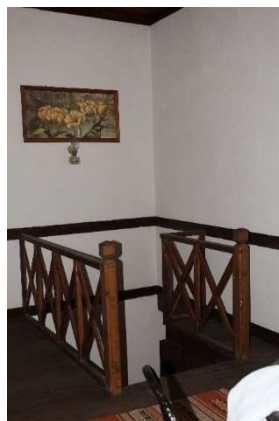
Figure 3.48. Post-intervention view of staircase, FPOI08 (Author, 2016)

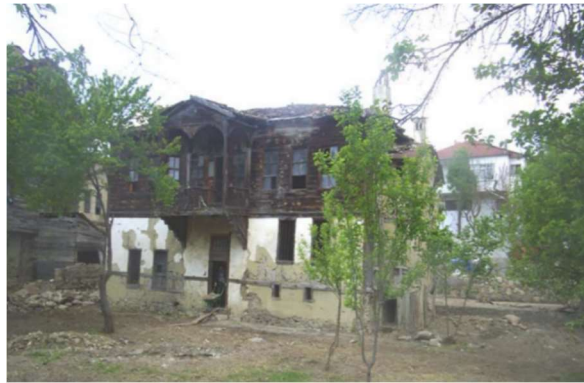
Figure 3.52. Pre intervention view of Hacı Rıfatlar house, south facade (Özkan, 2008, p.121)

The south facade of the Hacı Rıfatlar house (Figure 3.52), has a wooden door which opens to the garden and four wooden framed rectangular windows on the ground floor. It has also two wooden framed, small windows which belong to the basement floor. The construction style of this part is timber-framed mudbrick. This part is plastered and painted. The first floor has a balcony which emphasizes the entrance of the facade. The balcony has a double winged wooden door and a two wooden windows. It has a triangular roof with an arched decorations and wooden balustrade. The floor also has six wooden framed rectangular windows. At the right side of the facade, there is a wet space mass. It has wet space windows for ventilation. The walls of the first floor is covered with timber. There are cracks and lots of materials on the walls. Wooden parts were also damaged.

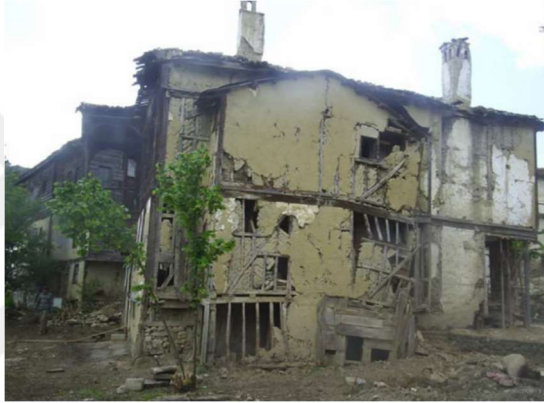
Figure 3.54. Pre-intervention view of Hacı Rıfatlar house, east facade (Özkan, 2008, p.123)

The east facade of the Hacı Rıfatlar house (Figure 3.54), has a wet space mass. There are small wooden windows but this facade was damaged. The construction style of this facade is timber-framed mudbrick. The wall is plastered and painted. Cracking, swelling, and flaking have been detected in plaster. There are cracks and loss of materials on the walls. Wooden parts are also damaged. Some part of the wet space mass is about to collapse.

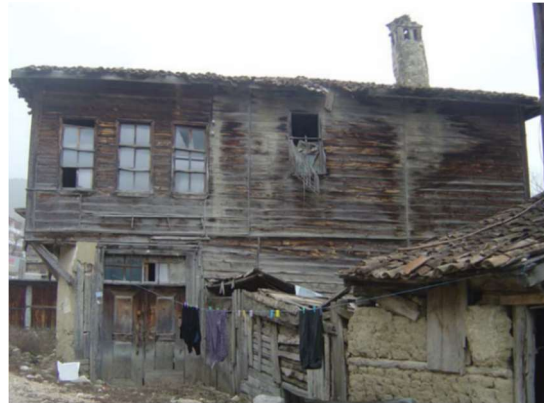
Figure 3.55. Pre-intervention view of Hacı Rıfatlar house, west facade (Özkan, 2008, p.125)

The west facade of the Hacı Rıfatlar House (Figure 3.55), has a wooden framed entrance door with a two wings. The door has a glass window on top of it. The first floor has four rectangular wooden framed windows. This facade has a timber

covering on ground and first floors. Timber coverings and frames are damaged. Window glasses are broken. On this facade, there is a mass addition.

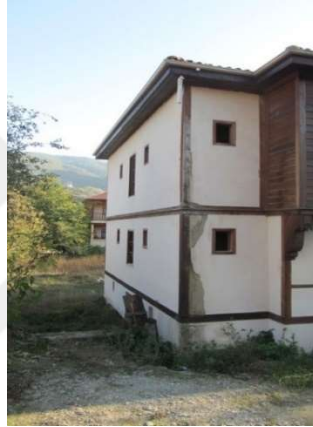
Figure 3.62. Post-intervention view of Hacı Rıfatlar house, east facade (Author, 2013)

The east facade (Figure 3.62) has wet space mass. There are four small, wooden framed windows and two rectangular, wooden framed windows on first and second floors and two small, wooden framed windows on ground floor. The ground, first and second floor of the facade is plastered and painted.

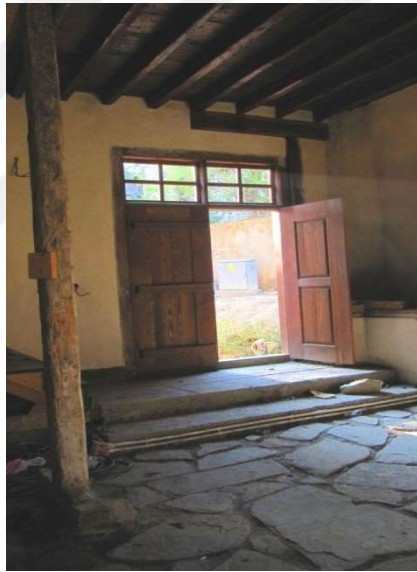
Figure 3.66. Current interior view of circulation Area (Author, 2013)

Ground floor has large circulation area (GPOI01) (Figure 3.66), reception area (GPOI03) under the staircase and a kitchen (GPOI02) Circulation area spreads the floor as *L shape*. Circulation area has two wooden staircases. One of them provides access to first (mezzanine) floor. The other one rises towards second floor. GPOI01 has another two staircases which provide an access to basement floor. The GPOI01 has two doors. One of them is on front facade and opens to street, secondary entrance is on right side and opens to garden. The floor material of GPOI01 is cut stone and its ceiling material is timber. Its walls are covered with plaster and painted. GPOI02 (Figure 3.67) keeps its fireplace and counter. Flooring was made out of stone and its ceiling material is timber. Its walls are covered with plaster and painted. Ground floor has high volume because of owning a mezzanine (first) floor. The floor has no ornamentation.

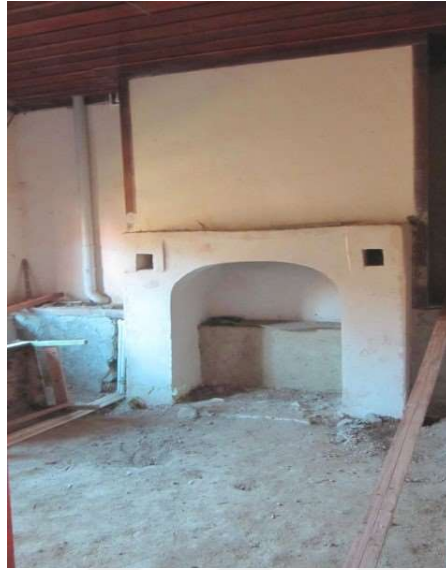
Figure 3.67. Current view of Kitchen and fireplace (Author, 2013)

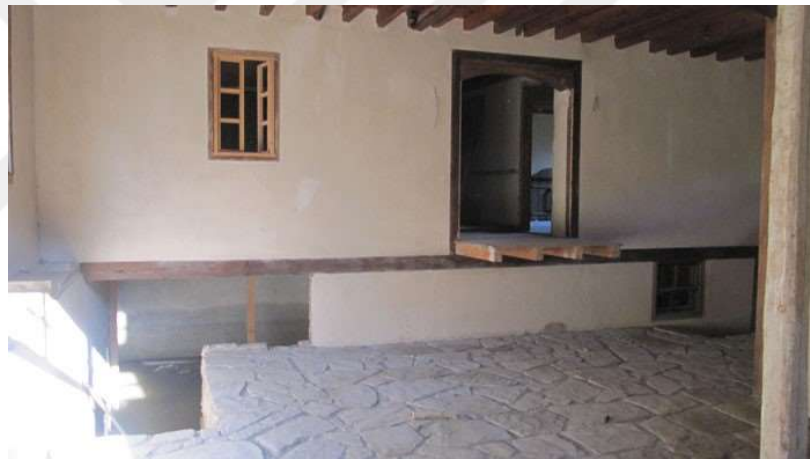
Figure 3.68. View of basement floor and mezzanine (first) floor from the main entrance (Author, 2013)

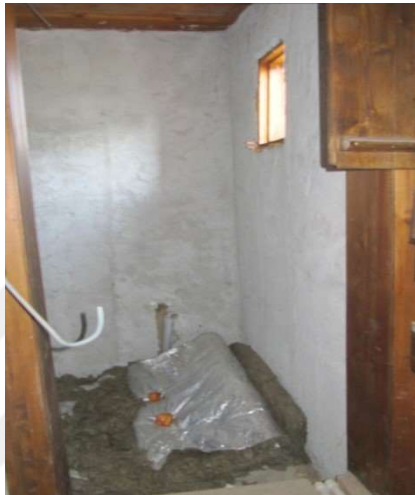
Figure 3.70. Wet space addition inside the closets at rooms of mezzanine floor (Author, 2013)

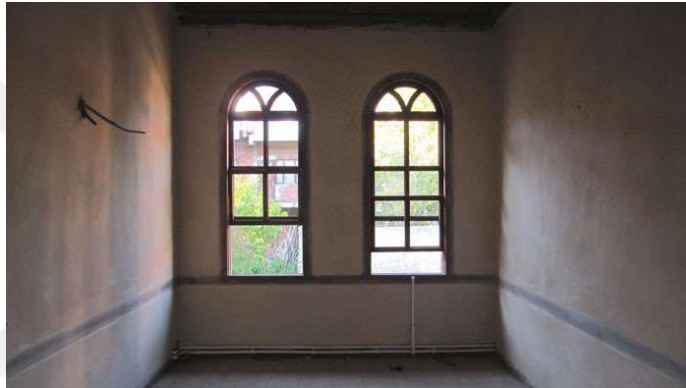
Figure 3.73. Post intervention of eyvan on second floor after its transformation  
(Author, 2013)

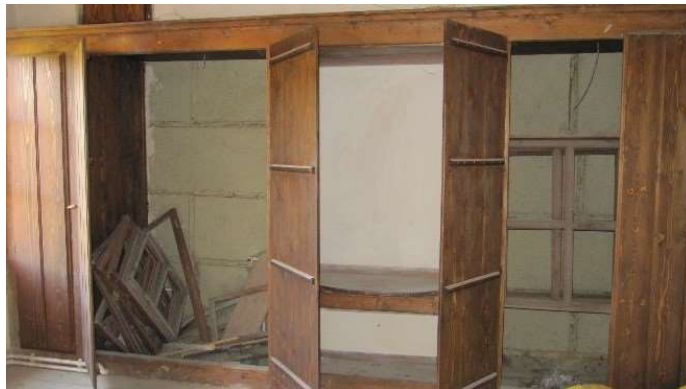
Figure 3.74. Post intervention of rooms on second floor after its taransformation  
(Author, 2013)

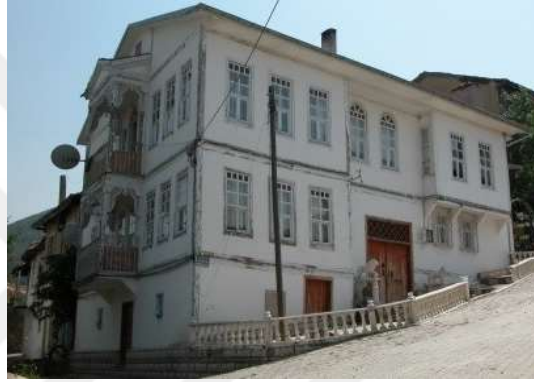
Figure 3.77. Pre-intervention view of Çakırlar house, north-east facade (Çetin, 2006, p.546)

The north facade (Figure 3.77) has a main entrance door on the first floor. The door has a wooden, rectangular frame. It has a glass window on top of it. The ground floor also has a small, wooden door. The ground floor has three, rectangular framed windows. There are small, colored glasses on top of these windows. It also has two small windows. The second floor has eight windows with rectangular, wooden frames. The floor also has two arched windows. All of the windows have small, colored glasses on top of them. This facade is plastered and painted. The north facade includes stairs for adapting it to the sloped ground.

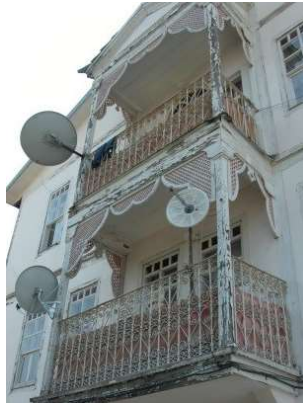
Figure 3.78. Pre-intervention views of Çakırlar house, east facade (Çetin,Y, 2006, p.550)

The east facade (Figure 3.78) includes a secondary entrance and small, rectangular windows on its right and left sides on the ground floor. The facade has balconies on the first and second floors. Each balcony has a door and two windows. Balconies were made out of timber. They have timber ornamentations. Their ballustrates are cast iron and decorated. The balcony of the first floor has a triangular forehead on top of it. The door opening of the balcony is also arched. Other windows of the east facade are rectangular. This facade is plastered and painted.

Its ground floor was made out of stone masonry and upper floors were made out of timber structure with mudbrick infill.

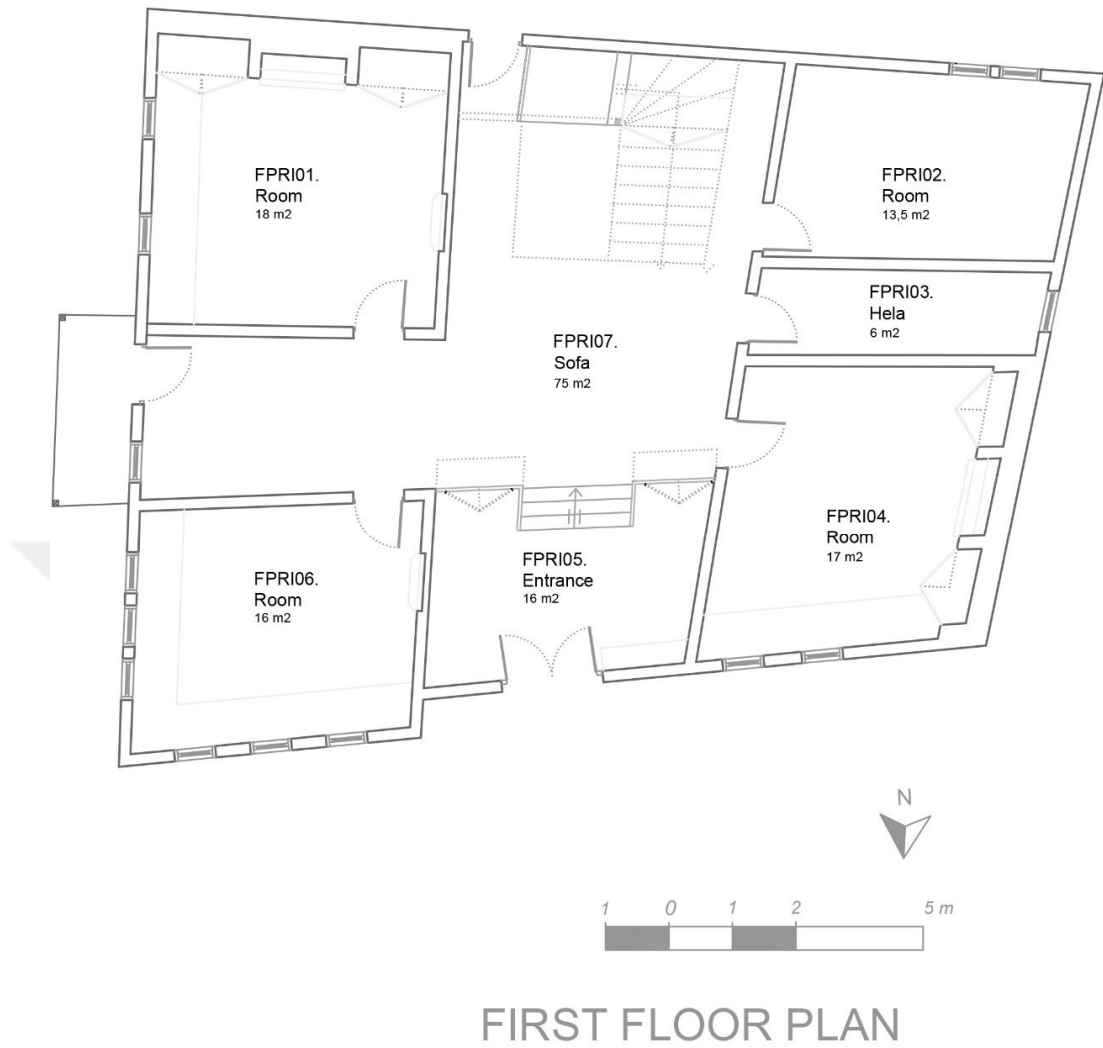
Figure 3.80. Pre-intervention first floor plan of Çakırlar house (Author, 2023)

The first floor (Figure 3.80) consists of three rooms, a bathroom, kitchen, staircase, and balcony which surround a sofa. It has two entrances. The main entrance is on the north facade and the secondary entrance is on the south facade. The secondary entrance is located near the staircase. The main hall (FPRI07) was raised by three stairs from the entrance space. Entrance stairs have two closets under them on both its right and left sides. FPRI07 has a balcony on the west facade. The flooring

Room FPRI04 has original plan elements such as gusülhane, closet, fireplace, sedir and nish. It has a sedir as a seating unit. The material of the flooring and ceiling is timber. Its walls are plastered and painted.

Room FPRI06 is a room which has a door, six windows and a nish. It also has a sedir as a seating unit. The material of the flooring and ceiling is timber. Its walls are plastered and painted.

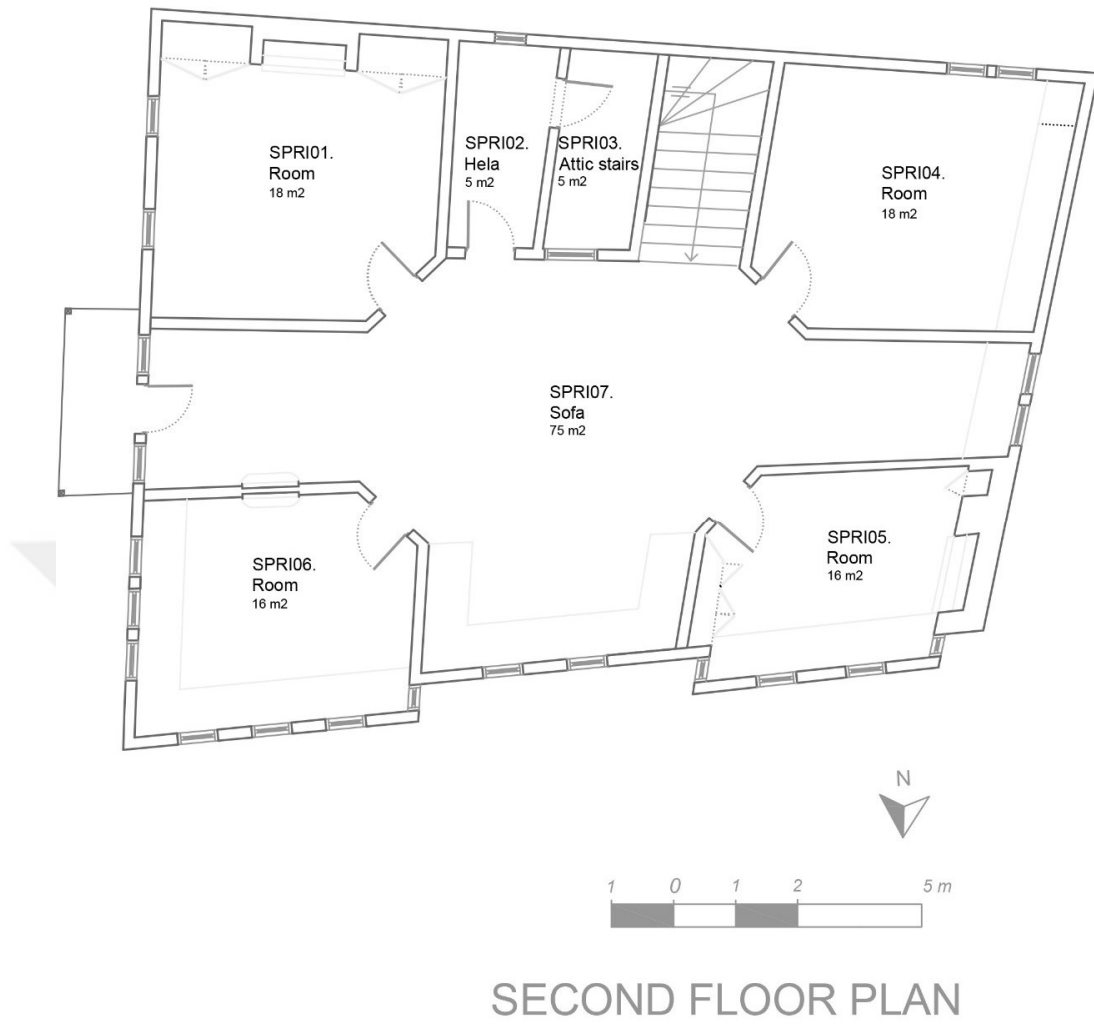
Figure 3.81. Pre-intervention second floor plan of Çakırlar house (Author, 2023)

The second floor (Figure 3.81) has a sofa (SPRI07). It has a balcony with two windows and a door, and also four windows. SPRI07 has a wooden staircase. There are also four doors that open to rooms SPRI01, SPRI04, SPRI05 and SPRI06 and a door that opens through SPRI02. The flooring and ceiling material of the SPRI07 is timber. Its walls are covered with plaster and painted.
