ASSESSING THE IMPACT OF CHANGES ON VALUES DURING THE  
TRANSFORMATION OF TRADITIONAL HOUSES INTO HOTELS: THE  
CASE OF TARAKLI

IN PARTIAL FULFILLMENT OF THE REQUIREMENTS  
FOR  
THE DEGREE OF MASTER OF SCIENCE  
IN  
CONSERVATION OF CULTURAL HERITAGE IN ARCHITECTURE

APRIL 2024

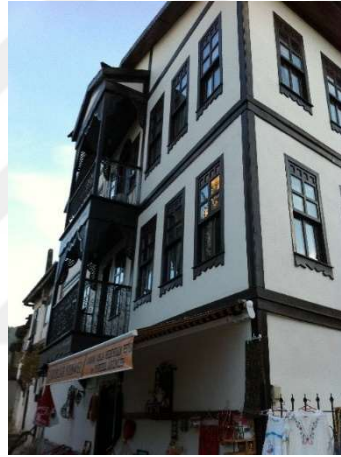
Figure 3.83. Post-intervention view of Çakırlar house, west facade (Author, 2013)

The west facade (Figure 3.83) has an entrance door on the ground floor. The ground floor has a room and it is used as a shop. The ground floor is a completely independent floor in the house with its entrance and usage area. It has a door and two small windows with a wooden frame. The first floor has a balcony with a door and one window. The material of the balcony is timber. It also has five rectangular windows with a wooden frame. The second floor also has a balcony. It has a door and one small window with a wooden frame. The first floor has a balcony with a door and two windows. The material of the balcony is timber. The second floor also has five windows. The facade is plastered and painted.

Its ground floor was made out of stone masonry and upper floors were made out of timber structure with mudbrick infill.

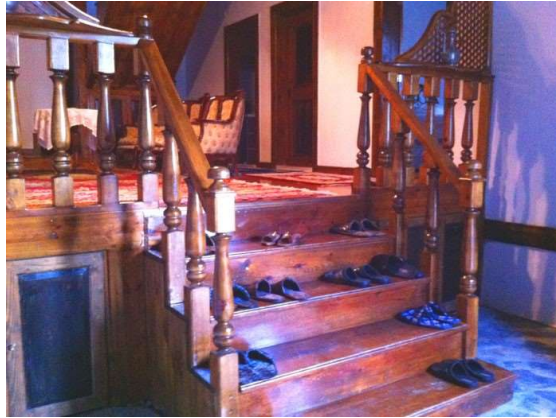
Figure 3.86. Post-intervention view of GPOI05 (Author, 2013)

The first floor (Figure 3.85) has a main entrance on the north facade. In front of the door, there is an entrance area (GPOI05) (Figure 3.86) with a staircase and two closets on the right and left sides of the staircase. The material of the staircase and closets is timber. The staircase has three steps (Figure 3.87).

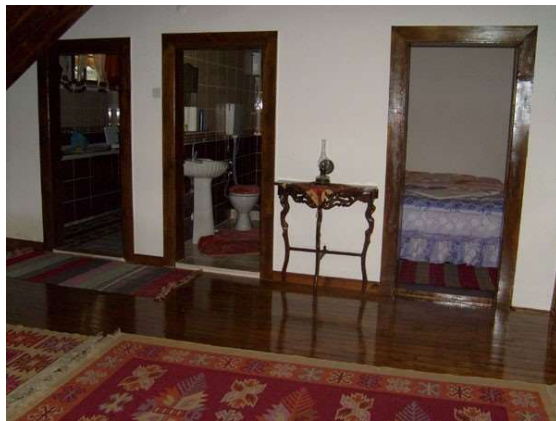
Figure 3.88. Post-intervention view of GPOI07 (taken from the Taraklı Municipality, 2013)

On the upper part of the GPOI05, there is an area which is called a main hall (GPOI07). GPOI07 (Figure 3.88) has a main staircase. The material of the staircase

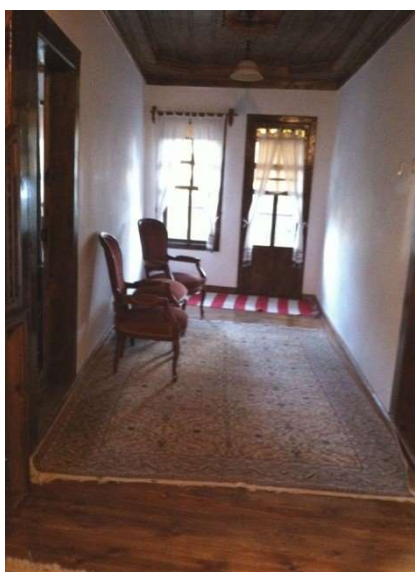
Figure 3.89. Post-intervention view of balcony entrance on GPOI07 (Author, 2013)

is timber. GPOI07 has an entrance to the balcony (Figure 3.89) The balcony has a window and a door. GPOI07 also has another door that opens to the outside on the south facade of the house. It is used as a service door. GPOI07 is surrounded by three rooms, a bathroom and a kitchen.

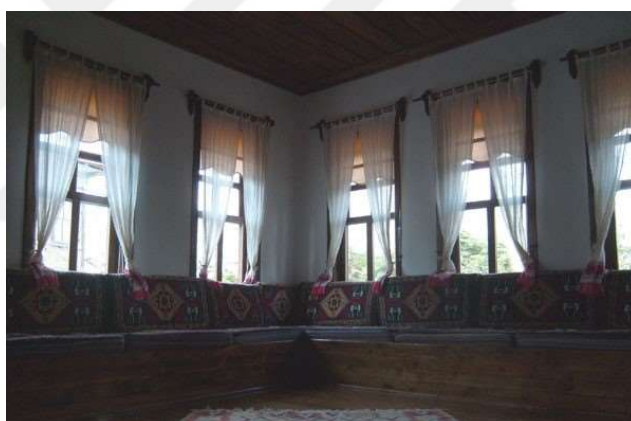
Figure 3.90. Post-intervention view of GPOI06 (Author, 2013)

The room GPOI06 (Figure 3.90) is used as a living room. It has a door, six windows, a niche and a sedir. The material of the floors, walls and ceiling is timber.

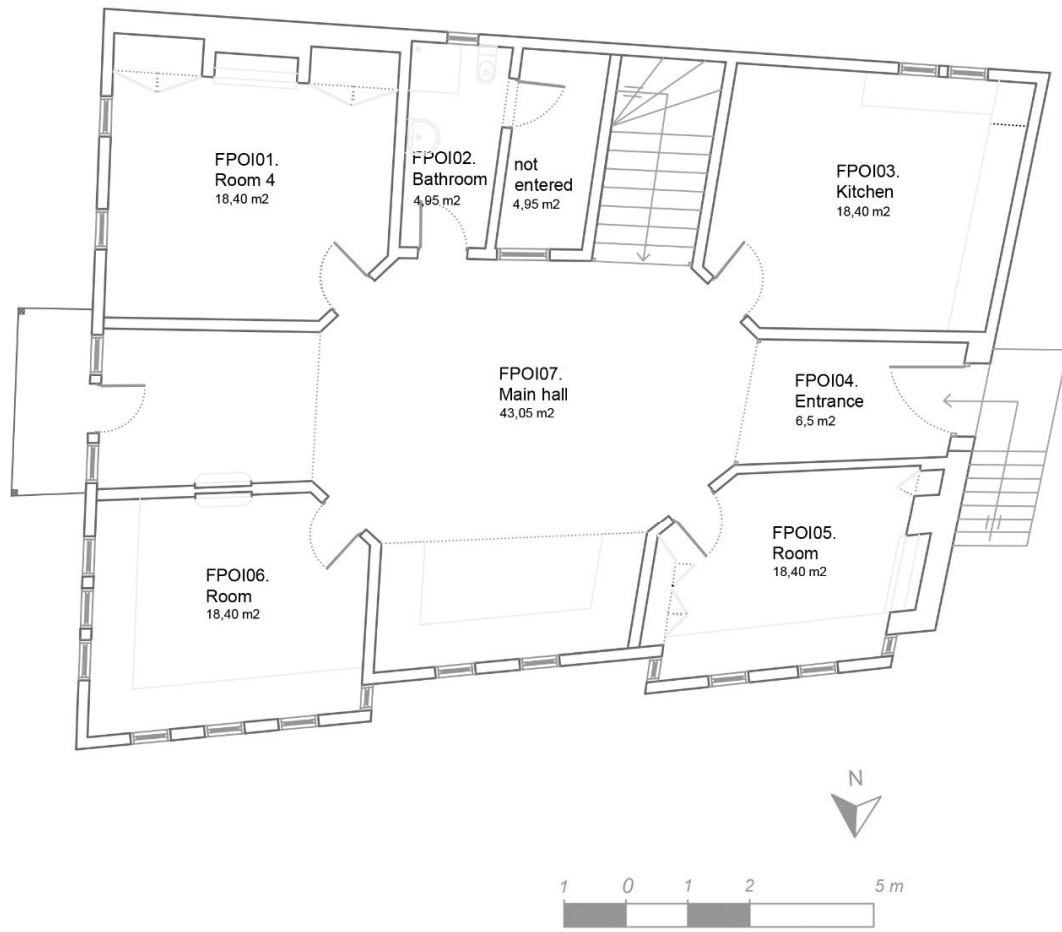
Figure 3.91. Post-intervention second floor plan of Çakırlar house (Author, 2023)

The second floor has access to it by the staircase from the first floor. It also has an independent entrance on the east facade. FPOI07 (Figure 3.92) is surrounded by rooms, a staircase on the south facade, and a balcony on the west facade. The balcony has a door and two windows. The floor and ceiling material of FPOI07 is timber.

FPOI05 is used as a bedroom (Figure 3.98 and Figure 3.99). It includes a door, four rectangular framed windows, a niche, fireplace, closets and sedir. The material of the ceiling and floor is timber. The walls are covered with plaster and painted.

FPOI06 is used as a living room. It has a door, seven wooden windows with a rectangular frame, a niche and sedir. The material of the ceiling and floor is timber. The walls are covered with plaster and painted.

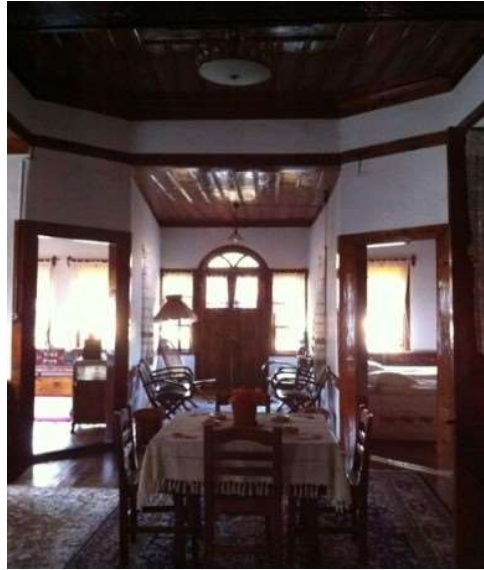
Figure 3.92. Post-intervention view of FPOI07 that looks towards balcony entrance (Author, 2013)

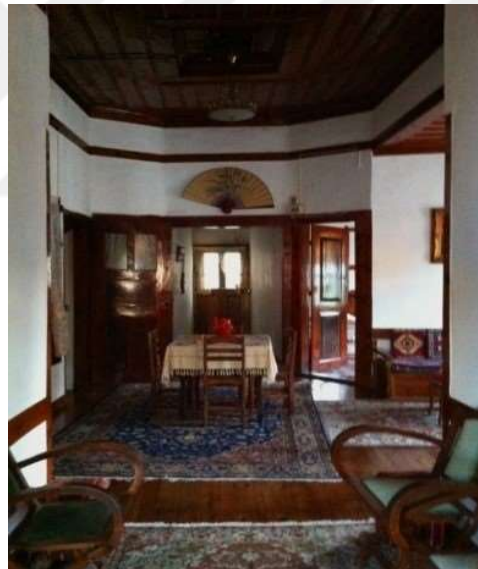
Figure 3.93. Post-intervention view of FPOI07 that looks towards secondary entrance of the house (Author, 2013)

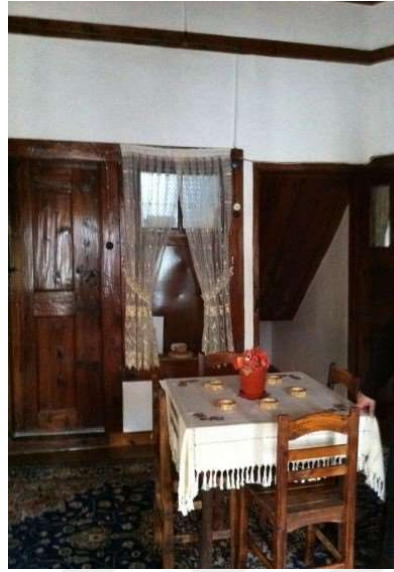
Figure 3.94. Post-intervention view of FPOI07 that looks towards bathroom and staircase of the house (Author, 2013)

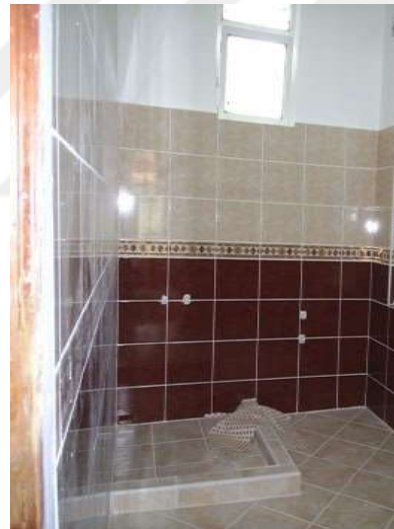
Figure 3.95. Post-intervention view of FPOI02 (taken from the Taraklı Municipality, 2013)

FPOI02 is used as a bathroom (Figure 3.95). The material of the floors, walls and ceiling is ceramic tile. The bathroom has a connection with a closed room that serves as a service room for the staircase. The service room was locked during the site survey so it remains unstudied.

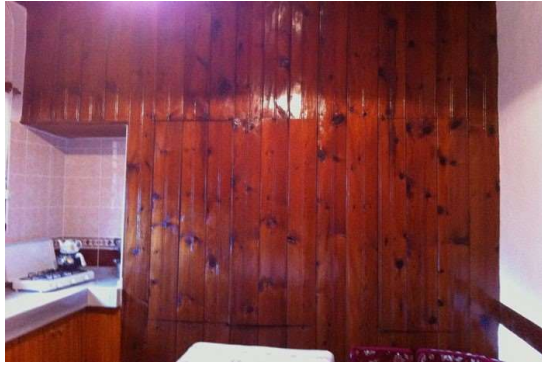
Figure 3.96. Post-intervention view of FPOI03 at second floor (Author, 2013)

FPOI03 is used as a kitchen (Figure 3.96 and Figure 3.97) It has a door, two windows, a kitchen counter and cabinets. The material of the floors and walls is ceramic tile. The material of the ceiling is timber.

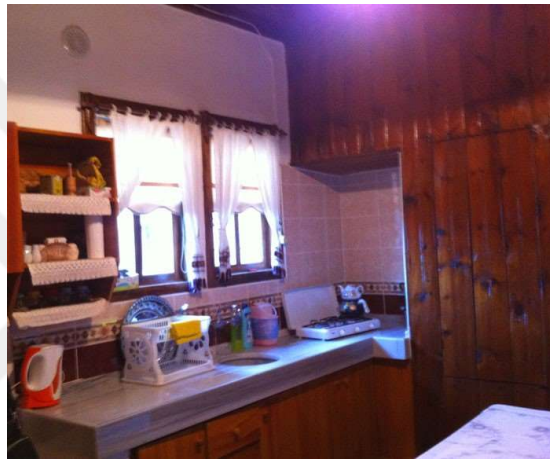
Figure 3.97. Counter and cabinet addition of FPOI03 (Author, 2013)

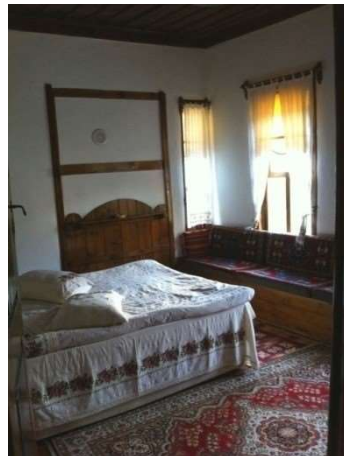
Figure 3.98. Post-intervention view of FPOI05 (Author, 2013)

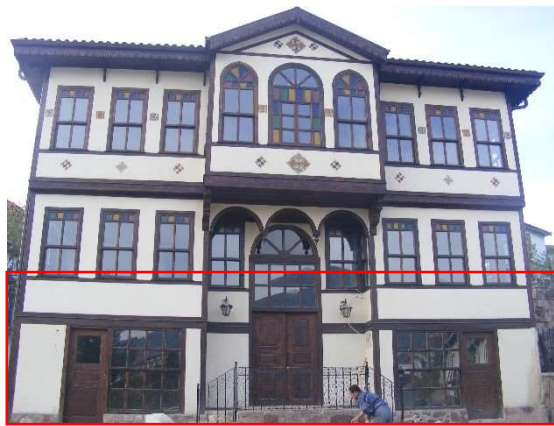
Figure 4.3. Pre-intervention view of east side facade that show the alterations of entrance staircase and alterations of shop windows and doors at ground floor (taken from the Taraklı Municipality, 2013)

For the ground floor (Figure 4.1) G.A1 and G.A4 (Figure 4.2 and Figure 4.3) indicate the alterations on the doors and windows of GPOI06 and GPOI04. Windows and doors were changed with a new type of ones. Their color was also changed. G.A2 and G.A3 show the material change on the floors of GPOI06 and GPOI04. The wooden floor material was changed with ceramic tile. The original material of the north side wall of the main building was stone masonry but it was altered with concrete material (G.A5). G.A6 shows the alteration of the floor material of the garden. The floor material was concrete. It was altered as stone.

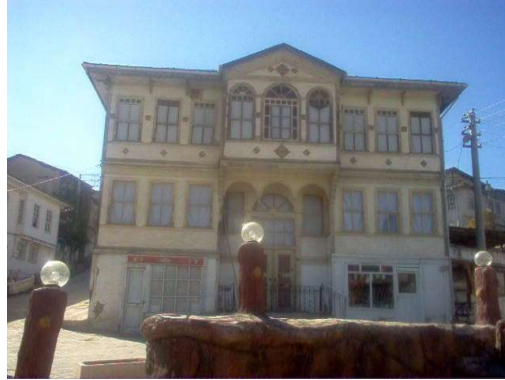
Figure 4.4. G.AD2, Post-intervention view of north side facade that show the addition of the kitchen (Author, 2013)

The addition indicated as G.AD1 is a staircase addition to the left side of the existing staircase. GPOI02 was added mass (G.AD2). It is used as a kitchen (Figure 4.4). G.AD3 is a staircase addition to the garden. G.AD4 is a new lot addition to enlarge the garden. G.AD5 is a new wall addition with a wooden door (Figure 4.5). G.R1 and G.R2 are the removal of walls. They were used as a wall of old mass additions.

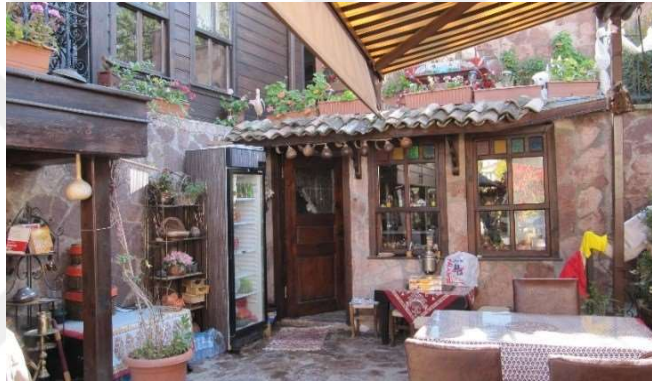
Figure 4.5. Pre-intervention view of north side facade (taken from the Taraklı Municipality, 2013)

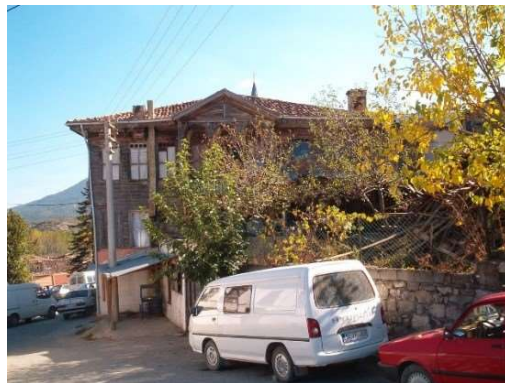
Figure 4.6. North side view that indicates the changes in the garden during the hotel transformation (taken from the Taraklı Municipality, 2013)

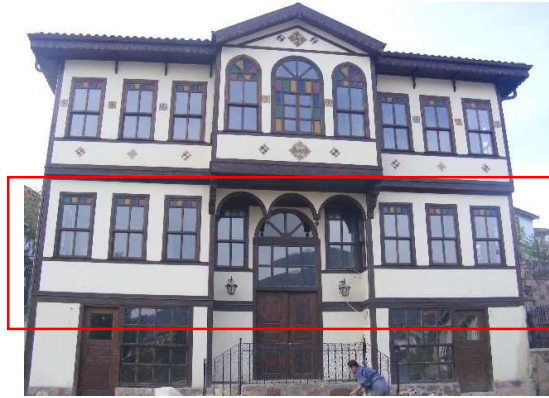
Figure 4.9. Pre-intervention view of east side facade that show the alterations of windows at first floor (taken from the Taraklı Municipality, 2013)

For the first floor (Figure 4.7), F.A1 indicates the alteration of window and door frames (Figure 4.8 and Figure 4.9). New types of window frames were used instead of old ones. New types of window frames include colored rectangular glasses on top of them. F.A2 shows the alteration of kalemişi works on the walls (Figure 4.10 and Figure 4.11). There are some changes in the patterns and colors of kalemişi works. F. A3 is an alteration of the balcony. The balcony was re-constructed according to the original balcony with the same material and same size. Wet spaces were altered. Their wooden floor and wall covering materials were changed with marble. New marble fixtures were added. New openings were created and old openings were closed. The related alteration is indicated with the F.A4 number (Figure 4.12 and Figure 4.13).

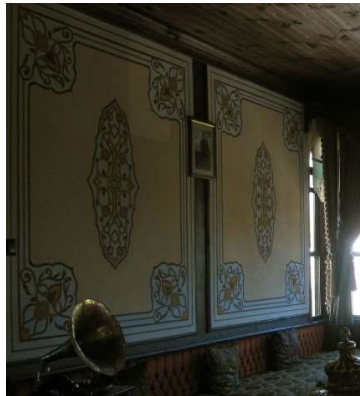
Figure 4.11. A2, pre-intervention view of alteration of kalemîşi works on the walls.  
(taken from the Taraklı Municipality, 2013)

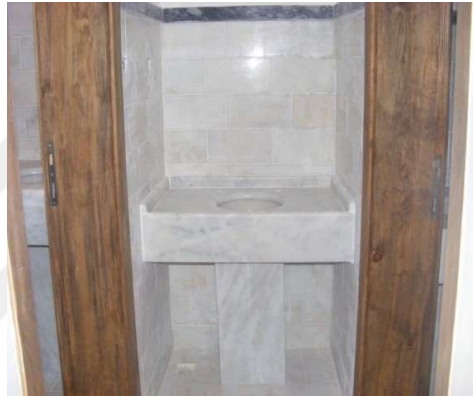
Figure 4.13. A4, alteration of bathrooms II (taken from the Taraklı Municipality, 2013)

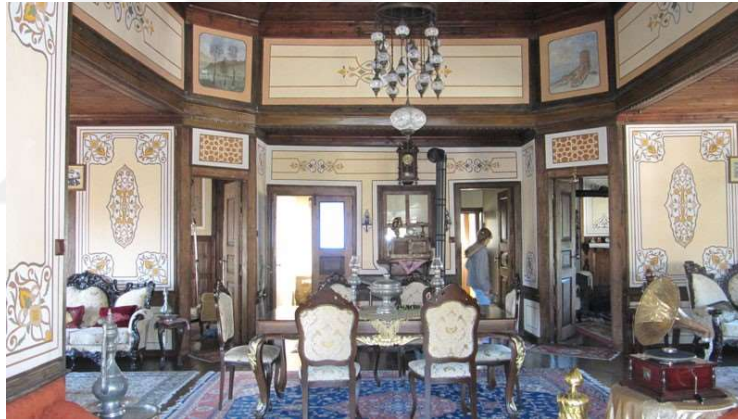
Figure 4.17. S.A1, pre-intervention view of kalemişi works on the walls of first floor (Author, 2013)

For the second floor (Figure 4.15), S.A1 is an alteration of kalemişi on walls (Figure 4.16 and Figure 4.17). S.A2 is an alteration of a wet area (Figure 4.18). The opening which opens to the street was opened after the hotel transformation. S.A3 indicates the alterations of bathrooms. Wall and floor coverings were changed to ceramic tile. Also, new fixtures were added. S.A4 (Figure 4.19 and Figure 4.20) shows the alteration of the bathroom and closet of room SPOI04. Wall and floor coverings were changed to ceramic tile. Also, new fixtures were added and the closet of room SPOI04 was altered. It was opened to the bathroom. It is used as a door not as a closet. New openings were created and old openings were closed.

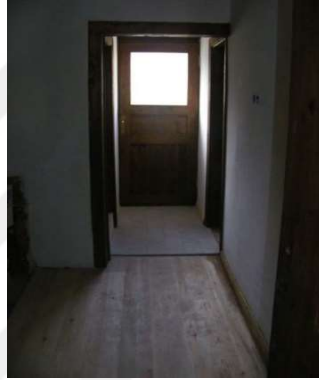
Figure 4.19. S.A4, Alteration of a closet. It is transformed to the door which opens through the altered bathroom (Author, 2013)

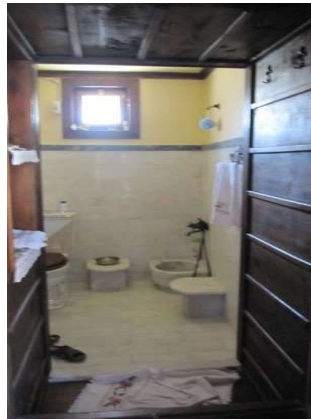
Figure 4.20. S.A4, Alteration of a bathroom (Author, 2013)

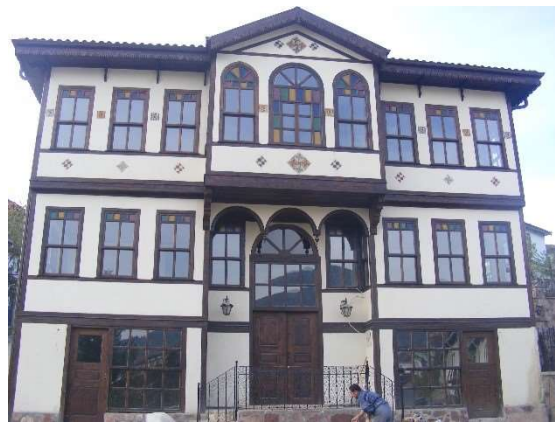
Figure 4.23. Post-intervention view of east side facade (Author, 2013)

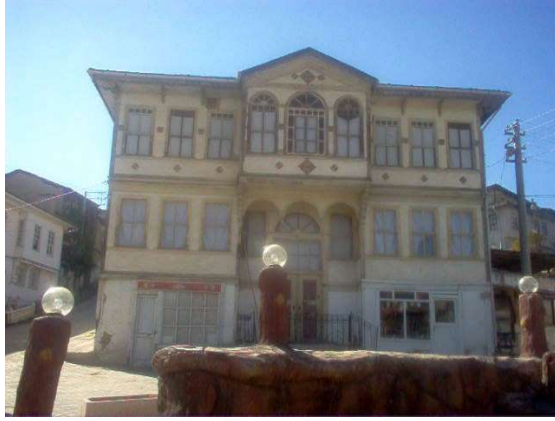
Figure 4.24. Pre-intervention view of west side facade (taken from Taraklı Municipality archives, 2013)

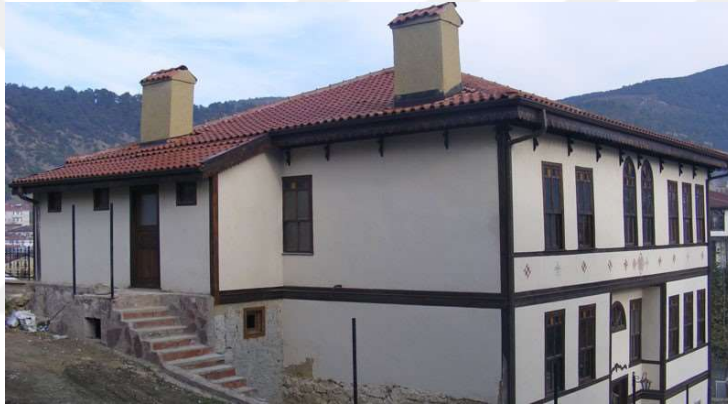
Figure 4.29. Post-intervention view of west facade (Author, 2013)

For the west facade (Figure 4.28), G.AD2 is an addition to the kitchen area on the ground floor. F.AD2 is an addition to the outdoor staircase. F.A4 is an alteration of wet spaces (bathroom and WC). S.AD2 is a mass addition to bathroom and WC spaces. S.A2, S.A3, and S.A4 are alterations of wet spaces. These are the changes on floor plan layouts and affect the west side facade (Figure 4.29 and Figure 4.30).

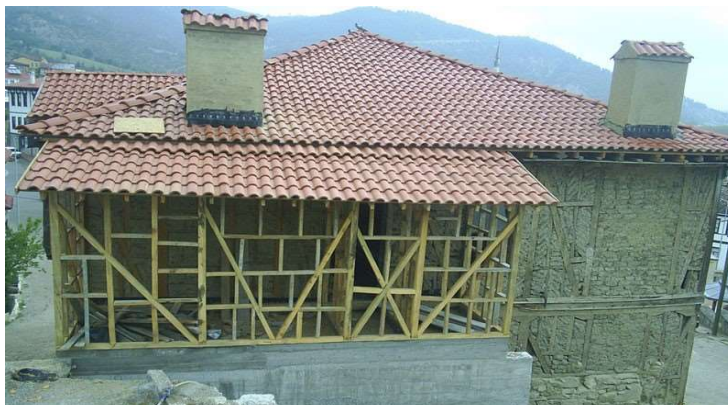
Figure 4.30. Pre-intervention view of west facade (Author, 2013)

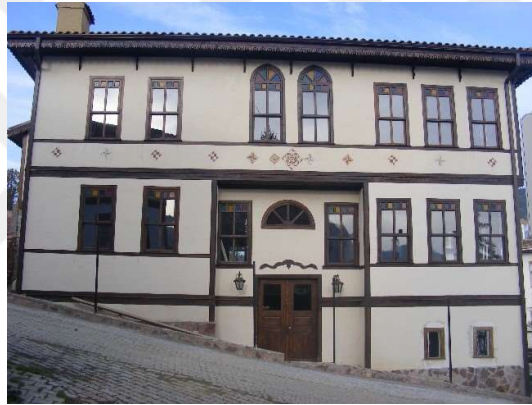
Figure 4.32. Post-intervention view of south facade (Author, 2013)

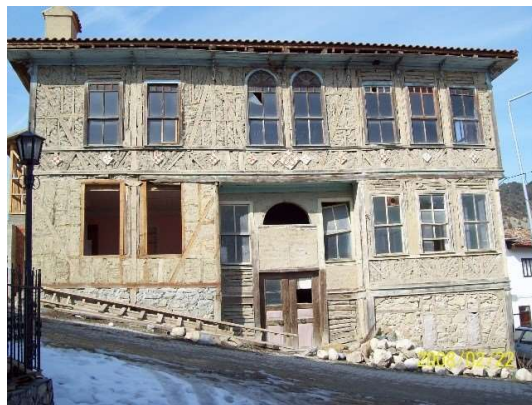
Figure 4.33. Pre-intervention view of south facade (Author, 2013)

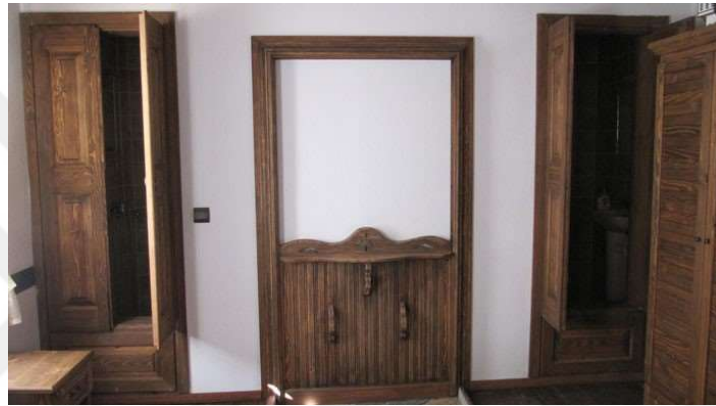
Figure 4.35. G.A1, closets that were altered and transformed into bathroom and wc in GPOI07 (Author, 2013)

For the ground floor (Figure 4.34), G.A1 (Figure 4.35 and Figure 4.36) indicates the alteration of the fireplace and closets on this wall. The fireplace was closed and lost its original function. Closets also lost their function and had been used as a bathroom. Floors and walls of old closets were covered with ceramic tile. New bathroom fixtures were added there. G.A2 (Figure 4.37 and Figure 4.38) is an alteration of the fireplace and closet on this wall. G.A3 is an alteration of window and door frames. Their frames were changed with new ones. A new, small window was opened on this wall. G.A4 is an alteration of the related wall. A new window was opened on this wall. G.A5 is an alteration of WC. The wall and floor covering were changed with ceramic tile. New bathroom fixtures were added to the WC. G.A6 is an alteration of wc. The wall and floor covering were changed with ceramic tile. New bathroom fixtures were added to the WC. The outer walls of the WC areas were demolished before the transformation so that new walls were constructed. G.A7 is an alteration of a wall. The new door was opened on this wall. G.A8 is an alteration of the kitchen (Figure 4.44). The wall and floor covering were changed with ceramic tile. New bathroom fixtures were added to the kitchen. G.A9 is an alteration of the kitchen counter. The old kitchen counter was changed with a new type of kitchen counter.

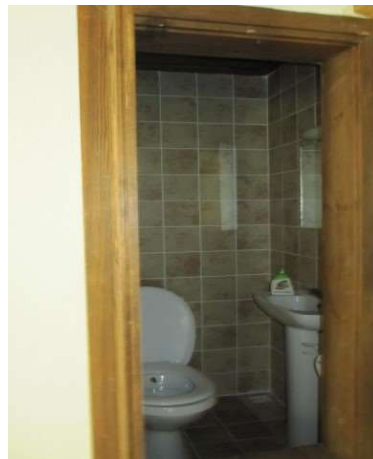
Figure 4.36. G.A1, interior of the closets that were altered and transformed into bathroom and wc in GPOI07 (Author, 2013)

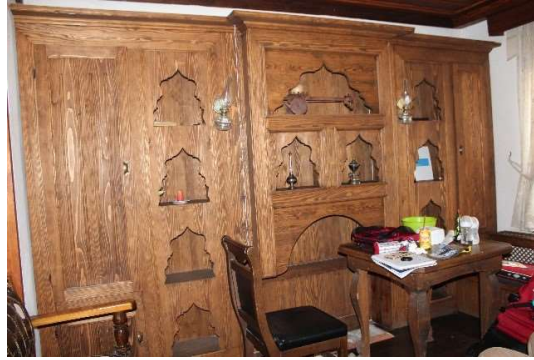
Figure 4.37. G.A2, Alteration of closet during the hotel transformation (Author, 2013)

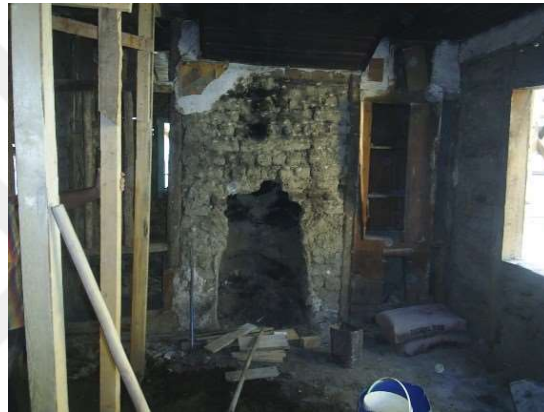
Figure 4.38. G.R1 is a removal of original fireplace in GPOI08 (taken from the Taraklı Municipality, 2013)

G.R1 is a removal of the original fireplace. G.R2 is a removal of the wall in between wc.

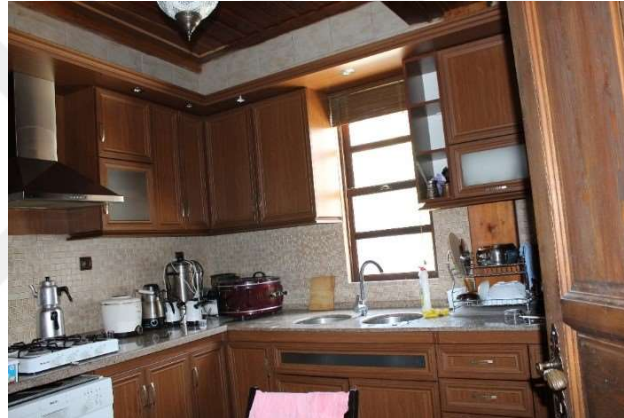
Figure 4.44. G.A8 and G.A9. Alteration of the kitchen (Author, 2013)

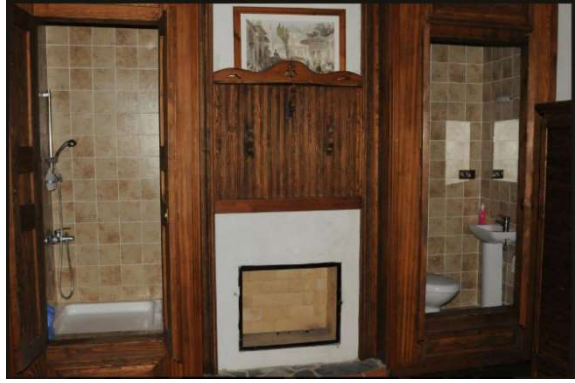
Figure 4.46. F.A1, alteration of fireplace and closets in room FPOI09 (taken from the Taraklı Municipality, 2013)

F.A1 indicates the alteration of the fireplace and closets on this wall (Figure 4.46). The fireplace was closed and lost its original function. Closets also lost their function and had been used as a bathroom. Floors and walls of old closets were covered with ceramic tile. New bathroom fixtures were added there. F.A2 is an alteration of the wall. This part of the wall was opened to create an entrance to the bathroom. Its doors were designed as wooden closet doors. F.A3 is an alteration of WC. The wall and floor covering were changed with ceramic tile. New bathroom fixtures were added to the WC. F.A4 is an alteration of wc. The wall and floor covering were changed with ceramic tile. New bathroom fixtures were added to the WC. The outer walls of the WC areas were demolished before the transformation so that new walls were constructed. F.A5 is an alteration of the wall. A new door opened on this wall to create an entrance to the bathroom.

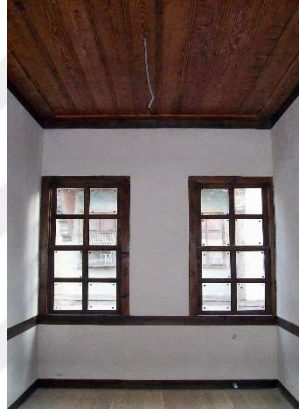
Figure 4.47. F.R1 is a removal of the sedir (taken from the Taraklı Municipality, 2013)

F.R1 (Figure 4.47 and Figure 4.48) is a removal of the sedir (seating unit) from FPOI10.

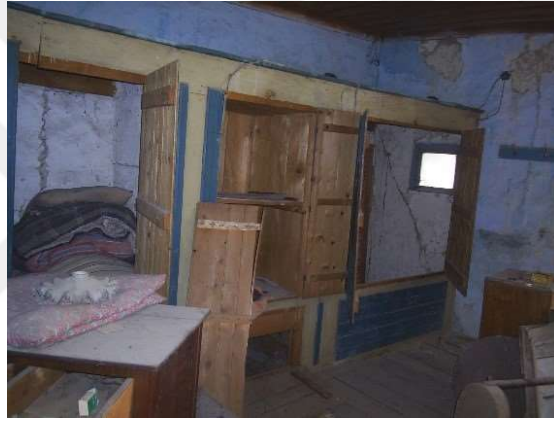
Figure 4.50. Pre-intervention view of the sofa (taken from the Taraklı Municipality, 2013)

F.AD1 is an addition to a new room. A new door and a window were added to this part to create a new room. F.AD2 (Figure 4.49 and Figure 4.50) indicates a new bedroom and two bathroom additions. To create related spaces, new walls, and doors were added to this part. F.AD3 is an addition of a new wall to divide the two wc areas into two.

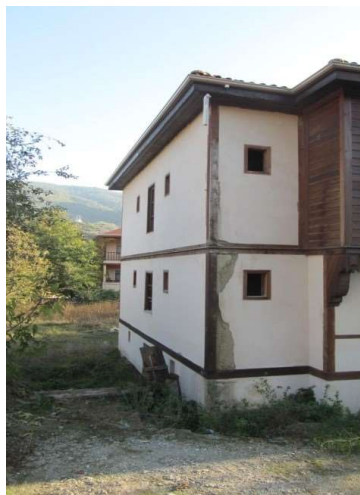
Figure 4.55. Current view of east side facade that indicate the G.AD1 and G.A1 (Author, 2013)

G.AD1 (Figure 4.55 and Figure 4.56) is an addition of a mass. G.AD2 is an addition of a reception desk.

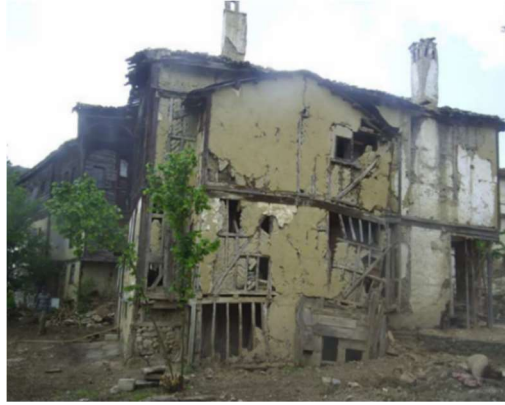
Figure 4.56. Old view of east side facade that indicate the G.AD1 and G.A1 (cited in Selçuk, 2008, p.123)

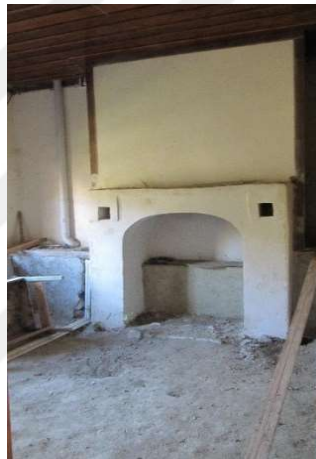
Figure 4.57. Current pictures of the kitchen that indicate the G.R3 (Author, 2013)

G.R1 (Figure 4.59 and Figure 4.60) is a removal of a storage area. It had a connection between the kitchen but after the hotel transformation, this part removed from the ground floor. Instead of storage space, the reception desk was placed to there. G.R2 is a removal of the staircase. G.R3 (Figure 4.57 and Figure 4.58) is a removal of old kitchen cabinets.

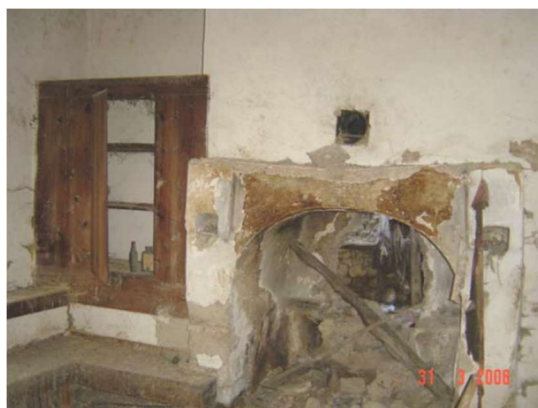
Figure 4.58. Old pictures of the kitchen that indicate the G.R3 (Selçuk, 2008, p.107)

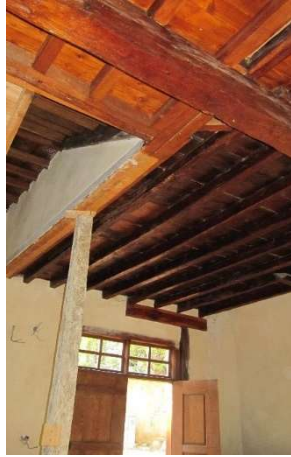
Figure 4.59. Current view of the GPOI03 that indicate the G.R1 (Author, 2013)

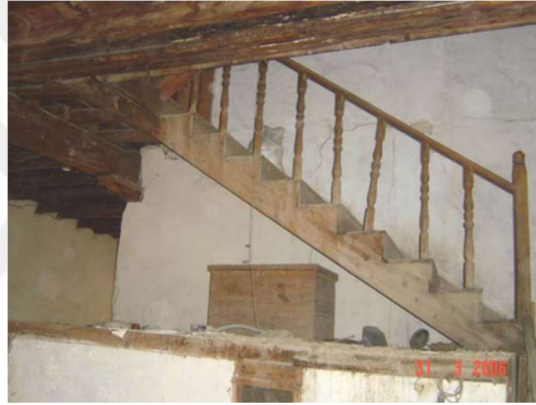
Figure 4.60. Pre-intervention view of the GPOI03 that indicate the G.R1 (Selçuk, 2008, p.104)

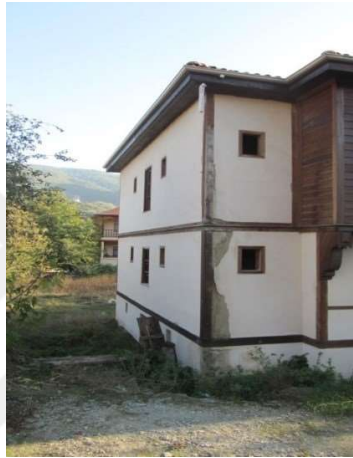
Figure 4.62. Current view of east side facade that indicate the F.AD1 and F.AD2 (Author, 2013)

F.AD1 and F.AD2 (Figure 4.62 and Figure 4.63) are mass additions that are used as a part of bathrooms.

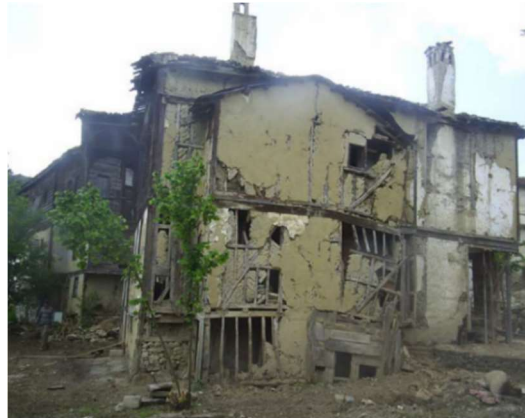
Figure 4.63. Pre-intervention view of east side facade that indicate the F.AD1 and F.AD2 (Özkan, 2008, p.123)

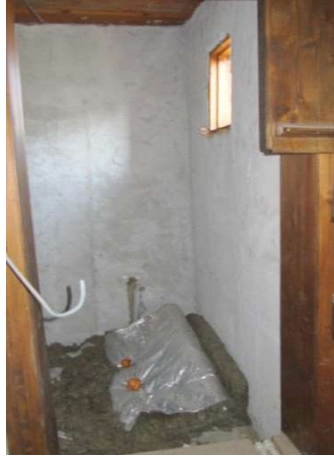
Figure 4.64. Alteration of wet spaces in first floor (Author, 2013)

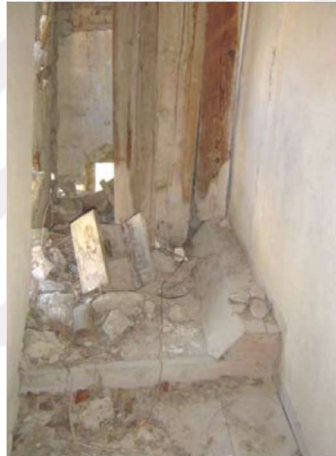
Figure 4.65. Pre-intervention view of wet spaces in first floor (Özkan, 2008)

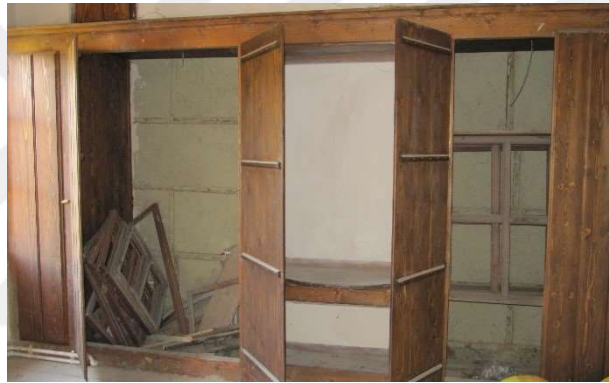
Figure 4.67. Alterations of closets at second floor of the house (Author, 2013)

For the second floor (Figure 4.66), S.A1 is an alteration of the fireplace and closets. Some parts of the closets were altered and used as a bathroom. The closets of SPOI01 and SPOI05 were altered. One of their closets was used as an entrance to the bathroom. The typology of closets and fireplaces was also altered. The closets of SPOI07 and SPOI08 were altered. Bathroom solutions were provided in the closets (Figure 4.67 and Figure 4.68). S.A2 is an alteration of SPOI03. S.A3 is an alteration on the facade. This part was altered and pulled back through the SPOI06.

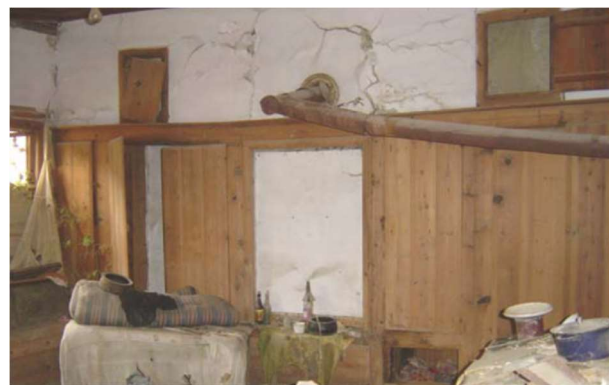
Figure 4.68. Pre-intervention view of closets at second floor of the house (Özkan, 2008, p.111)

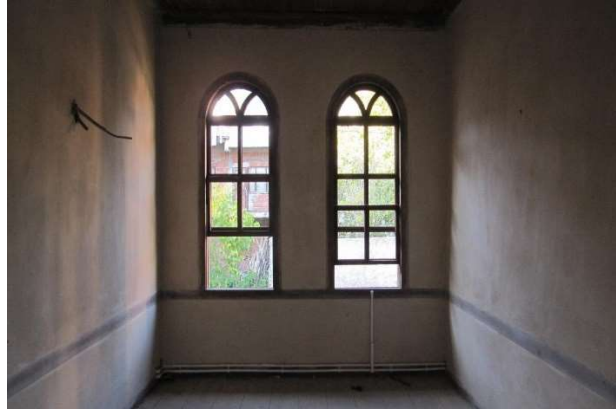
Figure 4.69. Removal of a sedir from SPOI06 (Author, 2013)

S.R1 indicates a removal of sedirs (Figure 4.69).

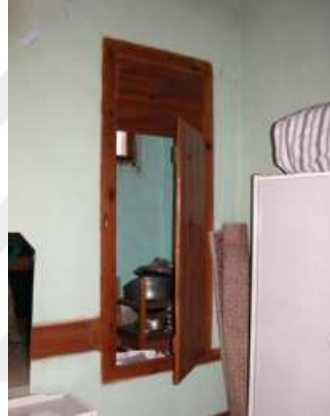
Figure 4.76. Pre-intervention view of FPOI02 (Çetin, 2006, p.508)

The function of the room was changed to the kitchen in FPOI02 during the hotel transformation (Figure 4.75 and Figure 4.76).

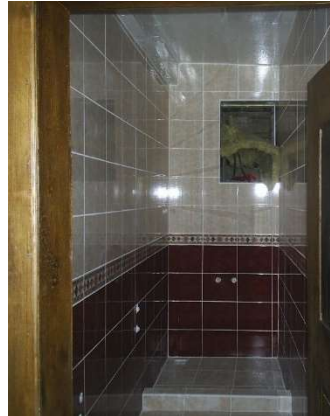
Figure 4.77. Alterations of FPOI03 during the hotel transformation of Çakırlar House (taken from the Taraklı Municipality, 2013)

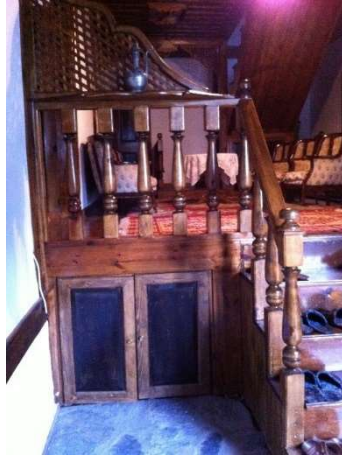
Figure 4.78. F.A6 indicates the alteration of details on entrance staircase at left side (Author, 2013)

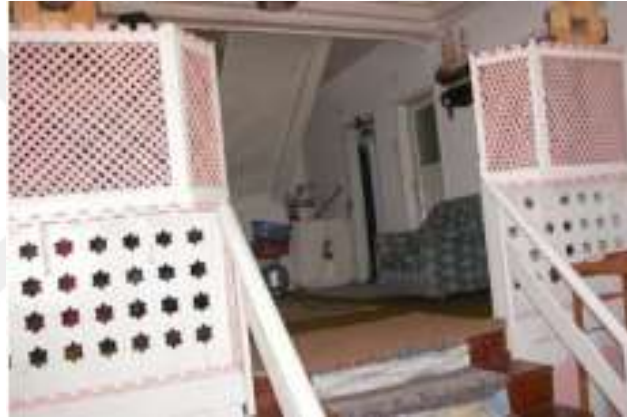
Figure 4.79. Pre-intervention view of the entrance staircase at right side (Çetin, 2006, p.548)

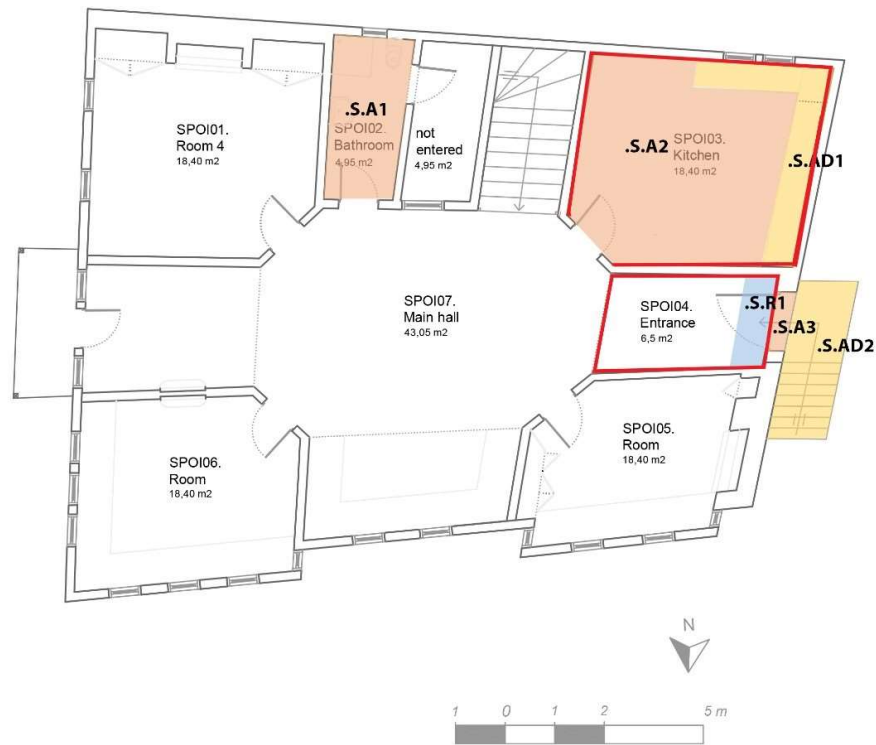
SECOND FLOOR PLAN

S.A1 is an alteration of the bathroom (Figure 4.81). The floor and wall material of the bathroom were changed with ceramic tile. Contemporary type of bathroom fixtures and a bathtub were added. S.A2 is an alteration of the kitchen (Figure 4.82). The floor and wall material of the kitchen were changed with ceramic tile. S.A3 (Figure 4.83) is an alteration of the window. The window was enlarged and altered. A new door opening was opened instead of a window.

S.AD1 is an addition to the kitchen counter and cabinet. S.AD2 (Figure 4.84) is an addition of an outer staircase.

S.R1 is a removal of sedir.

SPOI03 is a change in the function of space in SPOI03. It was used as a room. After the hotel transformation, it was used as a kitchen. There is a change in the function of space in SPOI04. It was used as a part of a sofa. After the transformation, it is used as an entrance to a floor.

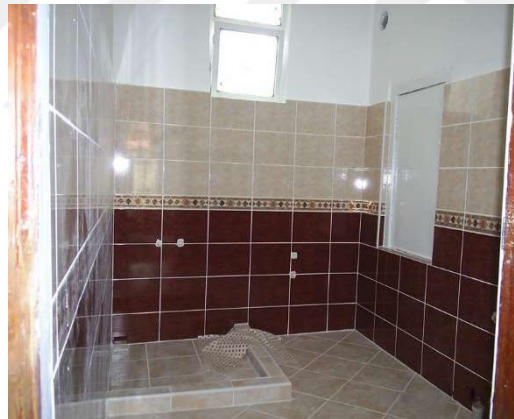
Figure 4.81. Alteration of SPOI02 during the hotel transformation (taken from the Taraklı Municipality, 2013)

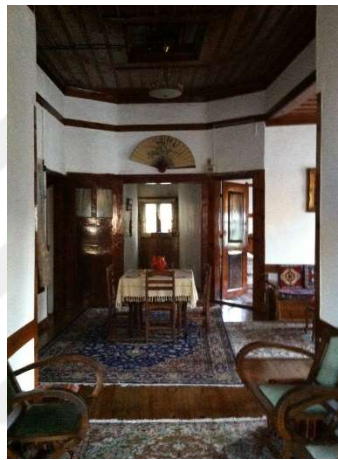
Figure 4.83. The picture indicates S.A3 and S.R1 in SPOI04 (Author, 2013)

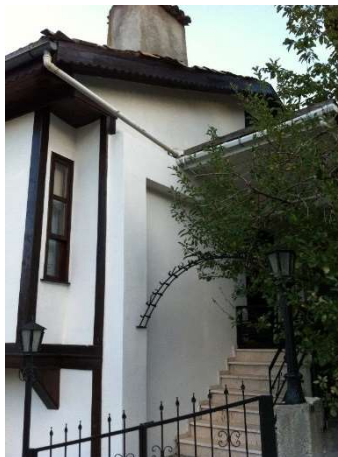
Figure 4.84. The picture indicates S.AD2 (Author, 2013)
