**SLOPE STABILITY ANALYSIS FOR WASTE LANDFILL IN
CENTRAL DISTRICT TEGUCIGALPA HONDURAS**

Graduate School of Science and Engineering of Hacettepe University

for being Award of the Degree of Master of Science

in Civil Engineering

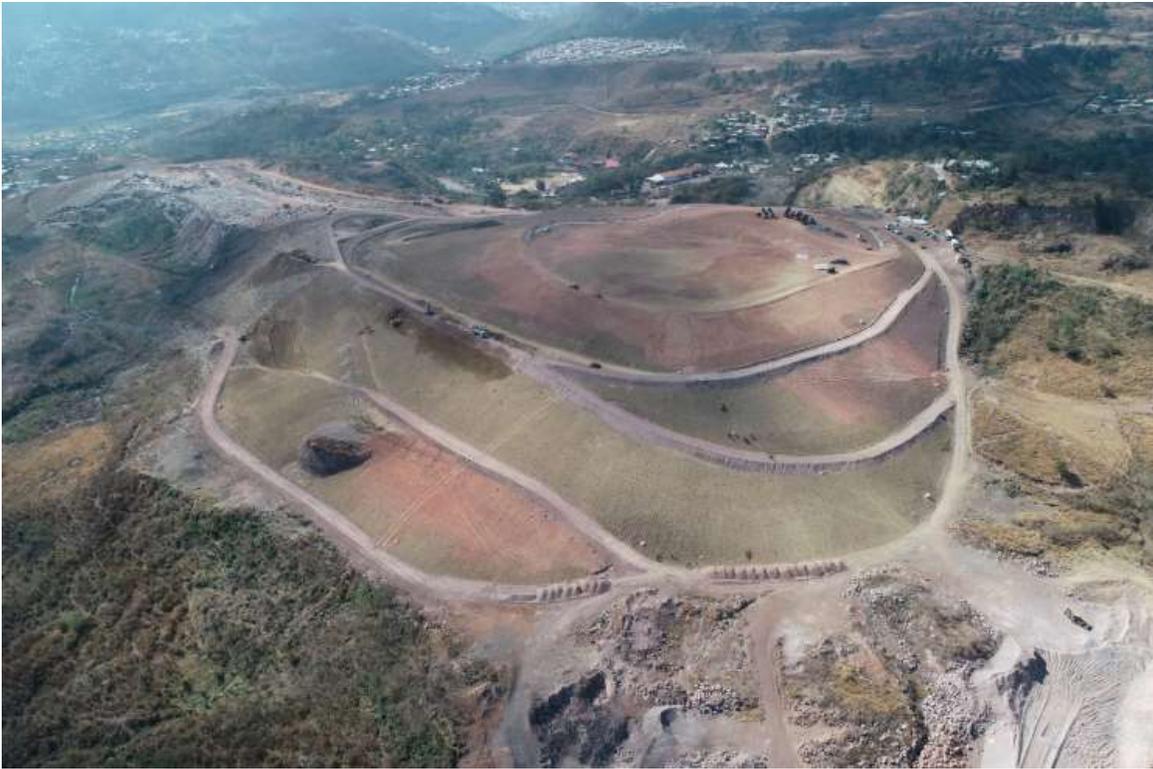
Figure 2. 2 Aerial view from the Municipal Landfill in Tegucigalpa. Photograph by German R. Pavón

The capital city main waste disposal center according to the Central American Bank for Economic Integration (CABEI) is used approximately by 600,000 beneficiaries in the urban area of the Central District as registered users of the sanitation service plus 40,000 users from the areas surrounding the landfill. The rest of the population of the Central District (600,000 inhabitants) are considered indirect beneficiaries. An aerial view of the landfill can be seen in Figure 2.2.

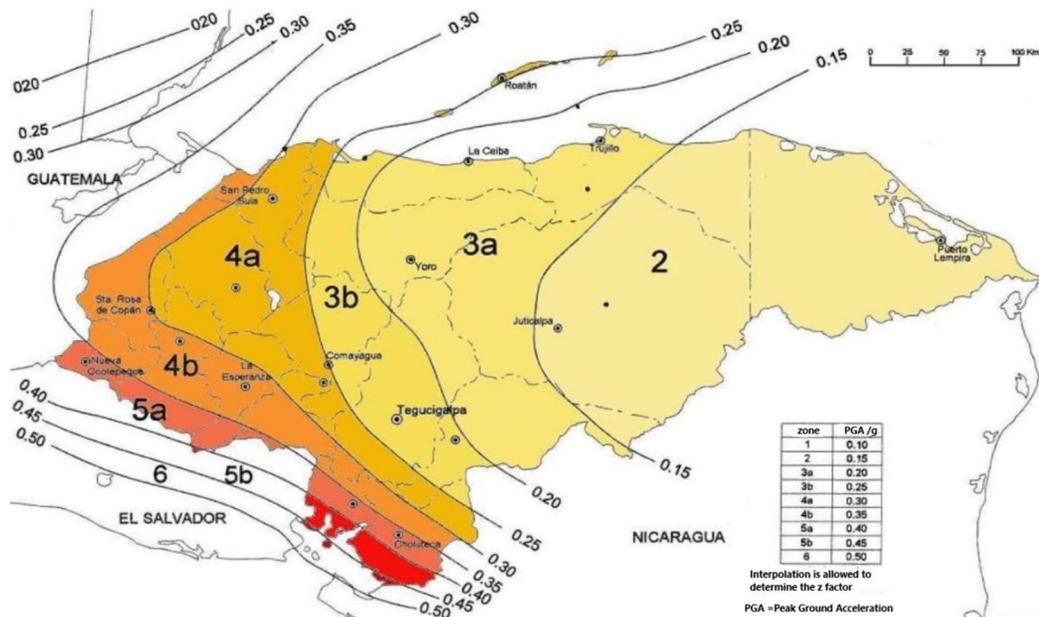
Figure 2. 8 Seismic zoning map of Honduras CHOC 2008

According to the Honduran Code of Construction (CHOC), the Iso-acceleration maps valid for Honduras in the new landfill project area indicate a 3b zone corresponding to values of 0.25g which should be considered for design within this zone (see Figure 2.8).

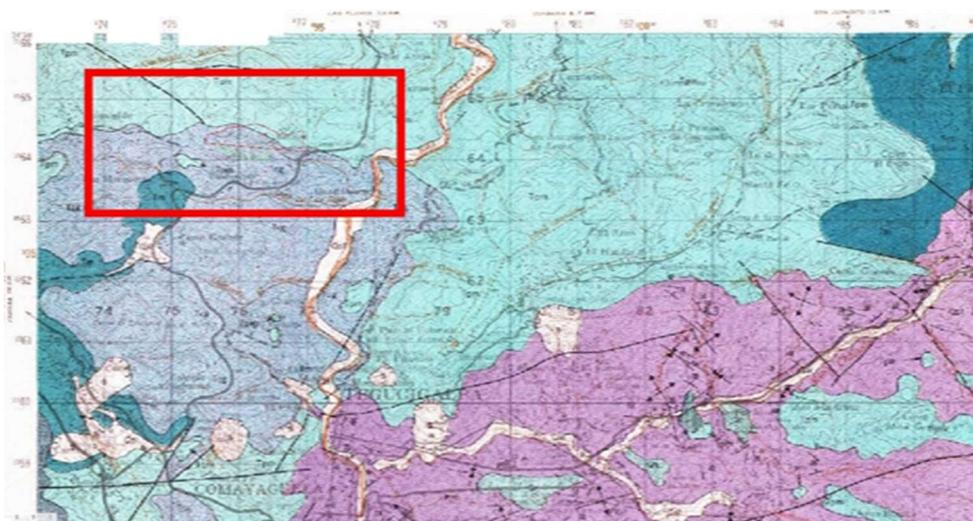
Figure 2. 9 The geological map of Tegucigalpa Honduras scale 1:50,000

According to the geological map sheet edited by the National Geographic Institute (IGN), the geology of the area corresponds to the Padre Miguel Group, more specifically to two formations. In the northern area of the project, the TPM unit member and in the southern zone of the Cerro Grande TCG unit (see Appendix A.2 Soil Units Chart). The TPM unit is a sequence of rhyolitic, andesitic, and dacitic ignimbrites with tuffs of different colors and resistances (GEASA, 2021a). This unit is very marked on Cerro Tusterique which is the name given to the mountain located in the project and next to the residential San Jose on the northeastern side where these sequences can be observed. From the geological map sheet 2758 II of Tegucigalpa (Appendix A.3 Geological Map of Project area) a focus area is made on the northern TCD area and Project location shown in Figures 2.9 and 2.10 respectively.

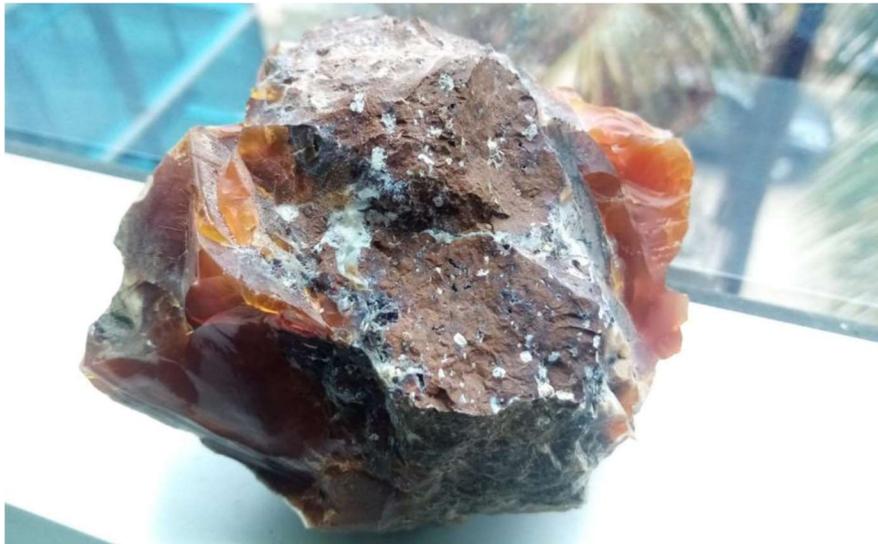
Figure 2. 11 Amorphous silica. Source: GEASA studies for the new municipal landfill report.

The Cerro Grande formation that is found in the south area corresponds to ignimbrites with quartz (amorphous silica) and sanidine in a vitrified matrix with deep and vertical fracturing. In Figure 2.11 the lithology with the fire opal type can be observed.

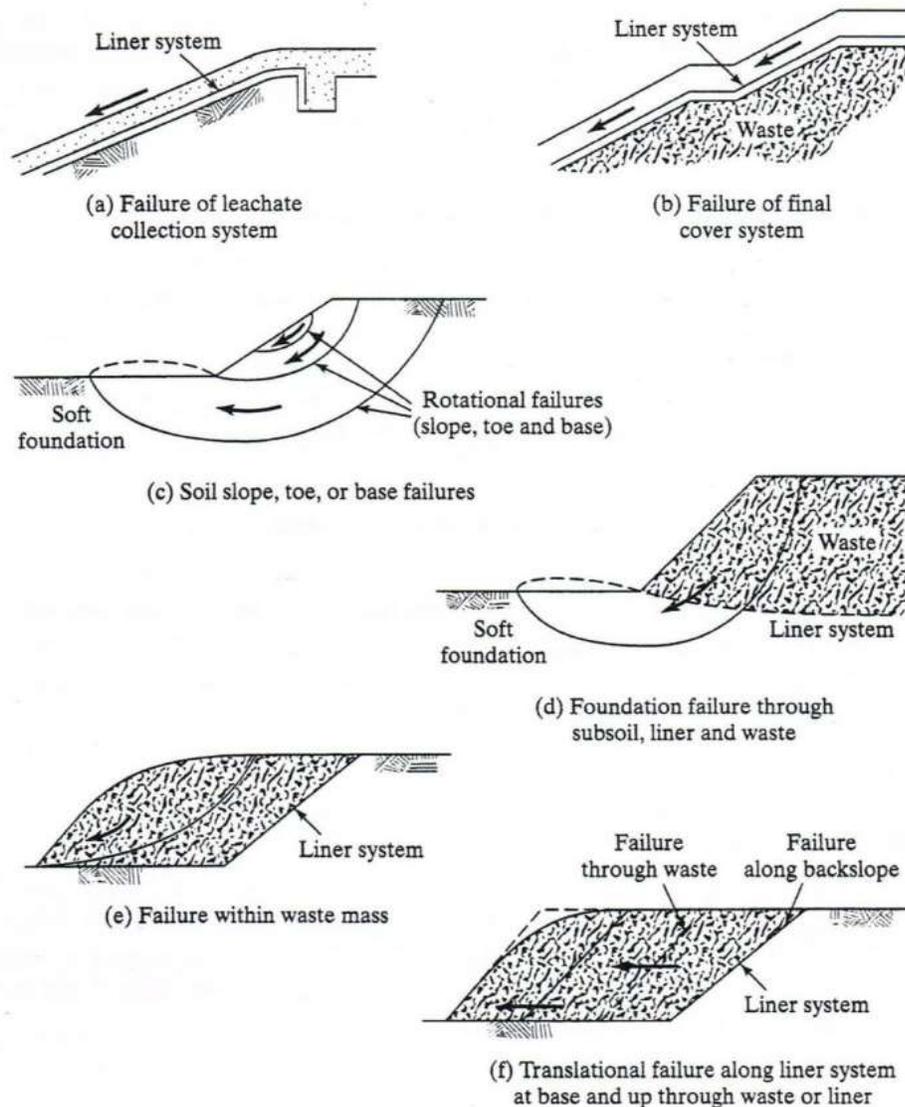
Figure 3. 1 Landfill failure modes (Qian et al., 2001).

Determining a slope failure mechanism mode may result in a challenging task due to the lack of field data in the exact location of a study which makes it hard to fully comprehend the potential failure mechanism. Expertise and field experience are crucial criteria to assess a slope stability failure with the appropriate method. Field observation plays an important role in cataloging the possible initial failure mechanism of a slope taking into consideration the geological parameters, the geometry of the slope, joint structures, and behavior of the rock and rock mass as it is the scenario case for El Crematorio which presents a predominating ignimbrite lithology. The importance of identifying the failure mode is to provide the engineer or designer with a field phenomenon from which a particular analysis with a defined mechanical model can be made to manage or control landfill stability. (Stark, 1999) classified landfill failure into two major modes, translational and rotational, from which based on previous records like the tragic rotational failure in the Payatas landfill in the Philippines, the translational failure mode is more catastrophic and common than the rotational failure. Payatas tragedy highlighted the necessity of more research on failure modes. Thus, a year later, (Qian et al., 2001) published the six main general landfill failure modes within the cover liner, waste materials and foundation soil interfaces, illustrated in Figure 3.1. In the following sections, some of these typical slope failure mechanisms are discussed.

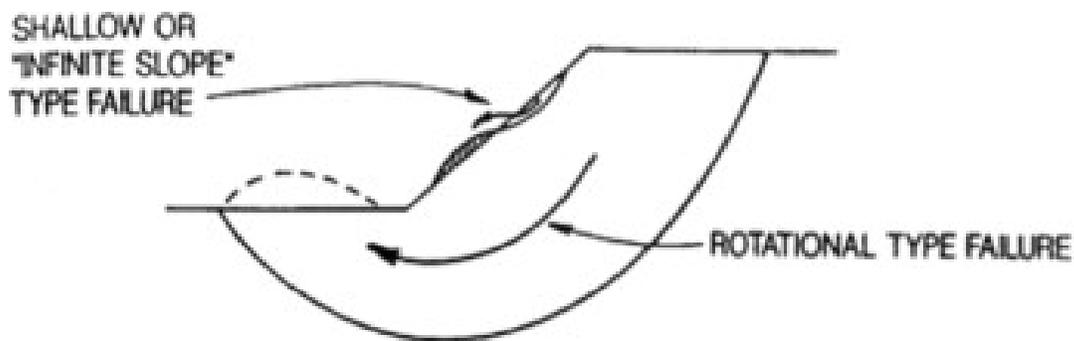
Figure 3. 2 Rotational failure of sidewall slope and base failure (Mitchell & Mitchell, 1993)

This failure occurs when the soil layers behind or beneath the waste mass are unstable and provoke a circular failure, see Figure 3.2. Failure plane can emerge from the slope, toe, or within the foundation. This geotechnical problem applies to steep side slopes and/or soft foundation soils and does not involve liner systems or their waste mass properties (Omari, 2012).

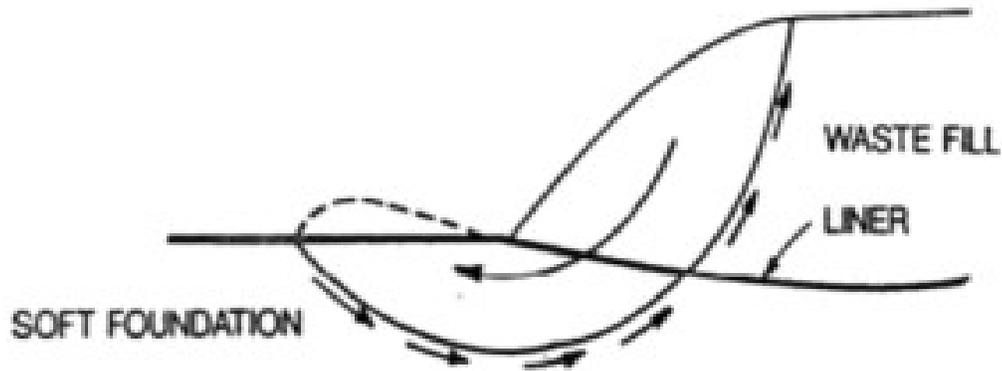
Figure 3. 3 Rotational failure through the landfill, liner, and foundation layer (Mitchell & Mitchell, 1993)

Failure by rotation through waste, liner, and subsoil starts at the foundation as a sloping of waste on the upper part and continues through the MSW mass all the way to the liner and subsoil as shown in Figure 3.3 (Qian et al., 2001). This type of failure occurs within the waste mass and is common in steep slopes with high moisture content, and low compaction density. Such failures can be massive, involving over 50,0000 m³ of waste (Omari, 2012). The weight of the MSW may be one of the triggering factors of these failures.

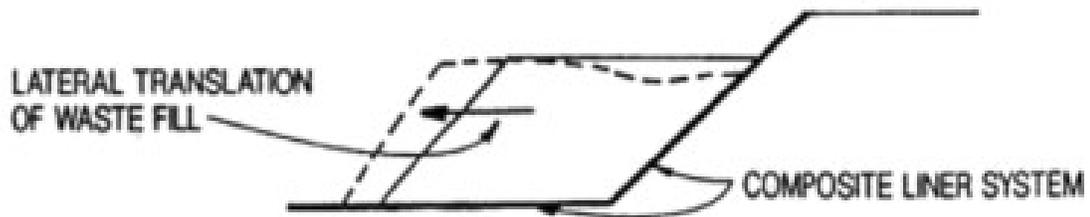
Figure 3. 4 Failure by sliding along the landfill liner system (Mitchell & Mitchell, 1993).

Translational failure can occur with the waste sliding above, within, or beneath the liner system. The failure plane can extend from the toe up through the waste mass, or continue in the liner system along the back slope (Qian et al., 2001). This type of failure is mostly possible in landfills and starts with a huge sliding mass that deforms and breaks into several

independent pieces (Stark, 1999). Normally starting from the weak surfaces within the waste mass or liner interface as shown in Figure 3.4. Stark (1999) claimed that homogeneous materials such as soft soils and clays are more prone to failure.

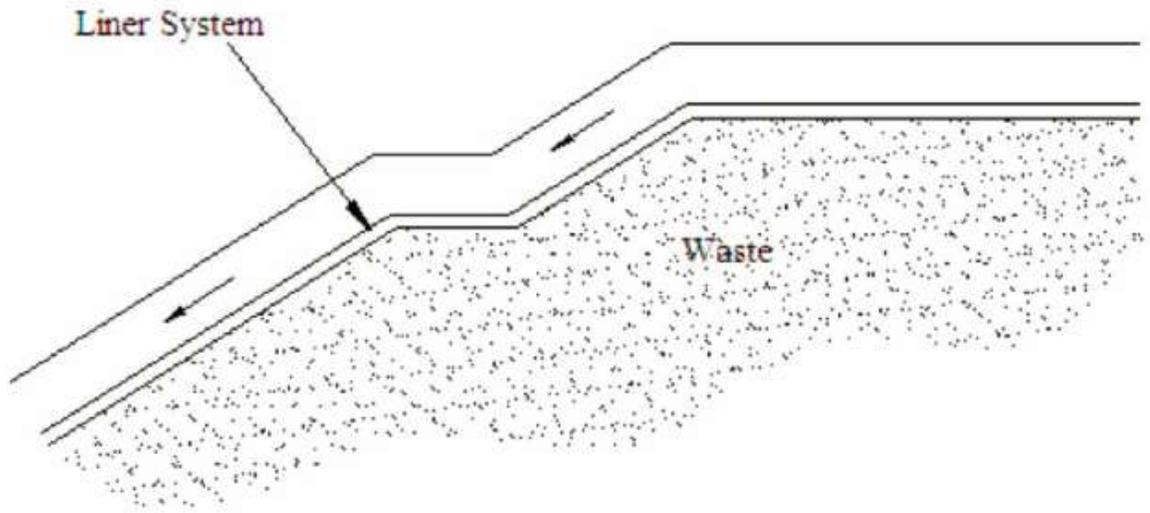
Figure 3. 5 Failure of a final cover system (Mitchell & Mitchell, 1993).

Long and steep slopes in the final cover system formed of topsoil and a protective layer, may fail on the liner system. This failure surface plane is always planar (Omari, 2012), usually parallel to the surface ground as seen in Figure 3.5, and relatively at low depths of about 0.5–2 meters deep. The cover system failure normally happens when excessive precipitation occurs. If only soil is displaced, replacing the soil will fix the problem. However, the long-term stability issue may continue. The consequences are more serious if the liner system contains the failure surface.

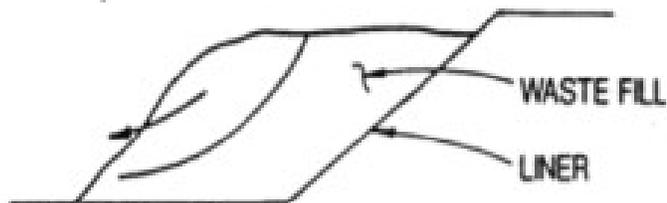
Figure 3. 6 Rotational failure of the waste pile (Mitchell & Mitchell, 1993).

This failure occurs within the waste mass, completely independent of the bottom liner system, see Figure 3.6. It is assessed exactly in the same methods as the failures described before, except that the material composition is MSW instead of soil. It consists of a circular failure plane associated with large volumes of MSW movement from the face to the toe of the slope (Omari, 2012). These types of failures are commonly prompted by steep slopes, high water pore pressure, and deficiency of operation control.

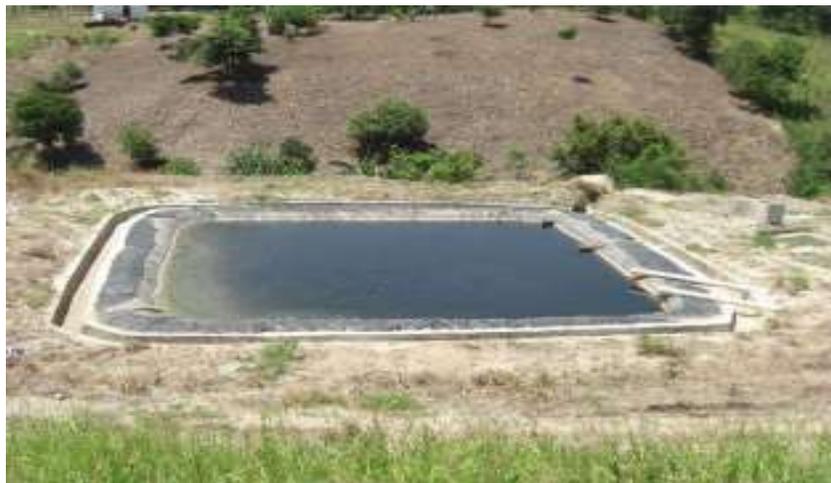
Figure 3. 7 Leachate collection Pond in Potrerillos department of Cortes, Honduras

The composition of leachate from a landfill is highly variable, depending on the stabilization stage in which the waste in the area is going through, the dilution of external water and the composition of the disposed waste in the filling. In general terms, the leachate coming from a sanitary landfill is characterized due to its high organic load, which can vary between 10 and 100 times the organic load of effluent sewerage (SERNA Honduras et al., 2014), which contains significant salt content, oxidizable chemical compounds, and heavy metals. El Crematorio has a leachate collection system that started to be in use in the 90s after it transitioned from an open-air dump to a controlled landfill site. This system partly collects the leachate generated from sections 1 through 3 and it takes them into an 8” collection pipe running all the way to the primary collection pond similar to the one shown in Figure 3.7.

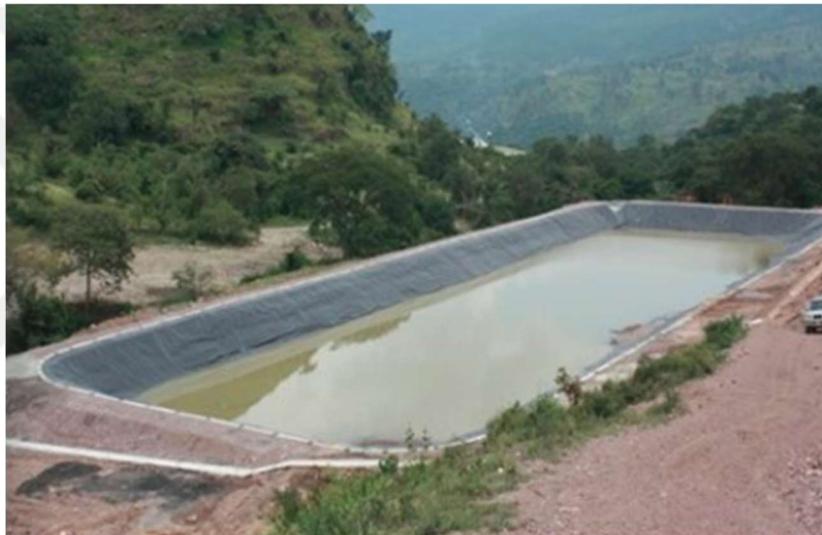
Figure 3. 8 El Crematorio leachate pond 2019, source: Honduras and Spain fund CABEI

A leachate recirculation system is used to pump the leachate accumulated in the primary collection pond. The purpose of recirculating leachate is to prevent spillage in the first pond, especially during the rainy season. The recirculation of the leachate on the residues speeds up the process of decomposition, especially during the dry seasons. The leachate collection system has the basic function of transporting the leachate percolated from the disposal wastes towards the leachate pond which consequently is transported to a secondary bigger capacity drying lagoon (Figure 3.8).

The existing leachate lagoons in El Crematorio have an approximate storage capacity of 300 m³ for the primary collection pond and 5,400 m³ for the secondary lagoon, and as they are currently in use, until now their capacity has been enough for the landfill site demand; as expressed by the landfill manager. The new landfill Section IV is considered to include both new primary and secondary leachate collection ponds which can have the capacity to manage the leachate from the upcoming new landfills. Following the technical procedures of the current landfill, the leachate will be collected through 6” perforated pipes in five rows, set 22 meters apart on each bottom liner terrace (Figure 3.9) which intercept an 8” collector pipe to a final main 10” landfill collection pipe that discharges on the primary collection pond. The space not occupied by the perforated tubes inside the drainage channels drainage is filled

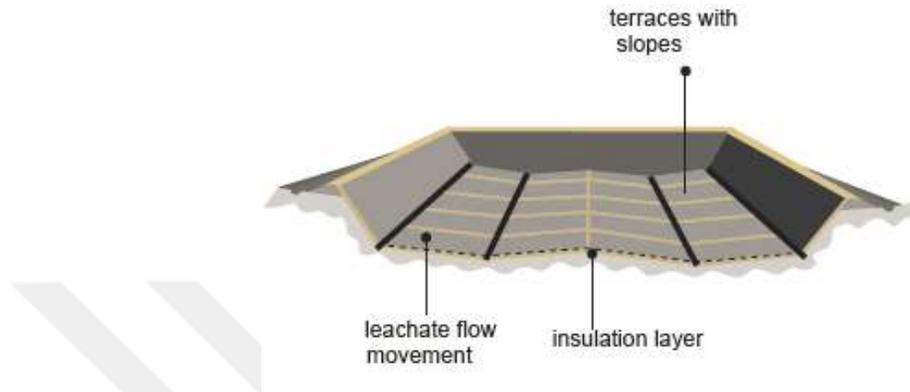
Figure 3. 9 Bottom drainage network arranged in the bottom liner.

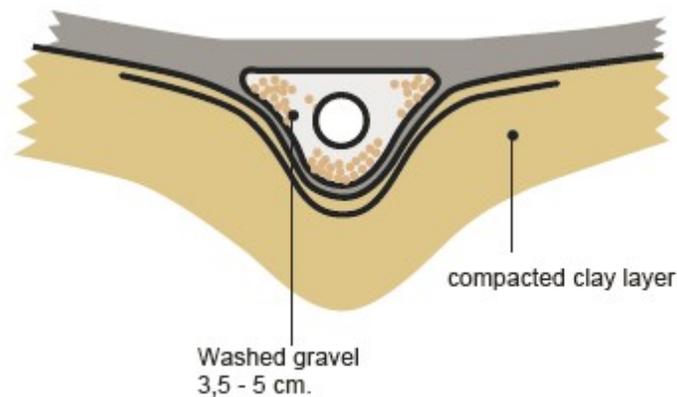
Figure 3. 10 Bottom leachate drain gutter detail.

with clean or washed gravel of 3.5 to 5 cm (Figure 3.10). These drainage pipes should have a slope of 0.5 to 1% towards the collector pipe.

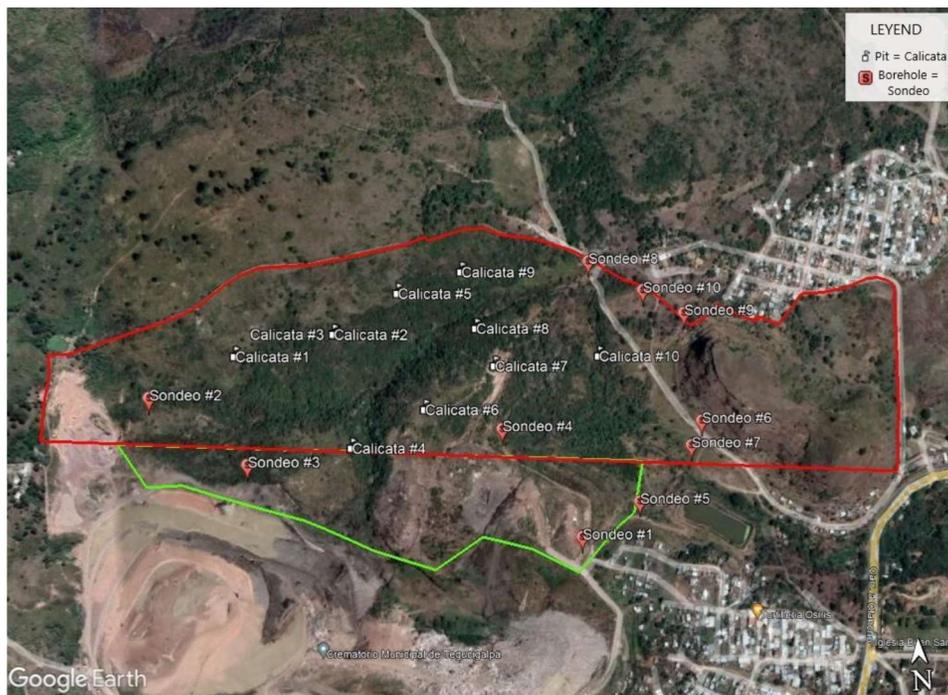
Figure 4. 1 Satellite location of the tests within the premises. Source (GEASA, 2021a)

As described by the surveying engineer, the West area of the future landfill was not thoroughly tested due to a lack of road access and rough terrain conditions presented (J. Arce, personal communication, July 19, 2022). In Figure 4.1, the pits (calicata) and borehole (sondeo) locations are presented.

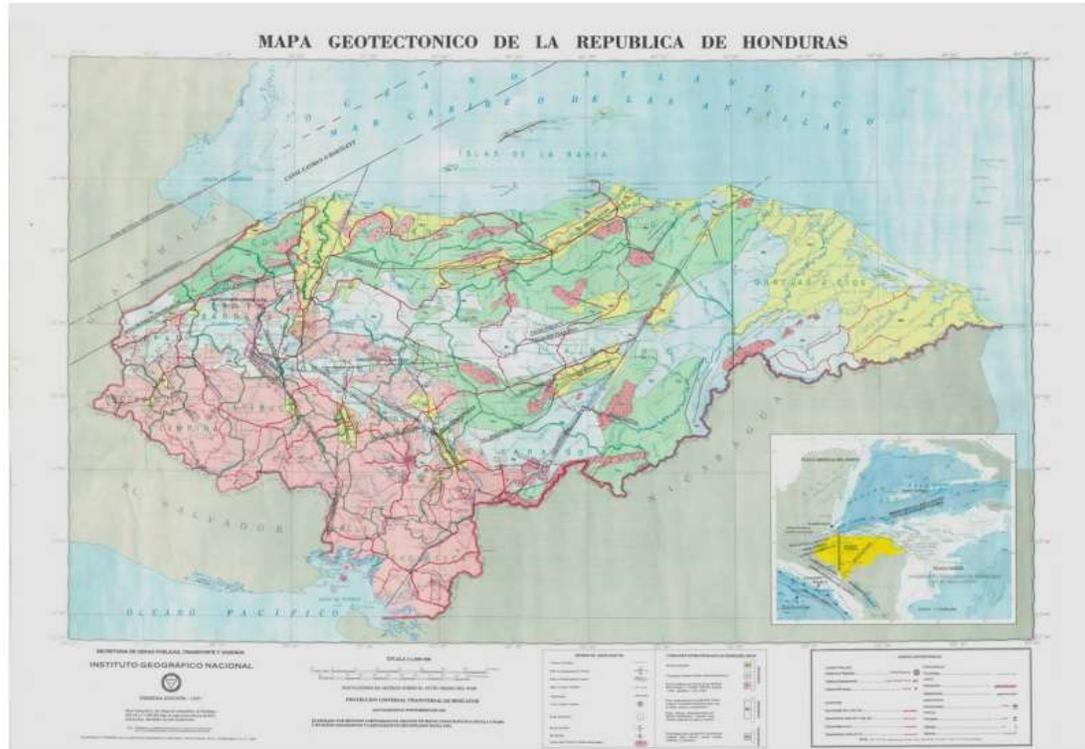
Figure 4. 2 Geotectónica Map from the Republic of Honduras. Author: Instituto Geográfico Nacional de Honduras 1997 1st Edition.

From the Geotechnical map of Honduras Figure 4.2, the Minas de Oro structural belt can be observed just below the site where the Central and Northern Chortis terrains meet.

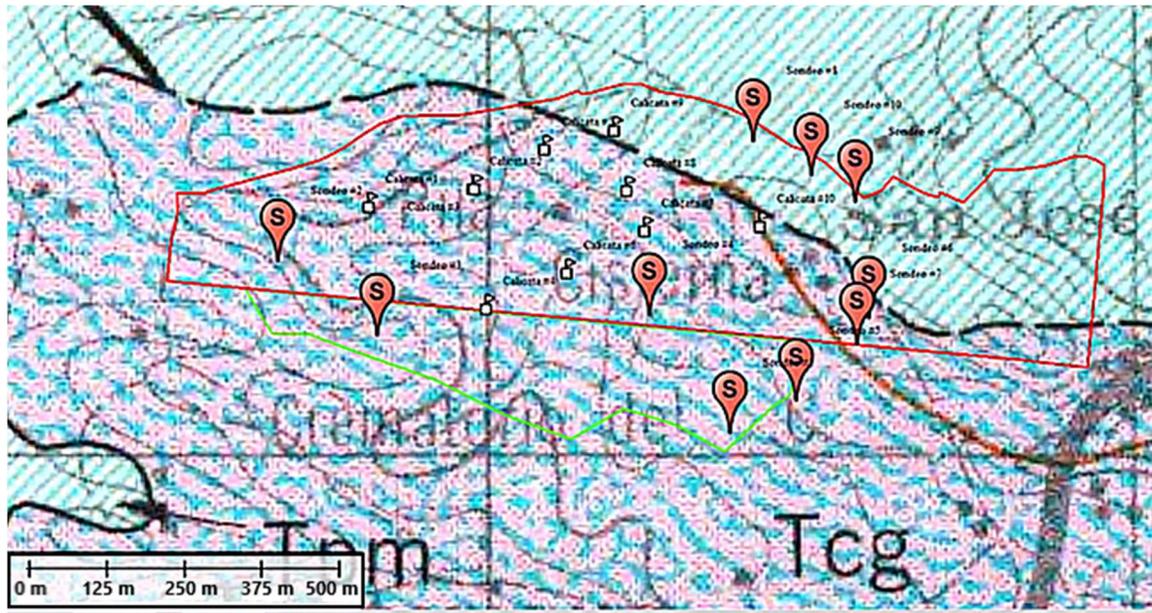
Figure 4. 3 Project area with the location of the boreholes.

A detailed description of the materials found in the surveys is described in the drilling log included in Appendix A.6. The strata found can briefly be described as rocky coming from the Cerro Grande and Padre Miguel formations. According to the geological map of Honduras sheet 2758 II, Cerro Grande formations will prevail in the southern part of the area and Padre Miguel in the northern part. The borehole studies done on the project can be observed in Figure 4.3 located with GPS data.

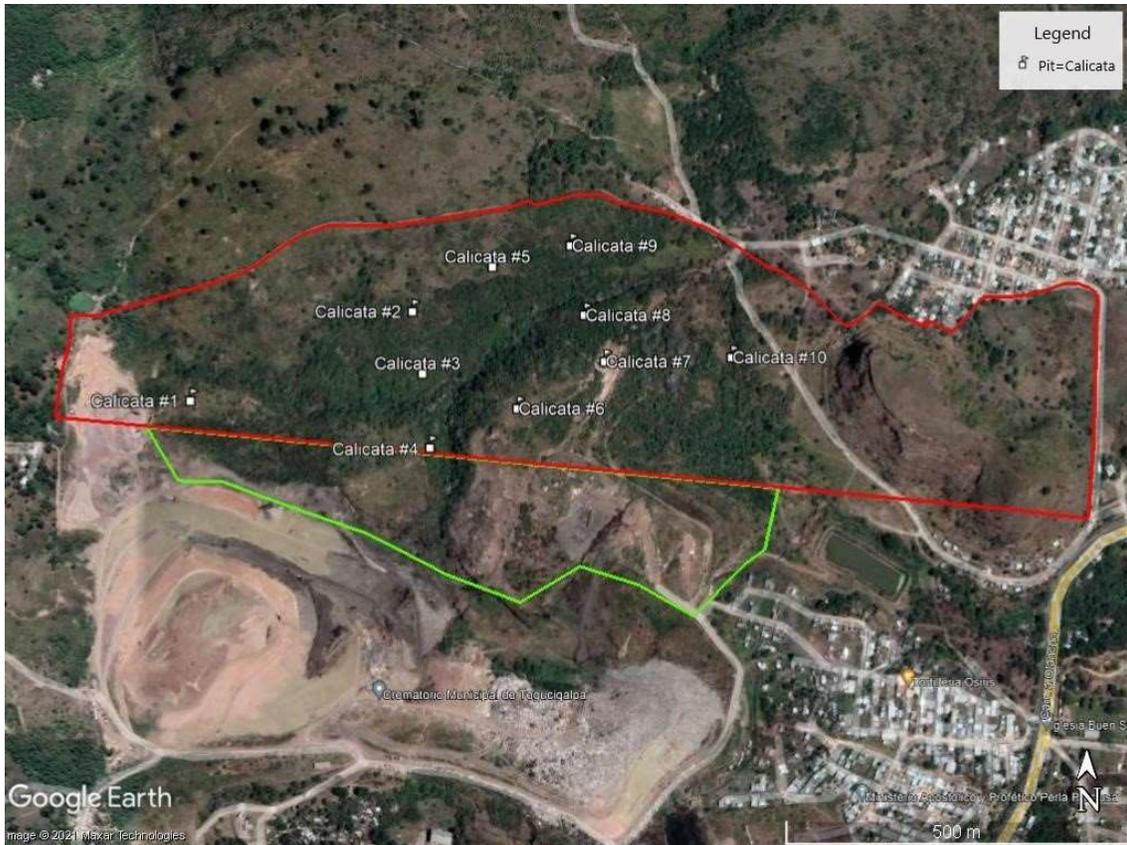
Figure 4. 4 Location of testing pits in El Crematorio premises.

Samples of the existing material at the bottom of the pits were analyzed in the laboratory. In general, the samples obtained correspond to altered or weathered material of the basement rock, being those of the north zone tuffs and ignimbrites (GEASA, 2021a). This material does not present plasticity and was easily obtained with the use of pikes and bars, see Appendix A.7 pit logs 1-10. Being able to state that the altered basement rock is located one meter from the surface. The location of the tested pits can be seen in Figure 4.4.

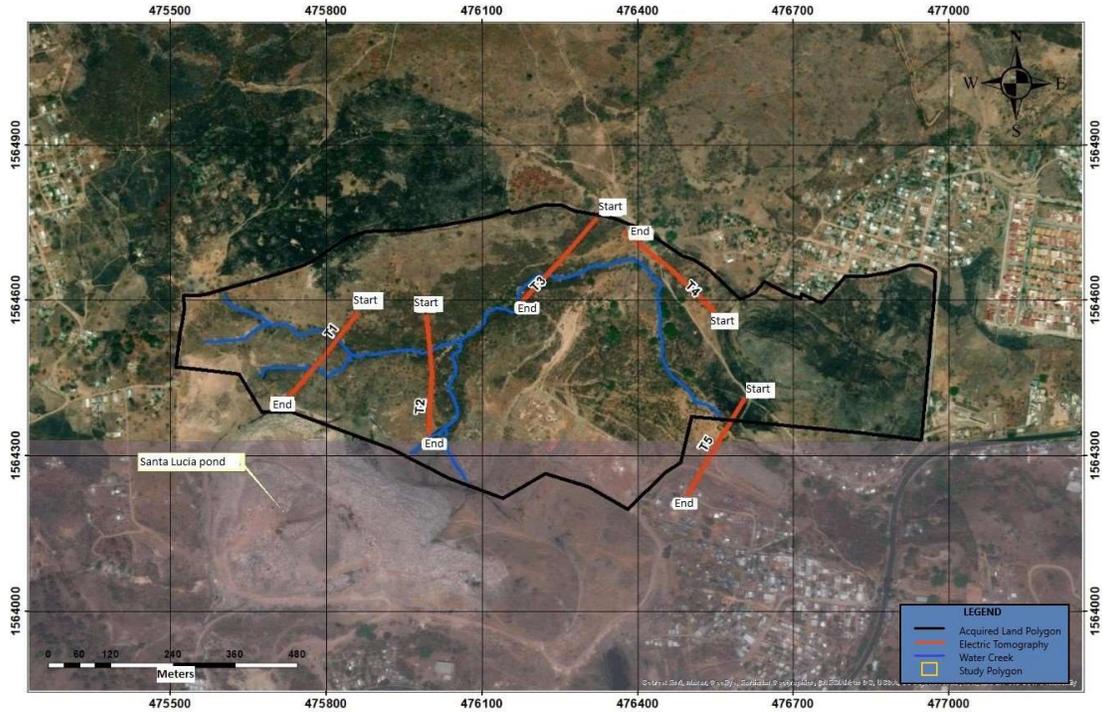
Figure 4. 5 Spatial distribution of the electrical tomography profiles raised (in red). Satellite image

As part of the studies made by GEASA, a geophysical study was carried out using the method of electrical tomography and Vertical Electrical Soundings (VES), to characterize and estimate the quality of the soil, as well as determine the geometry of the subsoil and other characteristics such as the presence of groundwater. Figure 4.5 shows the approximate study area and the spatial distribution of the tomography profiles made indicating the starting direction of each tomography.

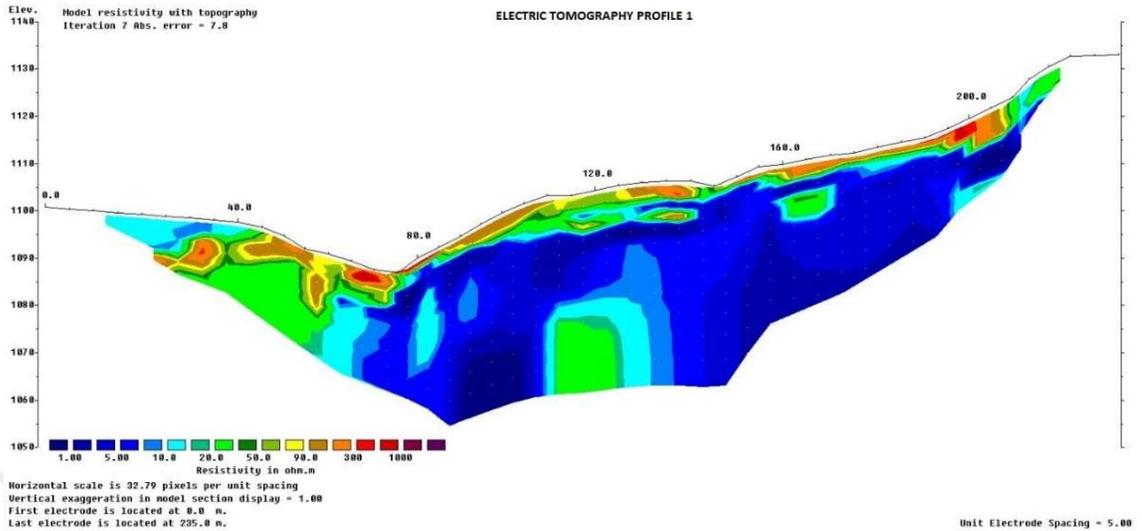
Figure 4. 6 Profile 1 Electric tomography. The different colors represent the resistivity of the material in ohm-m.

Figure 4.6 shows Profile 1. This profile was surveyed in a NE-SW direction, at the extreme west of the study area, with a length of 235m and reaching a maximum exploration depth of 45m. The endpoint is located on the edge of an access road in the area, and a water slide is located between points 70m and 80m. Materials with resistivities between 10 to 20 Ohm-m are observed in the initial part of the profile, continuing to the area around the ravine with materials having resistivities between 20 to 90 Ohm-m. From this point until the end of the profile the behavior changes, a small initial layer between 5m to 10m thick appears with materials with resistivities between 90 to 500 Ohm-m, and in some parts above 1,000 Ohm - m. These values can be associated with fractured rock and loose soils. Below these depths, the resistivity of the materials drops to less than 5 Ohm-m (materials in blue tones in the figure), which can be associated with the presence of groundwater (GEASA, 2021b).

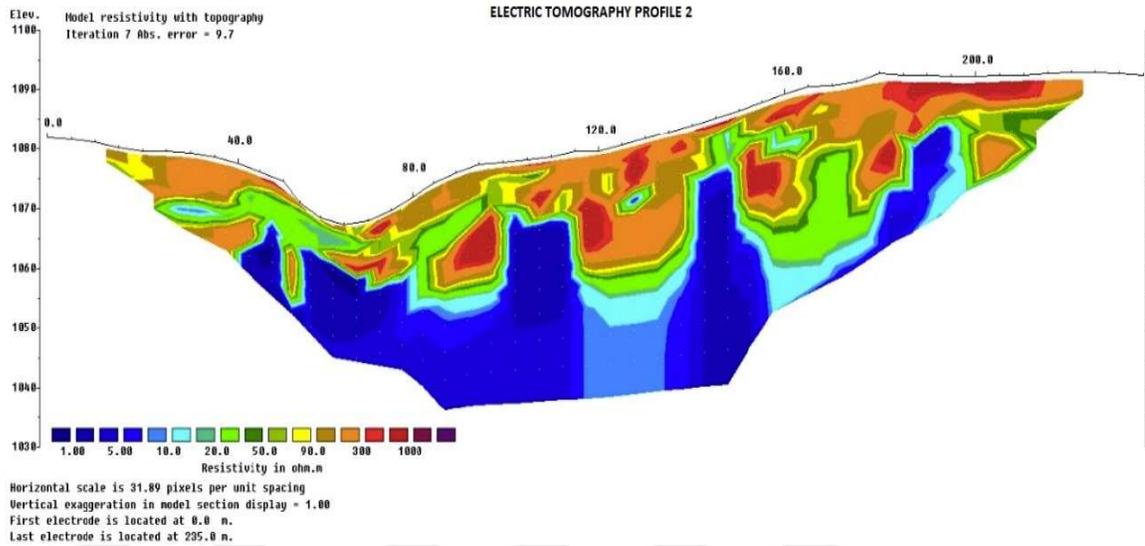
Figure 4. 7 Profile 2 Electric tomography. The different colors represent the resistivity of the material in ohm-m.

Figure 4.7 shows Profile 2. This profile was surveyed in an N-S direction, with the initial point approximately 130m to the east of the initial point of profile 1, with a length of 235m and reaching a maximum exploration depth of 45m. A first layer with materials between 90 and 300 Ohm-m (in brown to red tones) is observed in this profile and some points reach up to 1,000 Ohm-m. This layer appears quite irregular, varying in thickness from 5m to 20m. Below this layer appear materials with resistivities below 5 Ohm-m that can be associated with the presence of groundwater (GEASA, 2021b).

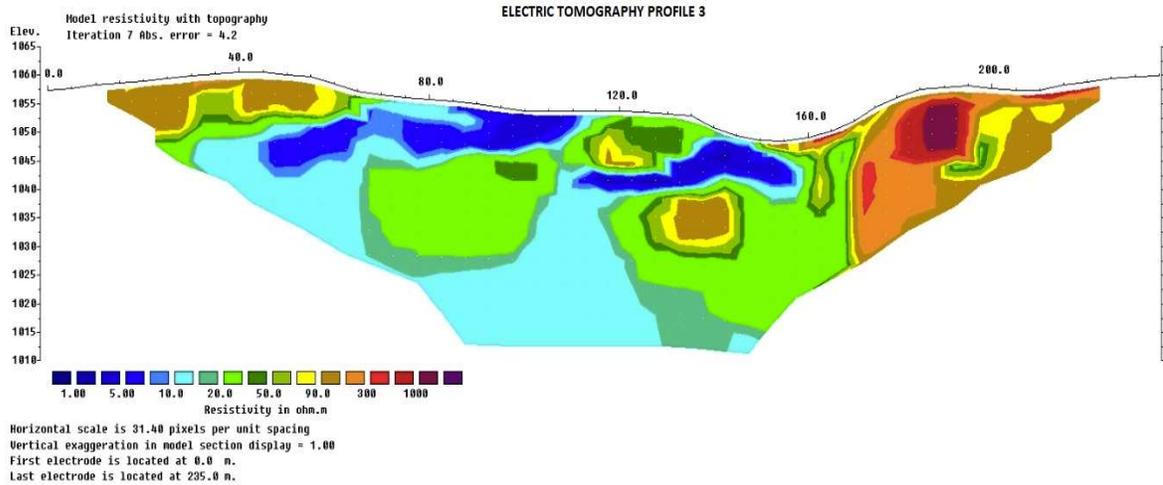
Figure 4. 8 Profile 3 Electric tomography. The different colors represent the resistivity of the material in ohm-m.

Figure 4.8 shows Profile 3. This profile was surveyed in a NE-SW direction, in the northern part of the study area, with a length of 235m and reaching a maximum exploration depth of 45m. The profile cuts the ravine in the area at approximately the 155m point. Materials with resistivities between 20 to 100 Ohm-m are observed in this profile in the initial part. An area stands out with materials with resistivities of less than 5 Ohm-m that can be associated with the presence of groundwater. Unlike profiles 1 and 2 where the materials with low resistivity extend to at least the maximum depth of exploration of the profiles (45m) in this profile 3 the low resistivities are concentrated on the surface and up to 15m to 20m deep. From the 170m point, there is an increase in the resistivity of the materials, increasing above 300 Ohm-m and reaching up to 1,000 Ohm-m. This may be indicating a contact with rock in the area (GEASA, 2021b).

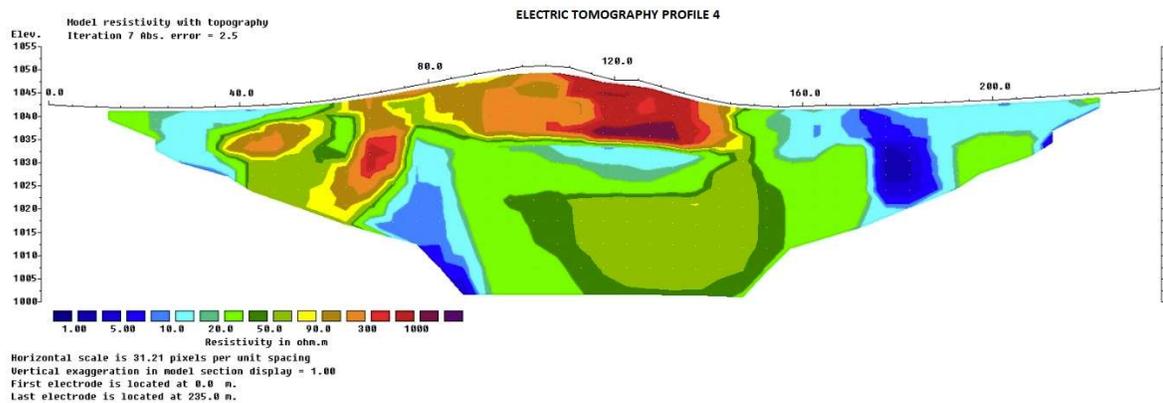
Figure 4. 9 Profile 4 Electric tomography. The different colors represent the resistivity of the material in ohm-m.

Figure 4.9 shows Profile 4. This profile was surveyed in a SE-NW direction, in the northern part of the study area, with a length of 235m and reaching a maximum exploration depth of 45m. The profile cuts the end of a water slide in the area at approximately the 175m point. It is observed in the central part of the profile a hill that stands out in the area, materials with resistivities above 300 Ohm-m, and extends to at least 20m depth. Towards the end of the profile, materials with low resistivity appear, which are associated with the presence of groundwater in the area (GEASA, 2021b).

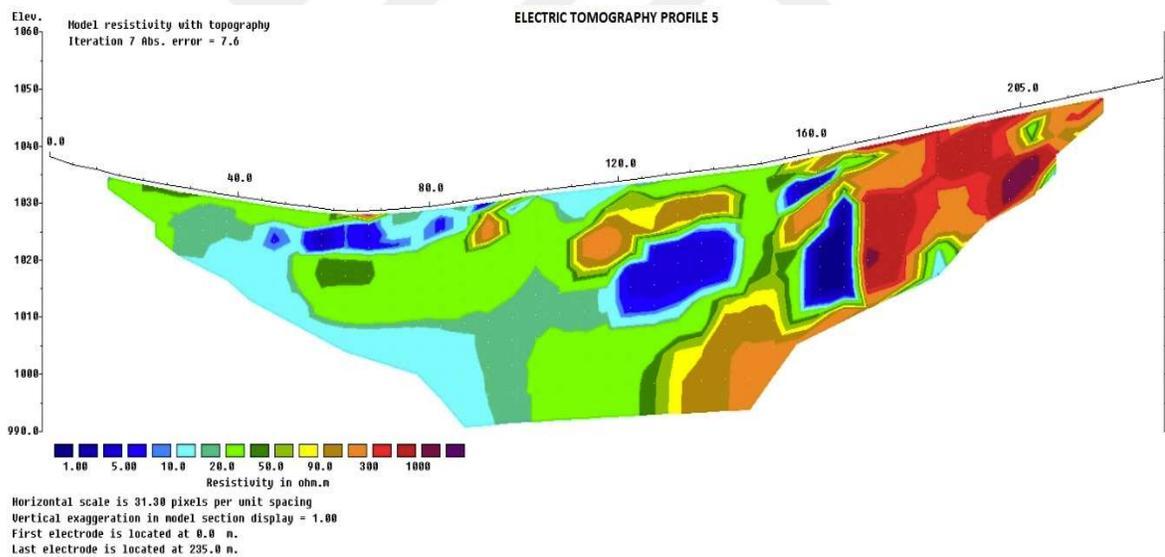
Figure 4. 10 Profile 5 Electric tomography. The different colors represent the resistivity of the material in ohm-m.

Figure 4.10 shows Profile 5. This profile was surveyed in a NE-SW direction, at the eastern end of the study area, with a length of 235m and reaching a maximum exploration depth of 45m. The profile passes approximately 25m next to an oxidation pond in the area and ends between some houses in a sector outside the study area. An access road cuts the profile around the 150m point. It is observed in the profile up to 150m that materials in green tones with resistivities between 20 to 90 Ohm-m predominate. with some areas with materials with blue tones that are associated with the presence of groundwater. The area around the 70 m point, where a water slide crosses the profile, had water on the surface, behaving like a swampy area. From the 150m point and towards the end of the profile, there is an increase in resistivity that is associated with the presence of rock that was observed to outcrop in the area. Water filtration can also be seen in this area denoted by areas in blue tones (GEASA, 2021b).

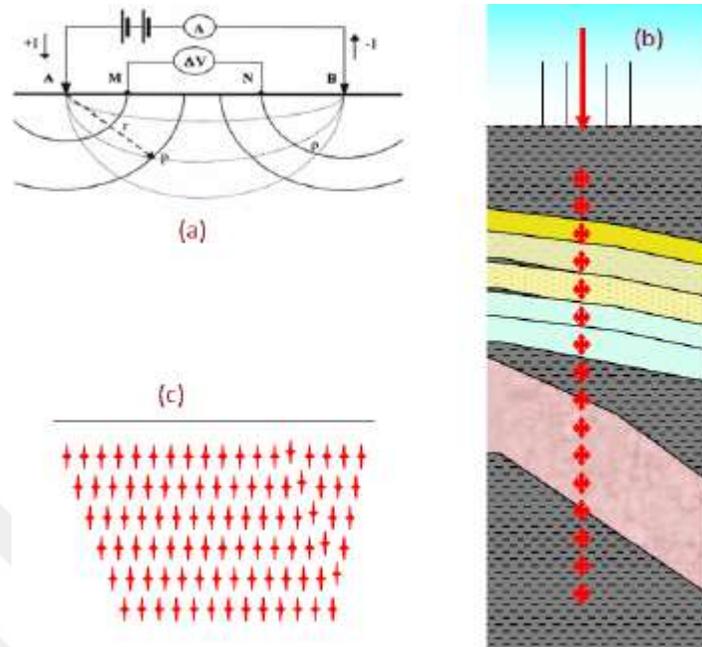
Figure 4. 11 a) Schematic of the electrical resistivity method. A, B, M, and N represent the different electrodes. b) Schematic of a Vertical Electrical Sounding (SEV) as it increases the separation of the electrodes increases the depth of exploration. c)

Where R is the resistivity in ohm-m, V is the voltage, I is current, and d is a factor of the distance between the electrodes, which varies depending on the electrode arrangement used. The obtained resistivity value represents the average of a large volume of soil since the current network extends in depth. To explore the resistivity of the soil at different depths, this procedure is repeated with different separations between electrodes, to perform what is known as a vertical electrical sounding or SEV (Figure 4.11b). If this procedure is repeated with the electrodes both at different separations and at different points, information can be obtained both along a profile and in-depth to perform an electrical tomography that is a 2D model (Figure 4.11c).

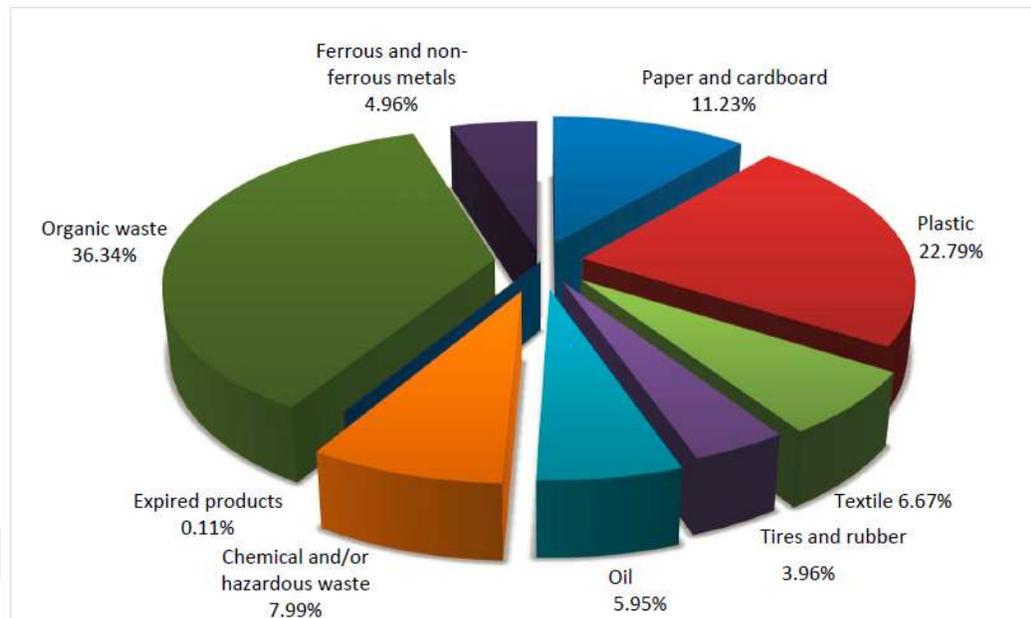
Figure 4. 12 Percentage representation of waste generated at industrial level. Source: Diagnosis of the situation of waste management in Honduras 2016

In many cases, materials contaminated with oils and lubricants are destined for controlled incineration with authorized supervision, alternatively in other cases mixed with organic waste into the disposal site. The chemical and hazardous residue percentage of adequate treatment is low when compared to the whole generation of this waste type. This is mostly due to elevated disposal costs in treatment and a lack of awareness about the impact of this kind of waste. Ferrous waste materials constitute scrap coming from machinery structures and obsolete buildings that are demolished, meanwhile, the non-ferrous materials are mostly made up of electrical wiring aluminum, copper, bronze, and beverage containers. Tire waste generated in representative amounts by different companies is part of collection and disposal alliances through which cogeneration processes in cement kilns with cement companies are done for example with Argos cement company. The waste which represents the fewer solutions regarding its treatment is industrial waste from which a mixture of waste is not classified and is contaminated with food residues and sanitary waste products. A chart resume of waste composition is shown in Figure 4.12.

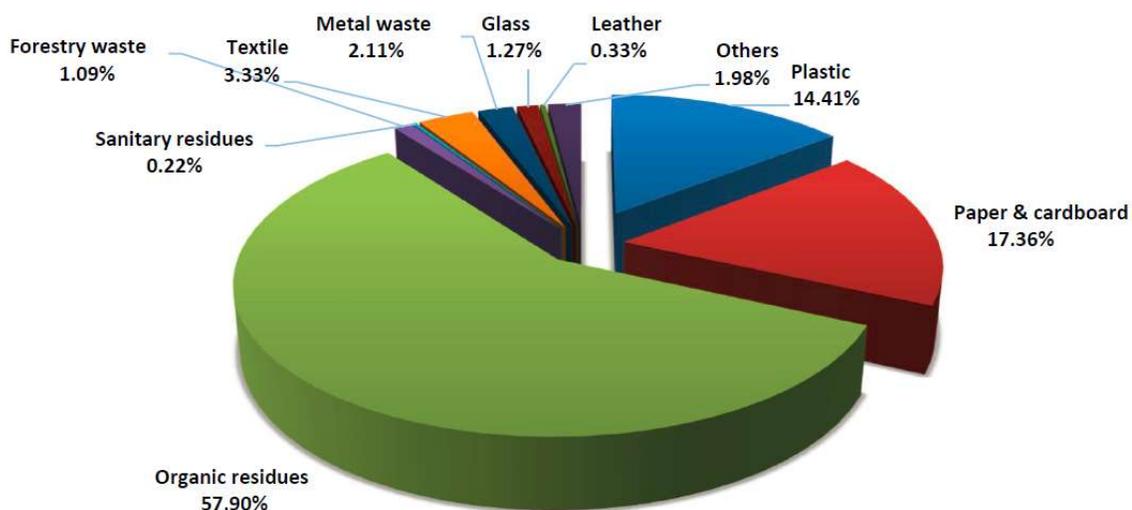
Figure 4. 13 Municipal wastes characterization, source: Diagnosis of the situation of waste management in Honduras 2016.

Due to the lack of updated information and difficulty in characterizing the waste composition of residues in the municipalities of Honduras, the information gathered by the different municipalities consists of an estimation of the residues characterization presented in the diagnostic report (Ambiente, 2017). This estimation was carried out taking into account the data of 10 municipalities (Villanueva, Choloma, Comayagua, San Pedro Sula, Tegucigalpa, Siguatepeque, Danlí, Puerto Cortes, Santa Rosa de Copan, and Choluteca) and four associations made up of 12 municipalities (Lenca Eramaní Commonwealth, AMVAS MANVASSEN and the Commonwealth of Güisayote). It is important to indicate that the information is based on 22 municipalities, among which 40.4% of the population at the national level is concentrated. As described in the report a critical difficulty was the different way municipalities carry out the characterization; in some cases, using four (4) and in others up to ten (10) different characterization types. According to the data of the municipalities that could be evaluated, the characterization presents a mixture of common hazardous and special waste. Figure 4.13 shows the compositions, being the highest proportion of waste of organic origin (food and garden waste) a 57.90%, plastic waste at 14.41%, paper and

cardboard at 17.36%, metal waste at 2.11%, textile waste at 3.33%, glass at 1.27%, forestry waste at 1.09%, leather at 0.33%, others (not reported accurately) at 1.98% and sanitary waste at 0.22%.

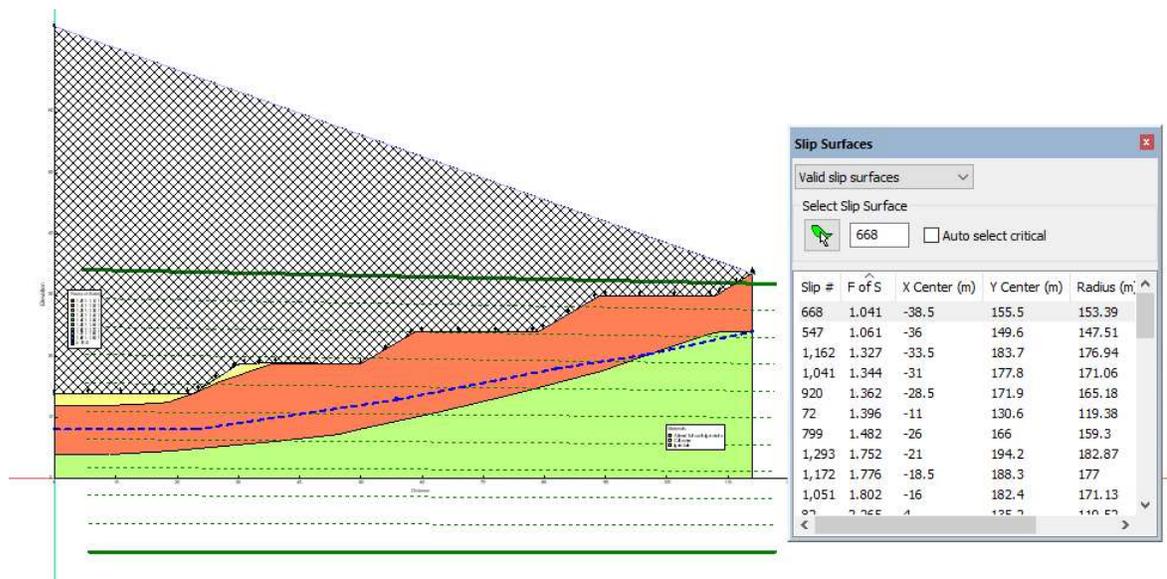
software. In Figure 4.14 the most critical profile of the landfill (profile 4) was modeled simulating the excavated scenario 2 ground profile with the MSW mass as a surcharge from which the most critical value obtained was a 1.04 FOS that is not even a representative slip surface, meaning that the higher values as 1.34 may be more accurate.

Figure 4. 14 Section IV excavated modeled profile 4 with waste mass surcharge analysis.

From the grid radius analysis performed on the excavated Profile 4 a 50-meter-high waste disposal section was achieved where the model assumes a 3:1 slope used as the filling closing cover and 3:1 excavation terraces to decrease slope, toe, and base rotational failure. It is to be stated that the liner and geomembrane characteristics have not been taken into account for this analysis.

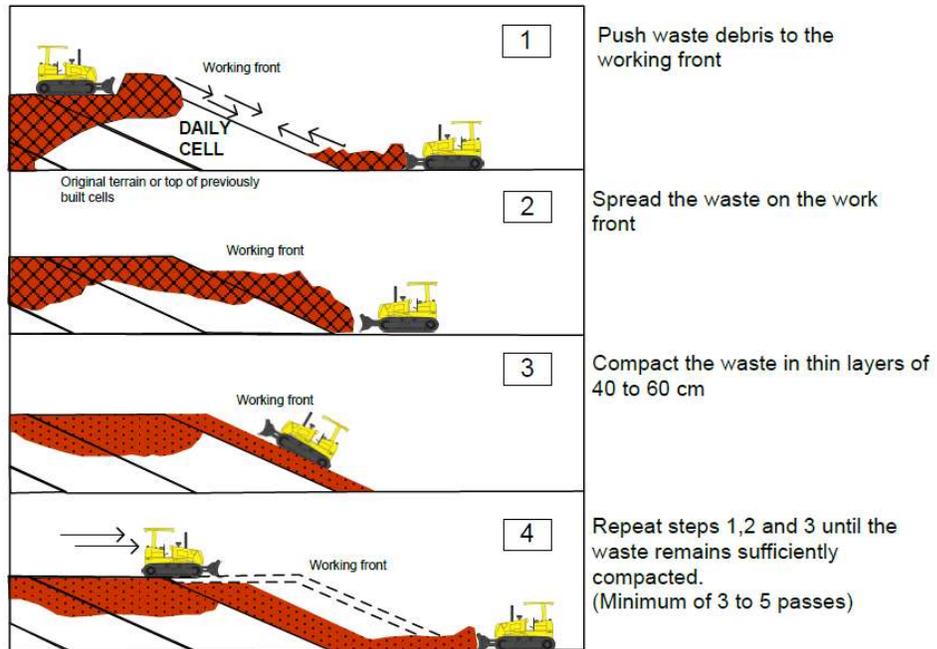
Figure 4. 15 Spreading and compaction of waste material cells, source: Manual de Operaciones Relleno Sanitario de Potrerillos Honduras 2013

Once the MSW is located at the assigned working front for that day, the process done with the waste material is described in Figure 4.15, and a daily 30 cm cover of the site is shown in Figure 4.16.
