**SLOPE STABILITY ANALYSIS FOR WASTE LANDFILL IN
CENTRAL DISTRICT TEGUCIGALPA HONDURAS**

Graduate School of Science and Engineering of Hacettepe University

for being Award of the Degree of Master of Science

in Civil Engineering

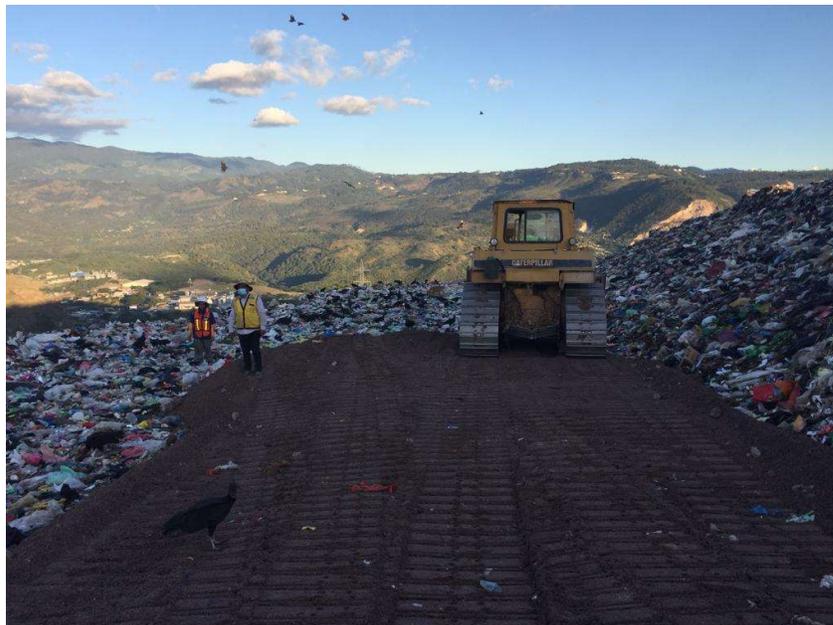
Figure 4. 16 30 cm daily cover layer in El Crematorio with material from site. Photograph provided by CINSA.

Once the MSW is located at the assigned working front for that day, the process done with the waste material is described in Figure 4.15, and a daily 30 cm cover of the site is shown in Figure 4.16.

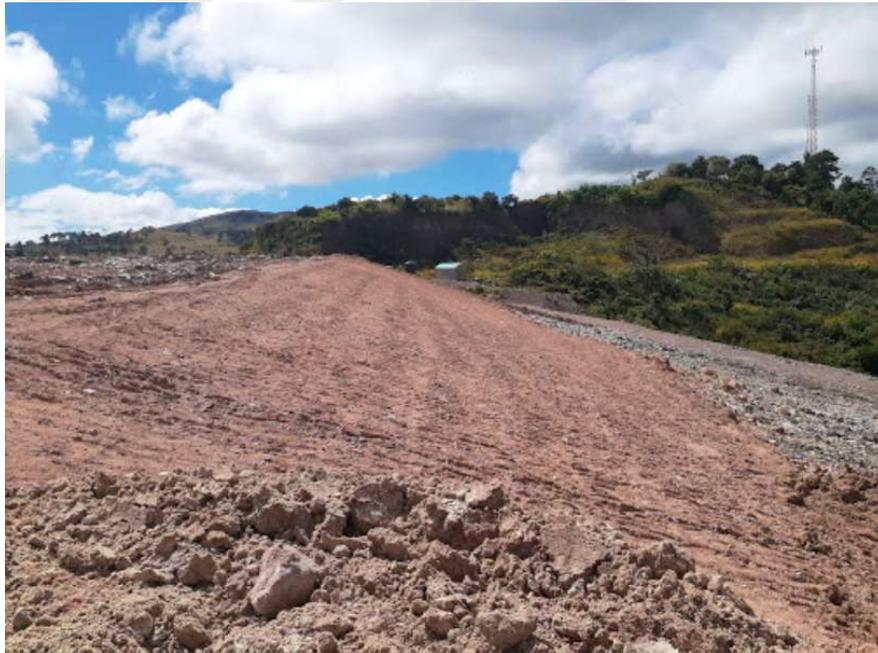
Figure 4. 17 Municipal Landfill in Tegucigalpa 3:1 slope closure. Photograph by German R. Pavón

The appropriate level of closure for the area phase should be the level that allows for a 3:1 slope (Figure 4.17). After the final cover a water drainage system around the site, dikes, controlled slope, and gas fireplaces are required. The final soil cover should be provided for environmental protection measures such as minimizing leachate production, preventing waste spreading, minimizing odors, and preventing fires. The recommended thickness for the final cover by the Honduras sanitary landfill manual is 60 cm of cover material plus 20 cm of organic soil from which El Crematorio is using a 1 m thickness closure layer and then installing a vegetative layer (see Figure 4.18) over this one. Final cover material compaction results from sections 1 and 2 are presented in Appendix A.8.

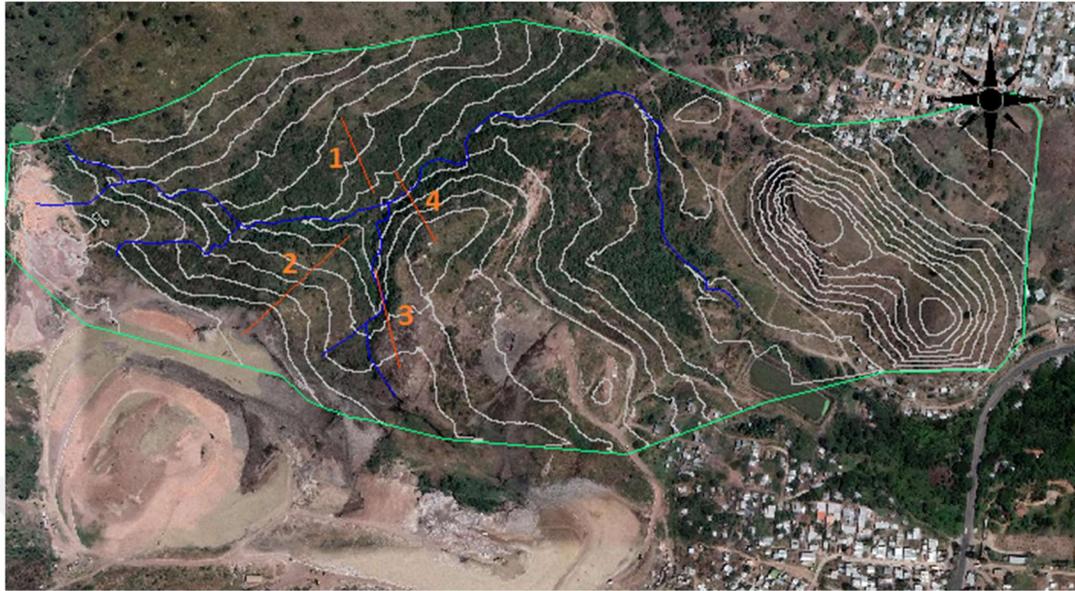
Figure 4. 19 Tegucigalpa El Crematorio landfill extension area topographic curves.

To execute the slope analysis parameters such as the topography, water table, lithology and soil mechanical characteristics had to be defined. As a start, the topography data was obtained and modeled in the Civil CAD software (Figure 4.19), from which different areas were analyzed for the new landfill. In the location of the landfill, the four (4) most critical slope areas were selected and their natural terrain profile coordinates were obtained for its posterior use in the slope analysis software.

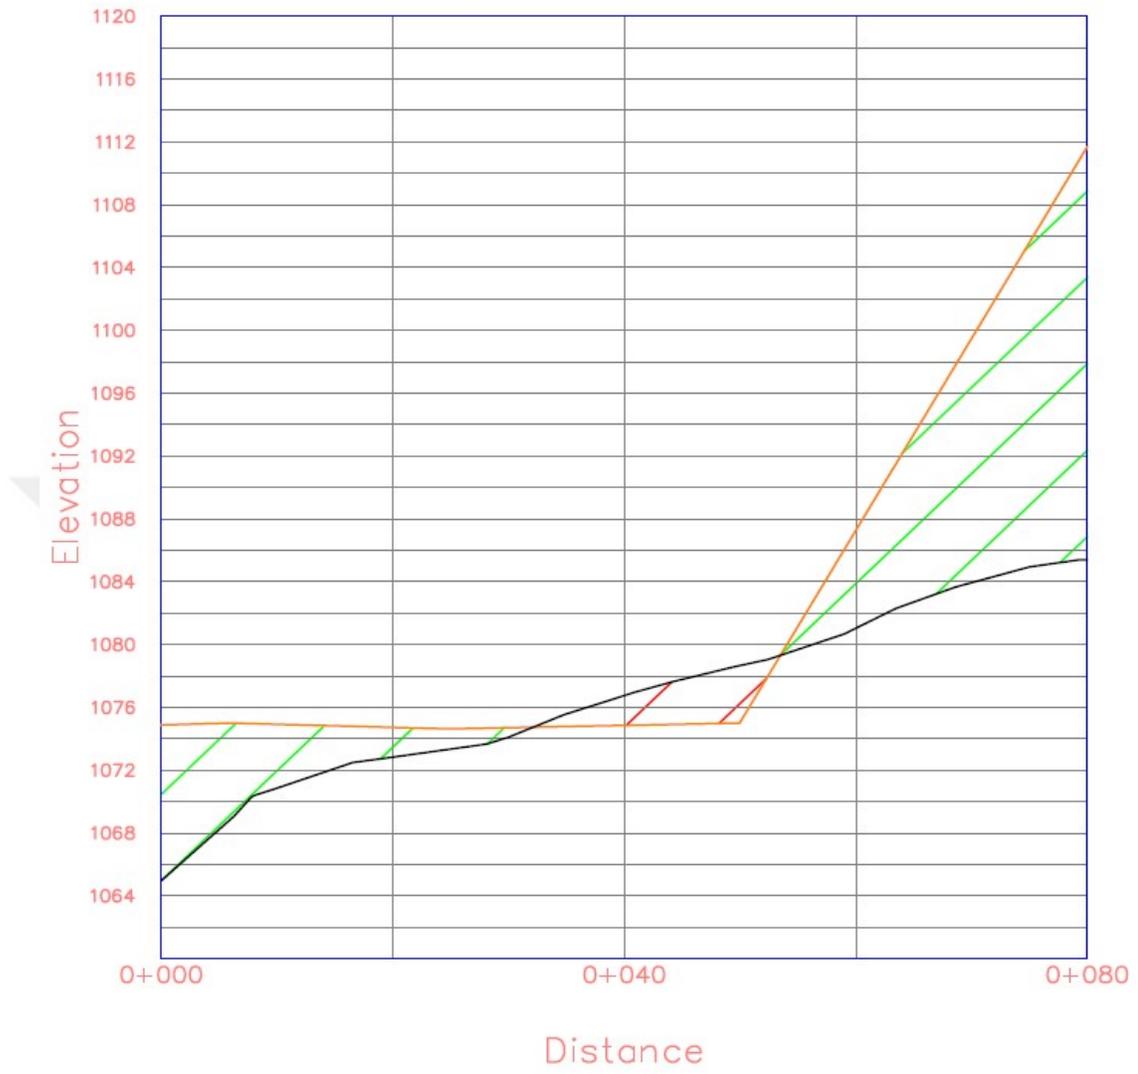
Figure 4. 20 Profile 1 green for fill, red for excavation, and orange for the engineered landfill.

Inside the landfill Section IV defined area, four (4) profiles were generated from the topography model created in Civil CAD; the profiles were located in such a way that the most irregular areas or slopes could be visualized and respectively analyzed. The profiles are shown in Figures 4.20,4.21,4.22 and 4.23 on which the white boundary represents the natural terrain, orange the landfill geometry, green for fill areas, red for excavation areas, and blue the waste cell areas.

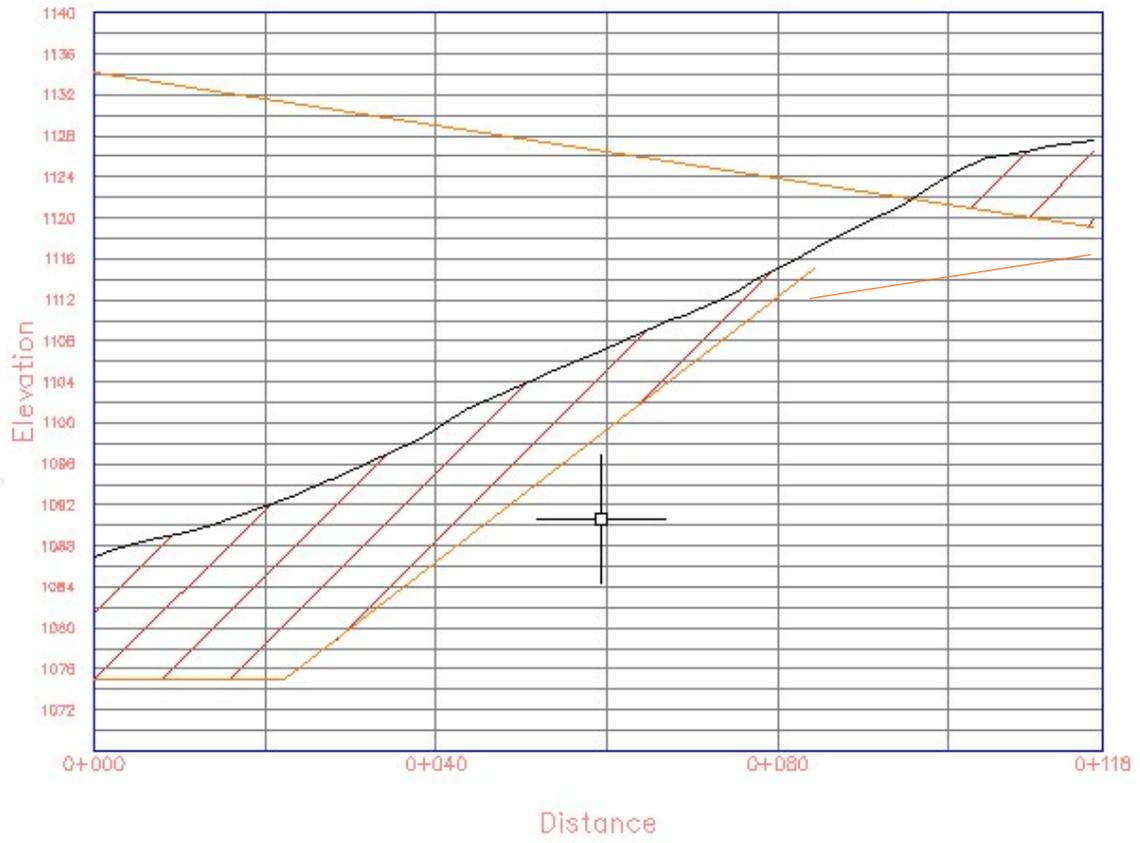
Figure 4. 21 Profile 2 red for excavation and orange for the engineered landfill.

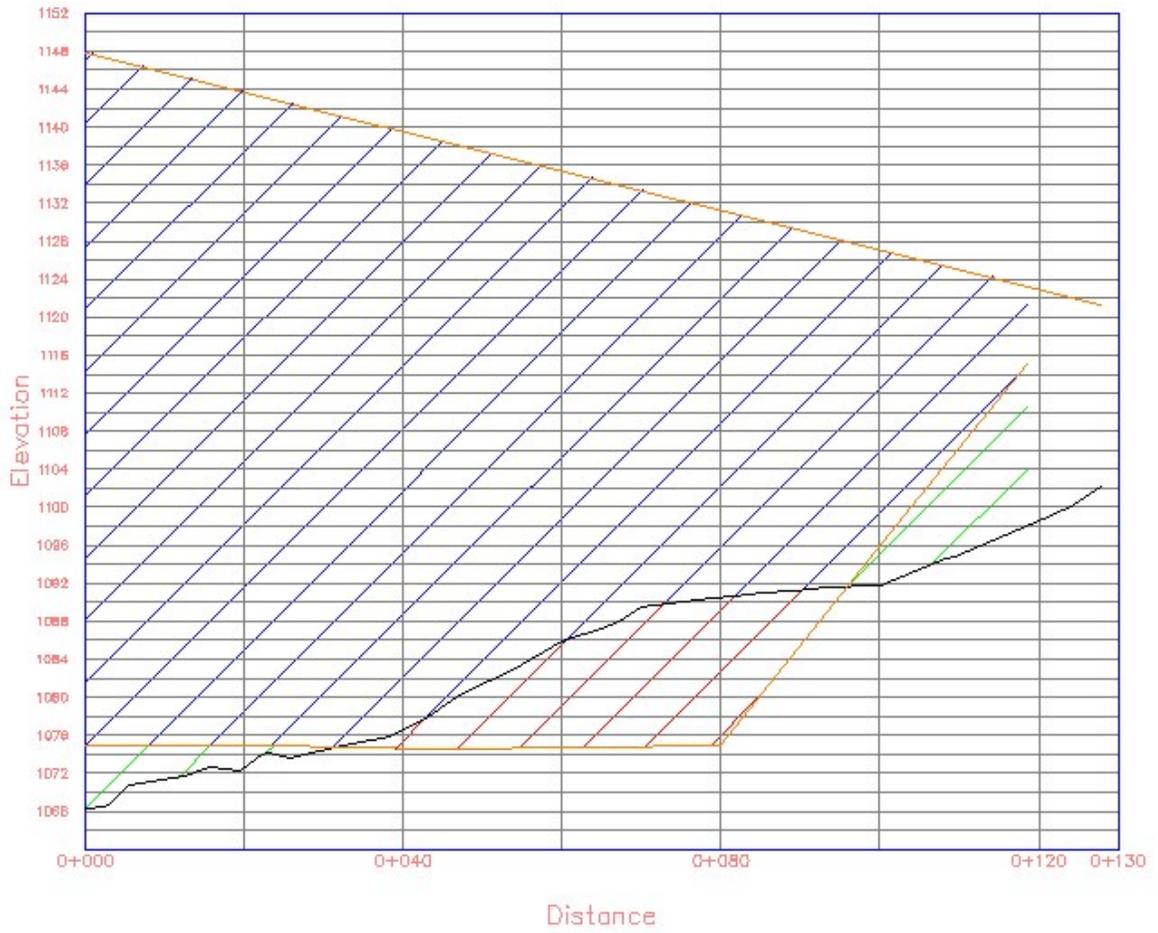
Figure 4. 22 Profile 3 green for fill, red for excavation, and orange for the engineered landfill.

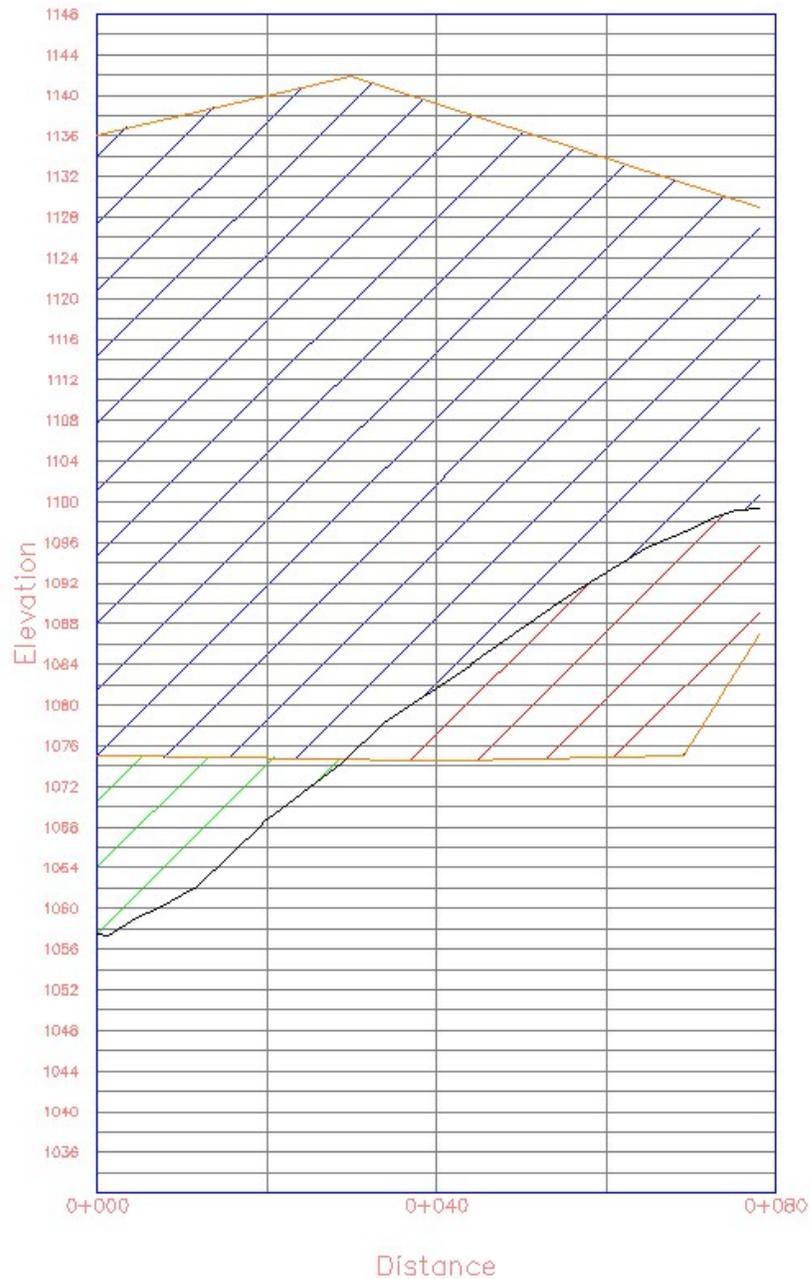
Figure 4. 23 Profile 4 green for fill, red for excavation, and orange for the engineered landfill.

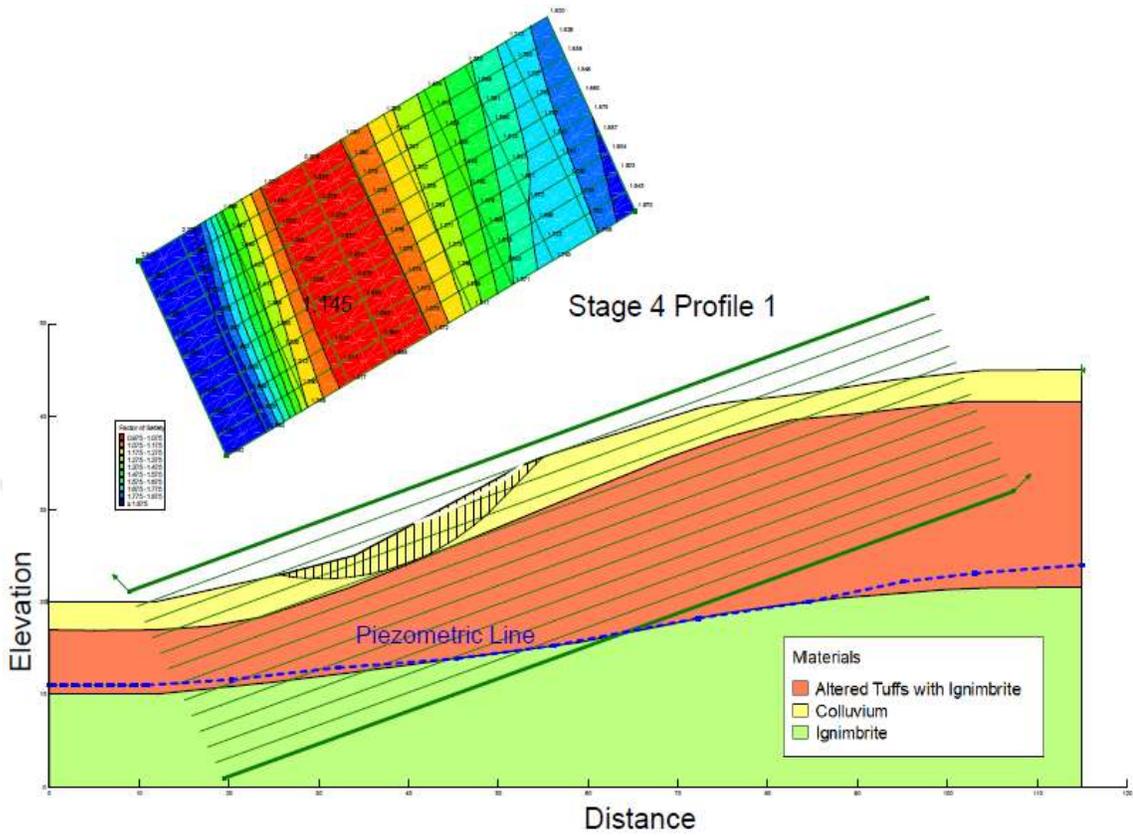
Located in the north-western area of Section IV, profile 1 with a 1.145 FS has an 80 meter length slope whose results show safe conditions for its natural slope geometry. Figure 4.24.

Figure 4. 24 Profile 1 Section IV scenario 1

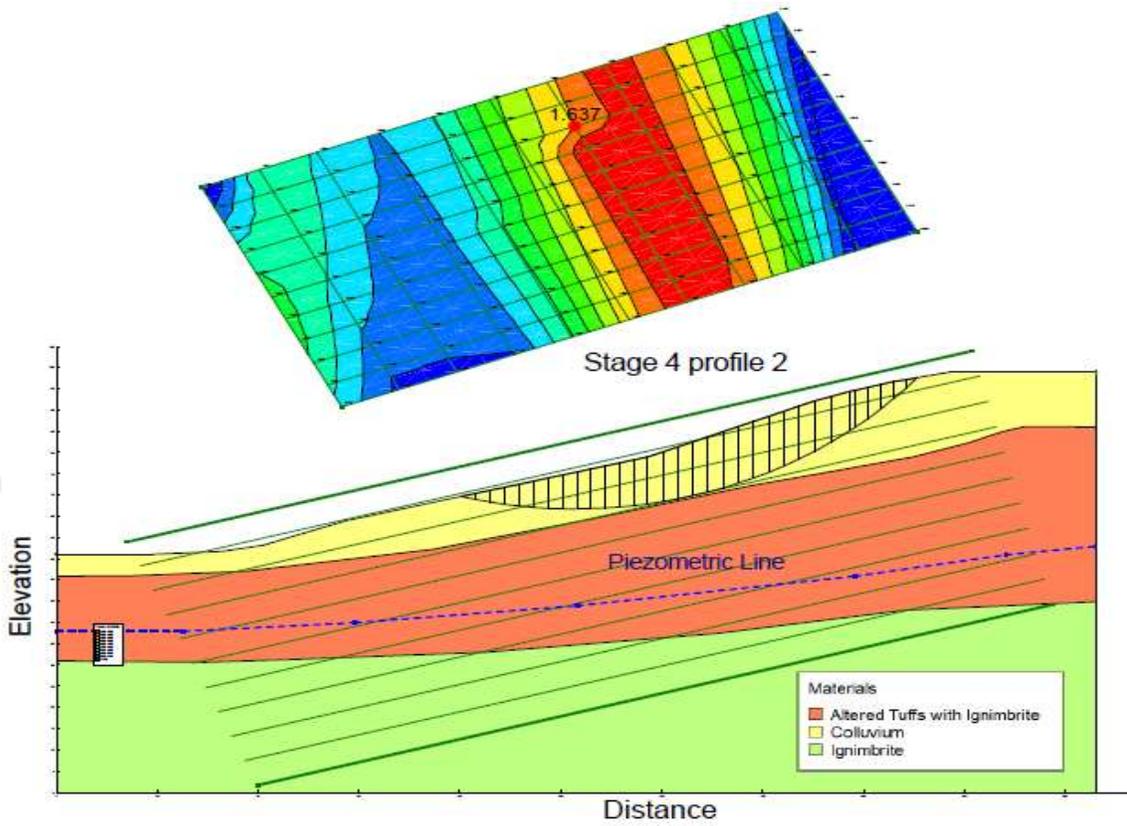
With an FS of 1.637 profile 2 does not represent an imminent danger to the southwestern area of the future landfill given its average 38% inclination slope on a horizontal 70 meter long-run. Figure 4.25.

Figure 4. 25 Profile 2 section IV scenario 1

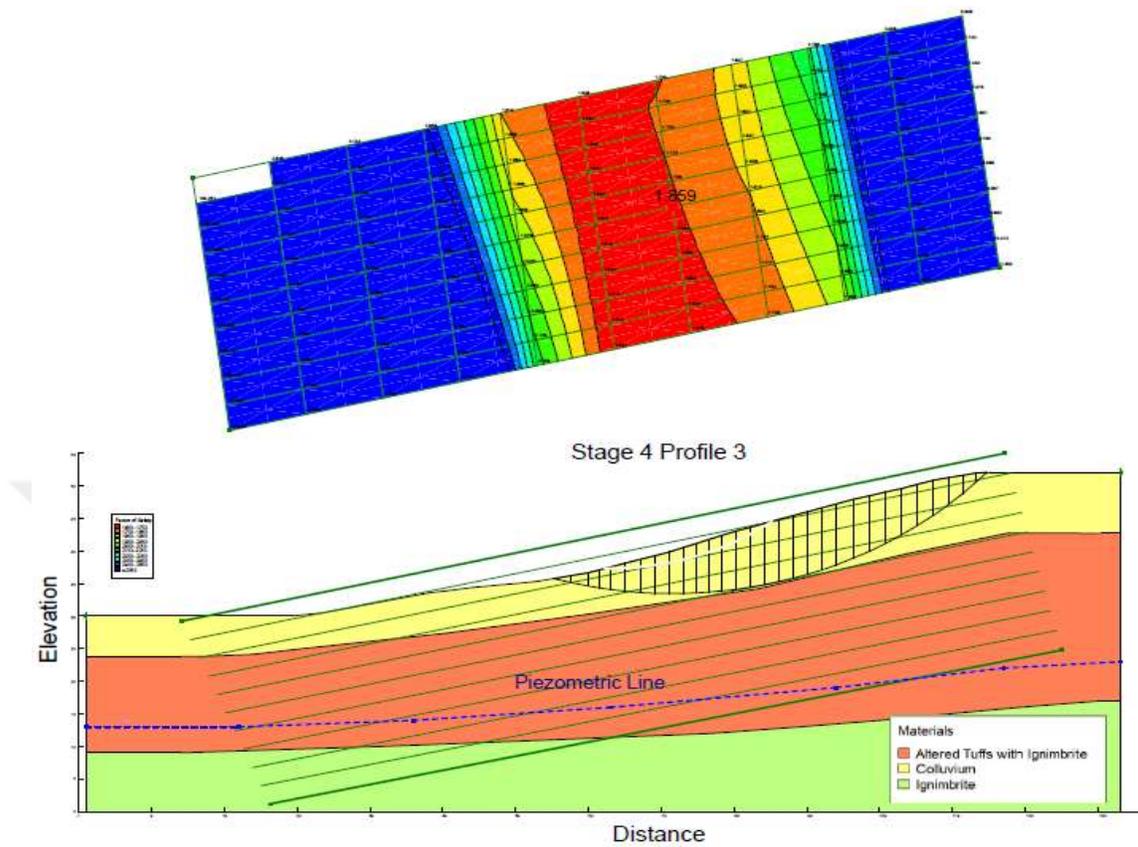
Profile 3 contains the highest FS of all the profiles in this analysis with a value of 1.859, given its horizontal 100 meter long and light slope geometry. Figure 4.26.

Figure 4. 26 Profile 3 section IV scenario 1

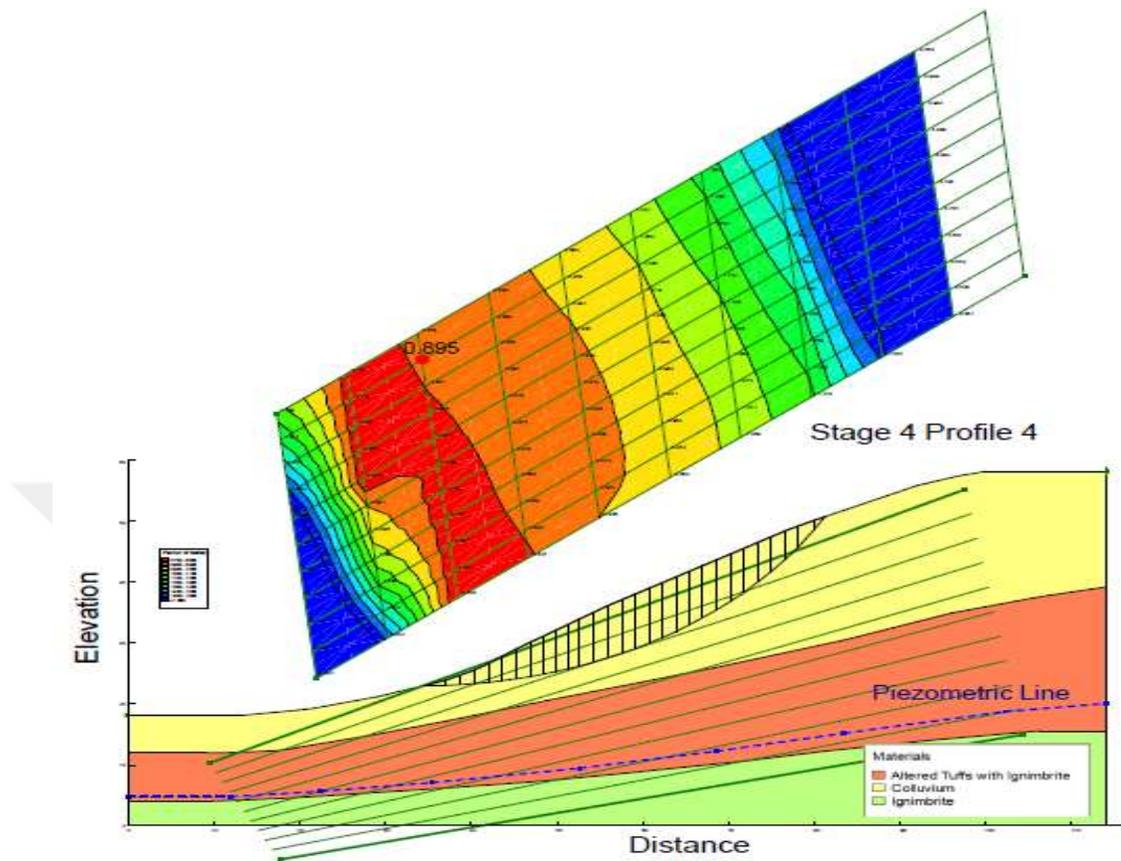
With an FS of 0.895 slope profile 4 represents the highest instability slope from the area. Located on the northeastern part from where the slope continues to prolong and rainwater is most probable to run. Figure 4.27.

Figure 4. 27 Profile 4 section IV scenario 1

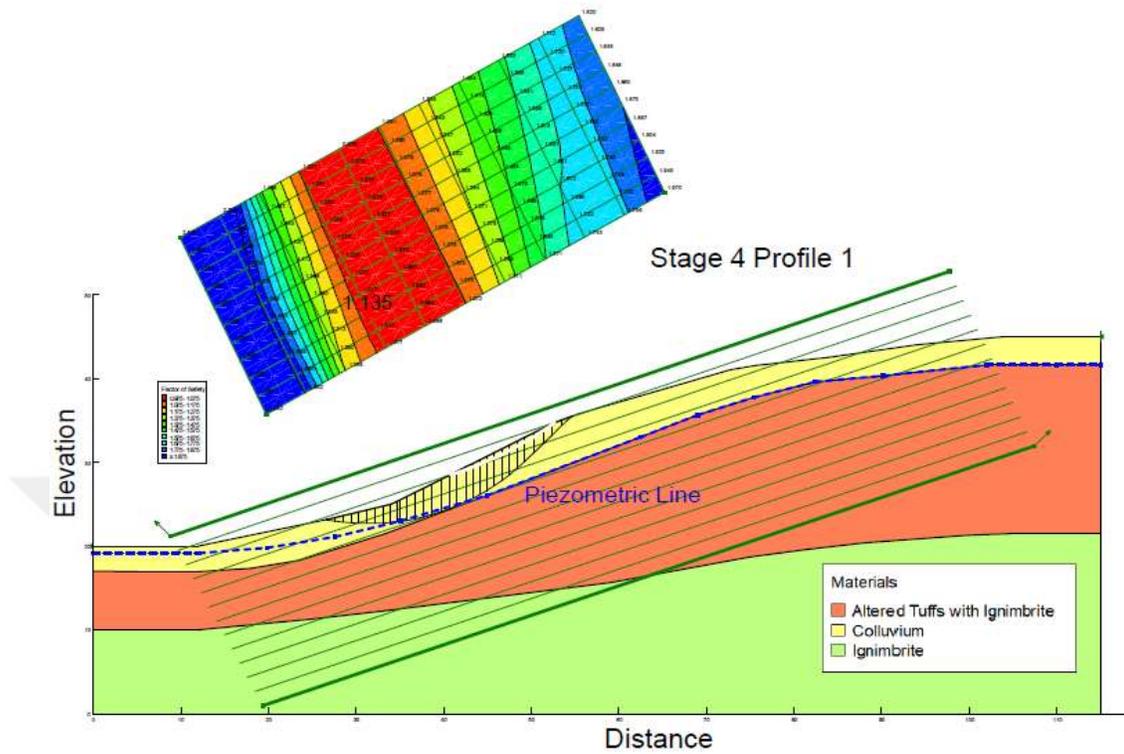
The elevated piezometric line decreased the FS by only 0.01 compared to scenario 1. From all scenario 2 this represents the lowest and most negligible result. Figure 4.28.

Figure 4. 28 Profile 1 section IV scenario 2

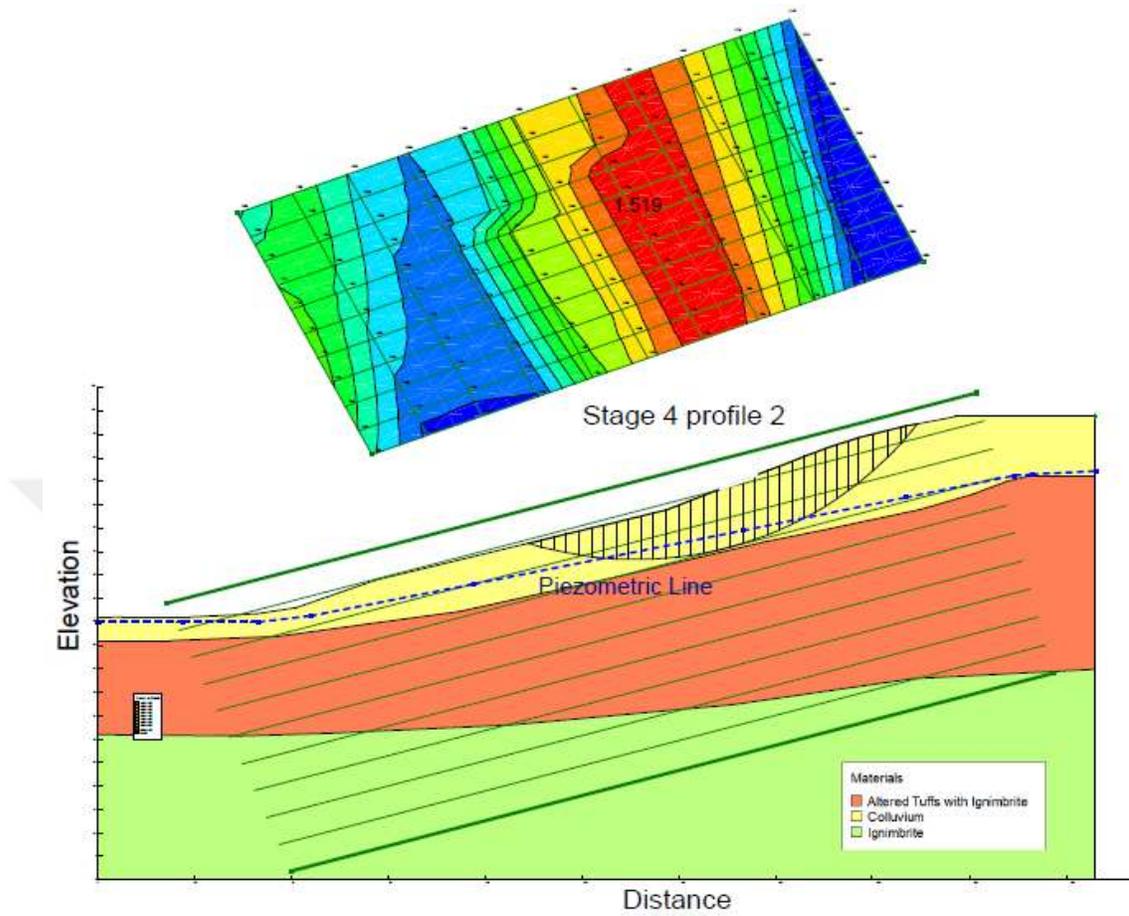
With a 0.118 lower FS compared to scenario 1, the difference is almost negligible, which is expected from colluvium material represents a good water-draining material. Figure 4.29.

Figure 4. 29 Profile 2 section IV scenario 2

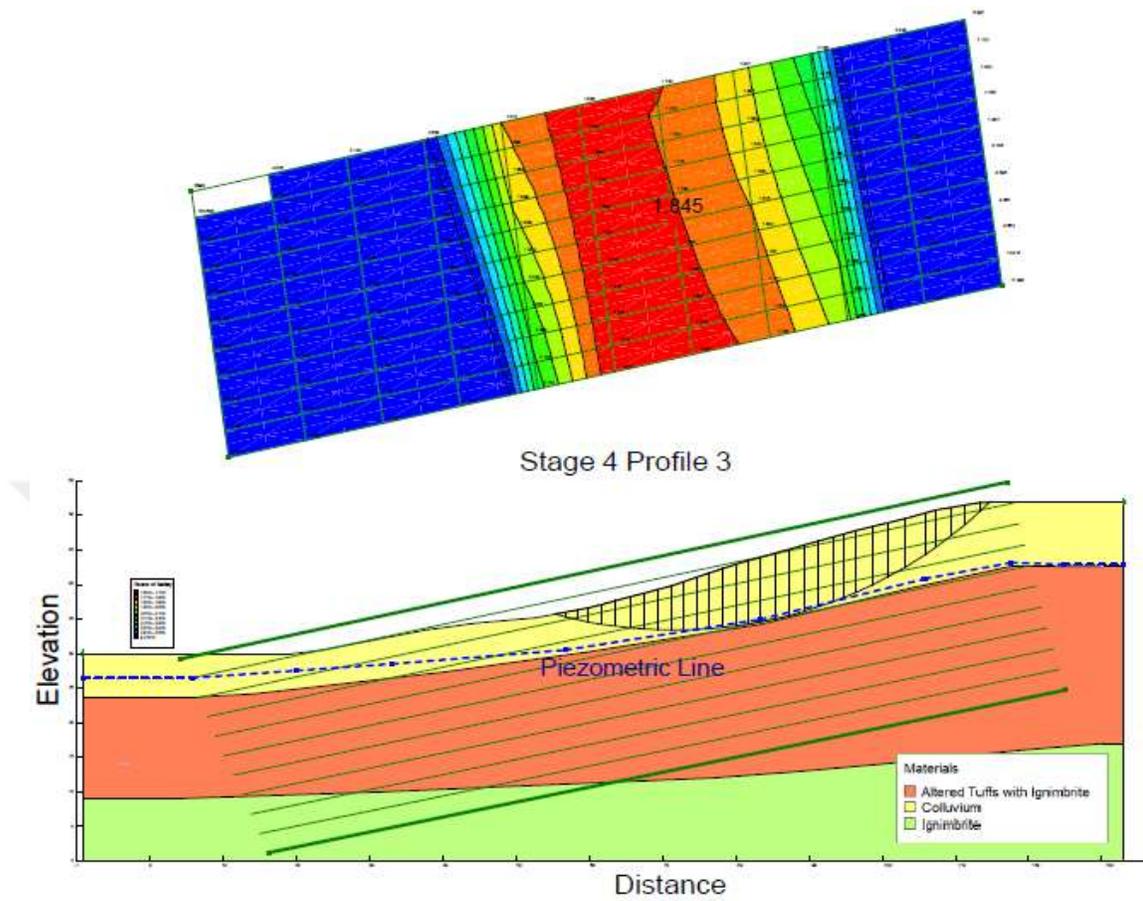
Only a 0.014 lower FS was achieved on this profile. Figure 4.30.

Figure 4.30 Profile 3 section IV scenario 2

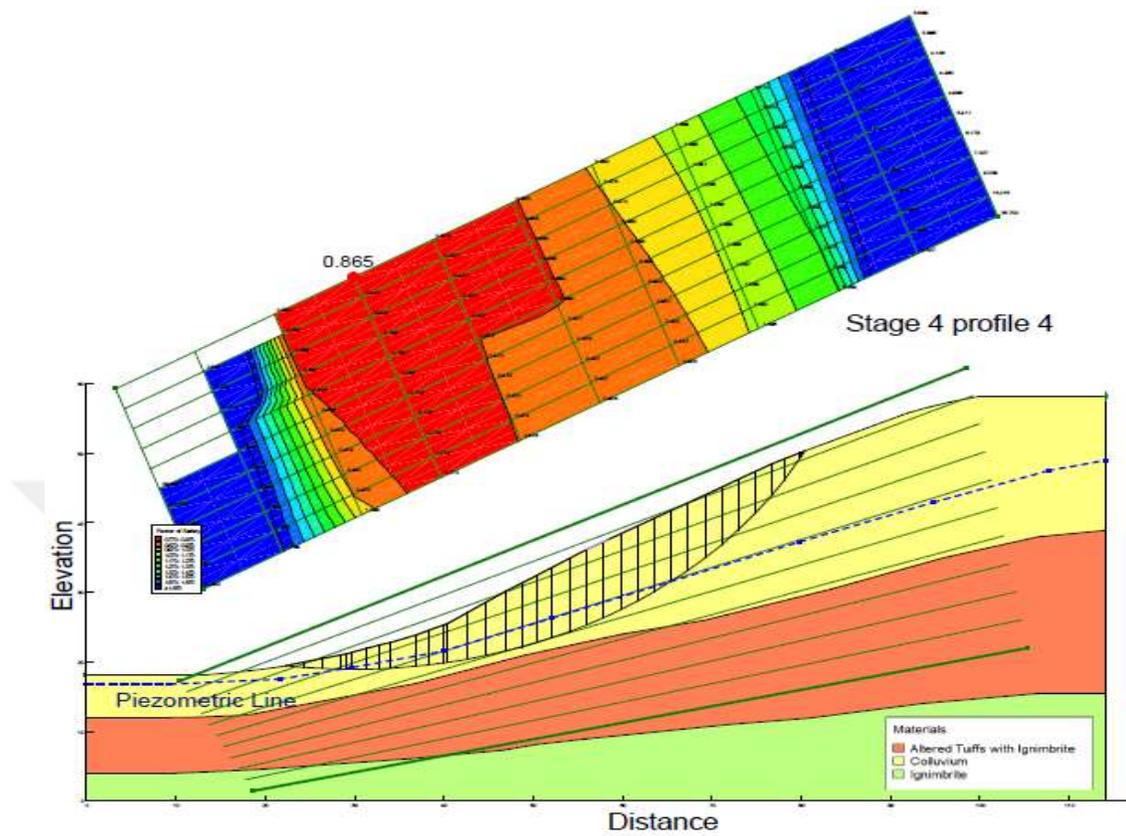
With a 0.865 FS, this scenario 2 profile 4 is identified as the most critical slope in this analysis study indicating where the most attention should be centered from a safety point of view. Figure 4.31.

Figure 4. 31 Profile 4 section IV scenario 2

From the available data and presented analysis it was able to be determined that even though the two scenarios presented different water table inputs, as a general the area of study does not represent a dangerous sliding area except for Profile 4 which compared to the others presented the most instability of the slopes. This risk is expected to disappear as the area will be excavated into a cone-shaped opened pit modifying its geometry.

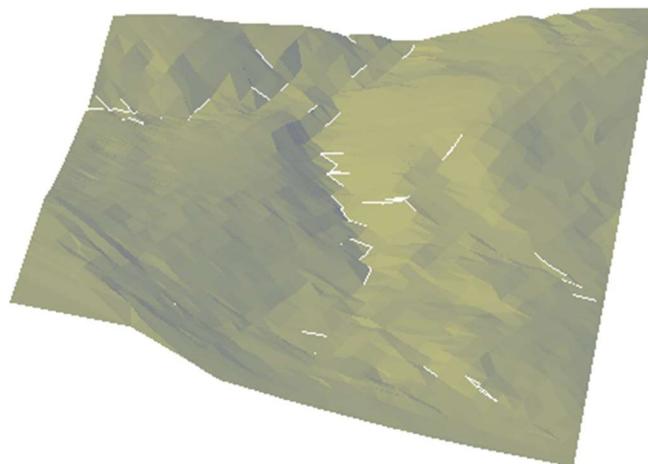
Figure 4. 34 Rendered realistic topographic view of the Section IV area in El Crematorio

Modeling the new landfill with AutoCAD Civil 3D built in tools enabled the modeling for natural terrain topography, landfill excavation area, cross sections and earth movements. As a start the topography obtained from site was inserted into the software and later created into a surface element with triangulation points obtaining as a result a topographical view of the Section IV terrain area as can be seen in Figures 4.34 and 4.35

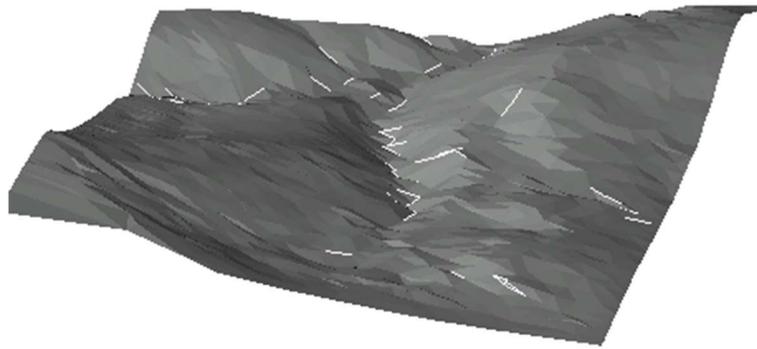
Figure 4. 35 Rendered shaded topographic view of the Section IV area in El Crematorio

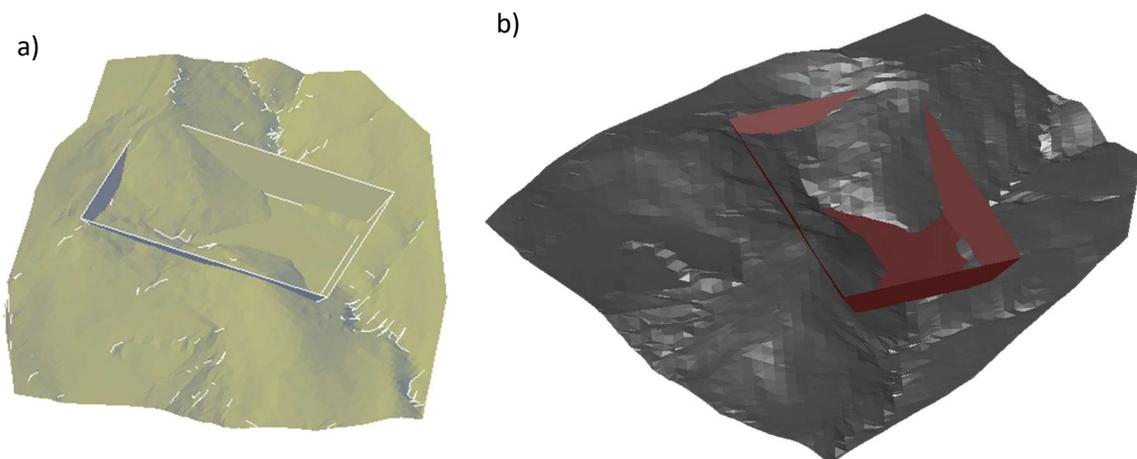
Figure 4. 36 a) Realistic render of the bottom liner; b) shaded render view of the bottom liner

After defining the most suitable landfill location, the bottom liner depth and length were created using featured lines enabling the 3D visualization of the model. Proceeding with grading the landfill excavation areas the bottom liner was defined at a depth of 1,074.56 m. at the lowest point. Starting from the lowest point a mid-point filling height is calculated at 1,115 m. (Figures 4.36 a and b) point from which the landfill is to be filled respecting a 3:1 relation slope until reaching a maximum closure elevation of 1,153 m. as shown in Figure 4.37.

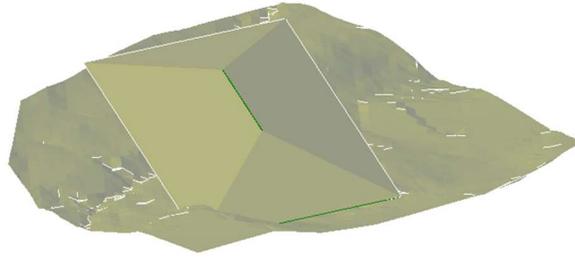
Figure 4. 37 Realistic rendered view of final closure 3:1 slope relation

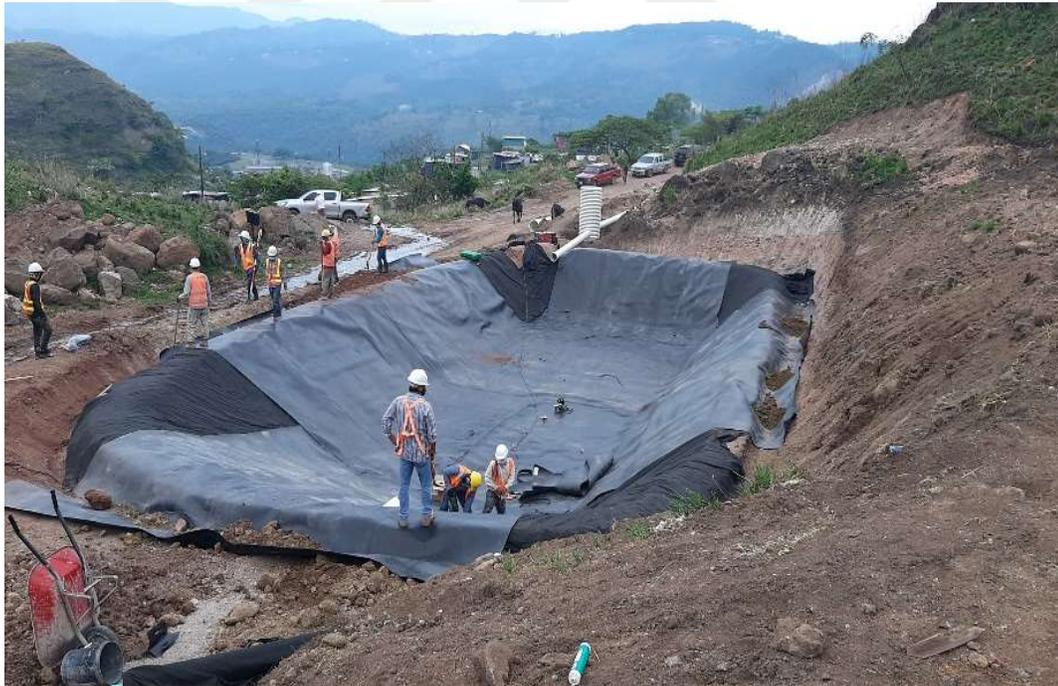
Figure 4. 38 Geomembrane and anchorage in El Crematorio leachate pond.

required to use 1.5 mm HDPE waterproofing geomembrane. For its correct use, a field assistant must check the area of the cells where the work fronts are being made to verify that heavy machinery does not cause any damage to it. Geomembranes must fulfill a series of strict quality controls with HDPE resin, carbon black as a stabilizer against UV rays, antioxidant additives, thermal stabilizers and appropriate thickness. A table with the reference characteristics is included in the Appendix A.11. Anchorage trenching is a fundamental constructive process in the installation of a geomembrane, where the geomembrane should extend over a rounded corner to a trench which is to be backfilled with compacted soil. An example of anchorage made in a leachate pond of El Crematorio is shown in Figure 4.38.

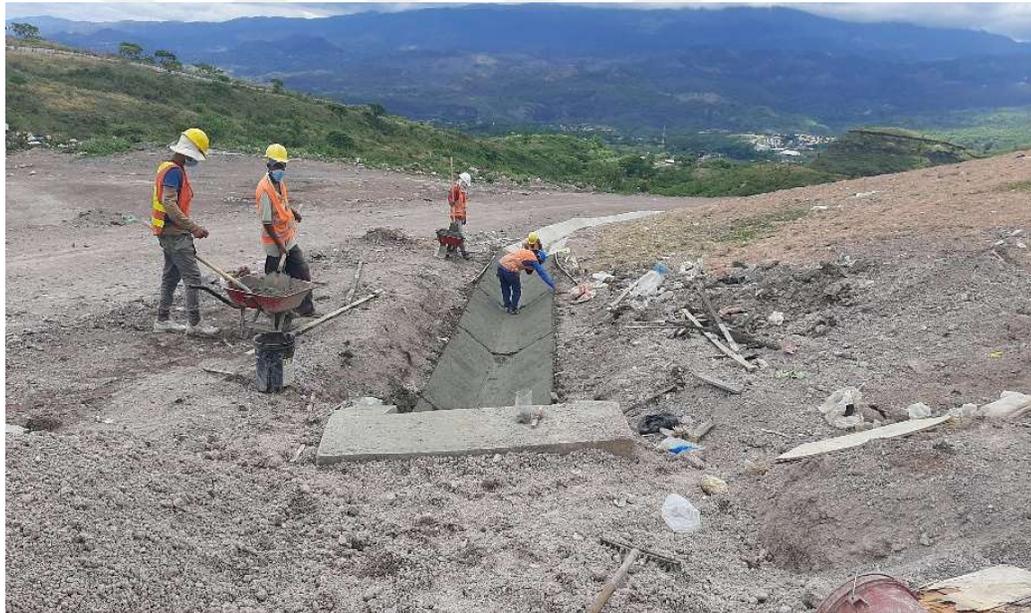
Figure 4.39 El Crematorio stage 1 and 2 gutters construction February 2020, Source: CINSAs landfill maintenance for section 1 and 3 photographic gallery.

from entering the landfill area. As explained before in the document the excessive percolation of water increases the unit weight of the waste mass therefore increasing the pore water pressure which may lead to the failure of the landfill. Rainwater is collected in the superficial drains (Figure 4.39) and transported to either water drains located outside the landfill or bigger natural running water bodies near the zone (Figure 4.40). The second case applies to El Crematorio which contains a series of ravines that collect rainwater and transport it for about 1.2 km until the Choluteca River. In Sections 1 and 3 of the landfill, gutters have been built on the natural ground with stone and concrete. These gutters need maintenance checks, especially during rainy seasons where any residues or dirt on them should be removed for their effective operation (Mi Ambiente Honduras, 2013).

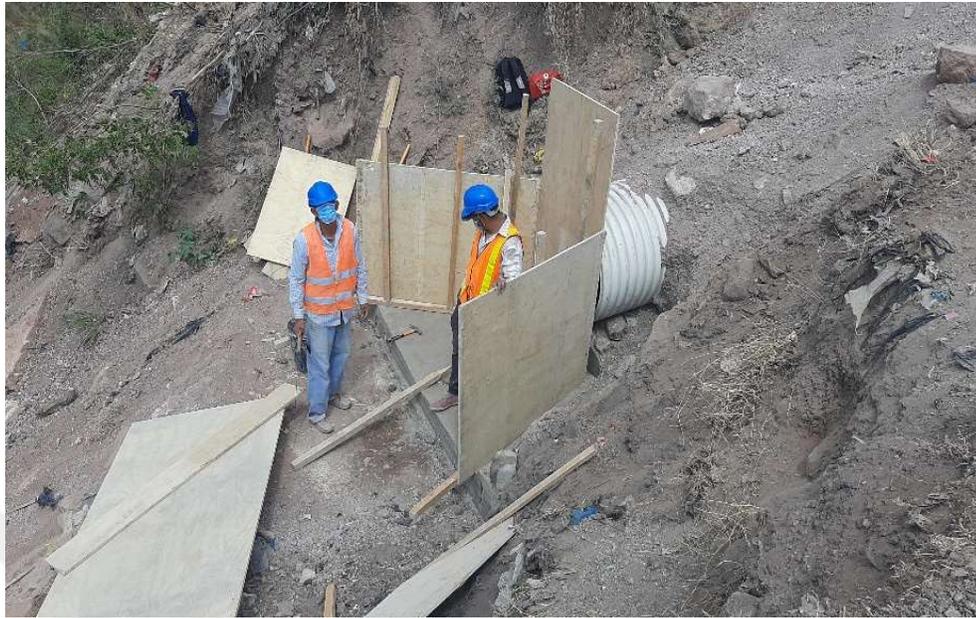
Figure 4. 40 El Crematorio stage 1 and 2 rainwater discharge tube construction February 2020, Source: Cinsa landfill maintenance for Sections 1 and 3 photographic galleries.

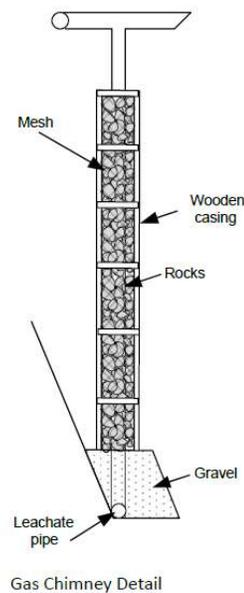
Figure 4. 41 Gas chimney detail.

The gas chimneys start directly placed on the leachate pipe (Figure 4.41), in such a way that they start from the base of the landfill and can evacuate as many gases as possible. The proper functioning of this system will depend on the speed of how the solid waste deposited is decomposed, which happens in the presence of oxygen. These chimneys are built with wood casing siding, lined with 1 ½" x 72" mesh, known as chicken coop mesh and filled with stone. As shown in the respective figure, in order for the gases circulate easily, a perforated 4" PVC pipe will be placed or grooved in the center to complete the fireplace. When finishing the chimney, a layer of 10 cm soil-cement is be placed with an area of 60 x 60 cm, placing a 6-inch concrete pipe that will protrude to the ground for its final flaring. See Figure 4.42 (Mi Ambiente Honduras, 2013).

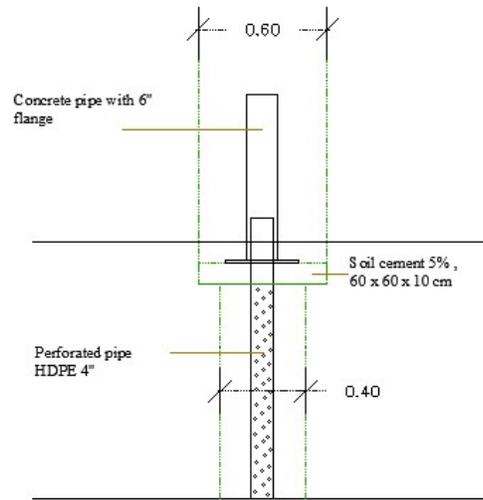
CHIMNEY PIPE DETAIL

Figure 4. 42 Gas chimney pipe detail.

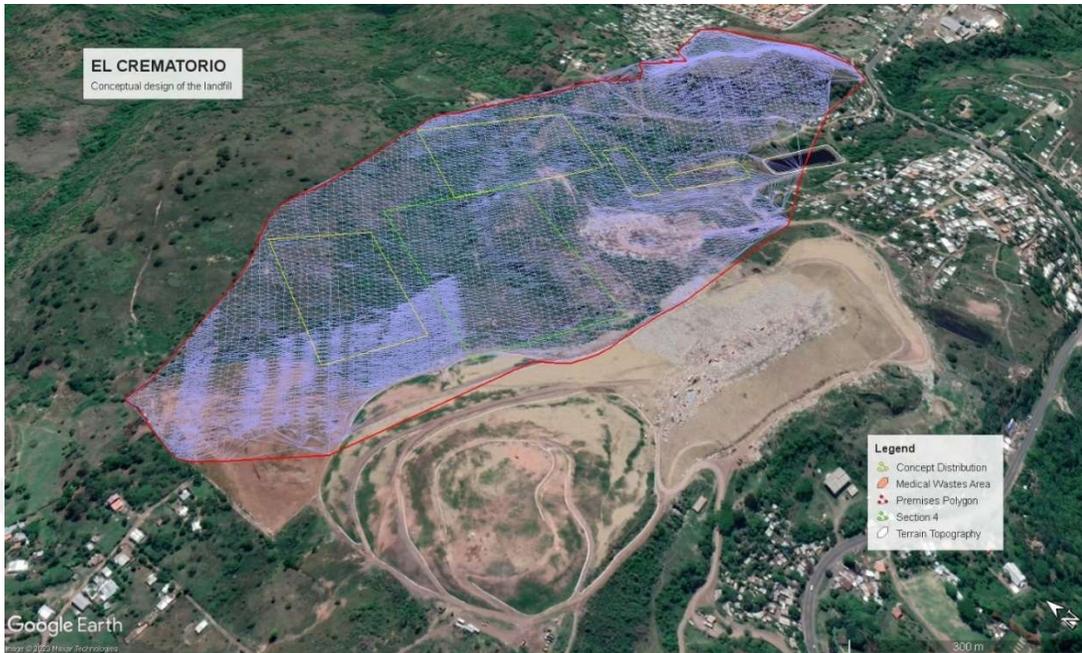
Figure 4. 43 Future landfill division concept of El Crematorio.

As part of the designing tasks of any engineering project, a futuristic concept view must be made for the structures to be built and their functionality in the future. El Crematorio management officials stated that this new site area should be enough to cover 24 years of service in terms of MSW quantification when based on the kg/capita/day of waste data obtained from the World Bank Group urban development series “What a Waste”, in 2010 and 2016 the kg/capita/day was 0.61 and 0.65 respectively (Kaza et al., 2018; SERNA Honduras et al., 2014); obtaining an increased rate value of 0.69 kg/capita/day for the year 2022. This value was compared to the landfill daily entry registry of 850 tons/day and as a result, a value of 890 tons/day is obtained which is just a 4.49% above the actual value, proving that the yearly 50-70 ton/day increase calculation is more or less near the actual value. Following the same calculation methodology, the proposed landfill Section IV expected capacity of 2.8 million m³ is estimated to be enough for the following 8 years meaning that at least two more landfills with similar or greater capacities will be needed to cover the 24 years of service as expected by the AMDC. A concept design is shown in Figure 4.43 which includes two more engineered landfills and 2 secondary major leachate ponds. As for Section IV, an estimate cut and fill calculation from the Civil CAD 3D model is presented in Table 4.8.
