**SLOPE STABILITY ANALYSIS FOR WASTE LANDFILL IN
CENTRAL DISTRICT TEGUCIGALPA HONDURAS**

Graduate School of Science and Engineering of Hacettepe University

for being Award of the Degree of Master of Science

in Civil Engineering

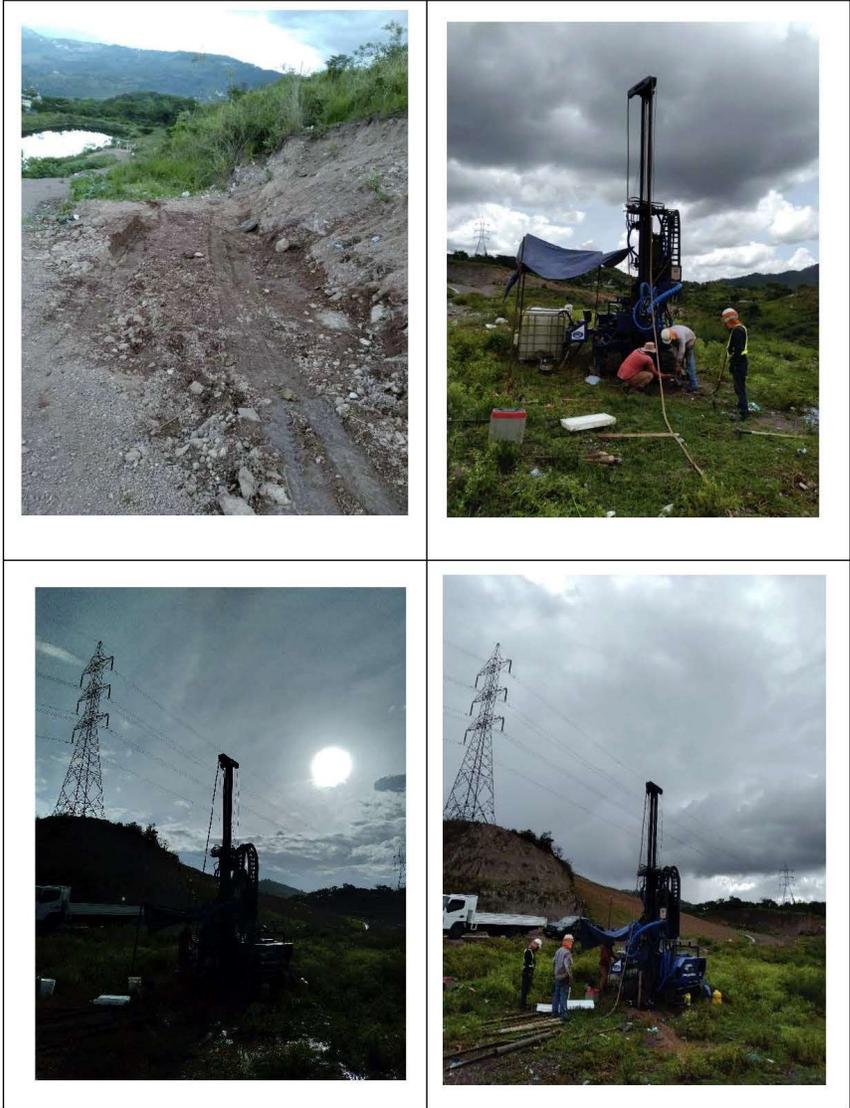
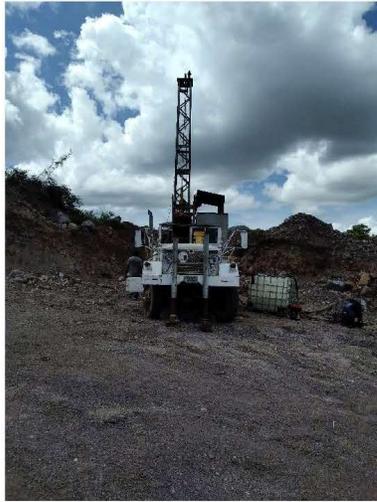
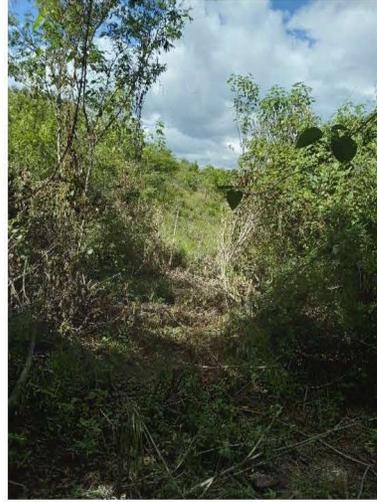
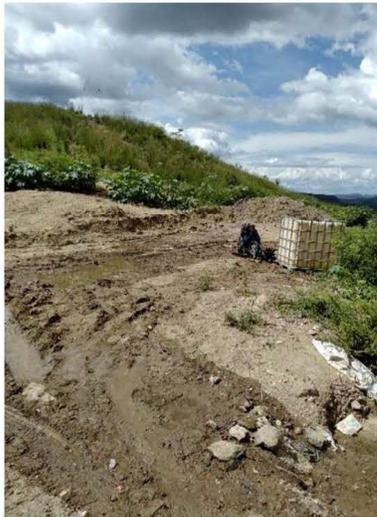
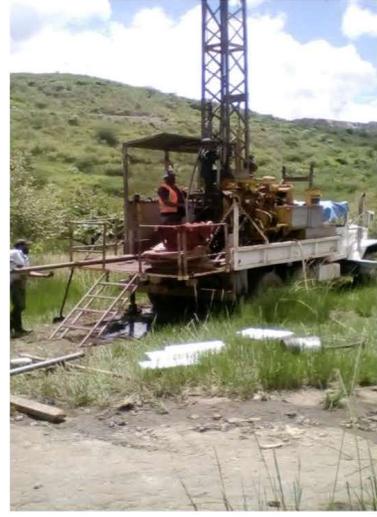
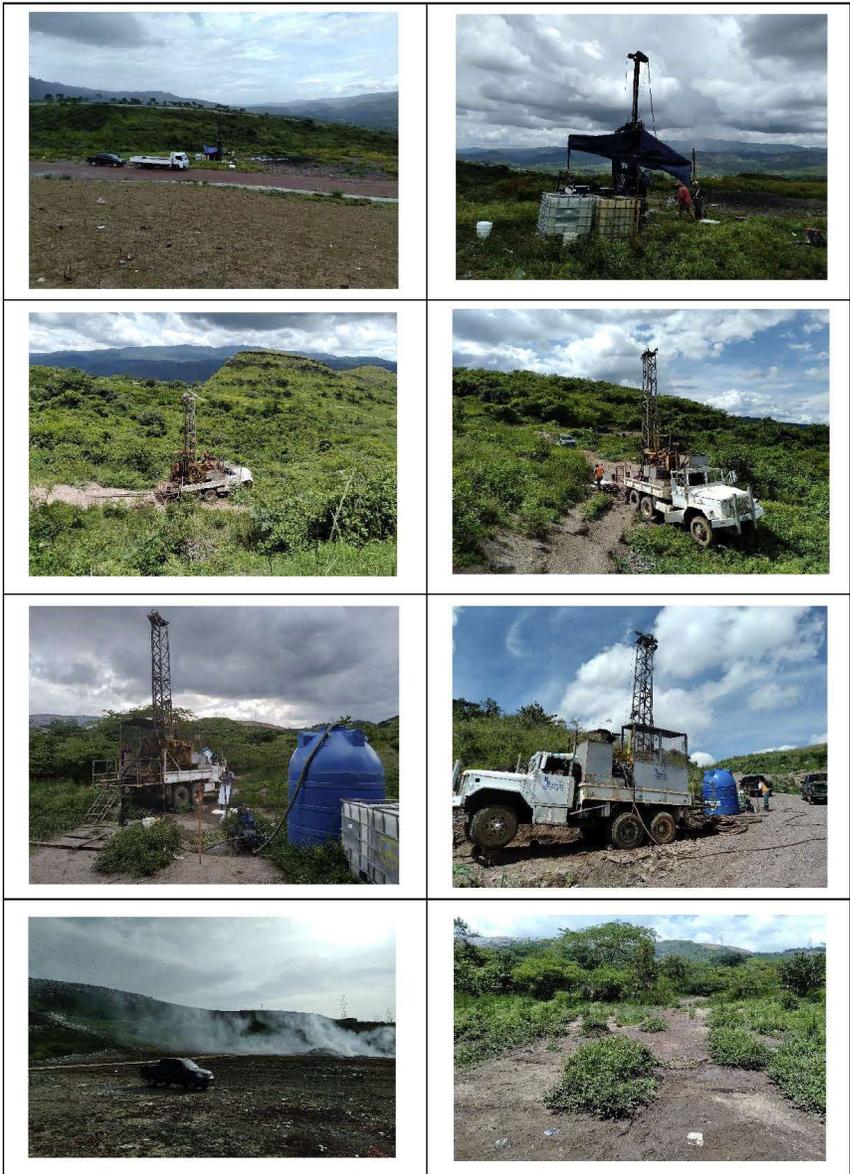
Photographic Gallery

Photographic gallery Studies for the New Landfill of the Central District, GEASA Honduras report September 9 2021
