**CAVITATION EFFECTS ON STABILITY, ECONOMIC LIFE AND
PERFORMANCE OF HYDRAULIC STRUCTURES**

**M.Sc. Thesis by
Mehdi JAHANI**

Department : Civil Engineering

Program : Hydraulic and Water Resources Engineering

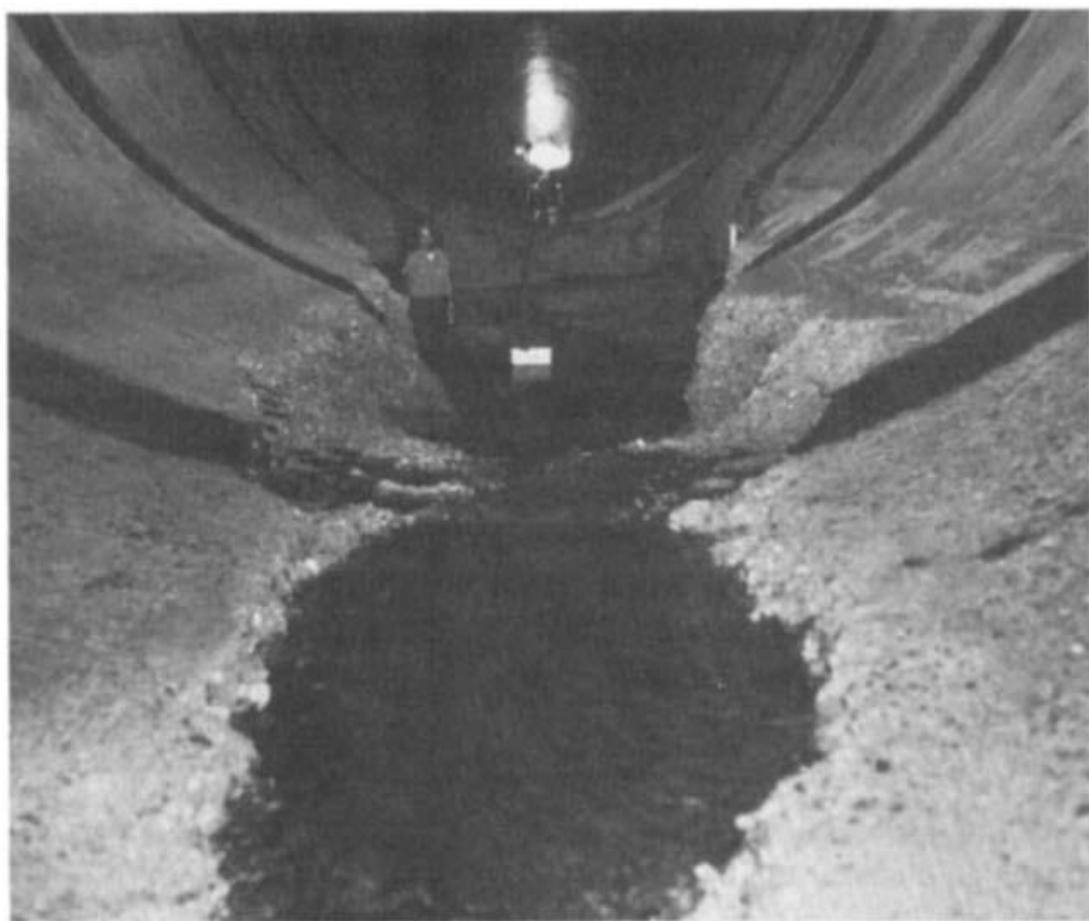
Figure 1.1: Cavitation damage in the spillway tunnel of the Yellowtail Dam (Arndt, 2009).

In the past decade high dams have been constructed and the flow rates discharged over the spillways have been very large. In many projects, the heights of dams are in excess of 200m and the velocities on the concrete chutes of spillway can be of the order of 50m/s. As the velocity on the spillway increases, the threat of damage to the structure by cavitation erosion also increases. Once damage is initiated on the concrete surface, catastrophic damage is accelerated by the combined action of cavitation and impingement attack. An extreme example is shown in Figure 1, which illustrates the damage sustained in the spillway tunnel of the Yellowtail Dam in South Central Montana.

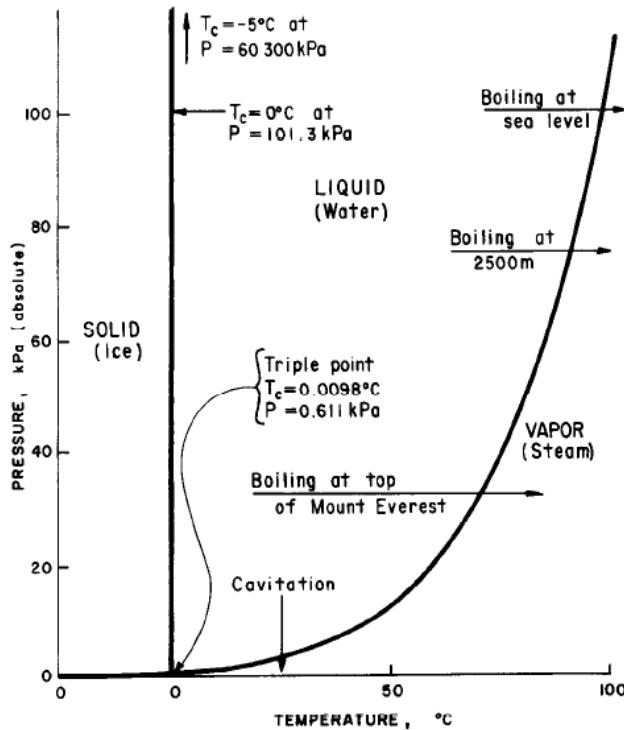
Figure 2.1: Phase diagram for water (Falvey, 1990).

Cavitation is a process that usually is associated with damage to a surface or marked by intense noise. Both phenomena may occur during cavitation, but actually cavitation is neither of these. Instead, Cavitation is defined as the formation of a bubble or void within a liquid. An understanding of the cavitation process can be obtained by examining the process of boiling. When water is heated the temperature increases which results in increases in its vapor pressure. When the vapor pressure equals the local pressure, boiling will occur. At the boiling point, water is changed into water vapor. This change first occurs at localized points within the water and it is observed as small bubbles. The temperature at which boiling occurs is a function of pressure. As pressure decreases, boiling will occur at lower and lower temperatures. Since the pressure is a function of elevation, boiling occurs at lower temperatures at higher elevations as noted on Figure 2.1. If it were possible to go to a high enough elevation, boiling would occur at room temperature.

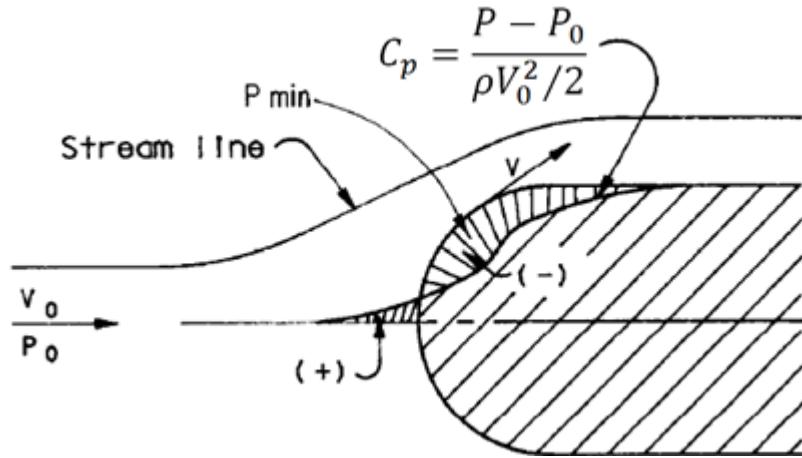
Figure 2.2: Pressure distribution on hemispherical rod (Falvey 1990).

(The subscript o refers to upstream flow location as noted on Fig 2.2)

The value of the Euler number, at any point on a body, is a constant as long as the minimum pressure on the body is greater than the vapor pressure of water. For example, on Figure 2.2, the pressure at any point on a rod-having a hemispherical end-is predictable in terms of the upstream conditions. However, if the pressure at the location that corresponds to the minimum Euler number drops to vapor pressure, then the pressure at that point will not decrease any further. The upstream conditions that correspond to the onset of cavitation can be calculated by replacing the boundary pressure in Equation 2.2 with vapor pressure and setting the value of the ratio equal to the minimum Euler number. The resulting parameter is known as the cavitation index, σ .

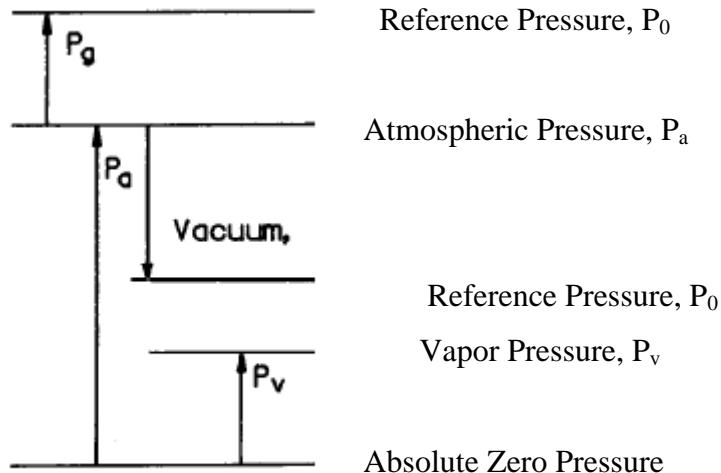
Figure 2.3: Definition of pressure scales.

To avoid ambiguities, both vapor pressure and reference pressure are referenced to absolute zero pressure as shown on Figure 2.3. For example, in absolute units, the reference pressure is given by:

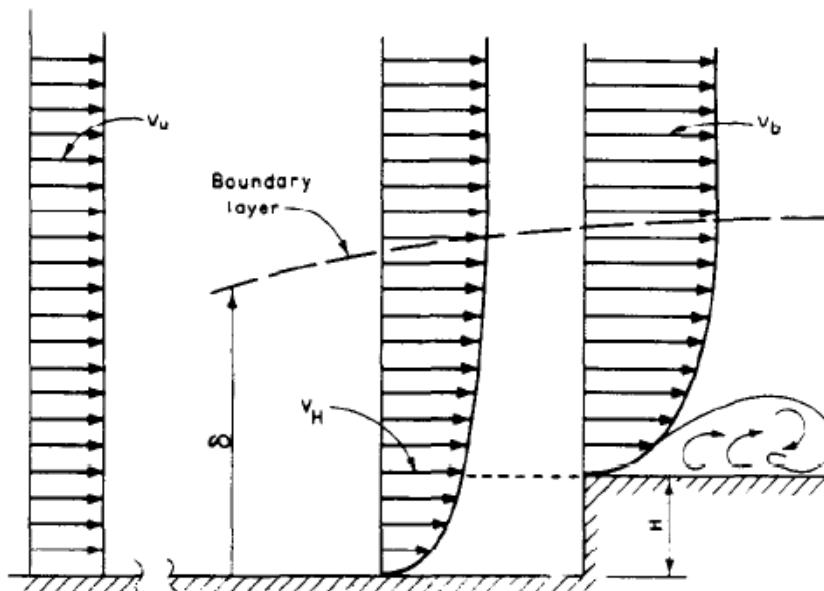
Figure 2.4: Reference Velocity definitions (Falvey, 1990).

In practical situations, flow conditions are not as ideal as those shown on Figure 2.2. For instance, for a bluff body within a boundary layer, the definition of the cavitation index depends upon the reference location as shown on Figure 2.4. In this case, three different reference locations are noted; the three locations and corresponding cavitation indexes are:

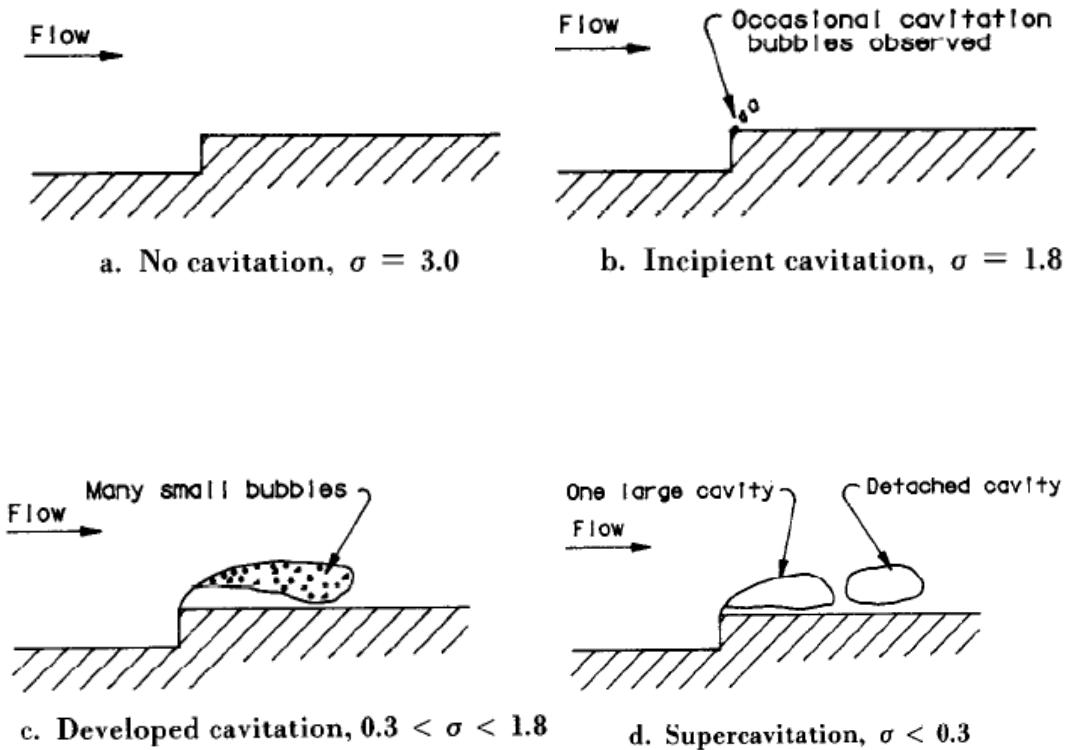
Figure 2.5: Cavitation development (Falvey, 1990).

Although one parameter such as the cavitation index-in whatever form it is expressed-cannot describe many of the complexities of cavitation, it is an extremely useful parameter to indicate the state of cavitation in a hydraulic structure. For example, for flow past a sudden into-the-flow offset, cavitation will not occur if the cavitation index (defined by Equation 2.7) is greater than about 1.8 as noted on Figure 2.5. As the cavitation index decreases below 1.8, more and more cavitation bubbles form within the flow. To the naked eye, the cavitation appears to be a fuzzy white cloud. However, a flash photograph reveals that the cloud consists of individual bubbles. For even lower values of the cavitation index, the cloud suddenly forms one long supercavitating pocket (Falvey, 1990).

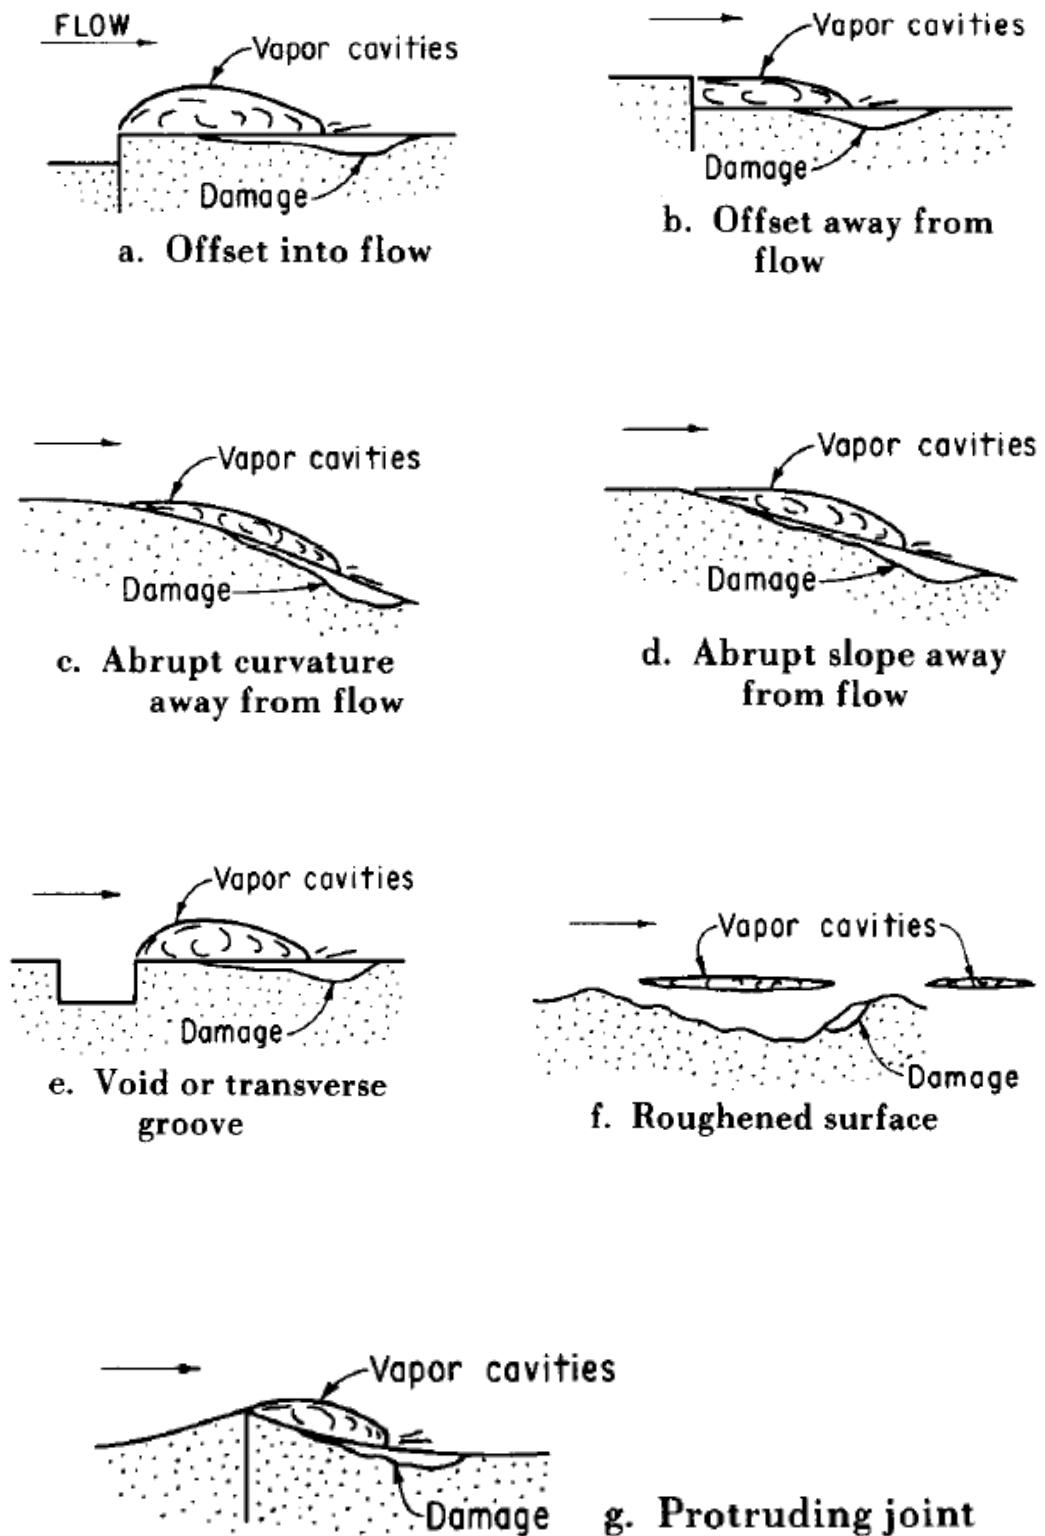
Figure 3.1: Typical isolated roughness elements found in hydraulic structures (Falvey, 1990).

1. offset into-the flow, Fig 3.1a;
2. offset away-from the flow, Fig 3.1b, c, d;
3. Voids or grooves, Fig 3.1e; and
4. Protruding joints Fig 3.1g.

Figure 3.1f depicts cavitation above a distributed roughness. Cavitation occurs within the flow because of turbulence generated by the roughness of the boundary. The cavitation location is not predictable; however, cavitation always occurs within the body of the flow for distributed roughnesses (Falvey, 1990).

Movement of concrete formwork is the most common cause of irregularities, and can give rise to abrupt offsets and chamfers (both into and away from the flow), sudden changes in slope, cusped joints, and undulations (see types a, b, c, d, e, f, g in Figure 3.1). Of these, abrupt offsets into the flow (Type a) have the greatest cavitation potential, and a suitable formula for calculating the σ_i value is that due to (Liu, 1983),

Data for chamfers angled away from the flow (Type c, d on Fig 3.1) are limited, and may not be comparable because of different definitions of the characteristic velocity (e.g. near the bed, or depth-averaged). Laboratory studies indicate that the values of σ_i tend to be higher than for into-flow chamfers of equal slope.

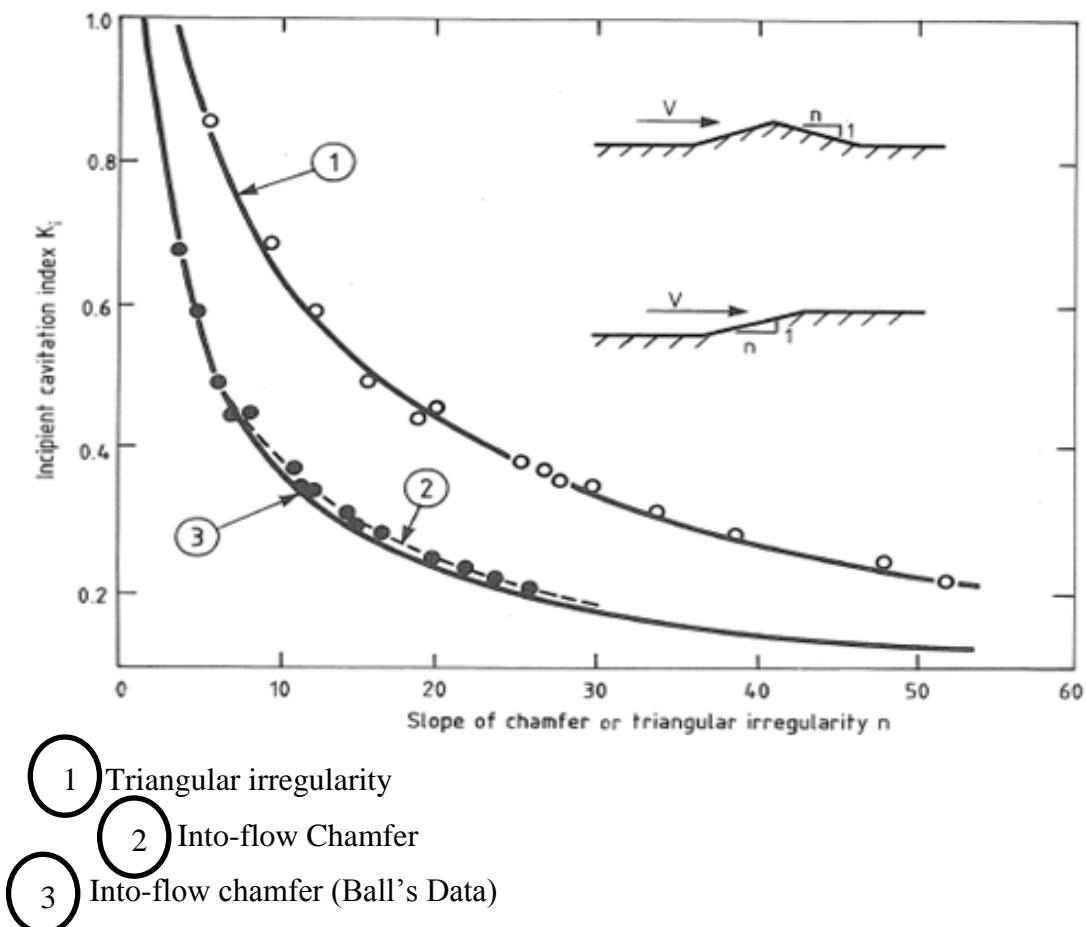
Figure 3.3: Values of σ_i for surface irregularities (Wang & Chou, 1979).

As the flow velocity is increased, the standards of surface finish required to prevent cavitation eventually become impracticable, particularly in cases where a convex surface reduces the static pressure, or the boundary layers are not fully developed. Some references suggest that use of the parameter σ_i for cavitation inception is not appropriate in design, because damage does not occur until the cavitation index σ of the flow falls below σ_i . Wang & Chou (1979) proposed that the design criterion should be $\sigma \geq 0.8 \sigma_i$. Field tests at Bratsk Dam (USSR) reported by Galpertin et al (1977) and Oskolkov & Semenkov (1979) provided values of the index σ_i for incipient damage at chamfers angled into and away from the flow.

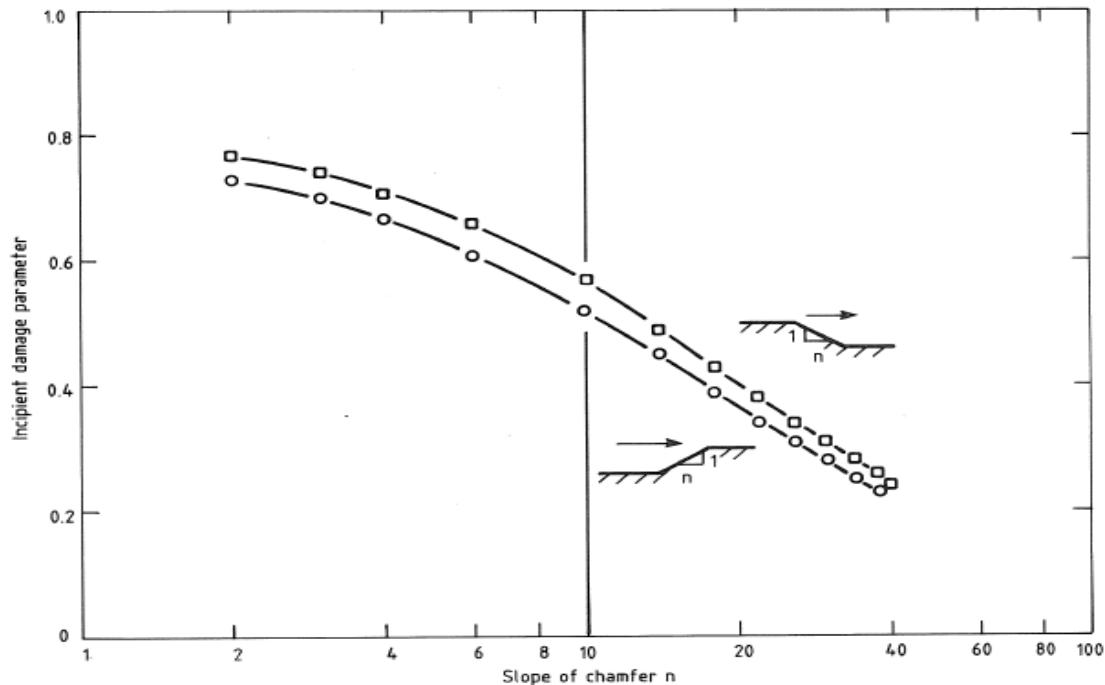
Figure 3.4: Values of σ_i for surface irregularities (Oskolkov & Semenkov, 1979)

The results are presented in Figure 3.4, and indicate that chamfers away from the flow have slightly higher values of σ_i than chamfers projecting into the flow.

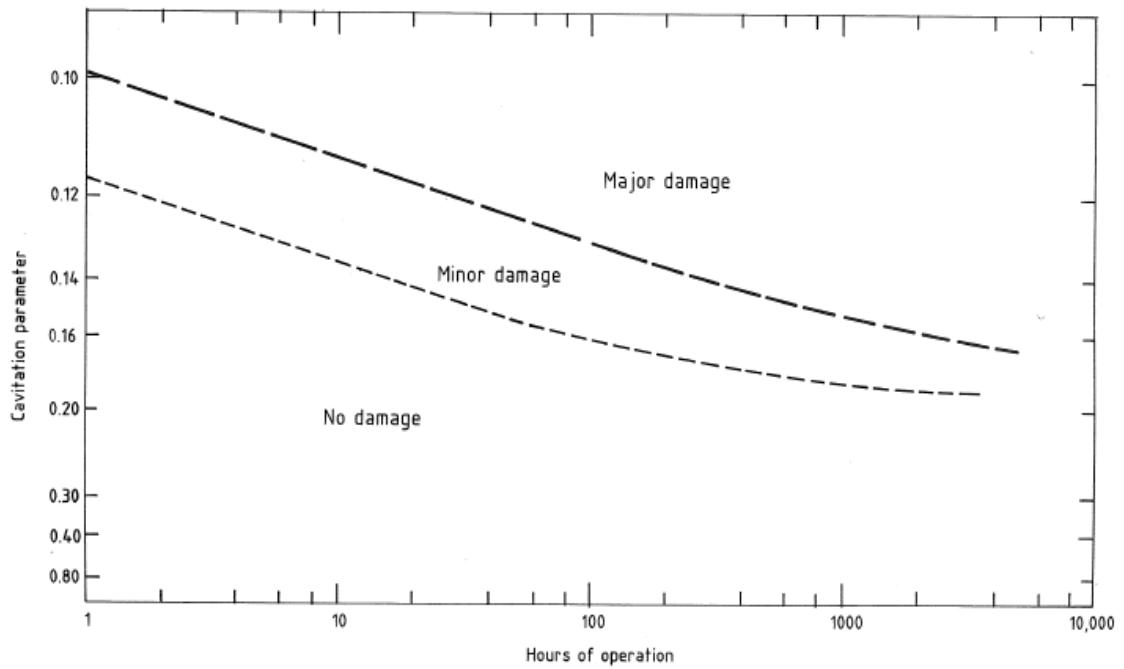
Figure 3.5: Cavitation damage curve (Falvey, 1983)

Another factor to be considered in design is the likely duration of the cavitation attack; as the cavitation number σ of the flow decreases, the safe operating time is reduced. Falvey (1983) used field data to produce Figure 3.5, which shows a relationship between the value of cavitation parameter, its duration and the amount of cavitation damage.

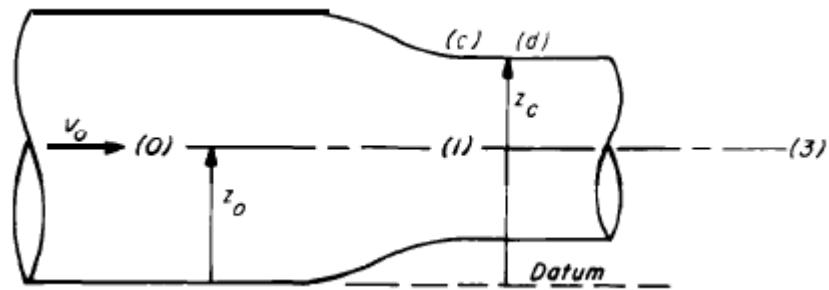
Figure 3.6: Tunnel Contraction

When the geometry of flow boundaries causes streamlines to curve or converge, the pressure will drop in the direction toward the center of curvature or in the direction along the converging streamlines. For example, Fig. 3.6 shows a tunnel contraction in which a cloud of cavities could start to form at Point c and then collapse at Point d. The velocity near Point c is much higher than the average velocity in the tunnel upstream, and the streamlines near Point c are curved. Thus, for proper values of flow rate and tunnel pressure at 0, the local pressure near Point c will drop to the vapor pressure of water and cavities will occur.

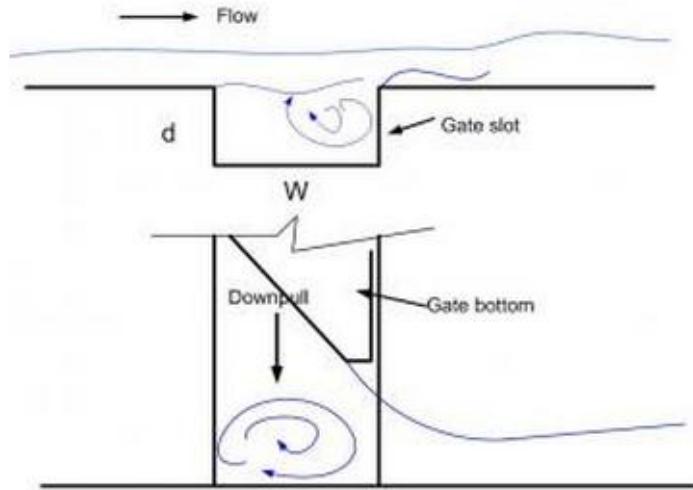
Figure 3.7: Flow around rectangular slot.

The supporters and lifting mechanisms for vertical leaf gates are normally located on the downstream side of the gate, and are accommodated in slots in the side walls so as to protect them from high velocity flow. Such slots have often been a cause of cavitation damage. High velocity flow past a rectangular slot (Figure 3.7) may produce cavitation in three ways:

1. Flow separation at the upstream corner, with cavities being generated in the free shear layer and carried downstream by the flow;
2. Flow separation at the downstream corner, with cavities collapsing where the flow re-attaches to the wall of the tunnel;
3. Vortex formation within the slot, with possible damage to the sides and the gate supports (May, 1987).

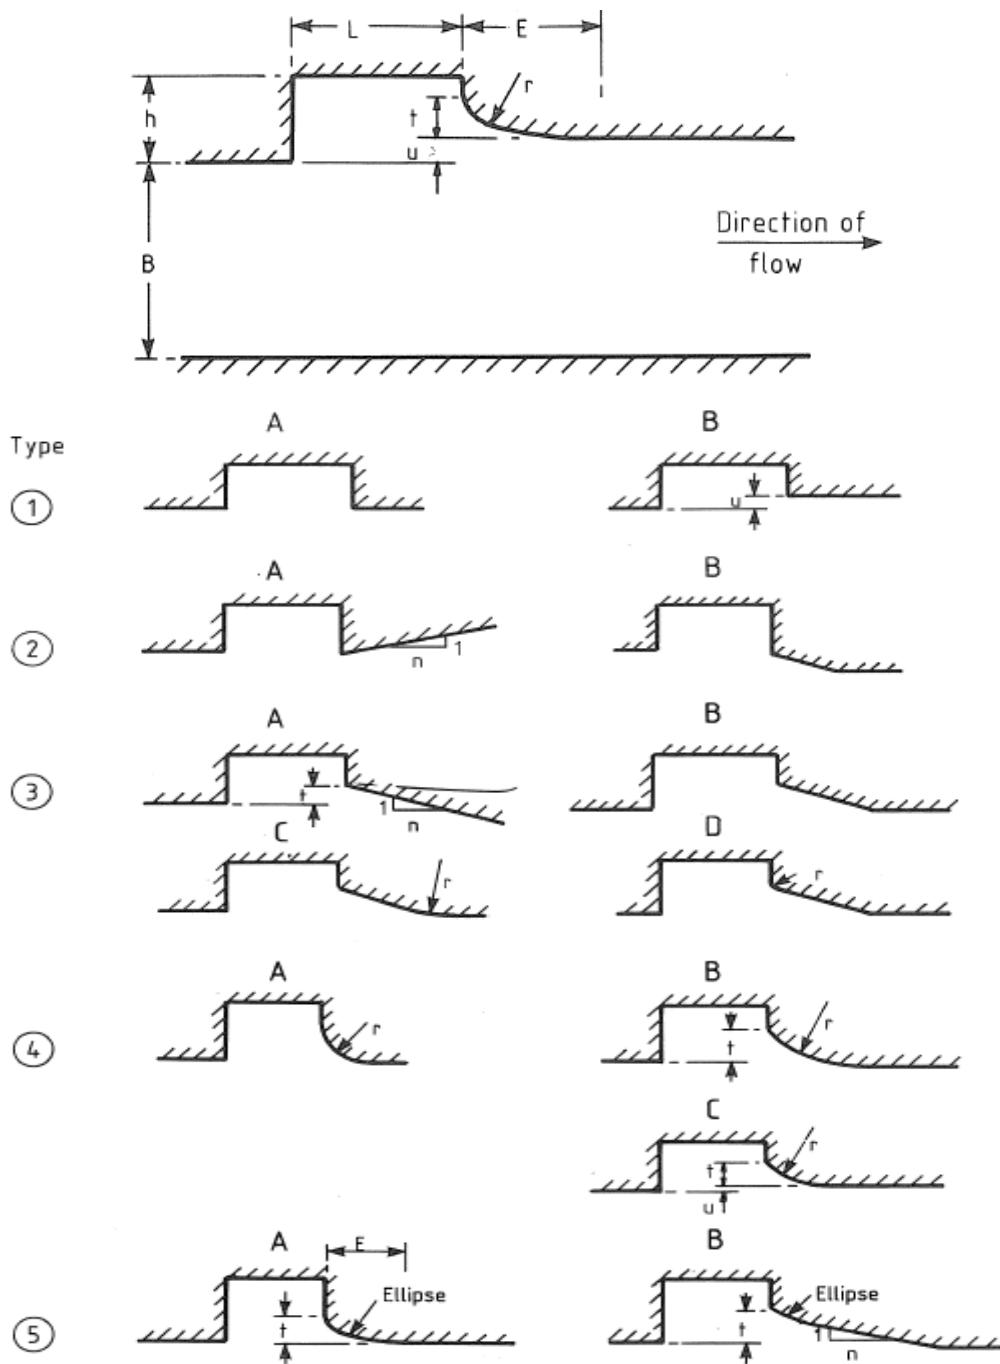
Figure 3.8: Types of Gate Slots

Many studies have been made of two-dimensional flow past various shapes of slot, some of which are shown in Figure 3.8. The tests correspond approximately to the conditions which exist when a gate is fully open and the slot is not occupied by the lifting mechanism. Some studies have compared different shapes of slot on the basis of pressure measurements around the boundaries. However, studies carried out in cavitation tunnels are more useful and reliable, because the conditions for cavitation inception can be measured directly.

There is general agreement between studies about which types of gate slot have the lowest cavitation potential. A plan rectangular slot (Type 1A in Figure 3.8) is satisfactory for low heads, but Jin et al (1980) recommend that the length/ depth ratio should be kept in the range $1.4 \leq L/h \leq 2.5$, and if possible between $1.6 \leq L/h \leq 1.8$ for the best performance.

Strong vortex action occurs if $L/h < 1.2$, and cavitation due to flow separation becomes serious if $L/h > 2.5$. Offsetting the wall downstream of the slot (as in Type 1B in Fig 3.8) is, by itself, not effective; the offset reduces the risk of cavitation at the downstream corner of the slot, but increases it at the upstream one. The designs which were found to have the lowest cavitation potential were slots with an offset ($t/h \approx 0.2$) and either a radius transition (Type 4B, $100 < r/t < 250$) or an elliptical transition (Type 5A, $E/t = 5$).

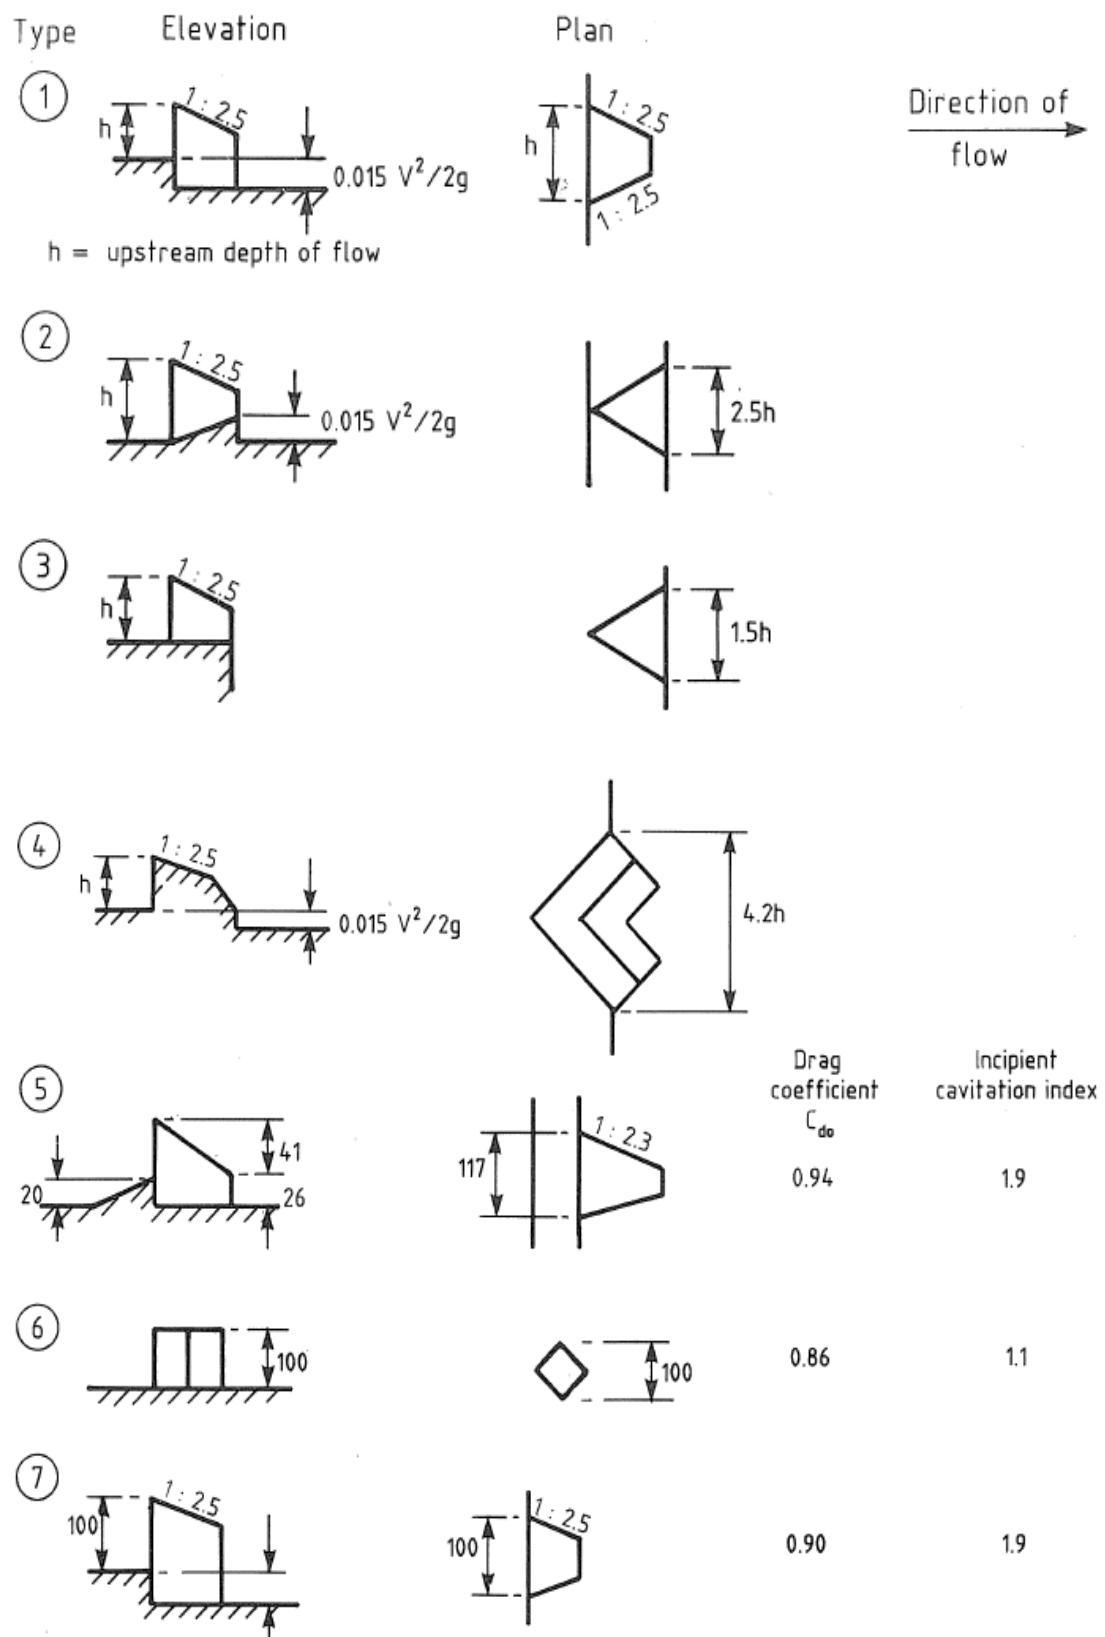
Figure 3.9: Types of baffle block

shorter basins, they are often omitted in high-head installations. To be effective, blocks need to have high drag coefficients (C_d), but this also results in high values of the cavitation inception parameter K_i ; rounding the corners reduces K_i but also C_d . Shapes of baffle blocks investigated by Oskolkov & Semenkov (1979) and by Rozanova & Ariel (1983) are shown in Figure 3.9. Cavitation damage can be reduced or avoided by using a super-cavitating design which causes the flow to separate at the upstream face and form a large fixed cavity that encloses the block; damage is avoided by removing the solid surfaces from the region in which the individual cavity bubbles collapse. This can be achieved by sloping the sides of the block away from the flow in the downstream direction and by introducing a step in the floor (see, for example, Type 1 in Figure 3.9).

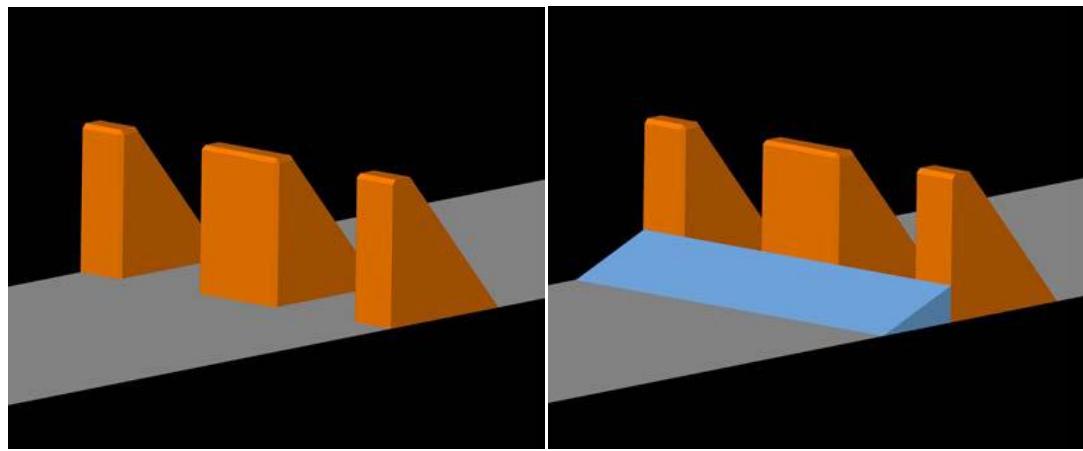
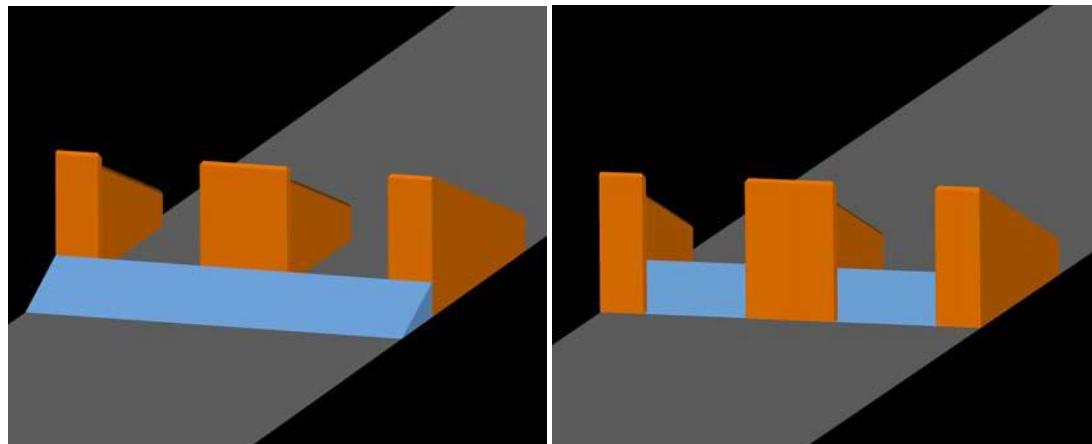
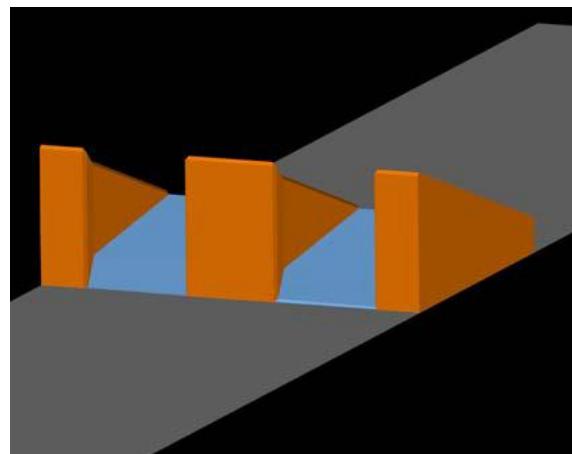
a.) Original block design.

b.) 1V:3H ramp (1.22-m-high (4-ft-high))

c.) tapered block with ramp preceding

d.) Tapered block with 1V:3H ramp inside

e.) tapered block with 1V:9H ramp between

Figure 3.10: Block/ramp combinations testing in the LAPC (Frizzell and Cox, 2009).

Schematic views of the block and ramp configurations tested appear in Figure 3.10.a to 3.10.e.

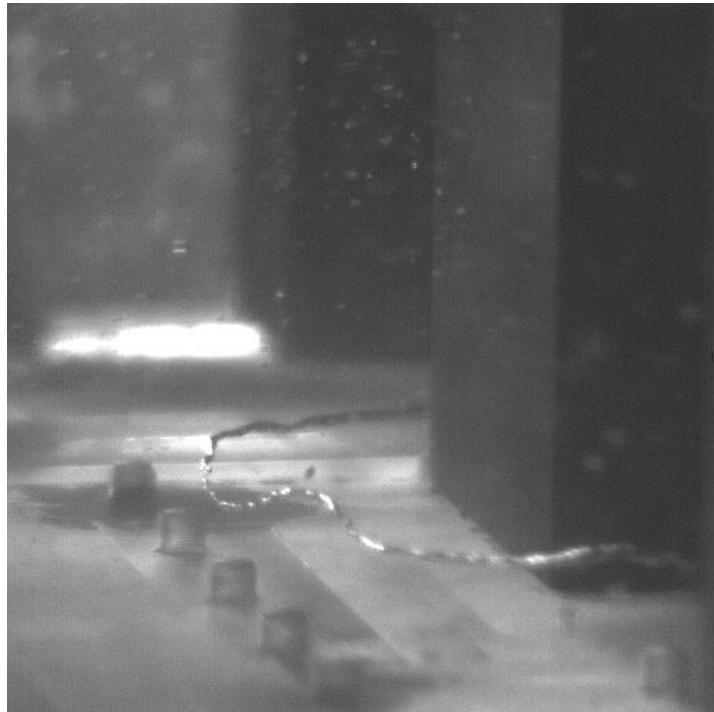
Figure3.11: Horseshoe vortex upstream from baffle block face (Frizell & Cox, 2009)

The original block design did show substantial cavitation potential. As with all the blocks, the first sign of cavitation takes the form of a horseshoe vortex out in front of the blocks, near the floor, Figure 3.11. This vortex is formed by the interaction of the streamlines due to the stagnation at the block face and the floor intersection.

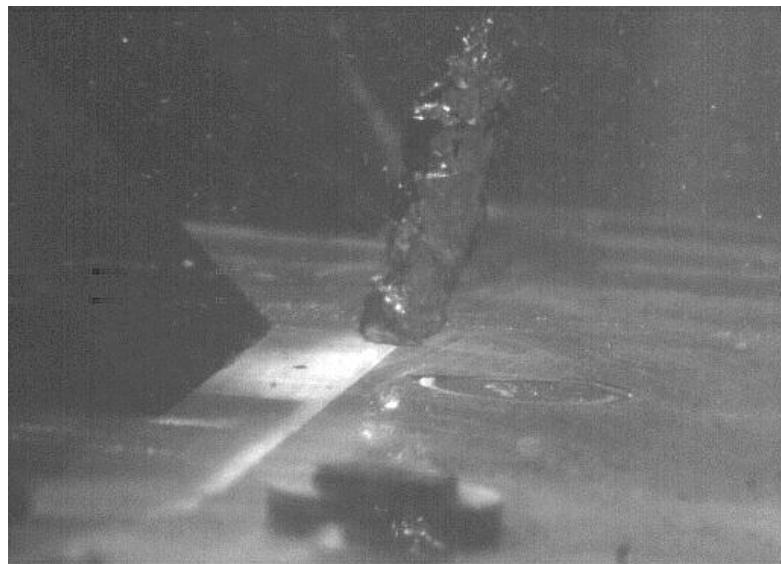
Figure 3.12: Floor attached vortex at downstream corner of baffle blocks (Frizell & Cox, 2009).

High-speed video allowed the observation of attached vortices at the downstream corners of the blocks, Figure 3.12. These vortices were formed in the shear layer of the block but attached to the floor and remained attached until dissipation or implosion. This location is typical of where damage at previous locations with similar designs has occurred. These vortices intensified in strength with lowering of the cavitation parameter. In addition, this shape would not pass into a supercavitating regime within the operating range of the facility. Addition of the ramp to the original block reduced the intensity and consistency of the floor attached vortices, however it transferred the attachment point up onto the down sloping edge of the block itself, still creating the potential to severely damage the baffle blocks during operation. On a positive note, the ramp prompted supercavitation at the design condition (Frizell and Cox, 2009).

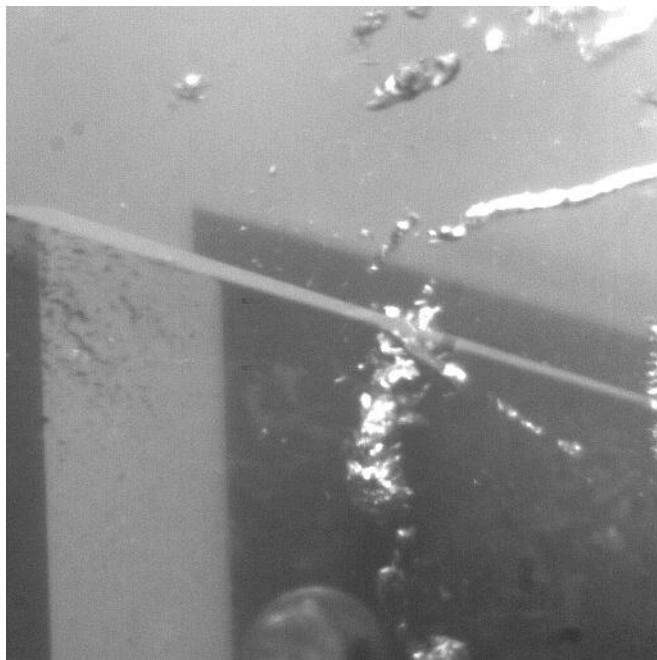
Figure 3.13: Near vertically oriented vortices in the shear layer between blocks (Frizell and Cox, 2009).

Half block against wall in clear acrylic to facilitate viewing between the blocks.

Two ramp configurations were tested, the same 1V:3H ramp as previously tested placed between the blocks starting at the front edge, and a 1V:9H ramp that began at the front edge and ended at the rear edge of the blocks. The first ramp showed general improvement but there was still visual evidence of possible vortex collapse on the floor between the blocks. The extension of the ramp to the end of the blocks lessened the occurrence of collapse or possible implosions on the blocks and floor ramp. For the design condition, any chance of damage with this final configuration will be relegated to downstream from the blocks on the floor of the basin.

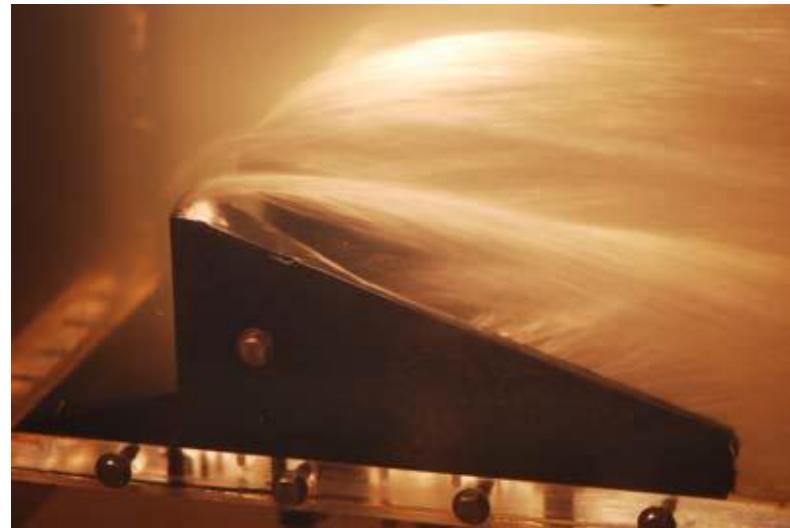
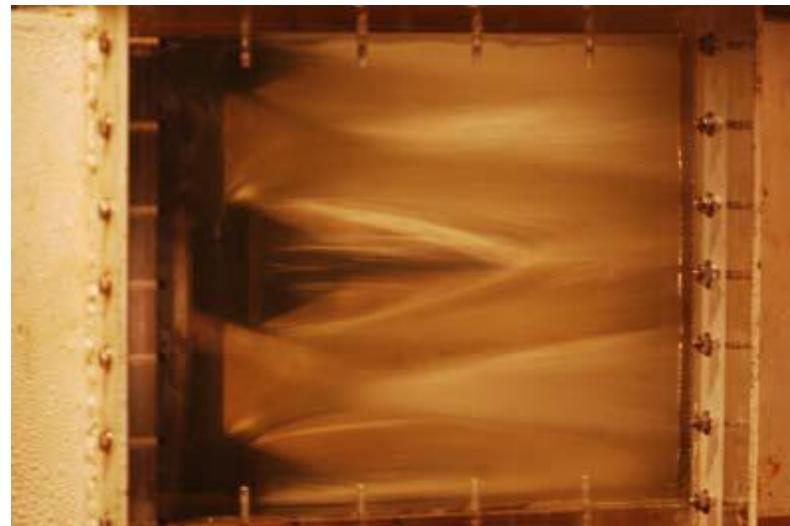
a.) Side View

b.) Top View

Figure 3.14: New block with preceding ramp in a supercavitating – ventilated cavity condition (Frizell and Cox, 2009).

of vortices that contacted the floor between the blocks even during ventilated supercavitation. Top and side views of this block/ramp combination in a supercavitating condition are shown on Figure 3.14.

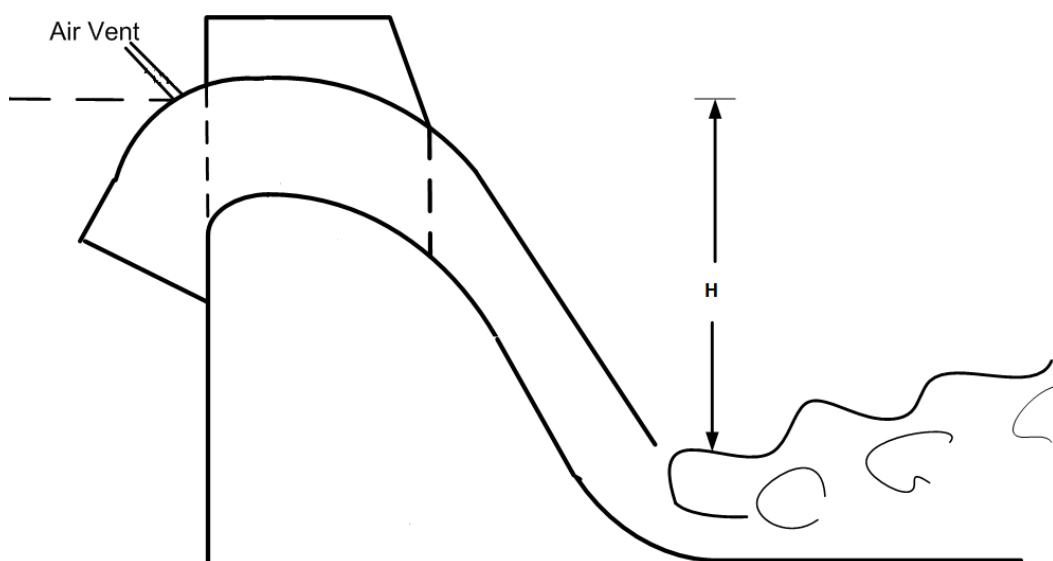
Figure 3.15: Siphon spillway

The discharge over an overflow spillway is a function of the head measured over its crest. Enclosing the crest and making the resulting conduit flow full can substantially increase this effective head. The head on the spillway (as shown in Figure 3.15) is then the difference in elevation between the reservoir surface and the spillway outlet. However, the flow near the crest of the spillway would then be under a negative pressure. In other words, the conduit becomes a siphon. All necessary precautions must be taken to ensure that the vacuum is maintained and that it does not become so excessive as to cause cavitation. The maximum negative pressure at the spillway crest is theoretically 10 m of water at sea level. Allowing for the vapor pressure of water, loss due to turbulence, etc., the maximum net effective head is rarely more than about 7.5 m. This corresponds to a velocity of $\sqrt{2 \times 9.81 \times 7.5} \approx 12 \text{ m/s}$. This means that the initial velocity in any siphon cannot exceed about 12 m/s at the inlet. The essence of the hydraulic design of siphon spillways, therefore, lies in ensuring maximum discharge capacity without harmful negative pressures.

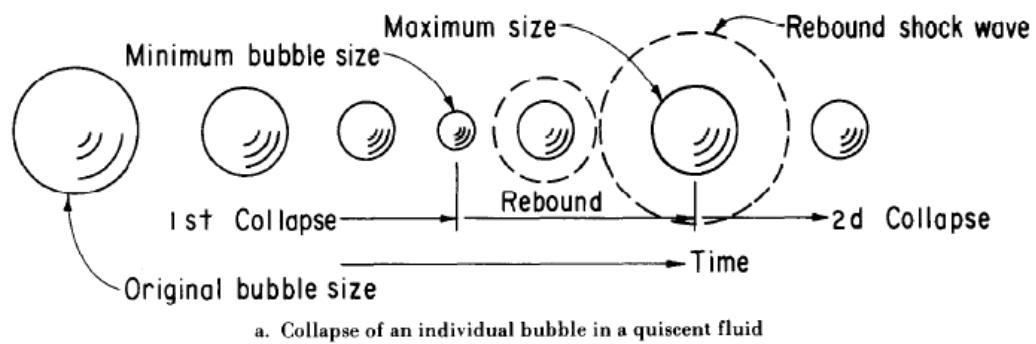
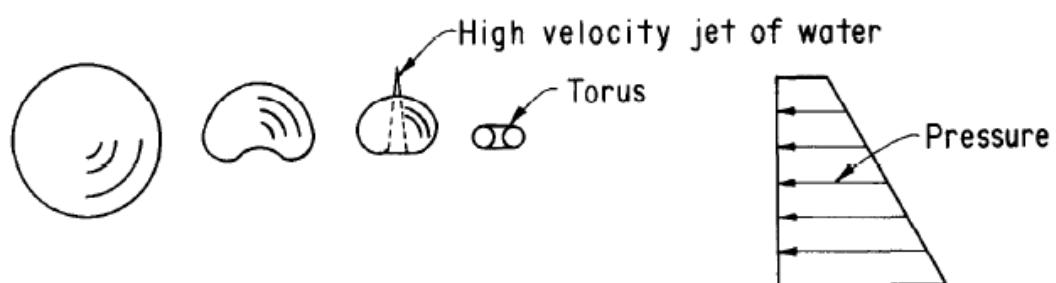
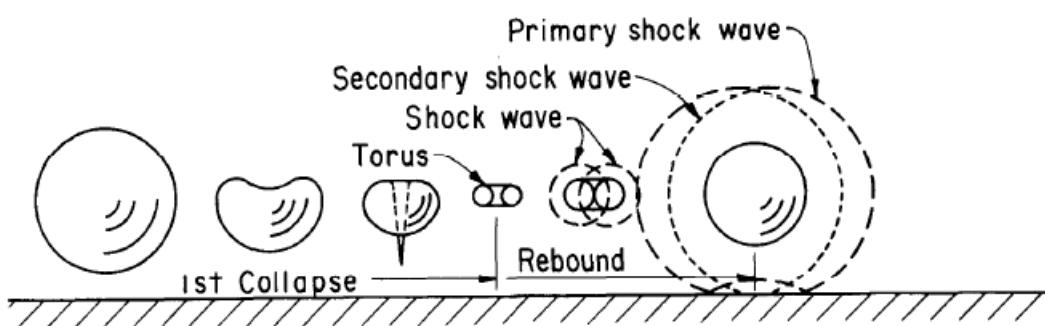
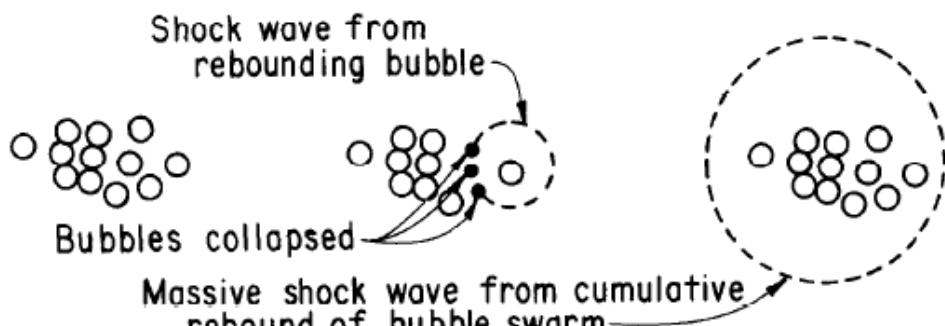
Figure 4.1: Collapse mechanisms of bubbles.

a. Collapse of an individual bubble in a quiescent fluid

b. Collapse of an individual bubble in a hydraulic gradient

c. Collapse of an individual bubble near a boundary

d. Collapse of a swarm of bubbles

Numerical solution of the equations reveals that bubble collapse consists of phases in which the bubble diameter decreases, reaches a minimum value, and then grows or rebounds as shown on Figure 4.1. The process is repeated for several cycles with the bubble diameter decreasing during each cycle until it finally becomes microscopic.

Both cases cause one side of the bubble to deform into a jet which penetrates the opposite side of the bubble as depicted on Figure 4.1. The jet formed by the unsymmetrical collapse of a single bubble is called a micro jet. The velocities of micro jets are large. Hammitt (1979) concluded that in most cases cavitation damage was due primarily to the liquid micro jet impact on the surface and not to the spherical shock waves which emanate from the rebounding bubble. However, more recent photo elastic studies Fujikawa and Akamatsu (1980) have shown that the shock wave generates much higher pressure impulses than the jet.

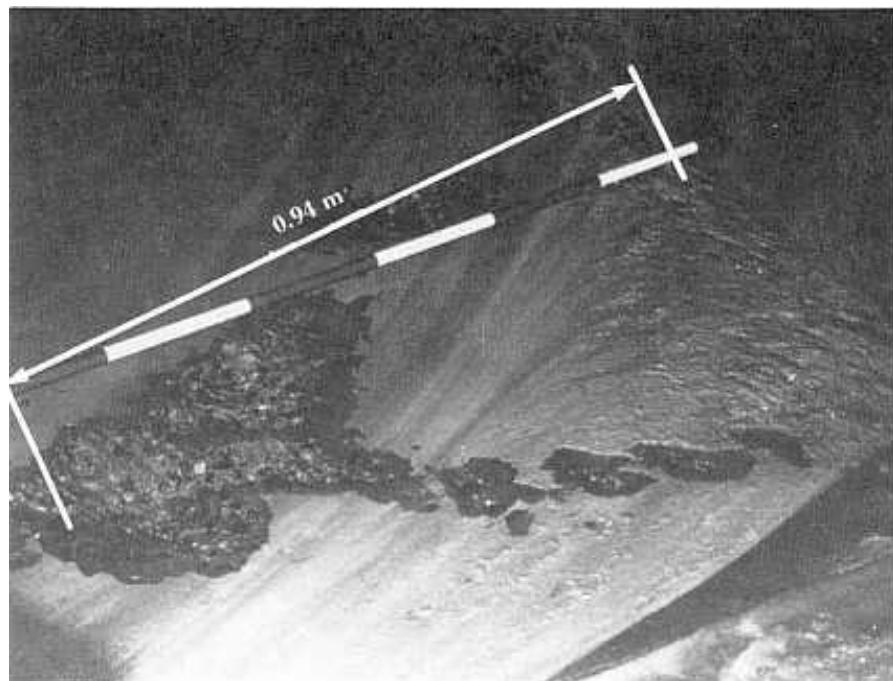
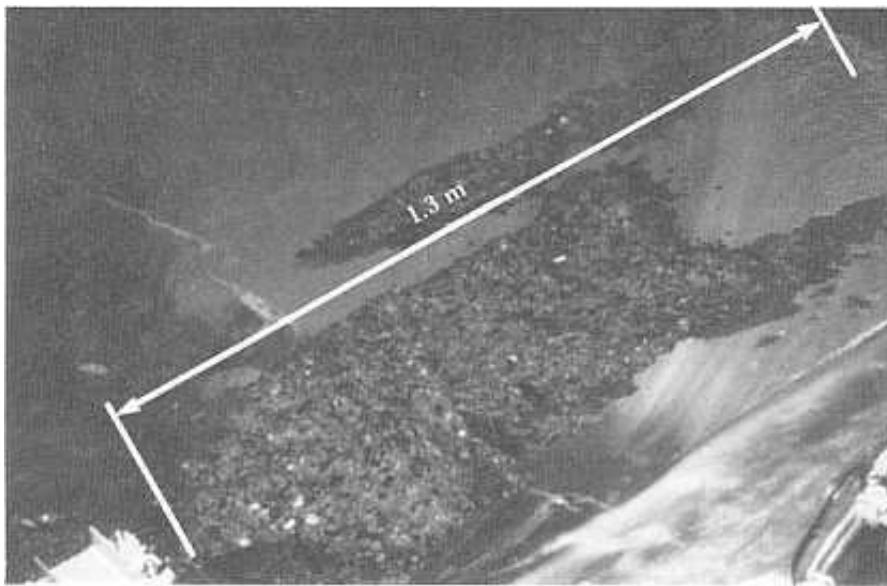
Figure 4.2: Glen Canyon Dam, left tunnel spillway-station 760.70 (Falvey, 1990)

Figure 4.2a: Damage observed during a photographic survey (Fall, 1981)

b. Damage observed on June 6, 1983

After approximately 20 days of operation, at a discharge of about $205\text{m}^3/\text{s}$, damage was observed in the left tunnel spillway downstream of a calcite deposit which formed in a shrinkage crack as shown on figure 4.2a. After 3-day operation, at an average discharge of about $425\text{m}^3/\text{s}$, a second damaged area was observed downstream of the first as shown on Figure 4.2b.
