**CAVITATION EFFECTS ON STABILITY, ECONOMIC LIFE AND
PERFORMANCE OF HYDRAULIC STRUCTURES**

**M.Sc. Thesis by
Mehdi JAHANI**

Department : Civil Engineering

Program : Hydraulic and Water Resources Engineering

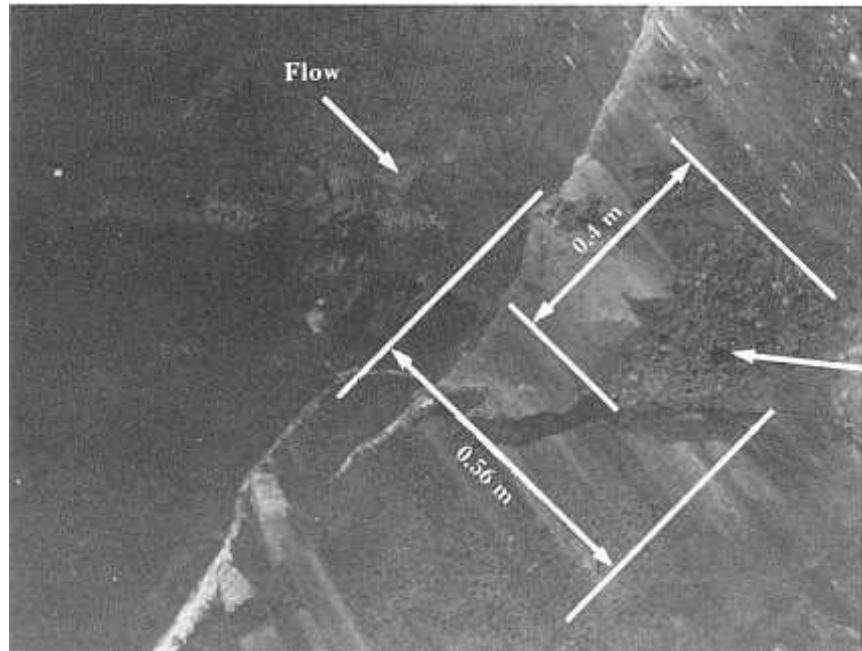
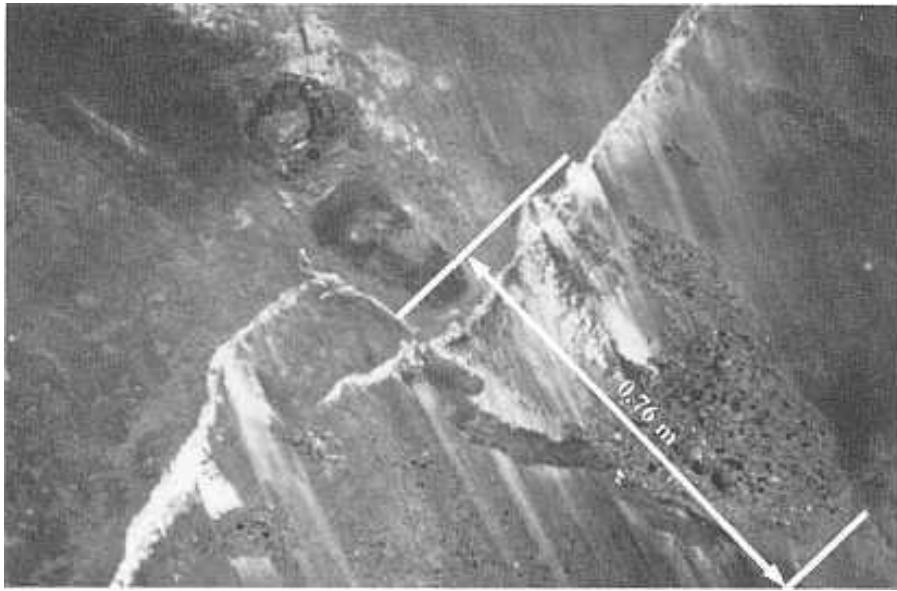
Figure 4.3: Glen Canyon Dam left tunnel spillway - station 739.38 (m) (Falvey, 1990)

Figure 4.3a: Damage observed during a photographic survey (Fall, 1981)

b. Damage observed on June 6, 1983

Farther up-in the spillway-damage was observed, but two distinct areas of damage did not develop as shown on Figures 4.3a and 4.3b. Stinebring's equation predicts a difference between the two damaged areas as shown in Table 4.2. However, the

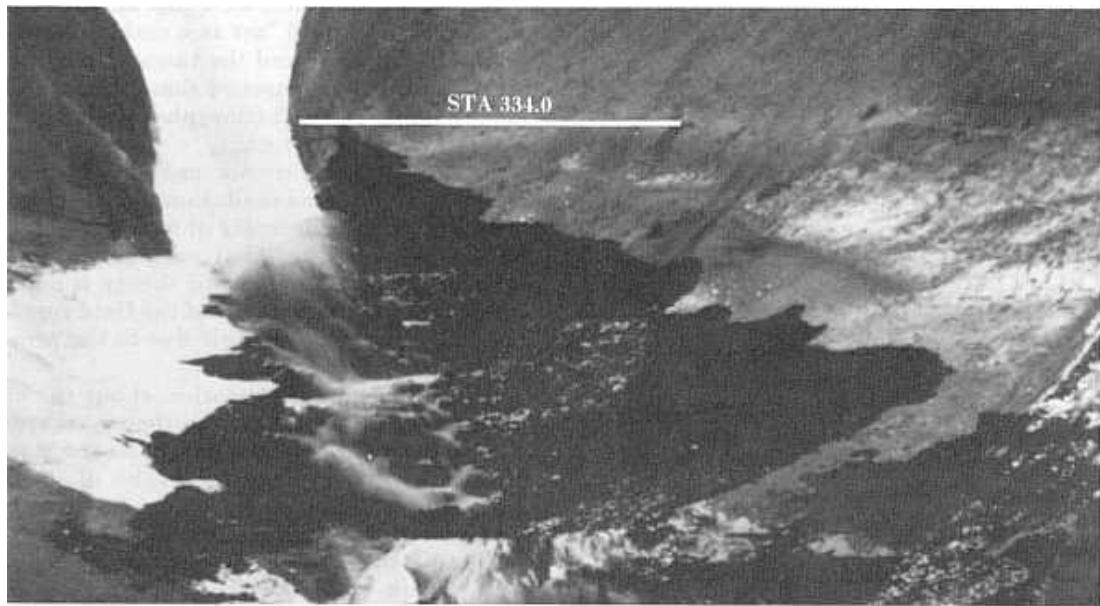
Figure 4.4: Hoover Dam, Nevada tunnel spillway- Christmas tree pattern of damage.

These two observations bring into question a widely held assumption about the formation of cavitation damage. This assumption is that cavitation tends to “leapfrog-forming a Christmas-tree shaped damage pattern as shown on Figure 4.4. That is, once cavitation damage has formed, it is assumed that the damaged area becomes a source of cavitation which then creates another damage area downstream.

The Christmas-tree pattern of damage develops only after the depth of the cavitation damage becomes large relative to the flow depth. For a large hole, the damage mechanism is undoubtedly more that of erosion-by a high velocity jet on a rough surface-than that of cavitation. The erosion of a surface by a high velocity jet in the absence of cavitation has not been systematically studied (Falvey, 1990).

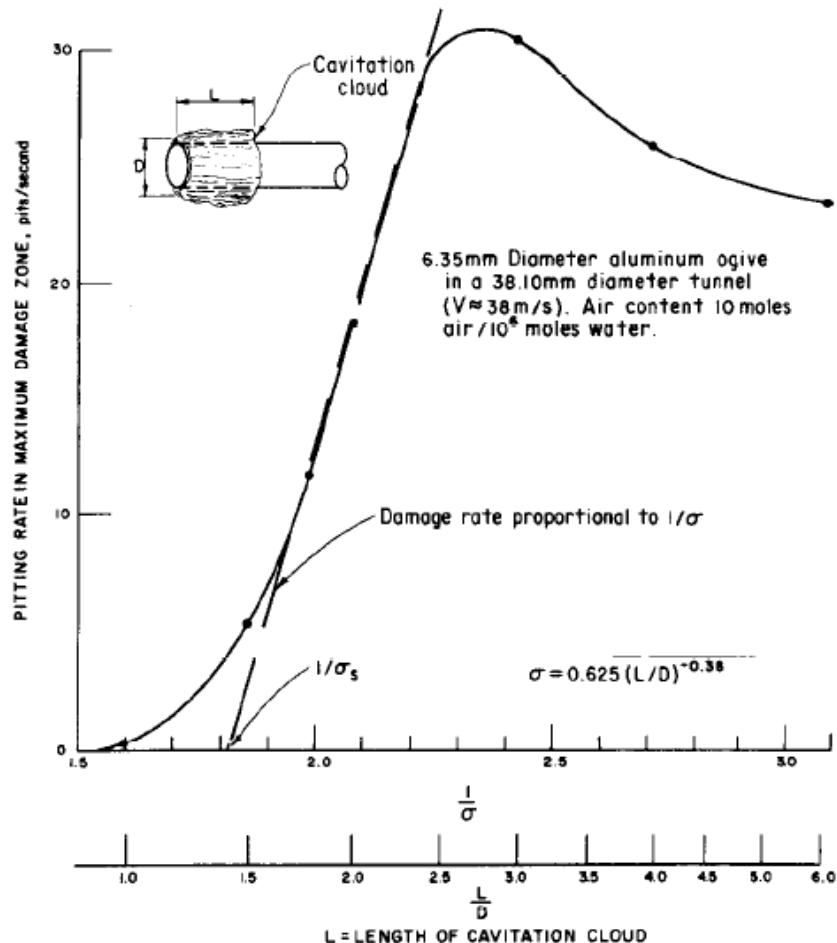
Figure 4.5: Cavitation damage rate (Stinebring, 1976).

Cavitation intensity is an extremely difficult parameter to quantify. Stinebring (1976) observed that as the cavitation index, σ , decreases relative to the incipient index, σ_i , the damage rate increases slowly as noted on Figure 4.5. If the cavitation index is decreased further, a zone is reached where the damage rate (expressed as pits per square centimeter per second) is inversely proportional to the cavitation index. Further decreasing the index will result in a point being reached where the damage rate has a maximum value. As the index is decreased even further, the damage rate decreases. From this, it appears that the cavitation intensity increases and then decreases as the cavitation index are lowered below the value of the incipient cavitation index. The noise spectrum has a similar behavior.

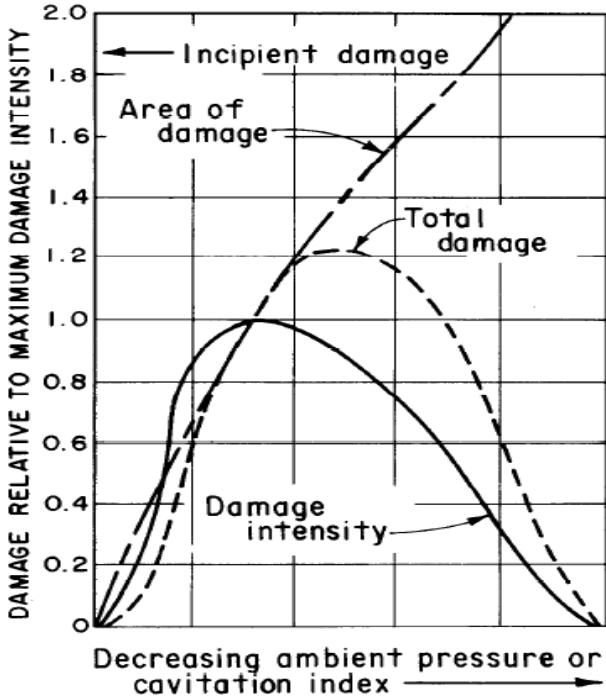
Figure 4.6: Cavitation damage with respect to cavitation index (Colgate, 1977).

Colgate (1977) proposed a similarly shaped curve for the damage intensity as the cavitation index decreases (decreasing ambient pressure). Also, he indicated the maximum of the total damage curve does not coincide with the maximum of the damage intensity curve. In addition, he showed the area of damage continues to grow larger as the cavitation index decreases as shown on Figure 4.6.

Colgate's observations can be explained by the following reasoning. As damage rate increases-for decreasing values of the cavitation index-the length of the cavitation cloud increases. However, length of the cavitation cloud is sensitive to variations in velocity. Therefore, length of the damage area tends to get larger and larger as the difference between the incipient cavitation index and the cavitation index of the flow increases. Thus, the intensity, measured in pits per square centimeter per second, may decrease while the total amount of material removed actually increases.

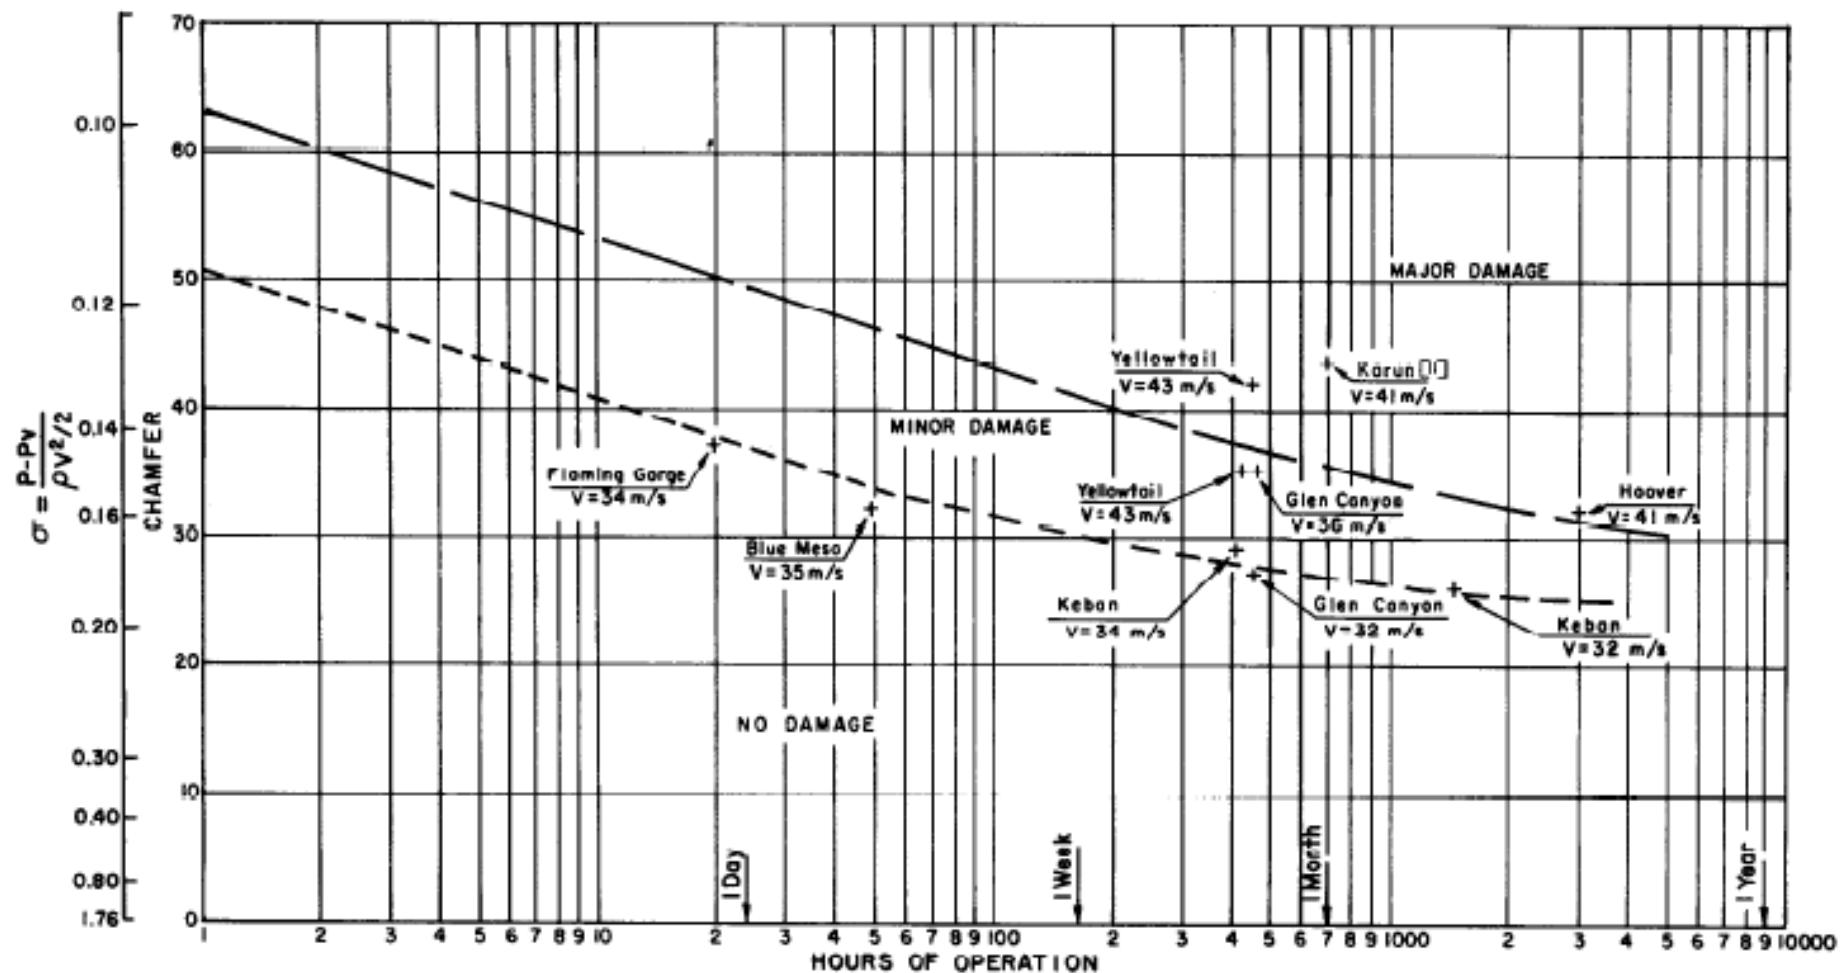
Figure 4.7: Damage experience in spillways (Falvey, 1990)

A common assumption is that a potential for damage exists when the flow velocity exceeds some critical value (Figure 4.7). Some justification exists for this assumption. For instance, a typical value of the incipient cavitation index for abrupt changes in geometry is on the order of 2.0. If this value is substituted into equation (2.4), along with the assumption that the reference pressure is equal to the barometric pressure at sea level, the resulting velocity is equal to 10m/s. Therefore, it is prudent to investigate the possibility of cavitation for velocities exceeding 10 m/s.

Damage experience, for flows in spillway tunnels and chutes, indicates that damage becomes significant when water velocities exceed 30 meters per second (Fig 4.7). This velocity corresponds to a head of about 45 meters. From cavitation damage viewpoint, this velocity or head can be considered as the borderline for high velocity or high head flows. Past practice recommended that surfaces exposed to high velocity flows be protected by strict attention to the surface tolerances. For new construction, this procedure may be acceptable. However, weathering of the concrete surface or the deposition of calcite through minute cracks in the boundary (after construction) can soon create a surface which is not within the specified or constructed tolerances. Therefore, other means of protecting the surface need to be considered.

Significant damage on spillways has been observed to occur when the cavitation index of the flow is less than 0.20 (see Fig 4.7). Minor damage can occur for indexes greater than 0.20, but the extent of the damage generally has not required repair. Therefore, from a design viewpoint, flow boundaries exposed to flows that have cavitation indexes greater than 0.20 will be essentially safe from damage. Obviously, the strength of the concrete and the surface tolerances will influence this assumption.

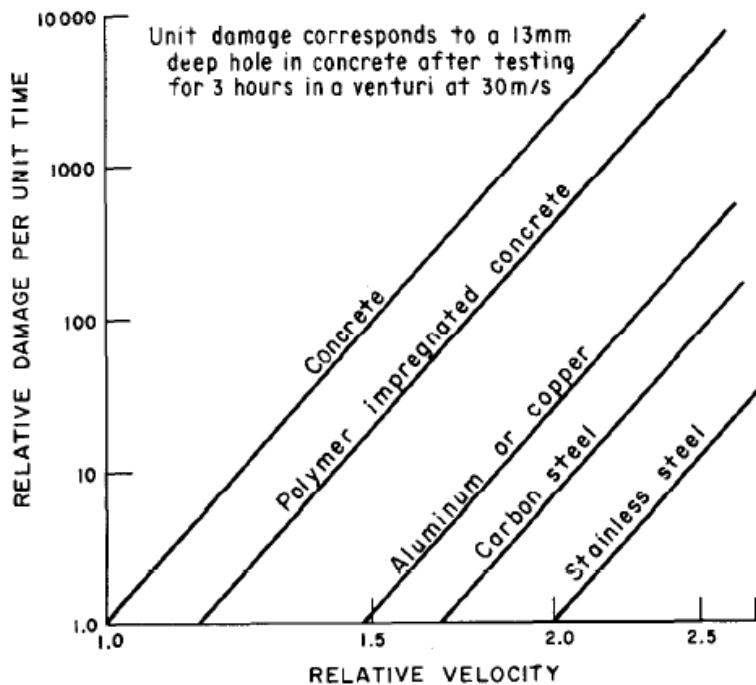
Figure 4.8: Comparative cavitation resistances of various materials (Colgate, 1977)

Presently, correlations have not been developed that quantify the amount of damage, of a given material, for a specified amount of cavitation. However, to express the resistance of a material relative to the resistance of other materials-for a given cavitation condition-is possible. For example, in a Venturi testing device, cavitation produced a hole 13 mm deep in concrete after 3 hours at a flow velocity of 30 m/s. The same size hole was produced in polymer concrete after 125 hours and in stainless steel after about 6,000 hours. Carbon steel was found to be damaged about 7 times faster than stainless steel; aluminum or copper is damaged about 25 times faster than stainless steel. Figure 4.8 shows a curve of relative damage developed for this and other data on materials conventionally used in construction of hydraulic structures. For the effect of velocity, an 11th power dependence on velocity was assumed (Colgate, 1977).

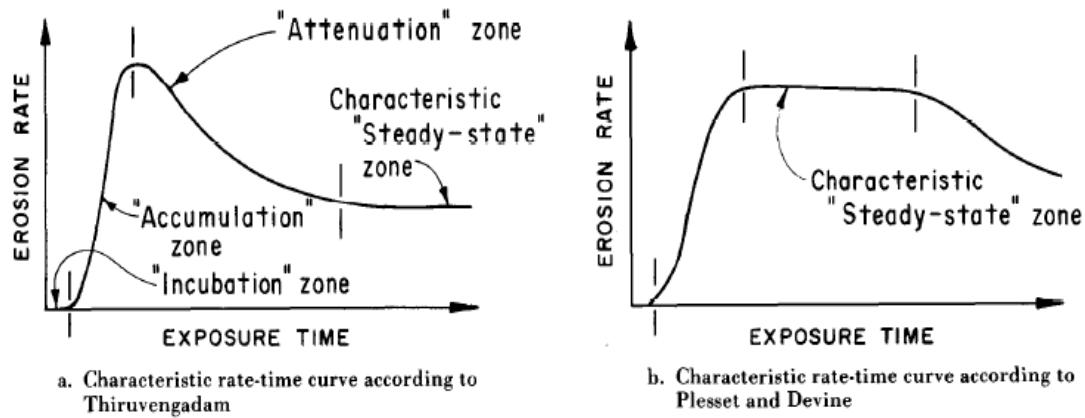
Figure 4.9: Cavitation damage rate (Heyman, 1967)

The rate of erosion-of any surface-caused by cavitation is not constant with time. Observations have shown that several different rates actually occur. Each rate has been given a specific name, (Heymann, 1967), as noted on Figure 4.9.

Following the incubation zone, the damage rate increases rapidly during a period called the “accumulation zone.” This rate reaches a peak. Depending upon the type of testing facility, the damage rate follows one of two trends. The damage rate either decreases into an “attenuation zone”- which is followed by a constant damage rate plateau called a “steady-state zone,” or the damage rate reaches a steady-state plateau-which is then followed by an attenuation zone, as shown on Figure 4.9. These damage rate characteristics have been explained using a statistical representation of the cavitation collapse mechanism (Heymann, 1967).

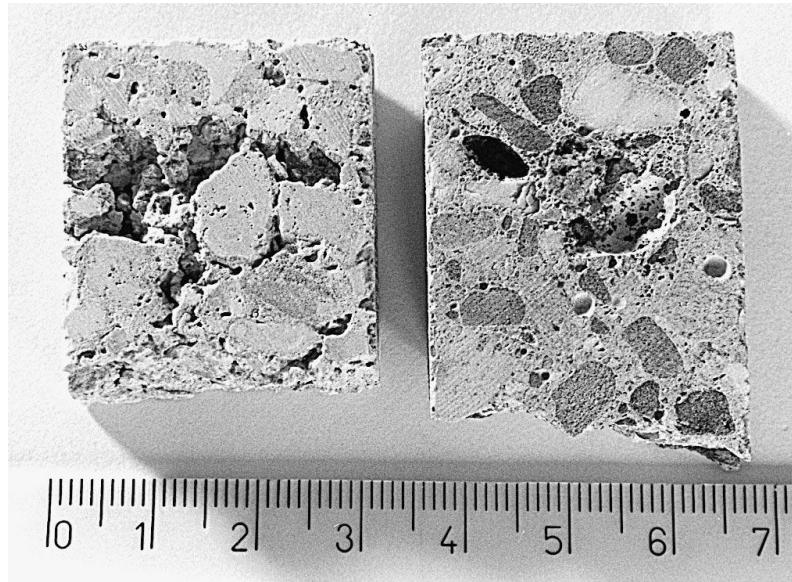
Figure 4.10: Macroscopic view on the cavitation damage for $t_c = 10s$ Left: concrete 1. Right: concrete 2.

With modeling the cavitation chamber, experiment is done and results are shown below on Fig. 4.10.

- The average mass loss after $t=10\text{s}$ was 1.1 g for concrete 1 and 0.3 g for the concrete 2. The cavitation resistance increases as the compressive strength increases. This is in agreement with experience from long-time cavitation experiments on concrete.
- Short-time cavitation erosion may be a considerable erosion phenomenon that directly contributes to the material removal in concrete hydro demolition processes.
- Even a very short exposure time $t=2\text{s}$ is sufficient to modify the surface topography of the investigated specimens.
- The material's behavior during cavitation erosion significantly depends on its capability to transfer local stresses and to locally deform. High stiffness and brittleness promote Trans granular fracture.

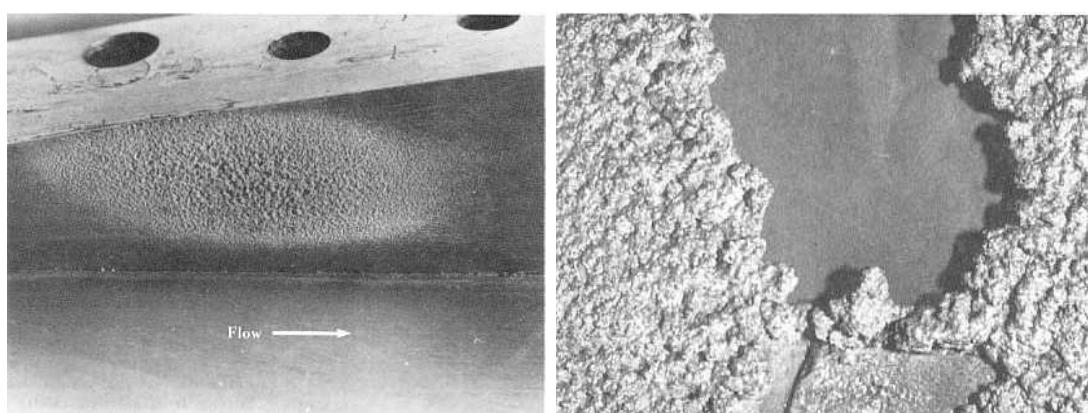
a. Venturi throat of cavitation test facility **b.** Ross Dam (Seattle, Washington) outlet works conduit

Figure 4.11: Texture of cavitation damage in steel (Falvey, 1990)

In steel, the effect of the collapse of the many minute cavitation bubbles perpendicular to the surface is to produce a grainy texture. The scale, of surface texture, depends upon the size of the cavitation bubbles which are produced. In a laboratory facility, the structure of the damage is fine grained as shown on Figure 4.11a because the bubbles are small. Whereas, in the liner of an outlet conduit the surface texture is much coarser grained because the cavitation bubbles are larger as shown on Figure 4.11b.

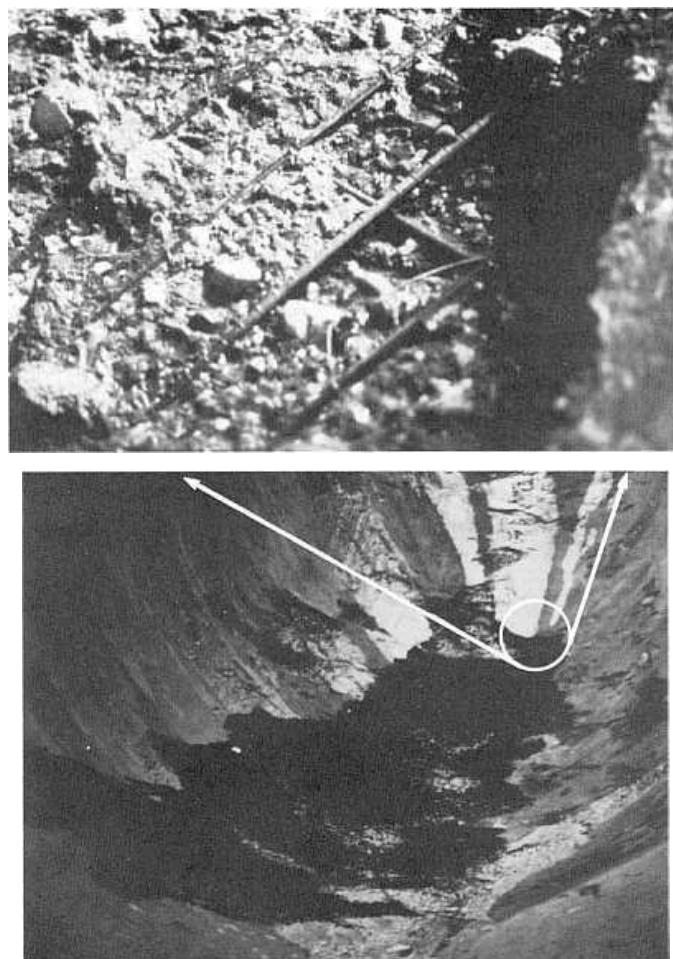
Figure 4.12: Kortes Dam, Wyoming, freeze-thaw damage.

Whereas, in the freeze-thaw zone, individual pieces of aggregate are broken and the profile through the damaged area is relatively flat as shown on Figure 4.12.

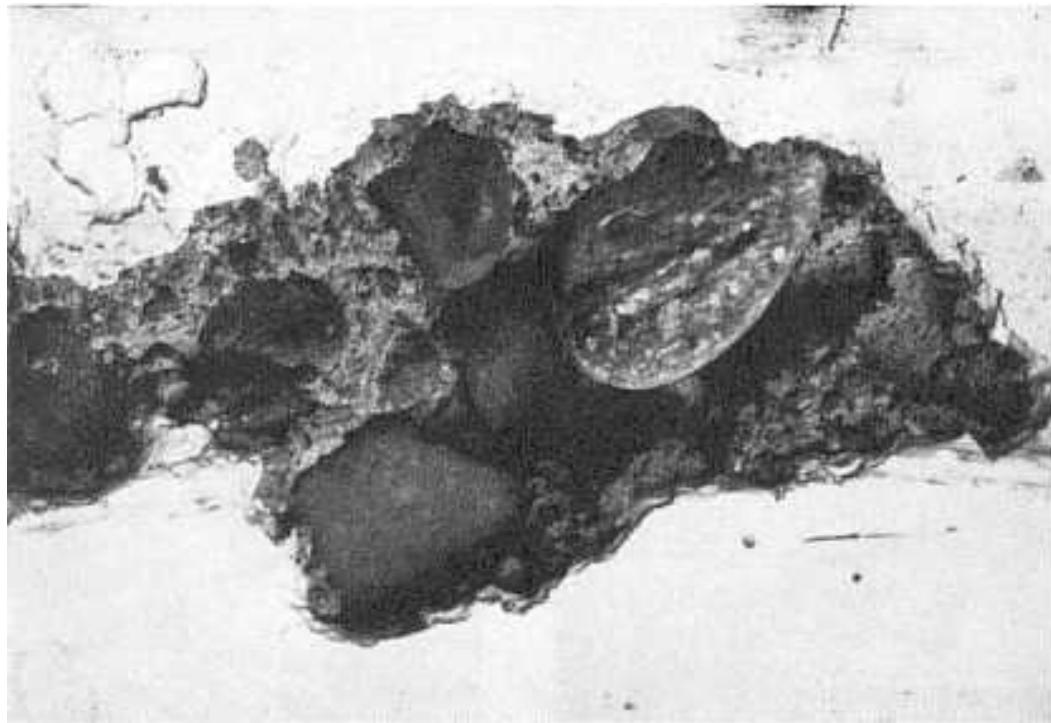
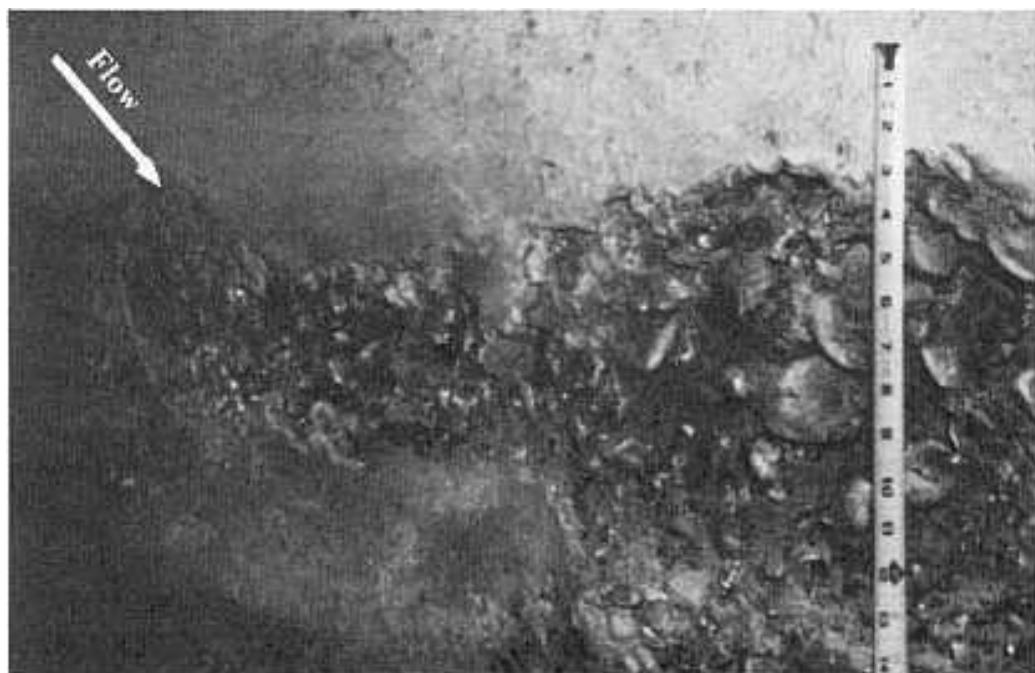
Figure 4.13: Cavitation damage in concrete (Falvey, 1990)

a. Cavitation damage produced in a Venturi cavitation test facility

b. Hoover Dam, Nevada spillway tunnel - initiation of damage

concrete. Deep crevices and holes can be found in the matrix. It almost appears as though worms bored into the concrete. The difference in appearance of laboratory and field produced damage is not significant as shown on Figure 4.13. None of the aggregate is broken.

Similarly, the difference between cavitation, freeze-thaw damage, and erosion by sand-laden water is apparent in concrete. With cavitation, individual, polished pieces of aggregate are exposed in the damaged zone as shown on Figure 4.13a.

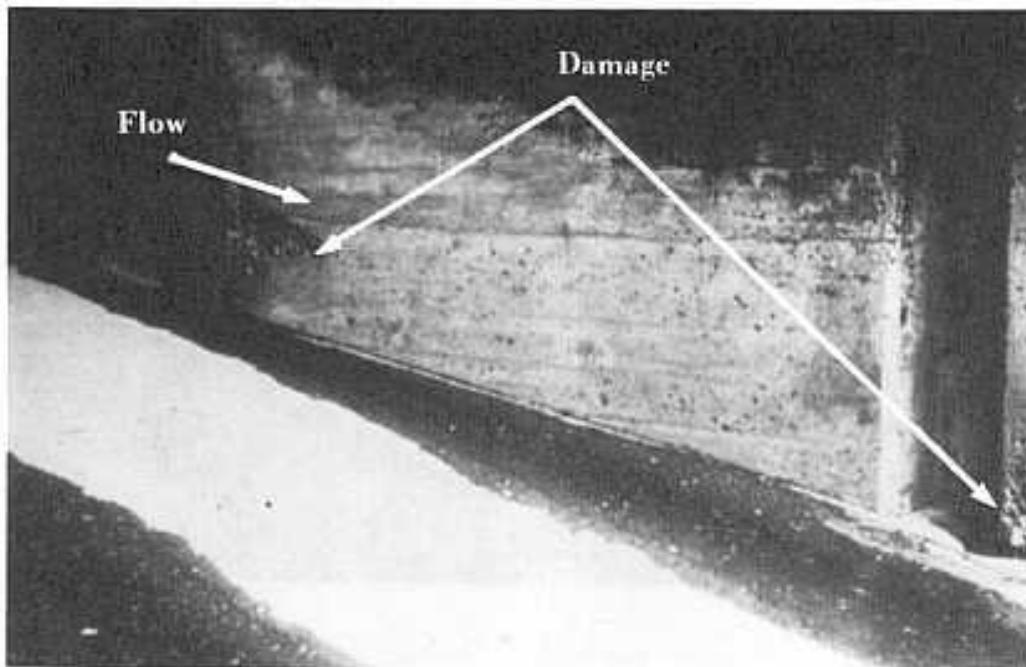
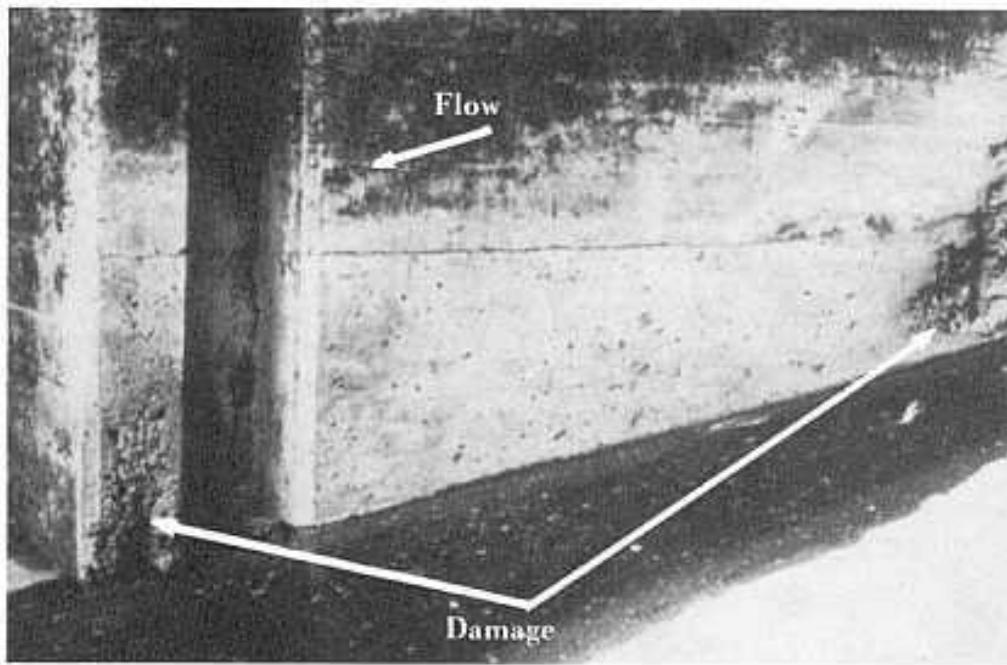
Figure 4.14: Palisades Dam, symmetrical damage in outlet structure.

a. Left side of outlet

b. Right side outlet

If cavitation damage occurs on a structure, it will occur in similar locations elsewhere on the structure. For instance, if cavitation damage is observed on the conduit wall downstream of a gate slot, it will occur downstream of the opposite gate slot as shown on Figure 4.14.

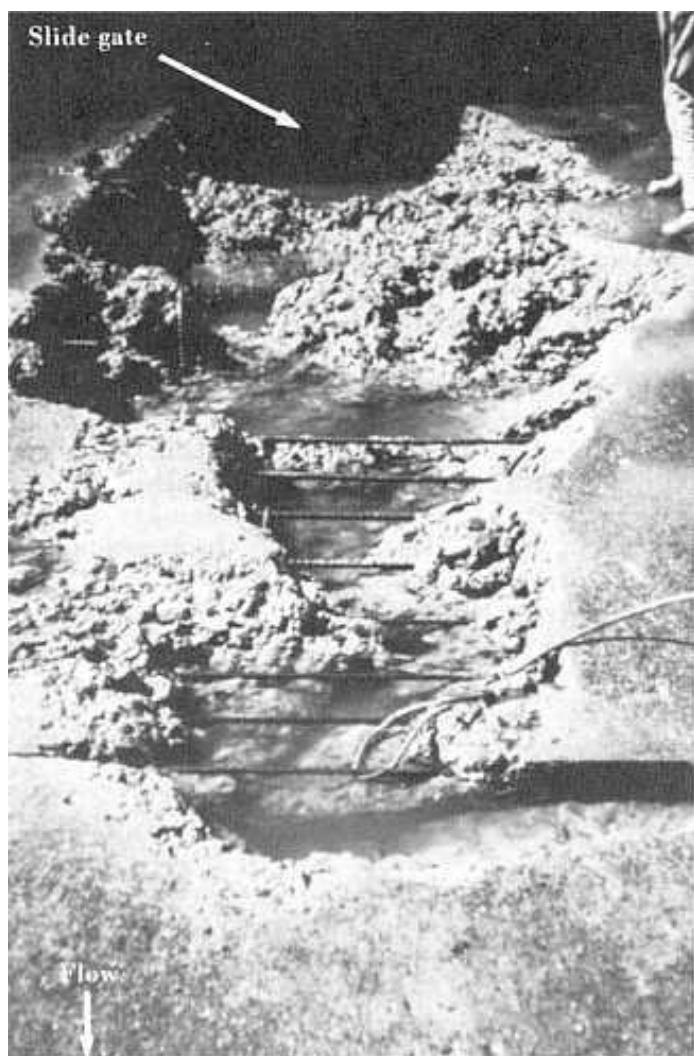
Figure 4.15: Palisades Dam, outlet works vortex caused damage downstream of slide gate (Falvey, 1990).

Longitudinal vortices in the flow are known also to be sources of cavitation which have caused damage. Generally, the exact location of these sources cannot be accurately specified. A typical example of cavitation damage caused by longitudinal vortices in the flow through a slide gate is shown on Figure 4.15.

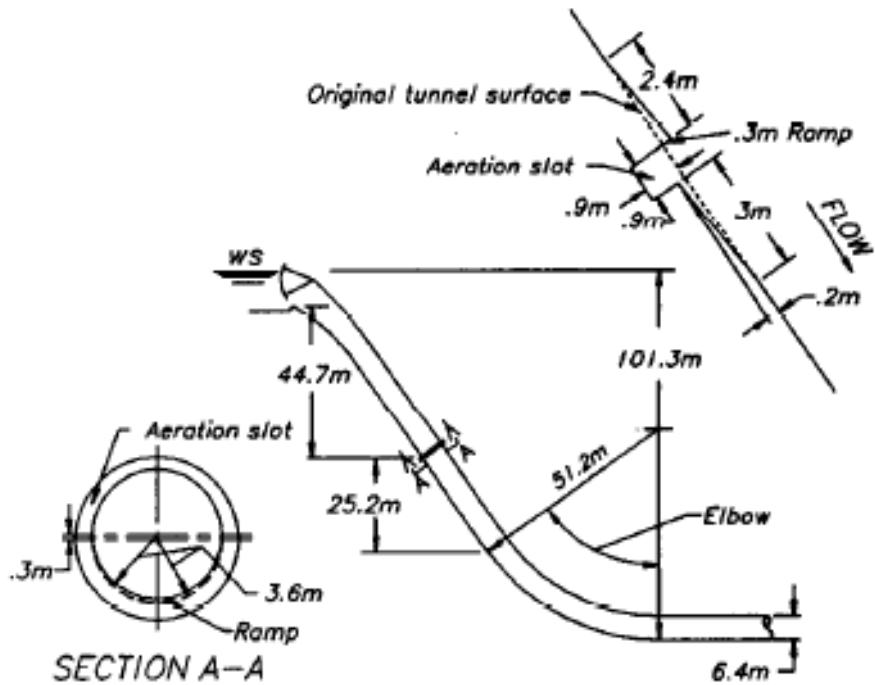
Figure 5.1: Blue Mesa Dam, tunnel spillway, aeration slot

Figure 5.1 shows the spillway on the right abutment (Beichley, 1964); its capacity is about $963 \text{ m}^3/\text{s}$ at the maximum reservoir water surface elevation of 2292m. Water discharges through: a gate section a tunnel transition section, a tapering inclined tunnel, a vertical bend, a nearly horizontal tunnel, and a flip bucket. The flip bucket directs flow into the river channel about 150 m downstream of the power plant.

The aerator consisted of a ramp, a downstream aeration groove, and a concentric conical offset located downstream of the aeration groove as noted on Figure 5.1.

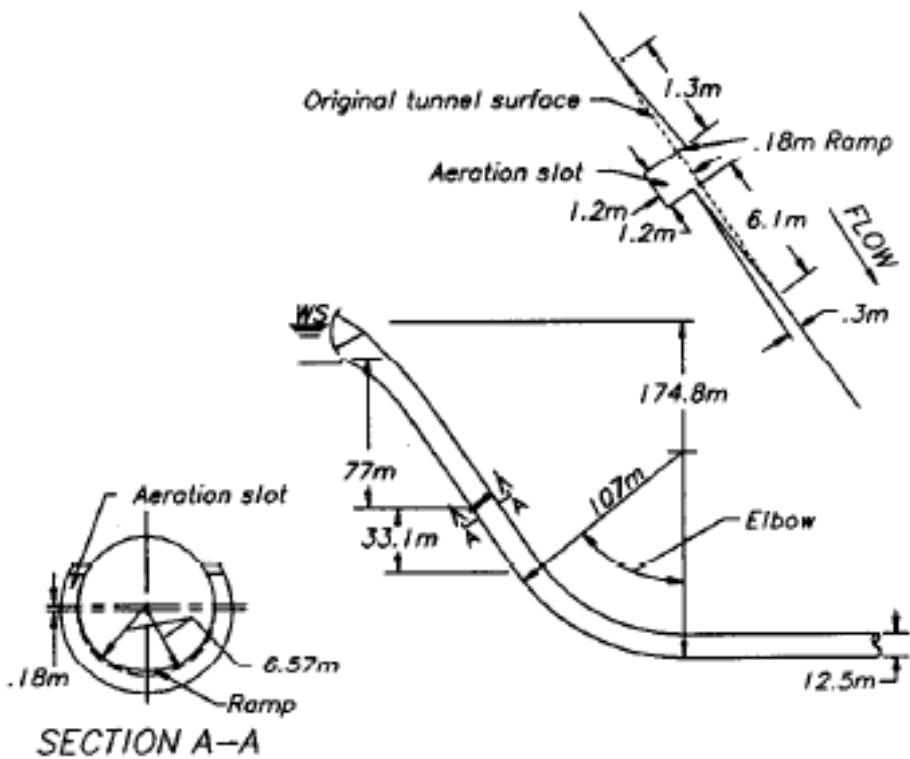
Figure 5.2: Glen Canyon Dam, tunnel spillways - aeration slots

The dam has an open-channel flow tunnel spillway on each abutment as shown on Figure 5.2. Each spillway is 12 500 mm in diameter and has a maximum capacity of $2900 \text{ m}^3/\text{s}$. Flow to each spillway passes radial gates, a 55° inclined tunnel, a vertical bend (elbow), and 305 m of horizontal tunnel to a flip bucket.

(Pugh, 1984). These aerators consisted of: a ramp, a groove or slot, a downstream offset, and a transition back to the original tunnel diameter as shown on Figure 5.2. The ramp is 1295 mm long and 180 mm high at the centerline of the invert. The groove is 1200 by 1200 mm. The downstream edge of the slot is offset 305 mm from the original tunnel diameter. The length of the transition to the original tunnel diameter is 6096 mm. The end of the ramp is at station 6+85.80 which is 96.2 m below the maximum reservoir elevation.

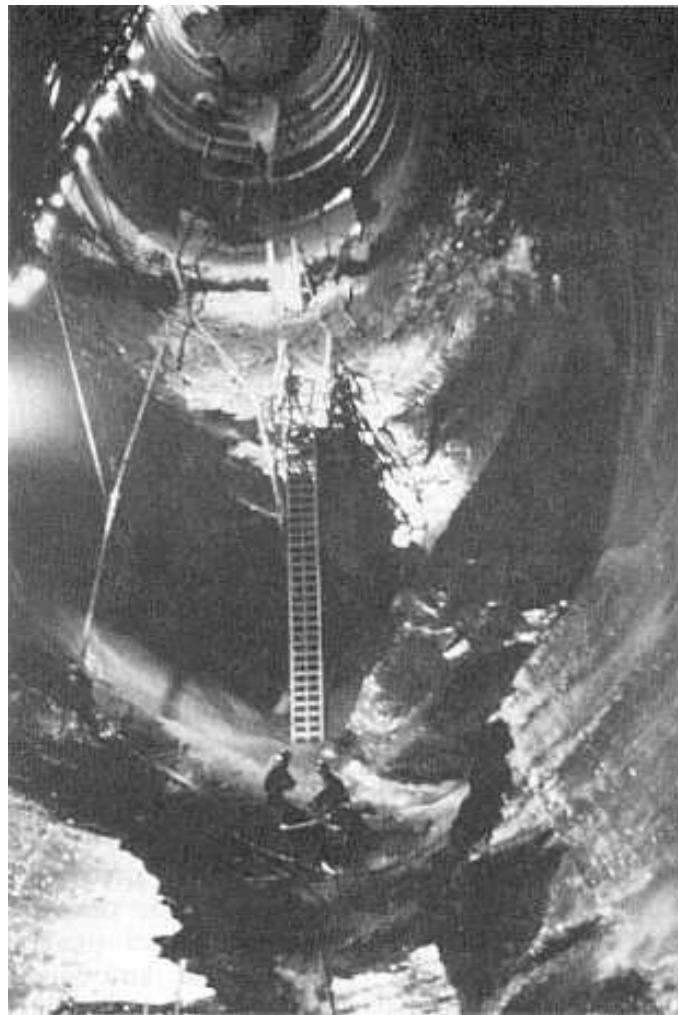
a. Left tunnel

In August 1984, the left tunnel was tested to verify the operation of the aerator. Pressure measurements were taken in the invert to compare with model studies and air velocities were measured in the air groove to estimate the airflow quantities (Frizell, 1985). Flow rates up to $1416 \text{ m}^3/\text{s}$ were passed through the spillway. This discharge was 40 percent greater than had previously passed through the spillways. In addition, a discharge of $566 \text{ m}^3/\text{s}$ was maintained for 48 hours. This flow rate and duration had caused damage to the spillway during the 1980-81 flows.

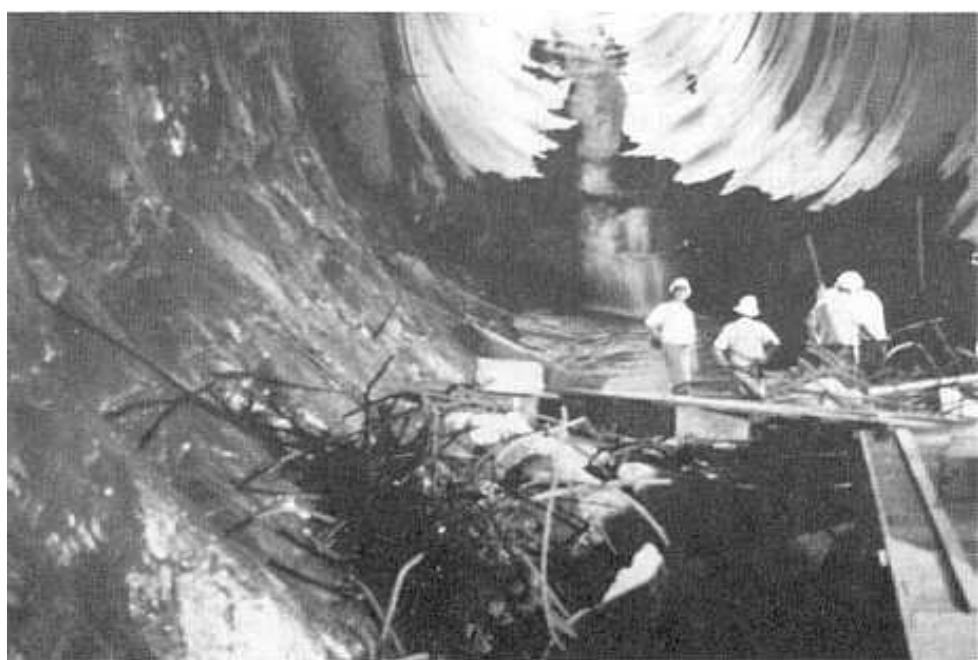
b. Right tunnel

Figure 5.3: Glen Canyon Dam, tunnel spillways major damage (Falvey, 1990).

The first indication that damage was occurring to the left tunnel spillway (during the 1983 flood) came on June 6, when loud rumblings were heard from the tunnel (Burgi et al, 1984). Several large holes were found in the invert during an inspection in the afternoon of June 6. Flows were resumed through both tunnels. At the end of the flood, extensive damage had taken place in both tunnels as shown on Figure 5.3. Even though damage was extensive, it only excavated a hole whose depth was about equal to the spillway diameter. At this point, the eroded cavity was evidently large enough to dissipate the energy of the high velocity water. In the elbow portion of the tunnels, the depth of the damage as noted on Figure 5.4 was on the same order as the depth of the flow.

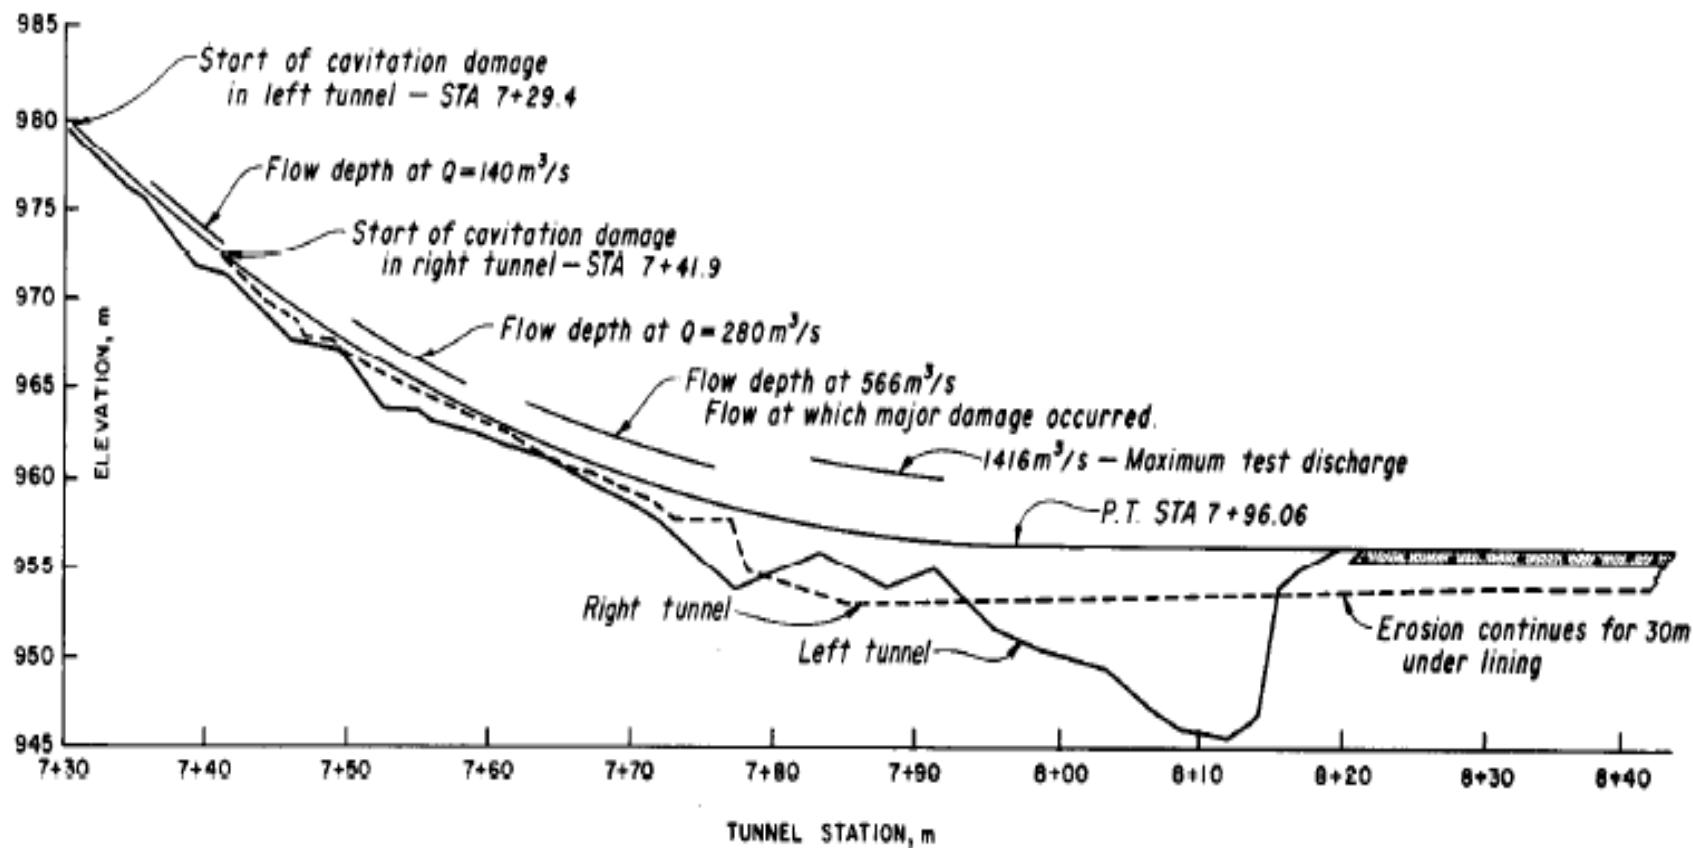
Figure 5.4: Glen Canyon Dam, tunnel spillways - damage profiles (Falvey, 1990).

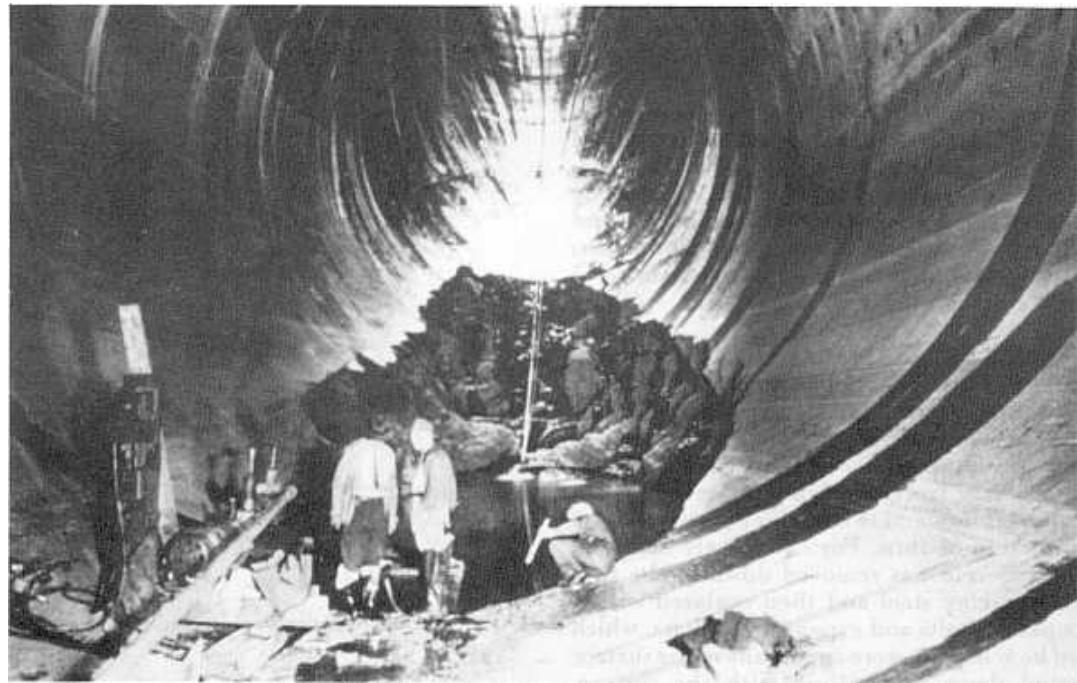
Figure 5.5: Hoover Dam, Arizona tunnel spillway-major damage (1942).

The spillway tunnels operated for the first time in the winter of 1941. The Arizona spillway operated for 116.5 days at an average flow of $366 \text{ m}^3/\text{s}$ with a maximum flow of $1076 \text{ m}^3/\text{s}$. The Nevada spillway operated for only 19.5 hours at an average flow of $227 \text{ m}^3/\text{s}$ and a maximum flow of $407 \text{ m}^3/\text{s}$ (Keener, 1943). At the conclusion of the spill, the Arizona spillway had suffered severe damage, but the Nevada spillway was essentially undamaged. Figure 5.5 shows the damage to the Arizona spillway consisting of a hole 35 m long, 9 m wide and 13.7 m deep. Evidently, the damage was caused by a misalignment in the tunnel invert (Warnock, 1945). The misalignment is shown on Figure 5.6.

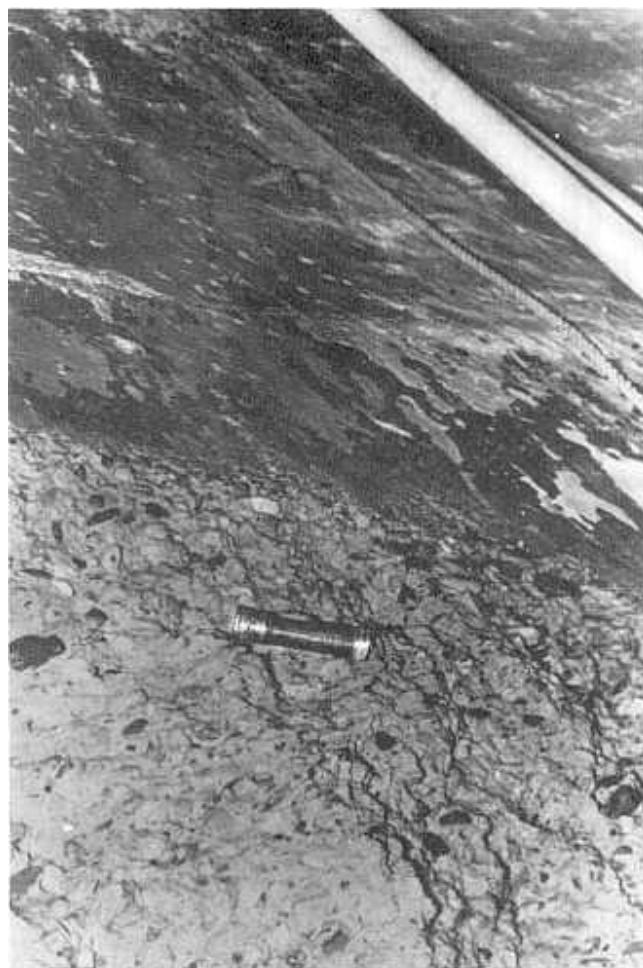
Figure 5.6: Hoover Dam, Arizona tunnel spillway-misalignment that caused major damage (Falvey, 1990).

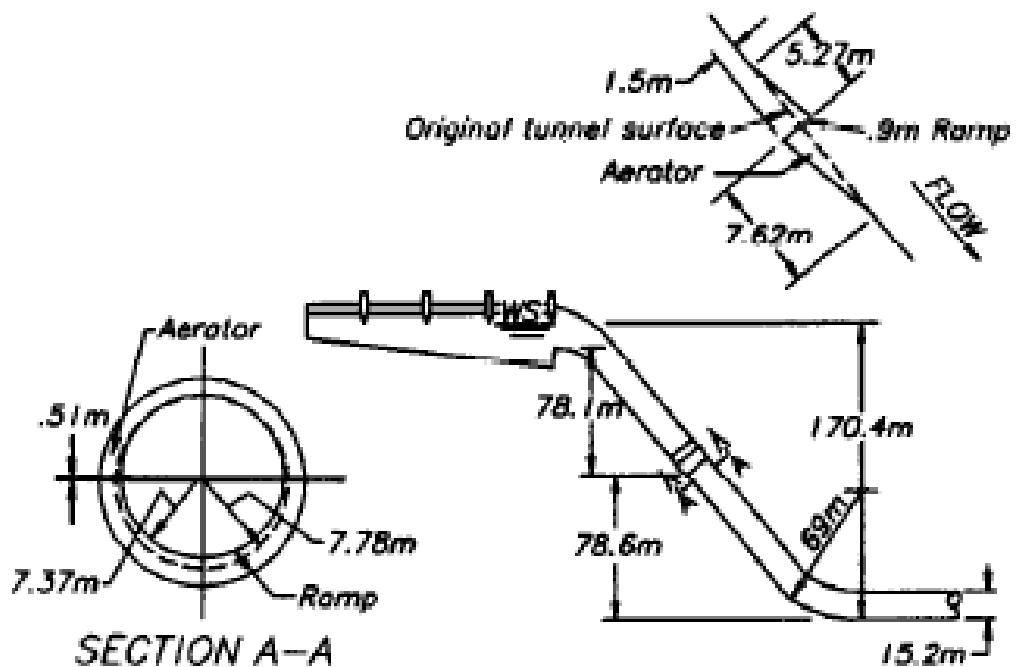
Since damage occurred in both tunnels—even with exceptionally smooth surfaces—aeration devices were designed for each spillway (Houston et al, 1985) as shown on Figure 5.7. Each aerator consisted of a ramp and a downstream offset. The ramp is 900 mm high on the invert and feathers to zero height at 35° on each side of the tunnel crown. The offset is concentric with the original tunnel diameter. The 1500-mm offset transitions back to the original diameter in 7620 mm. Each aerator is located about 78 m below the inlet to the tunnel. The installation of both aerators was completed in June 1987.

Figure 5.7: Hoover Dam, tunnel spillways-aeration slots (Falvey, 1990)

The dam has an open-channel type tunnel spillway on each abutment of the dam as shown on Figure 5.7. Water enters each spillway by first passing through a gated, side-channel overflow weir. Then it flows over an ogee crest into an inclined tunnel.

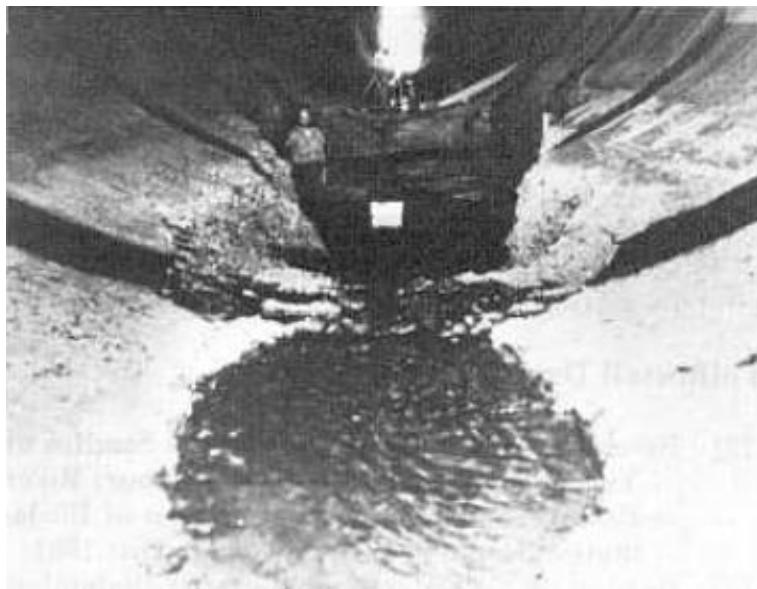
Figure 5.8: Yellowtail Dam, tunnel spillway-major damage downstream of elbow (Falvey, 1990)

Because of high inflows to the reservoir, the spillway began discharging for the first time on June 26, 1967 (Borden et al, 1971). On July 4, the flows were high enough to flip the water out of the bucket at the end of the spillway. The flows continued at a discharge of about $425 \text{ m}^3/\text{s}$ until July 14 when the flip suddenly stopped. The cessation of the flip indicated that energy dissipation was occurring within the spillway tunnel. The cause of the energy dissipation was discovered to be a large cavitation caused hole 2.1 m deep, 14.0 m long, and 5.9 m wide as shown on Figure 5.8. Downstream of this large hole, several smaller holes had developed. The large patch 6 mm deep, 152 mm wide, and 254 mm long at station 3+ 16. The damage index for this hole is 9600. The minimum cavitation index at station 3+16 is 0.15.

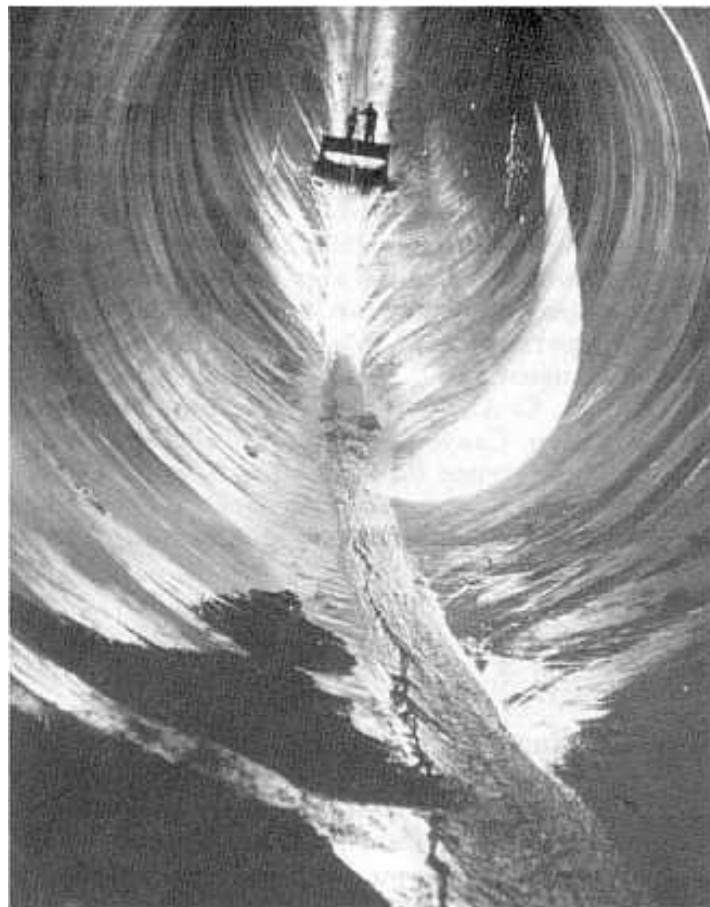
Figure 5.9: Yellowtail Dam, tunnel spillway - damage in elbow (Falvey, 1990)

Higher up in the elbow of the tunnel, another damaged area was found at station 2+88 which was 9 m long and centered about 1 m to the right of the tunnel center line as shown on Figure 5.9. This damage was initiated by the failure of an epoxy mortar patch located within a 457-mm square dry patch. This damage formed five distinct teardrop shaped holes. The most upstream hole was 305 mm wide and 152 mm deep. The next downstream hole was 610 mm wide, followed by a hole 910 mm wide. The fourth hole was 1829 mm wide and the last about 1520 mm wide. The damage index for this damaged area is 3520. The minimum cavitation index at station 2+88 is 0.15.
