**CAVITATION EFFECTS ON STABILITY, ECONOMIC LIFE AND
PERFORMANCE OF HYDRAULIC STRUCTURES**

**M.Sc. Thesis by
Mehdi JAHANI**

Department : Civil Engineering

Program : Hydraulic and Water Resources Engineering

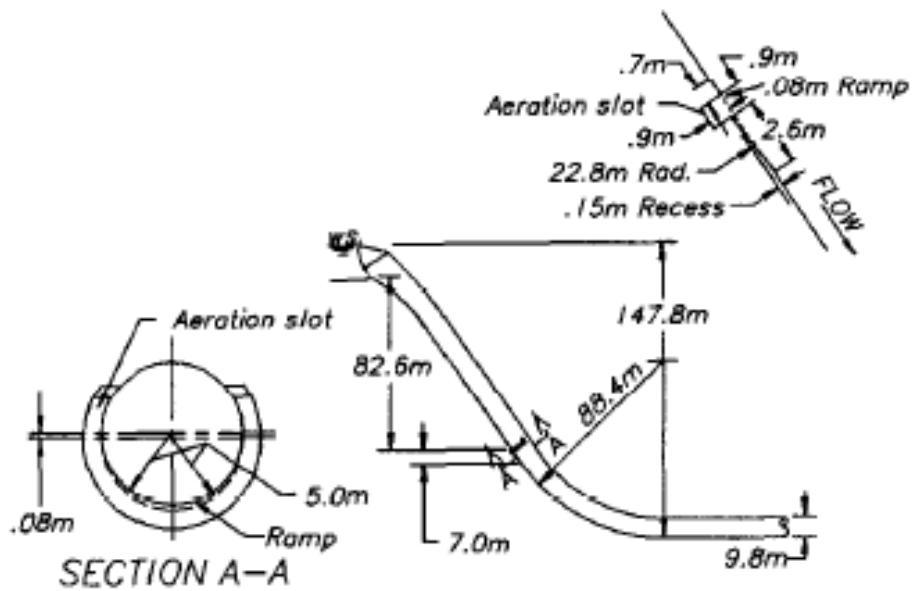
The downstream edge of the groove was connected to a 152-mm offset which transitioned back to the original diameter of the tunnel in 2635 mm. The transition had a 22.86-m radius of curvature in the flow direction.

Figure 5.10: Yellowtail Dam, tunnel spillway - aeration slot (Falvey, 1990)

Following this damage, one of the most ambitious repair procedures ever undertaken by the Bureau was begun. Borden et al. (1971) an aerator was designed for the tunnel, which was located 103 m below the maximum reservoir elevation (Colgate, 1971), as shown on Figure 5.10. The aerator consisted of a ramp 685.8 mm long and

76.2 mm high at the invert. Immediately downstream of the ramp, a 914-mm square aeration groove was located.

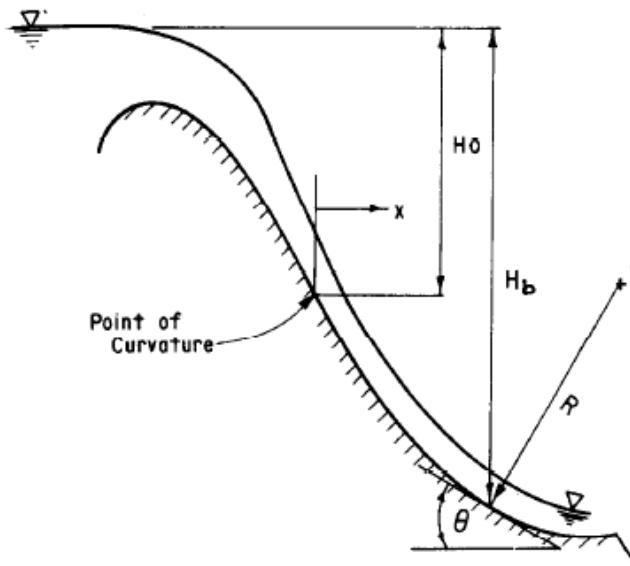
Figure 6.1: Definition sketch for geometry

The resulting profile produces a gradually increasing pressure distribution through the vertical curve. If the vertical curve terminates at a chute or in a tunnel, a large pressure gradient is produced at the point of tangency. The large gradient may have an adverse effect on the flow conditions at this point. However, if the vertical curve terminates in a flip bucket, the method produces an excellent spillway profile that has the minimum potential for cavitation damage. The invert profile produced by this method is known as a constant cavitation number profile, Fig 6.1.

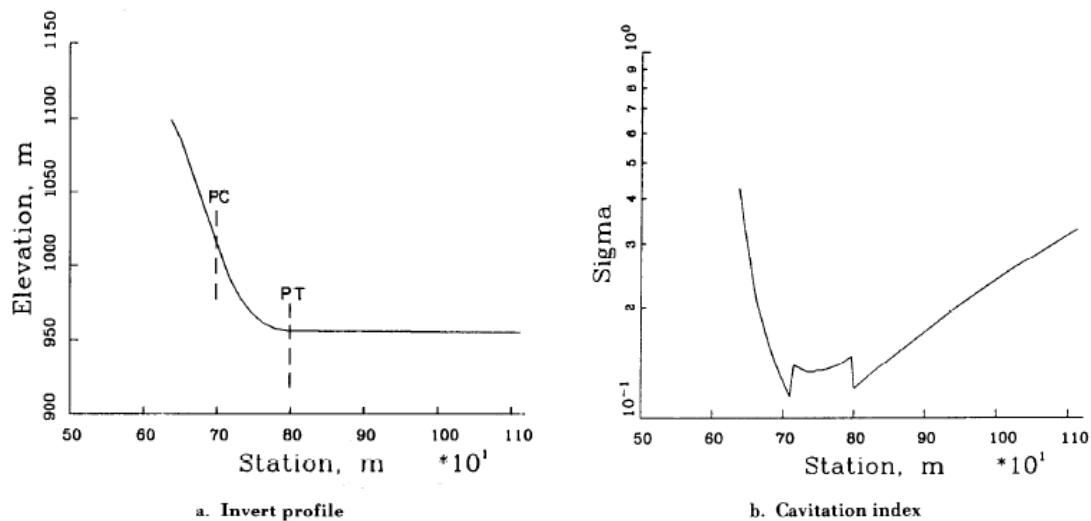
Figure 6.2: Glen Canyon Dam, left spillway tunnel-cavitation index for flow of $Q = 475\text{m}^3/\text{s}$ (Falvey, 1990).

An analysis of the cavitation potential, of Glen Canyon Dam tunnel spillway, using the program HFWS (A program which is developed to calculate the hydraulic and cavitation properties of free water surface flow), showed the lowest values of the cavitation index occurred upstream of the point of curvature and downstream of the point of tangency of the vertical bend (see Fig. 6.2). The lowest values of the cavitation index for flow through the elbow occurred for a discharge of about $475\text{m}^3/\text{s}$ (Falvey, 1990).

The results of the analysis show that the cavitation index could have been increased from a minimum value of $\sigma = 0.104$ (shown on Fig. 6.2) to a minimum value of $\sigma = 0.115$ (shown on Fig. 6.3) for the portion of the tunnel between the spillway crest and the point of tangency at the end of the vertical curve.

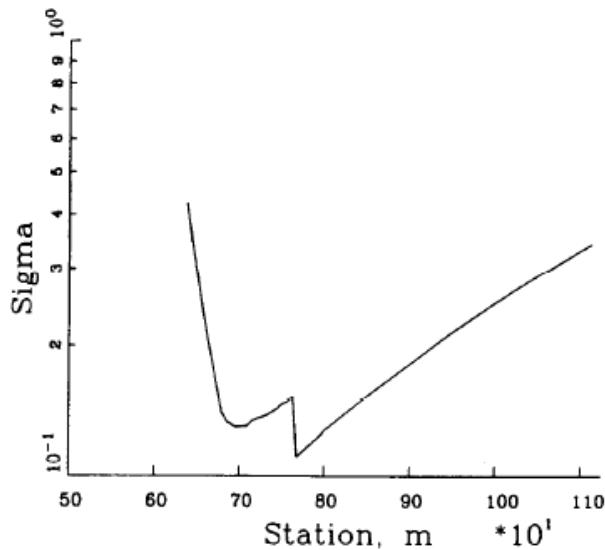
Figure 6.3: Glen Canyon Dam, equal cavitation number spillway profile – cavitation index for flow of $Q = 475\text{m}^3/\text{s}$ (Falvey, 1990).

The cavitation index of Figure 6.3 is not constant because the equal cavitation number profile was developed using rectangular sections. The conversion of the cavitation index from the rectangular to the circular section can be calculated by

The gradient will not induce cavitation, but it may cause rapid variations in the water level depth. The second problem is the most severe. Because the curve is too short, the cavitation index at the end of the curve is still very low-being about equal to 0.101.

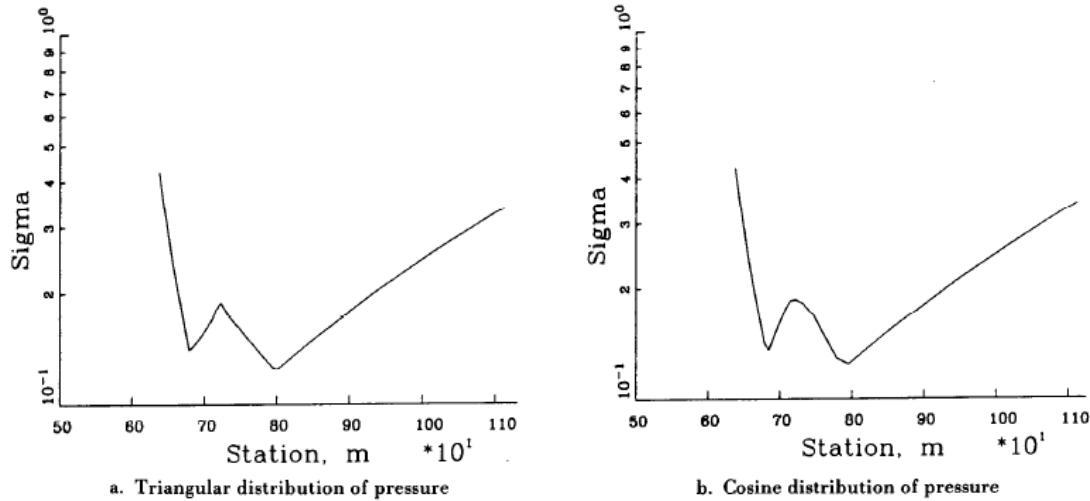
Figure 6.4: Glen Canyon Dam, controlled pressure spillway profiles - cavitation index for flow of $Q = 475\text{m}^3/\text{s}$ (Falvey, 1990).

A great difference between the cavitation indexes, with either the linear or the sinusoidal variation in pressure along the vertical curve, is not evident as noted on Figure 6.4. Because both curves are longer than the equal cavitation number profile, improvements in the cavitation index have been made at the point of tangency.

For Glen Canyon Dam, the controlled pressure profile resulted in the most favorable cavitation characteristics in the vertical bend. At station 720 the cavitation index reached a value of 0.20 as compared to a value of 0.14 in the existing design.

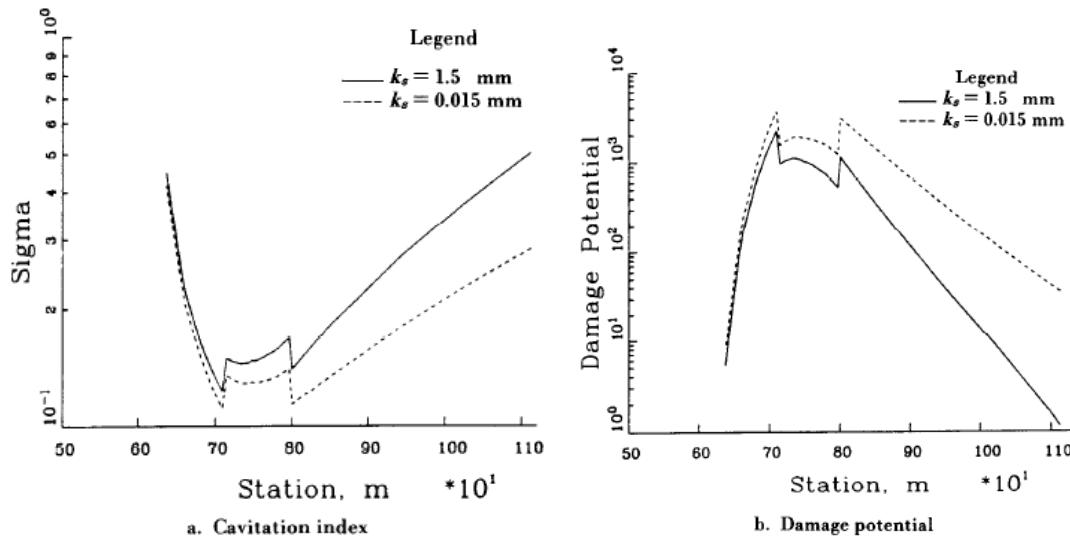
Figure 6.5: Effect of rugosity on cavitation characteristics (Falvey, 1990).

As shown on Figure 6.5, increasing the rugosity results in an increase in the cavitation index from 0.091 to 0.118 at station 800 the site of the most severe damage during the 1983 spill. The damage potential also experienced significant decreases. For the larger rugosity value, the damage potential was 3.2 times smaller than for the smaller rugosity as shown on Figure 6.5.

These examples show that, on Glen Canyon Dam tunnel spillways, the effect of increasing the surface roughness is greater than the effect of changing the invert curvature.

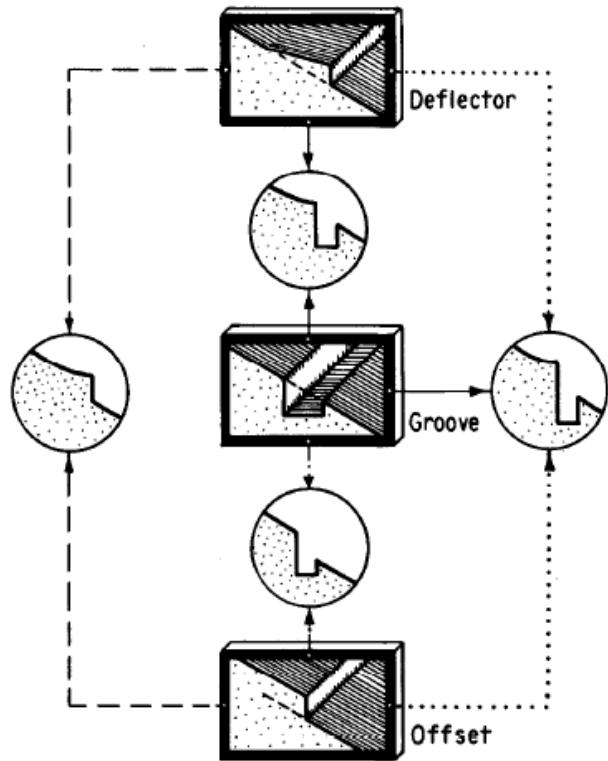
Figure 6.6: Types of aerators.

The principal types of aerators shown on Figure 6.6 consist of deflectors, grooves, offsets, and combinations of these, (Vischer et al, 1982). The purpose of the deflector is to lift the flow from the boundary so that air can be entrained underneath the flow surface. In this manner, air enters the flow without using mechanical methods like air pumps-which require energy. Aeration grooves, slots, or air ducts are used to distribute air across the entire width of the aerator. Finally, an offset is used on flat slopes to prevent the aerator from being submerged by a portion of the flow from the jet as it strikes the downstream boundary.

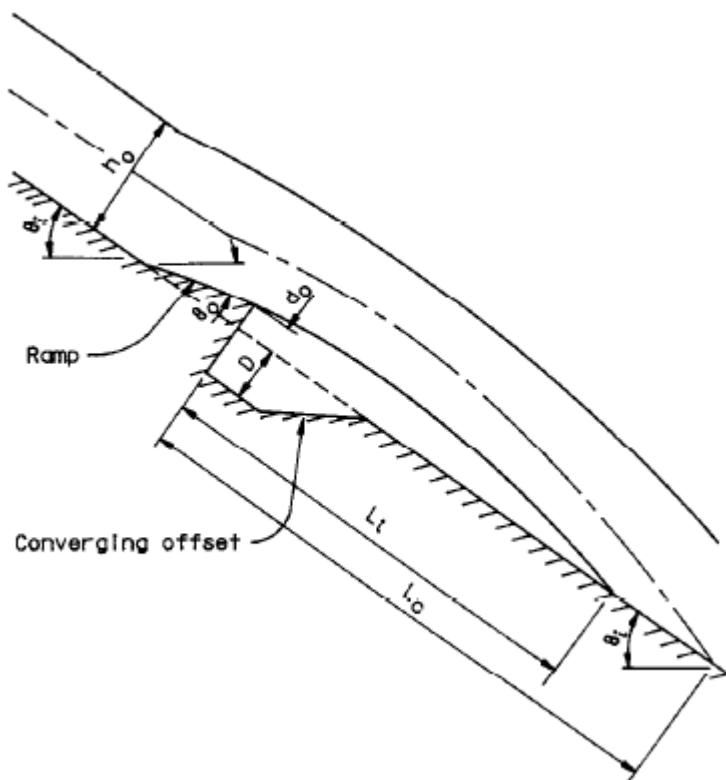
Figure 6.7: Length of jet trajectory.

Several methods are available to determine the jet trajectory. Wei and DeFazio used a finite element method to solve the Laplace equation for flow over the ramp. This method produces excellent results for both ramps and free over falls. In addition to solving for the jet trajectory, the pressure distribution around the ramp is determined. Knowledge of the pressure distribution is valuable for design of chute training walls in the vicinity of the ramp.

Through the proper choice of ramp angle and height, it is possible to cause the trajectory to impact the downstream chute at any desired location.

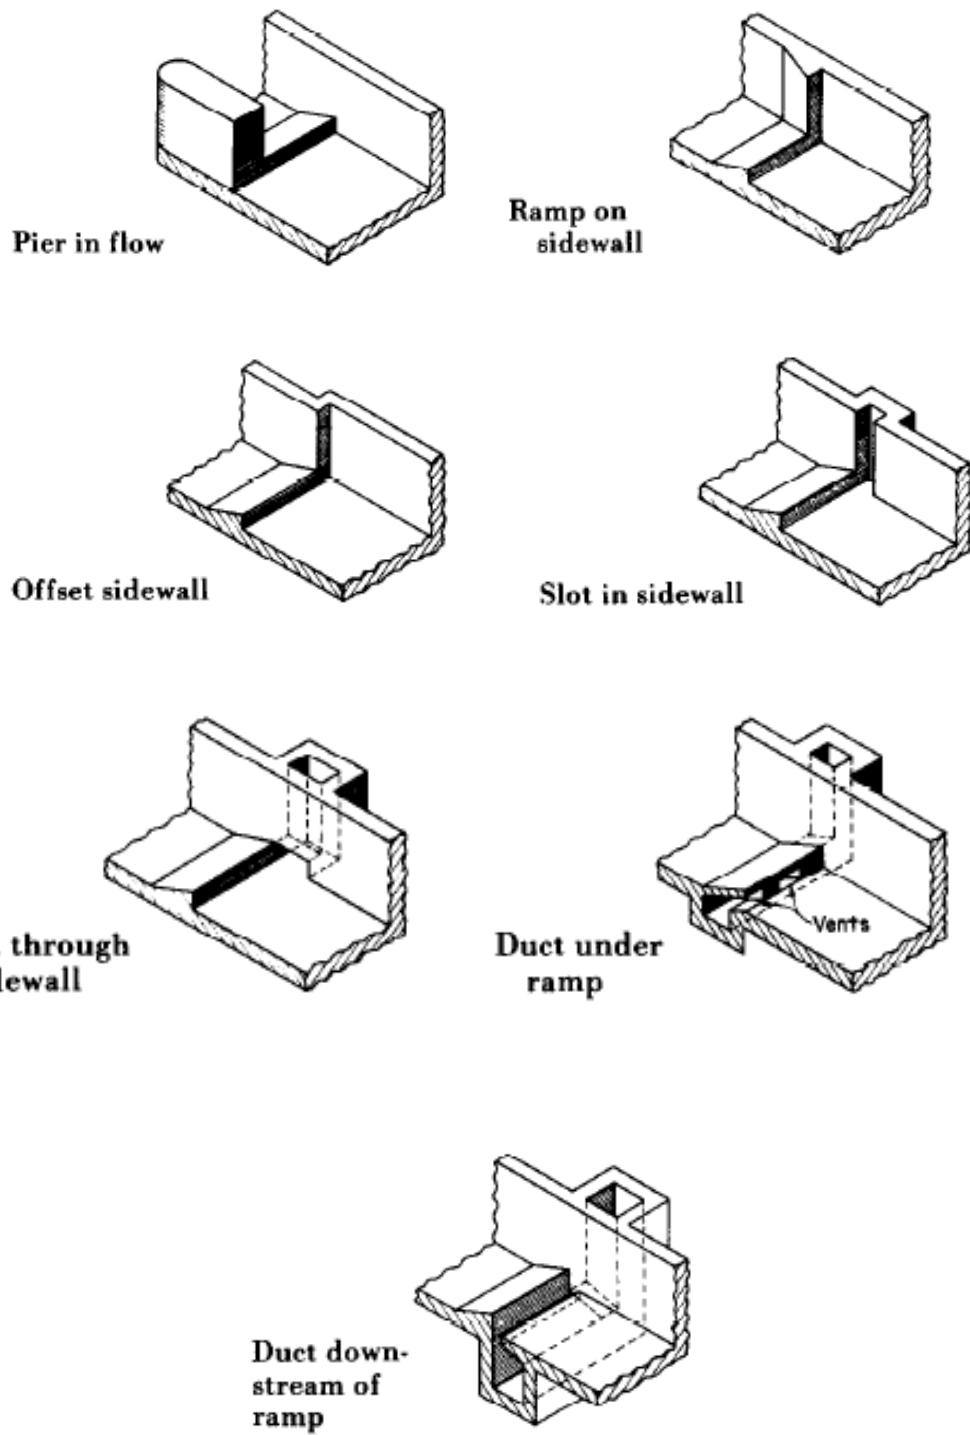
Figure 6.8: Air supply to aerator

Several methods have been devised to vent air from the atmosphere to the underside of the nappe as shown on Figure 6.8. These include the following:

Ducts through the sidewall are used on wide chutes when the required slot size or sidewall offsets are excessive. A duct is a closed conduit which may have a rectangular or circular cross section. In areas where freezing is a problem, ducts are routed through an embankment. This prevents the formation of ice plugs in the duct during times when water may be standing in the chute area (Fig. 6.8 Duct through sidewalls).

A duct, under the ramp, is used on wide chutes or in installations where a hydraulic jump may cover the ramp. In both cases, the system of ducts and vents ensures adequate aeration of the jet under nappe (Fig. 6.8 Dust under the ramp).

A duct-downstream of the ramp or offset-is used when the ramp height is too small to allow adequate venting. This scheme also simplifies construction. However, a drain for the duct must be provided to keep the duct free of water. Leakage and extremely low flow would tend to fill the duct on flat chutes if drainage is not provided. When operating the chute or spillway, air will enter the aerator not only through the duct but also through the drainage gallery (Fig.6.8 Duct downstream of ramp or offset).

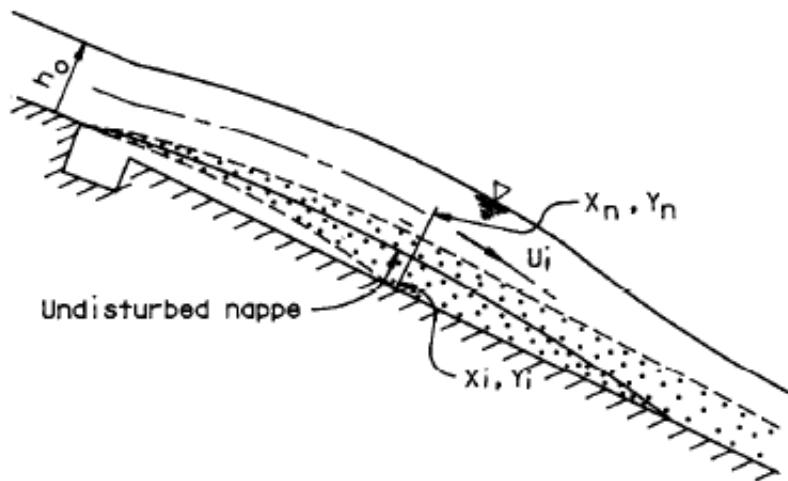
Figure 6.9: Air entrainment under nappe.

In some cases, an air duct design having a direct connection to the atmosphere is not feasible. This is true especially with tunnel spillways and control gates located in outlet-works tunnels. For these structure types, ventilation is supplied to the duct above the flowing water. If space above the free water surface is too small, pressures under the nappe may begin to fluctuate. Criteria for the air space above the flowing water have not been established, Fig 6.9

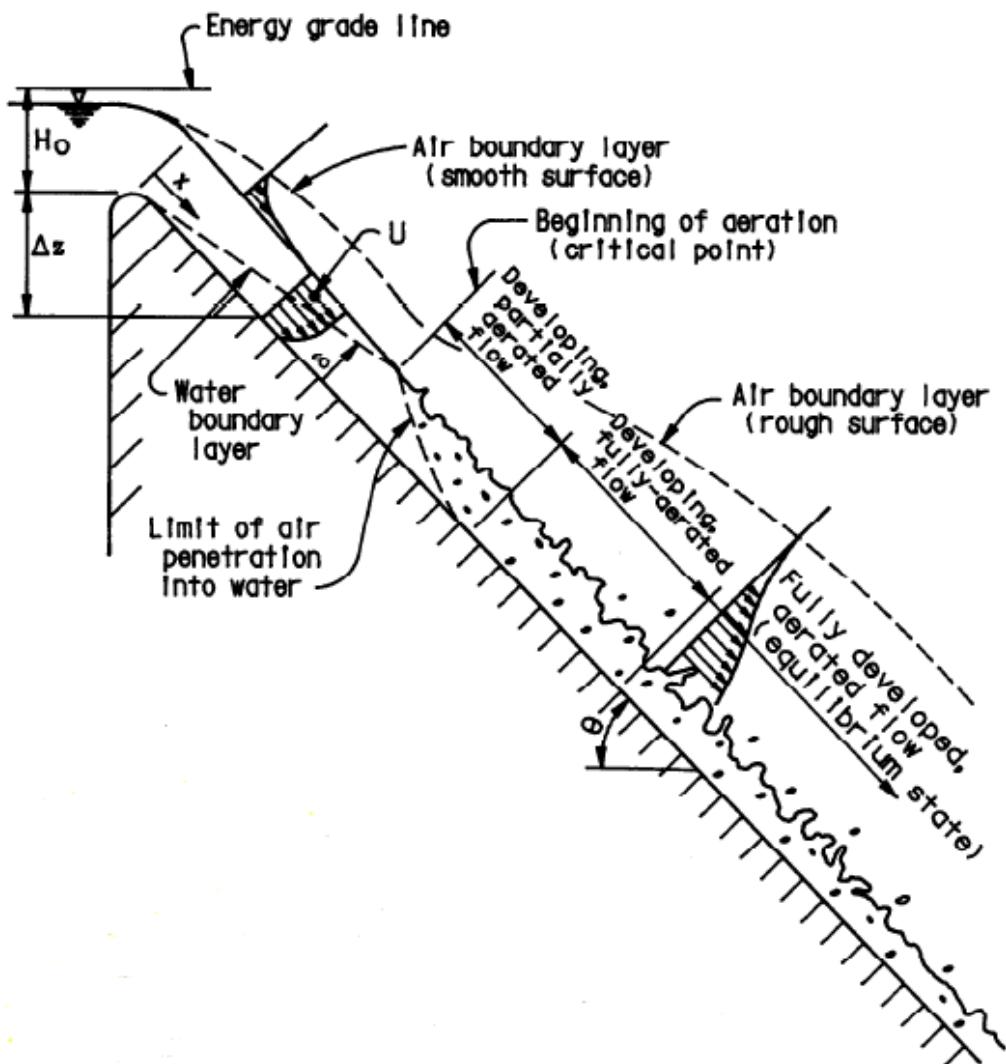
Figure 6.10: Development of self-aerated flow (Falvey, 1990).

None of these methods considers the process of self-aeration of flow in a chute or spillway. The development of self-aerated flow consists of three zones as shown on Figure 6.10:

- A developing, partially aerated flow
- A developing, fully aerated flow
- A fully developed, aerated flow (equilibrium state)

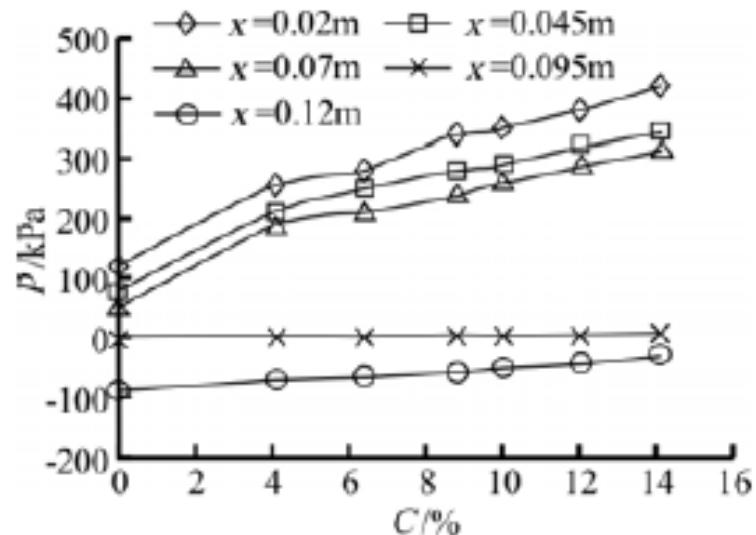
Figure 6.11: Variation of pressure with air concentration at $V=49.6\text{m/s}$ (Dong and Cheng, 2007).

The distances of measuring points from the entrance in observation section are $x=0.02$ m, 0.045 m, 0.07 m, 0.095 m and 0.12 m, and the air concentration near wall $C=4.1, 6.5, 8.8, 10.0, 12.0, 14.1$. It can be seen from the Fig.6.11 that the pressure at each point increases with increasing air concentration.

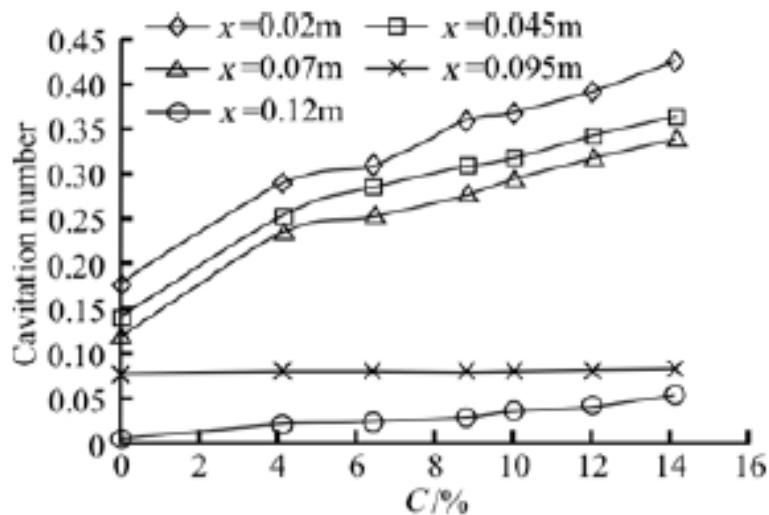
Figure 6.12: Variation of cavitation number with air concentration at $V=49.6\text{m/s}$ (Dong and Cheng, 2007).

It can be seen from Fig.6.12 that the cavitation number increases also with increasing air concentration.

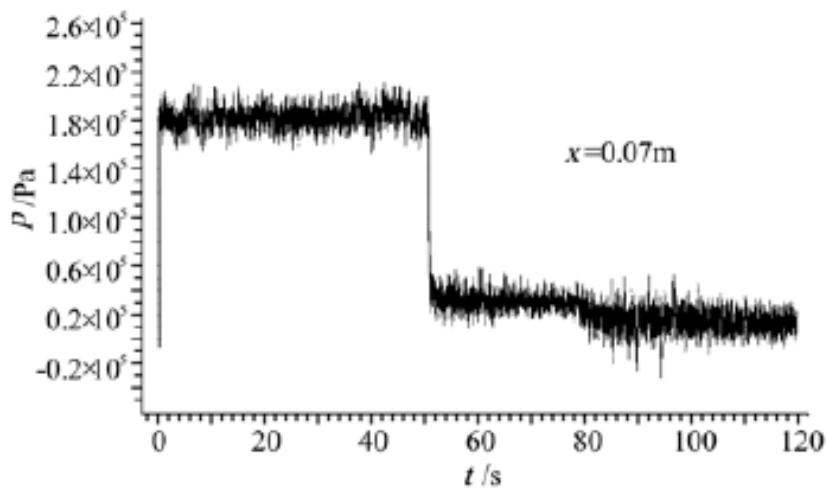
Figure 6.13: Pressure waveforms with and without aeration ($C=6.4\%$) at $V=49.6\text{m/s}$ (Dong and Cheng, 2007).

As it can be seen in Fig.6.13 sudden reduce in pressure due to removing the aerator was really big.

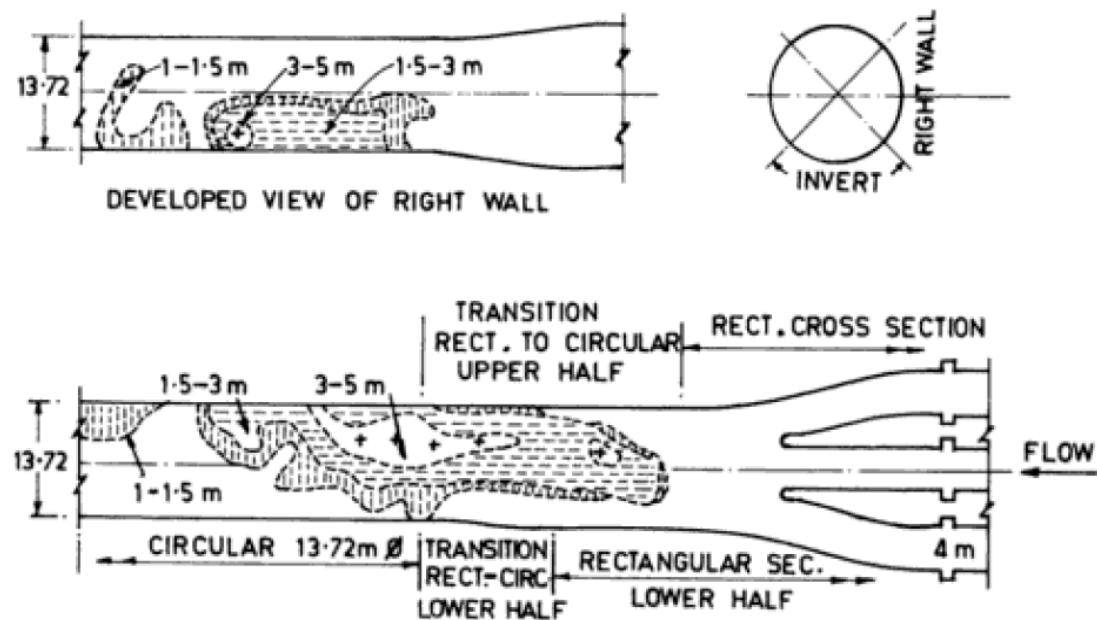
Developed View of Invert

Figure 6.14: Cavitation damage to concrete lining-Tunnel 2, Tarbela Dam, Pakistan.
(Kenn et al.1981)

The studies conducted by Kenn and Garrod (1981) investigating the cause of cavitation damage to Tarbela tunnel indicated that it could have occurred due to the presence of severely sheared flows with a velocity exceeding 30 m/s in a stagnant or slowly moving water pool. As shown in Figure 6.14, the central intake gate to tunnel 2 was for some time open (at first fully, later partly) while both side gates were closed. The evidence suggests that during this time, intense vortices- induced cavitation was generated in the two essentially vertical planes of severely sheared flows leaving the inner walls of the adjacent piers. These cavities collapsed in the regions of high pressure further downstream and caused severe erosion of the concrete lining of the tunnel.

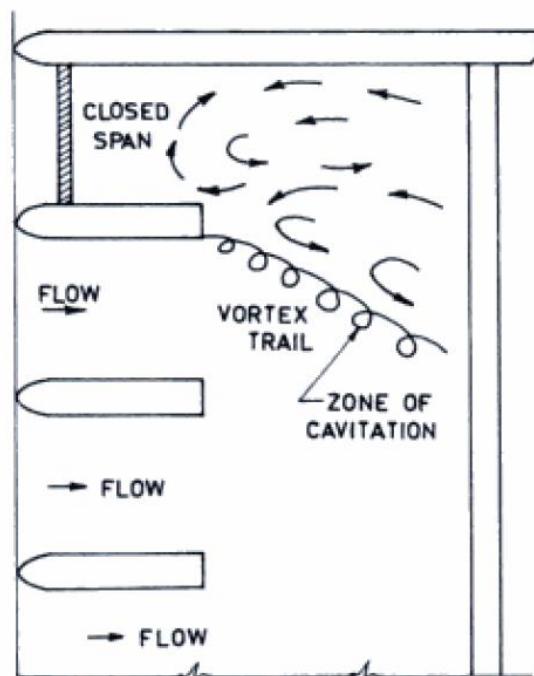
the stilling basin and downstream. However, operating staff often prefer to open a single gate, starting from central gate, adding on other gates as the discharge level increases. Conditions resulting from such operations-with potential to cause cavitation- are illustrated in Figure 6.15.

Figure 6.15: Flow separation and vortex trail due to asymmetrical operation of gates.

Structures that are not operated in accordance with the assumptions made in the design are likely to be damaged. A common example is the hydraulic jump stilling basin for a spillway having a number of gates. The design presupposes equal opening of all the gates; hence, the invert elevation of the basin is determined on this condition. A number of stilling basins have suffered damage due to abrasion cavitation, and uplift as a result of asymmetrically operating the crest gates.

Asymmetrical operation of spillway gates and sluice gates can result in a condition conducive to the formation of shear layers and cause cavitation. It is well known that

equal and simultaneous opening of all the gates ensures better hydraulic conditions in the stilling basin and downstream. However, operating staff often prefer to open a single gate, starting from central gate, adding on other gates as the discharge level increases.

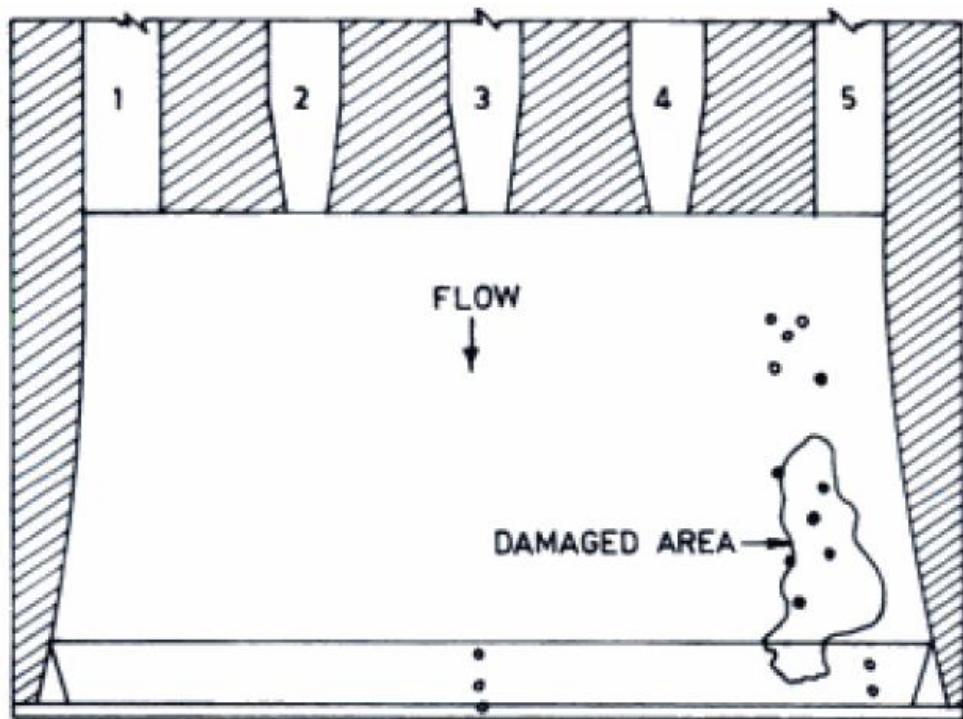
The deep-seated sluice structure consists of five sluices 10.5 m high by 6.0 m wide equipped with radial gates. The overall head on the sluices is 44 m, resulting in a velocity of about 29 m/s. the basin floor and the kicker block (a high-end sill) in front of sluice number five were repeatedly damaged, as shown in Figure 6.16.

It was found that sluice number 5 was operated most of the time while the other sluices were kept closed. Hydraulic model studies were conducted to study pressures at strategic locations in the damaged regions-also shown in Figure 6.16.

Figure 6.16: Damage to the basin floor and kicker block-Roseires dam, Sudan. (Burgess 1981)

- In all tests, pressures remained above the equivalent prototype vapor pressure
- Potential cavity formation and collapse condition recorded at least in one test

Burgess (1981) has described cavitation damage to the concrete floor and kicker block of the deep sluice-stilling basin of the Roseires Dam, Sudan, Also believed to be a vortex-induced cavitation.

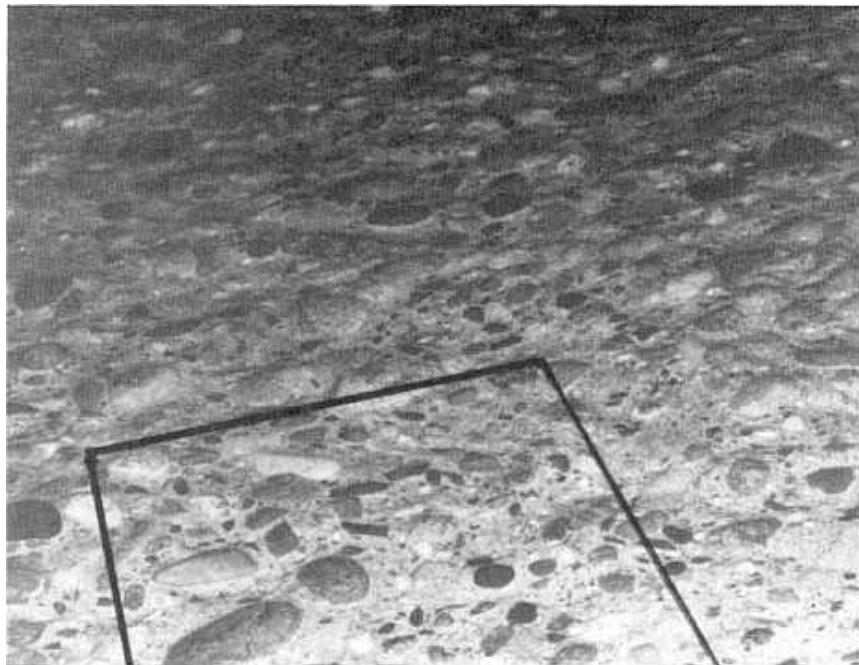
a. View of invert

The surface to receive the special finish should be thoroughly cleaned with high-velocity water jets to remove loose particles and foreign material and then brought to a surface-dry condition, as indicated by the absence of glistening-free water, by clean air jet. A plastic mortar consisting of 1 part of cement and 1 to 1-1/2 parts of sand, by weight, which will pass a No. 16 screen, should be rubbed over the surface and handstoned with No. 60 grit Carborundum stone, using additional mortar until the surface is evenly filled. Stoning should be continued until the new material has become rather hard. After moist curing for 7 days, the surface should be made smooth and even by use of a No. 50 or No. 60 grit Carborundum stone or grinding wheel. A flexible disk power sander may produce an acceptable surface. After final stoning, curing is continued for the remainder of the 14 day curing period, Fig 6.17.

Figure 6.17: Hoover Dam, Nevada spillway. Concrete surface near station 994.00

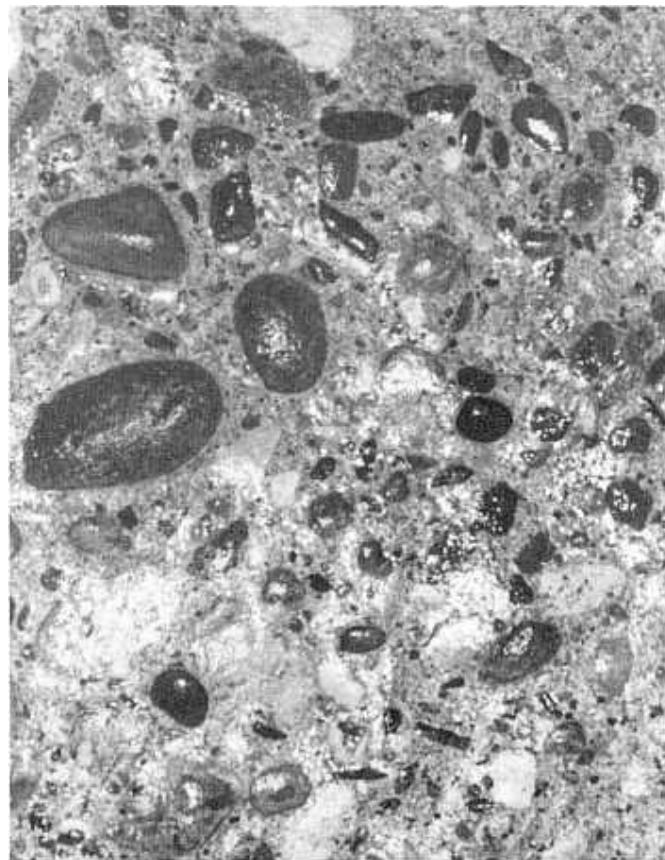
b. Invert close-up

Figure 6.17: Hoover Dam, Nevada spillway. Concrete surface near station 994.00

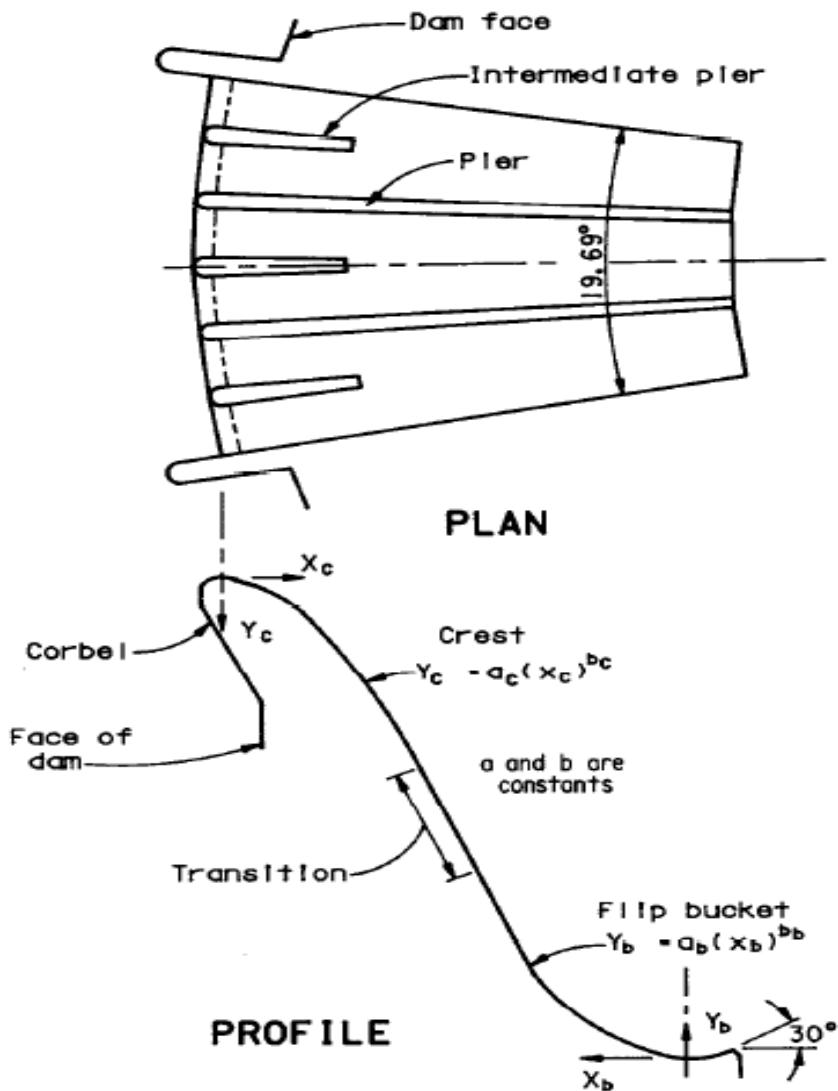
Control of pressures in the chute downstream of the spillway crest can be accomplished through variations in both the invert curvature and chute width. For example, a crest having both inverts curvature and converging sidewalls was designed by G. Lombardi of Locarno, Switzerland, as shown on Figure 6.18, (Colgate, 1976). This spillway profile consists of a conventional spillway crest, a transition section having a constant slope invert, and a flip bucket. The invert profile of the bucket obeys a power law. In plan, the sidewalls converge uniformly at an included angle of approximately 3.3°. Both of these variations in geometry (invert curvature and convergent sidewalls) were not sufficient to prevent the cavitation index of the flow from being less than a value of 0.2. Therefore, damage probably would be expected to occur with the profile if the flow is not aerated.

Figure 6.18: Lombardi crest

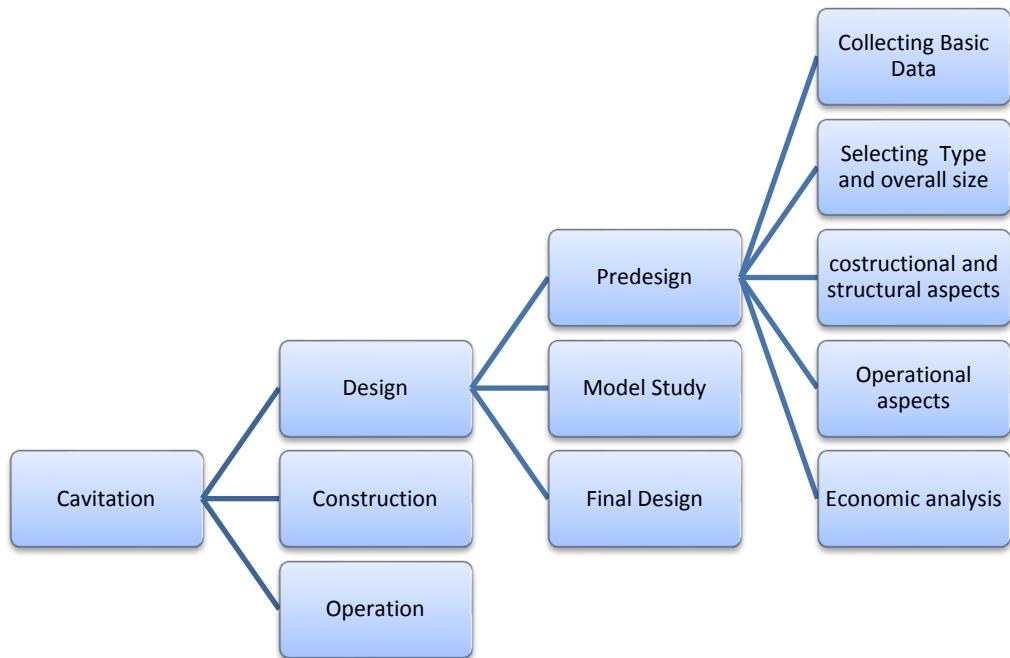
To have an overview about cavitation prevention and effects, we can gather information in a chart like Fig 7.1. It has detailed information under the chart.

Figure 7.1: Schematic view of cavitation prevention period
