**LIFE CYCLE ASSESSMENT OF BUILDING MATERIALS IN HOTEL  
REFURBISHMENT PROJECTS: A CASE STUDY IN ANKARA**

**A THESIS SUBMITTED TO  
THE GRADUATE SCHOOL OF NATURAL AND APPLIED SCIENCES  
OF  
MIDDLE EAST TECHNICAL UNIVERSITY**

**AYŞEM BERRİN ÇAKMAKLI**

**JUNE 2007**

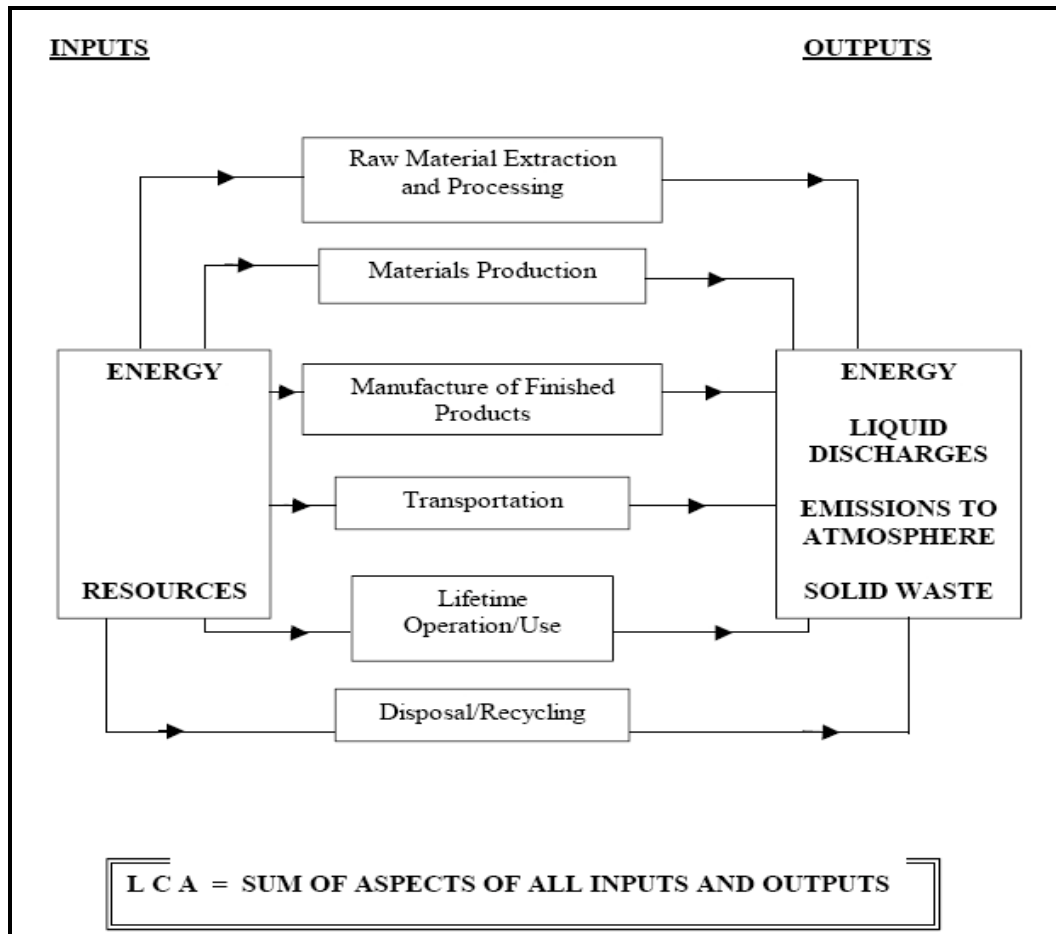
Figure 2.1. Summary of life cycle assessment procedure proposed by the Royal Society of Chemistry (1998: 3).

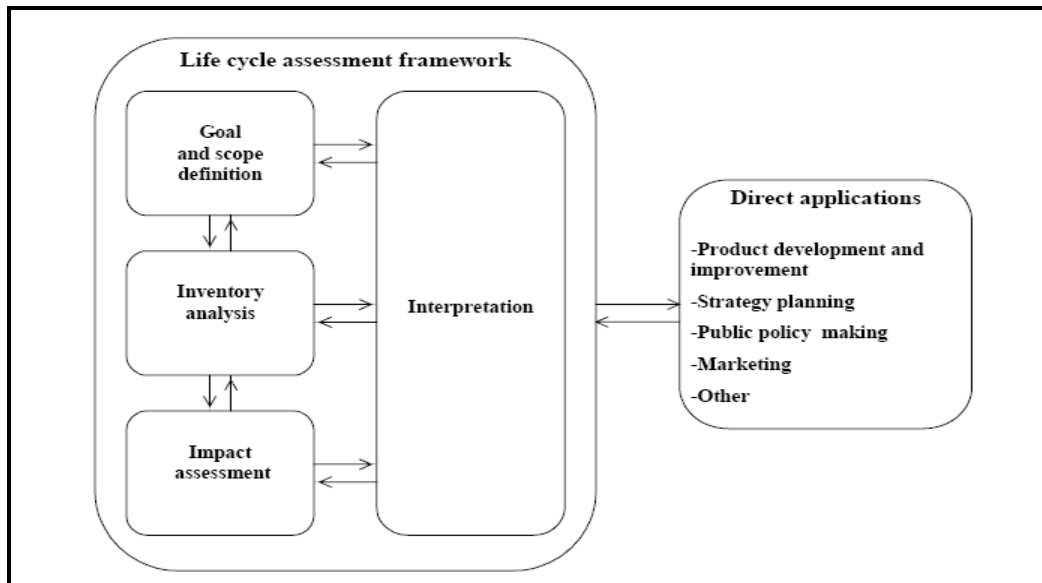
In order to adapt the application of the assessment process to any product or system, ISO 14040 Standard (1997: 4) proposes a framework, seen in Figure 2.2, that involves four interrelated phases; the goal and scope definition phase, the inventory analysis phase, the impact assessment phase and the interpretation phase which are explained in more detail in the following section.

Figure 2.2. The four phases of LCA.  
(Source: ISO 14040 Standard, 1997: 4).

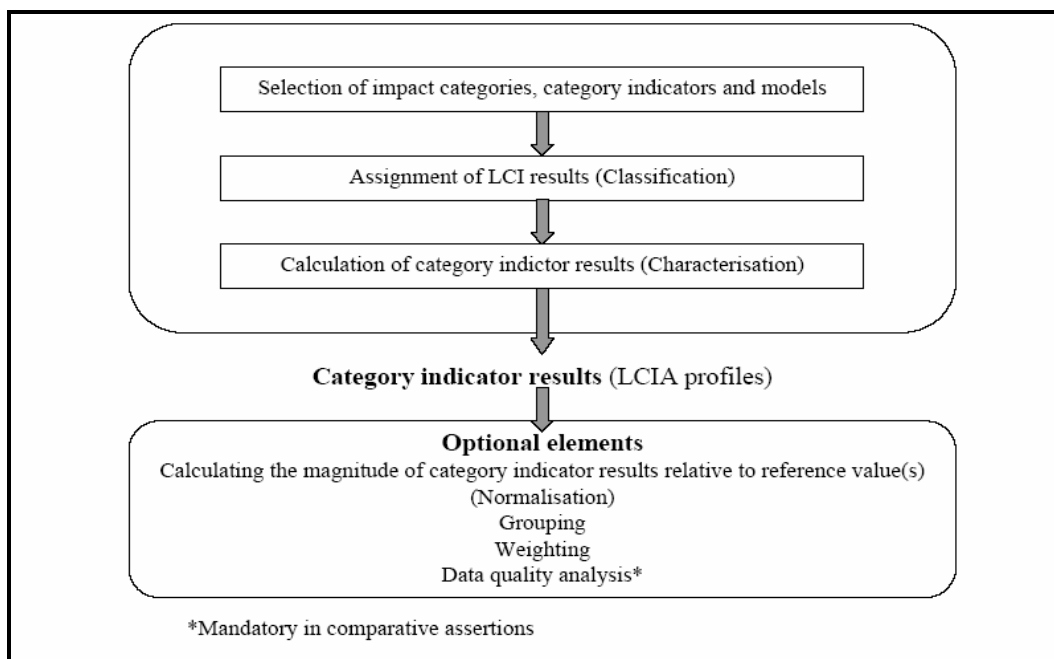
According to ISO 14042 Standard (2000: 2), the purpose of the impact assessment phase is to examine the product system from an environmental perspective using impact categories and category indicators connected with LCI results to better understand their environmental significance. This phase could be subdivided into four steps, which are: category definition, classification, characterization as mandatory elements and calculating the magnitude of category indicator results relative to reference values, normalization, grouping and weighting as optional elements, as seen in Figure 2.3.

Figure 2.3. Elements of the LCIA phase.  
(Source: ISO 14042 Standard, 2000: 3).

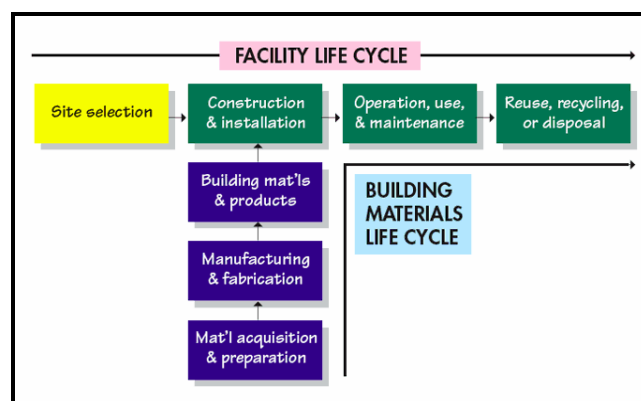
Figure 2.4. Facility and material life cycle (Source: Malin, 2002: 4).

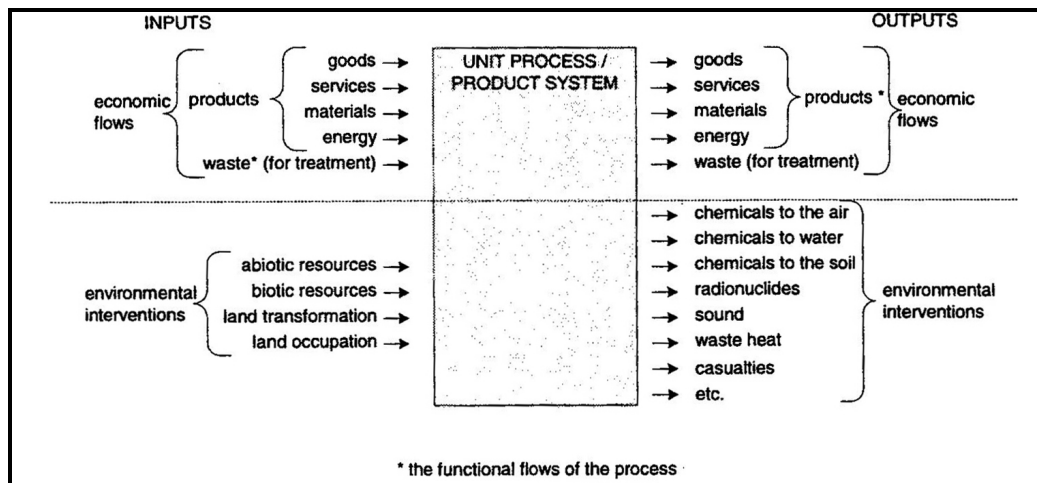
Figure 2.5. Environmental interventions and economic flows.  
(Source: Guinee 2002: 479).

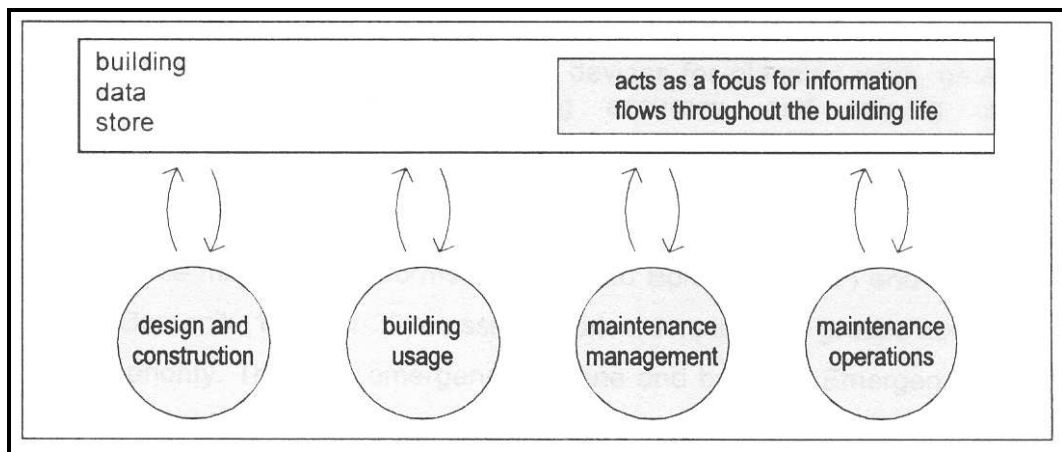
Figure 2.6. Inputs to building data store.  
(Source: Chanter and Swallow, 1996: 167).

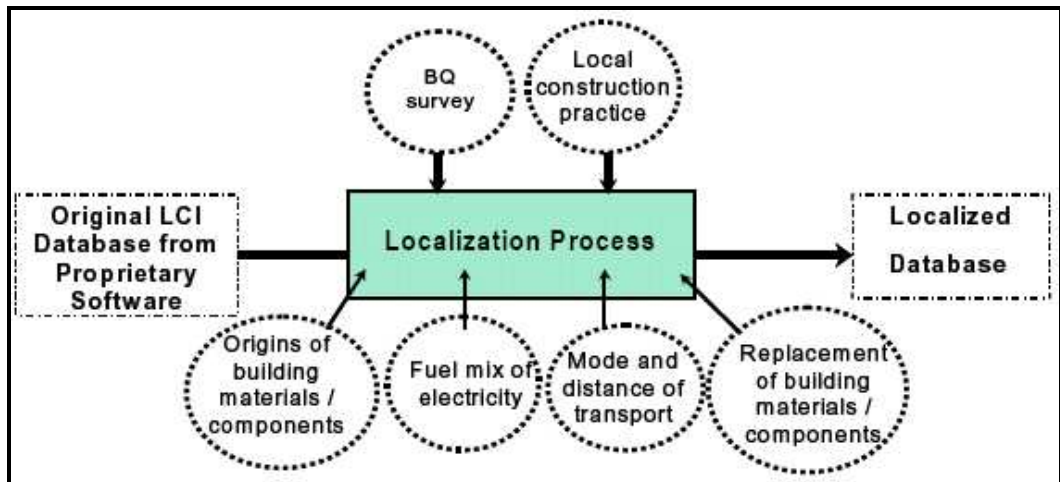
ARUP Group (2004) insists that input data should reflect the impacts due to consumption of resources and environmental emissions of all functional units. Localization of the data is essential in order to obtain LCA results that are relevant to the geographical region concerned. This localized process is presented in Figure 2.7 below.

Figure 2.7. Processes for developing a localized database.  
(Source: ARUP, 2004: 7).

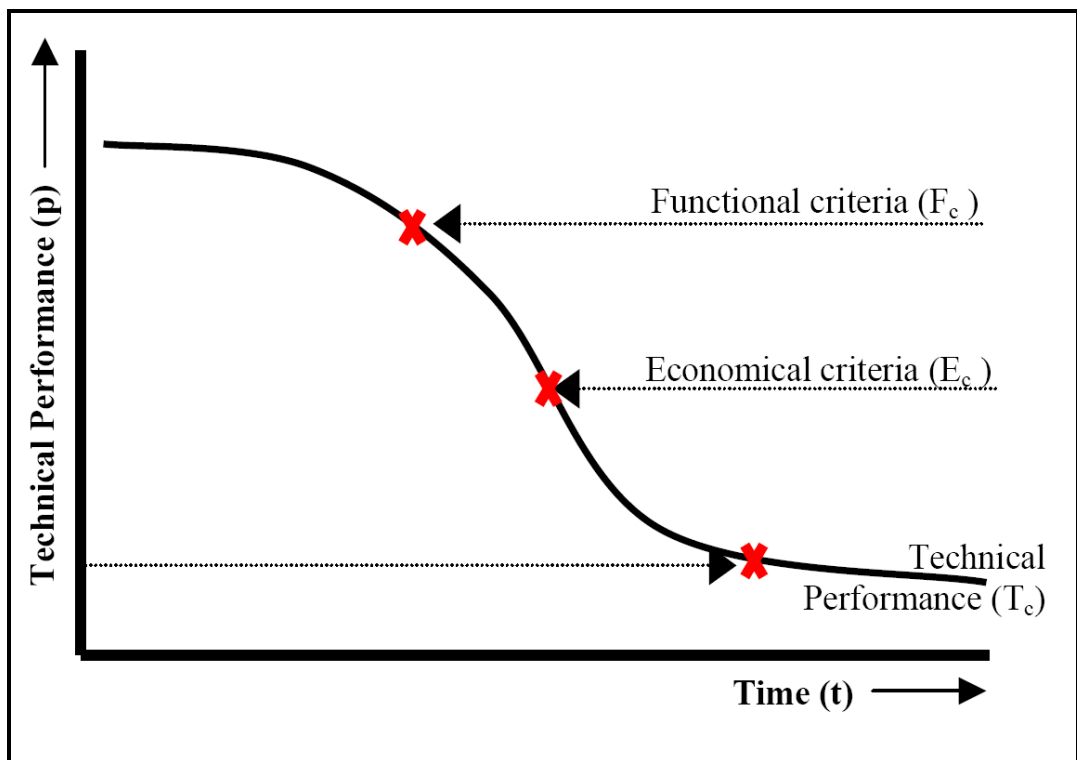
According to ISO 15686-1 (2000), there are three kinds of end-of-life scenarios in the building sector; namely: technical, economical, and functional end-of-life. The reference service life of components is the technical service life; which ends when the component can no longer sustain its performance. The economical end-of-life occurs when another component can be substituted with lesser costs; while the functional end-of-life occurs, when the component fails to meet the demand of people. In other words, the user decides that the service life of the product is over.

Figure 2.10. Different types ends-of-life scenarios.  
(Source: Nunen *et al.*, 2004: 5).

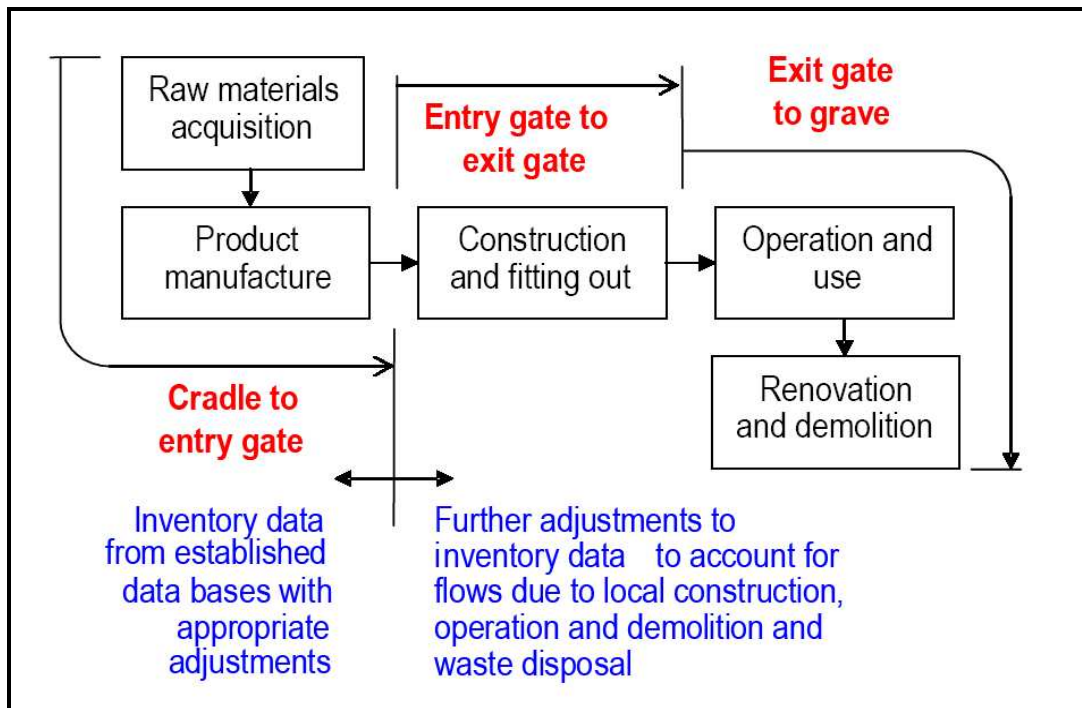
Figure 2.11. Stages of building life cycle.  
(Source: USEPA, 2002).

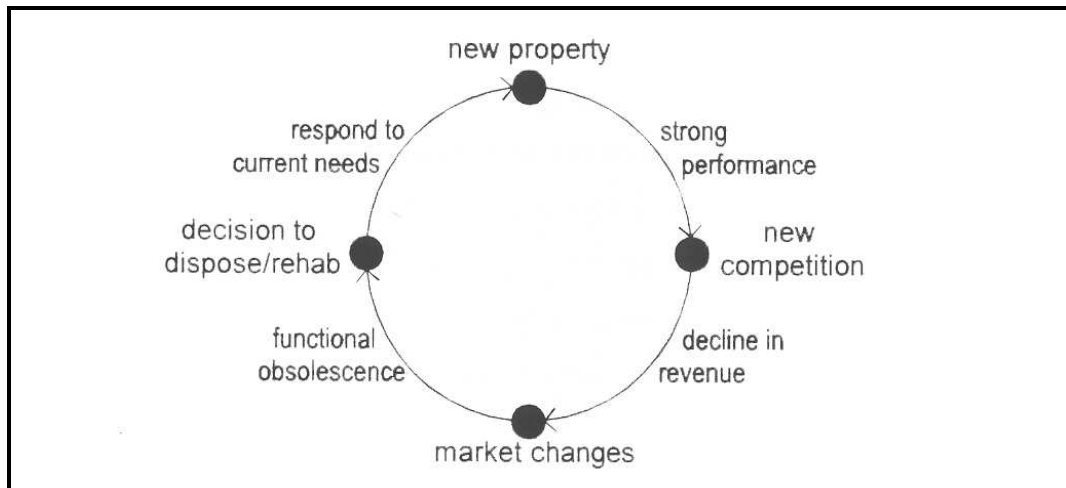
According to Stipanuk and Roffman (1992: 420), a hotel is constructed to meet the needs of a growing community and it can become the dominant force in the market for a number of years, enjoying higher occupancies and rates than its competitors. However, there are four phases in the lifecycle of a hotel; during the first phase when the property is new, it is more popular and shows a strong performance; in the second phase due to new competition the occupancy and average daily revenue declined over time; the market changes make occupants demand new and different services and so during the third phase the hotel faces functional obsolescence; finally decision has to be made to either dispose of it or rehabilitate it to respond to current needs in the fourth phase. In Figure 2.12, these four phases are presented graphically.

Figure 2.12. Lifecycle of a hotel.  
(Source: Stipanuk and Roffman, 1992: 421).

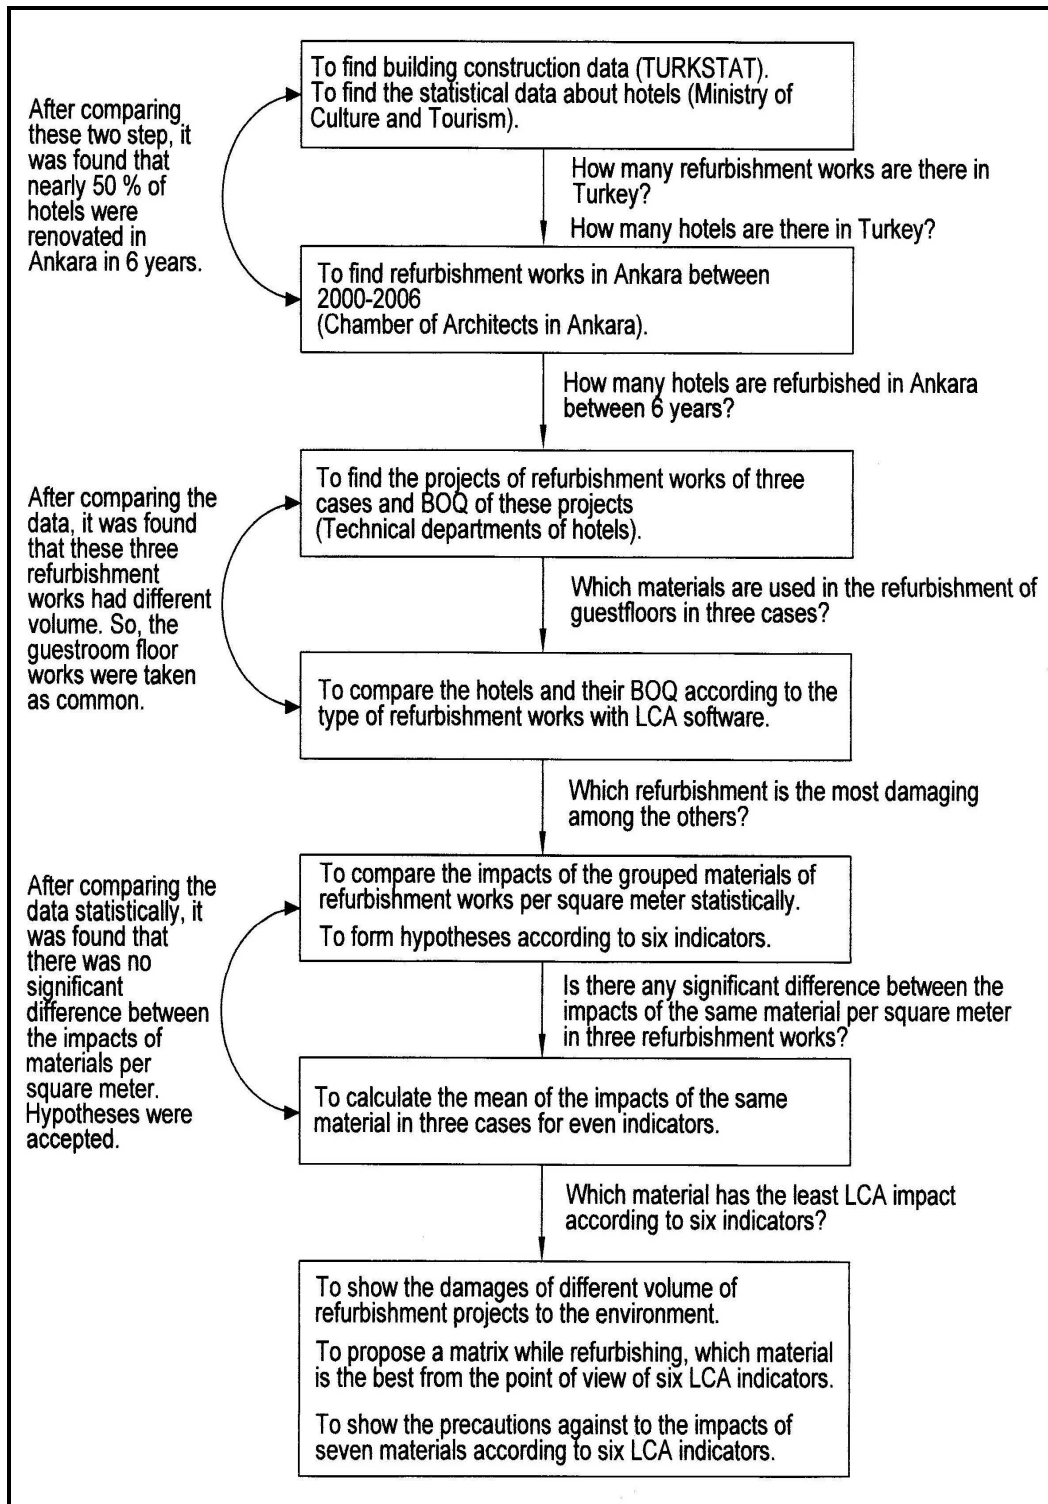
The methodology adapted for this investigation is summarized in Figure 3.4. In order to fulfill the objectives of methodology of this investigation, the bill of materials of refurbishment works of three subject hotels are compiled and its process is stated in Section 3.2.1. The simulation of refurbishment works is given in Section 3.2.2. Also included are the simulation procedure, the phases of this LCA study and interpretations of six environmental impact indicators according to international standards. Finally, the hypotheses were formulated according to data generated from software and listed in Section 3.2.3.

Figure 3.4. The methodology adapted by the author.

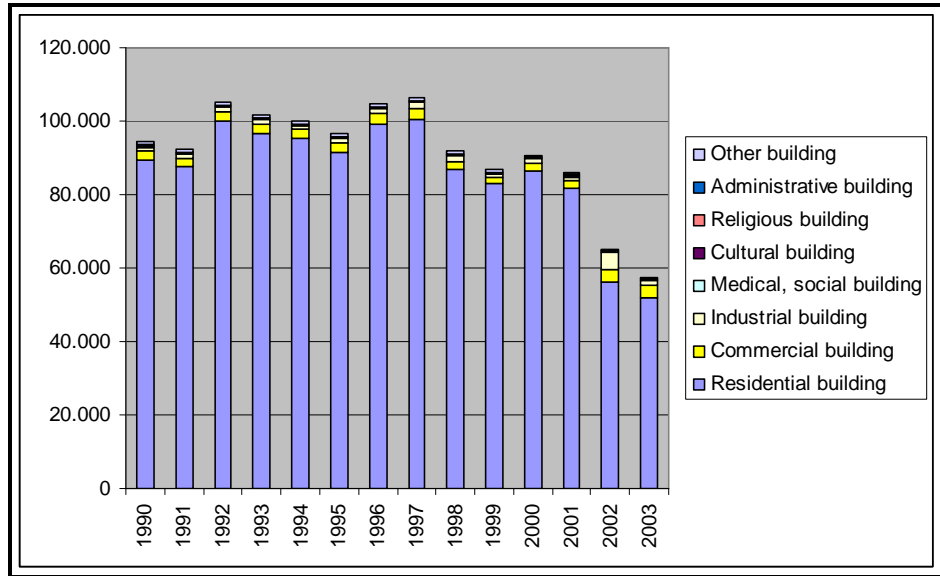
Figure 4.1. The number of completed or partially completed new buildings and additions by use of building according to years Table B.2. (Source: TURKSTAT).

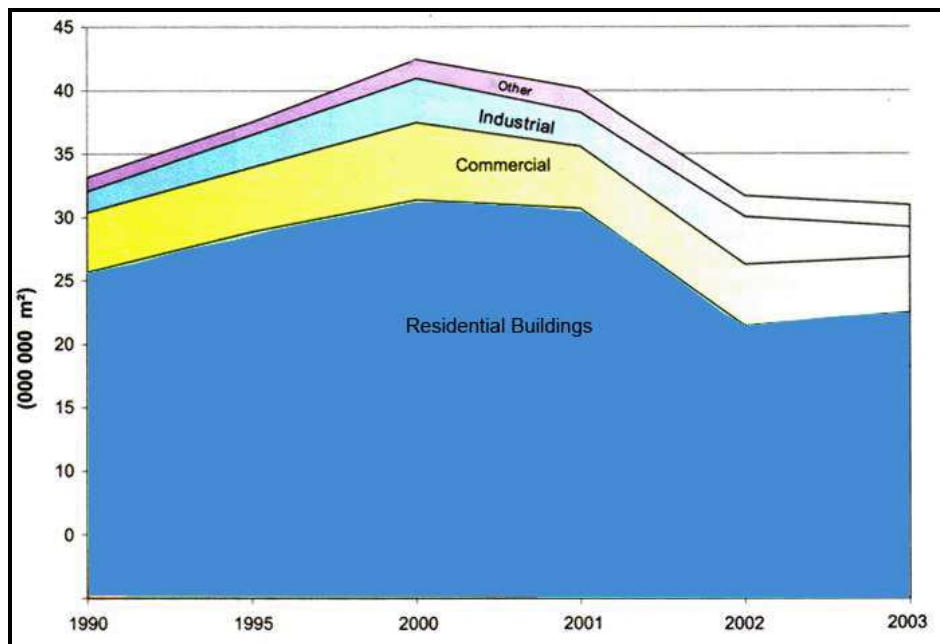
Figure 4.2. Total floor area of completed or partially completed new buildings and additions by use of building according to years Table B.2. (Source: TURKSTAT).

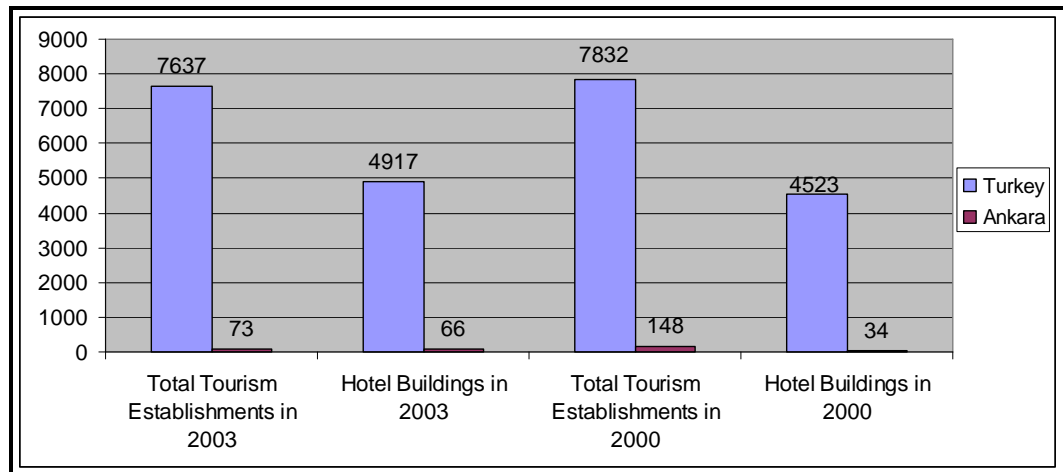
Figure 4.3. Data related to the number of tourism establishments in Turkey and Ankara derived from Table B.3, B.4, B.5, B.6. (Source: Ministry of Culture and Tourism).

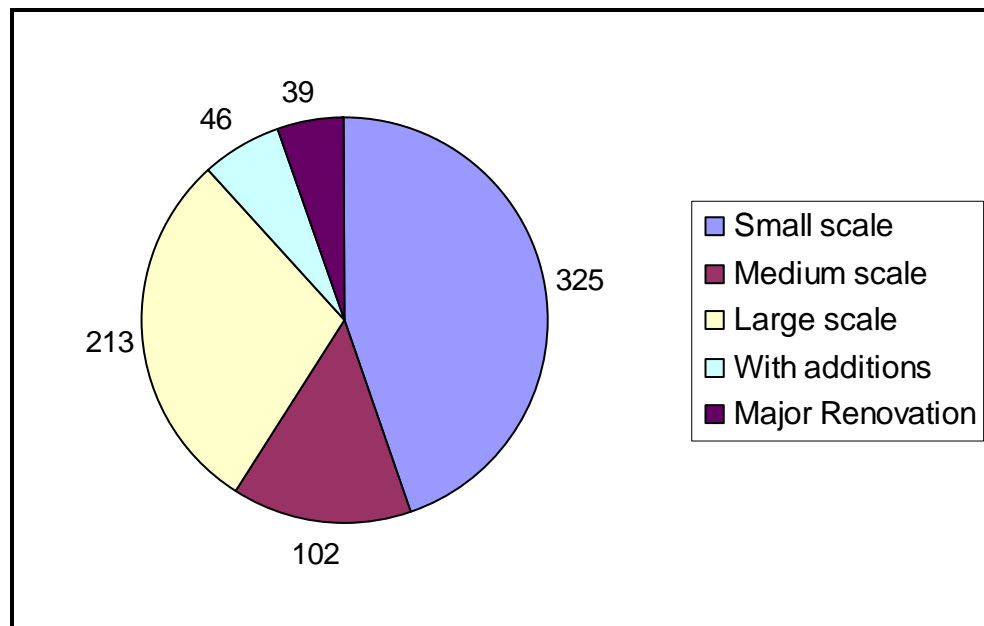
Figure 4.5. Data related to the different types of renovation projects approved by the Chamber of Architects in Ankara, during the 6 year period of 2000-2006, derived from Table B.7, Appendix B. (Source: Turkish Chamber of Architects in Ankara).

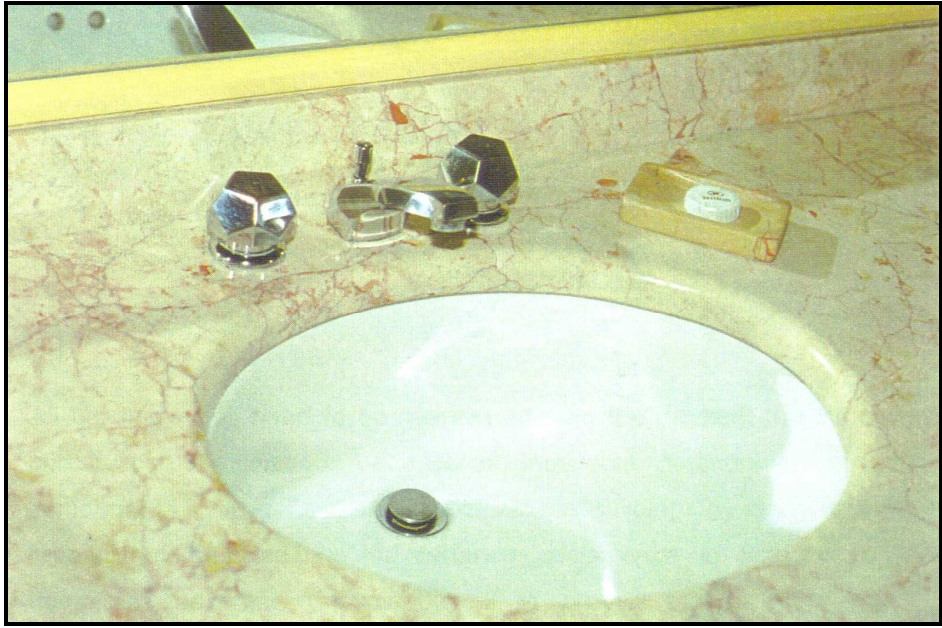
Mr. Çalışkan stated that, the refurbishment of guestroom floors of Hotel A was started in 2002 and finished at the end of 2004. The guestroom floors were divided into four sections. The rooms were decorated in light colors to offer a comfortable and spacious working environment. Ash veneered chip-board panels were disassembled and gypsum-board panels were used for the suspended ceiling. Vinyl wallpaper on walls was renewed and timber beading used as wall trimming. Also, the wooden pelmets were disassembled and replaced with gypsum pelmets. There were light-colored marble tiles and vanity basin with matching faucet fittings in the bathroom of the guestrooms before refurbishment. Although these fittings and fixtures were in good condition, they were replaced with darker new marble cladding and fittings only because of the changing fashion trends; as seen below in Figure 4.9 and Figure 4.10.

Figure 4.9. The faucet fittings and marble claddings in typical standard room of Hotel A before refurbishment.  
(Source: Ozgurel, 2001: 92).

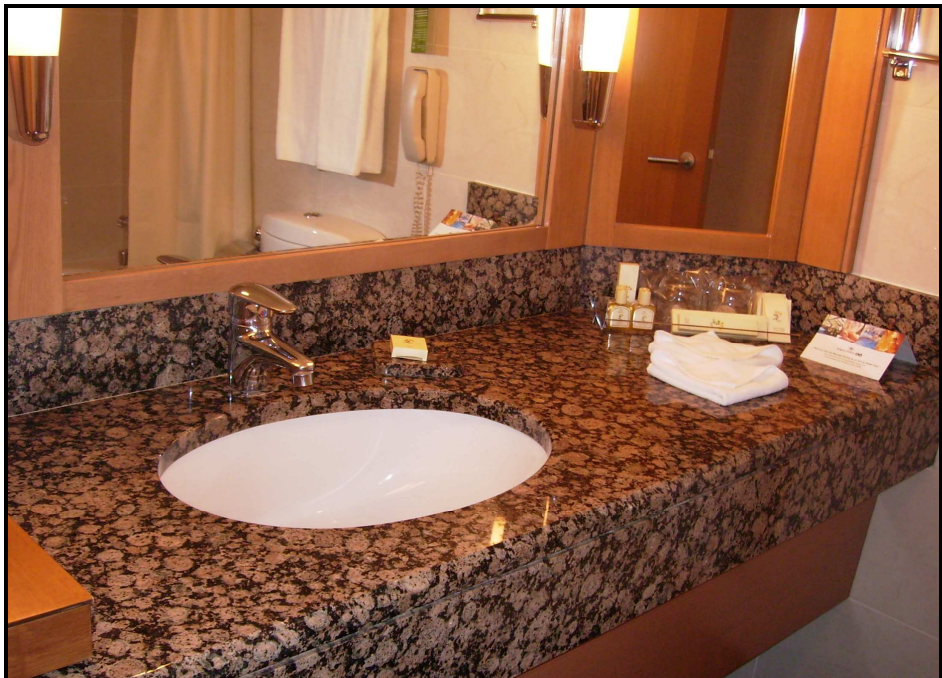
Figure 4.10. Typical bathroom of a standard room of Hotel A after refurbishment.

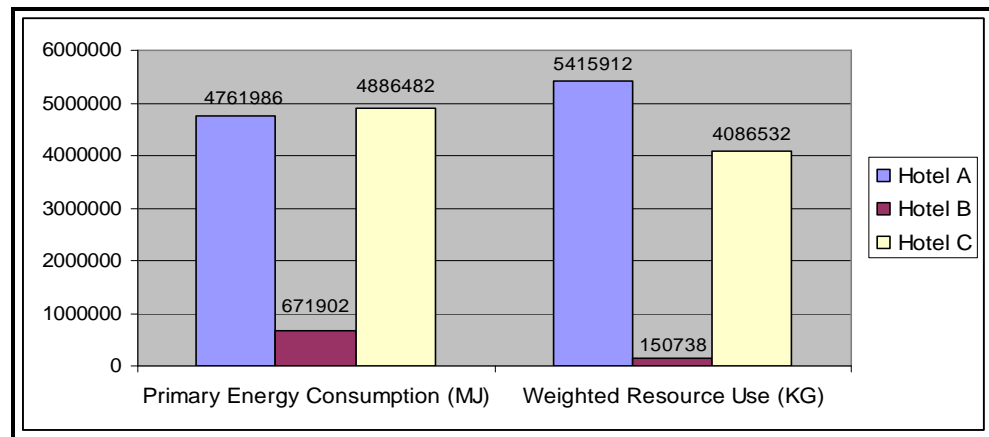
The comparisons of three hotels according to the absolute values of six indicators in total stages -excluded operating energy- were shown in Figure 4.11, Figure 4.12, and Figure 4.13. The operating energy stages were ignored while discussing the results in graphs because the impacts of these stages were calculated according to only the area of the hotels. This was not changed due to the magnitude of the project. So if only the impacts of the refurbishment and the materials used in the refurbishments were wanted to analyze, this stage should be ignored.

Figure 4.11. The impacts of three hotels according to primary energy consumption and weighted resource use.

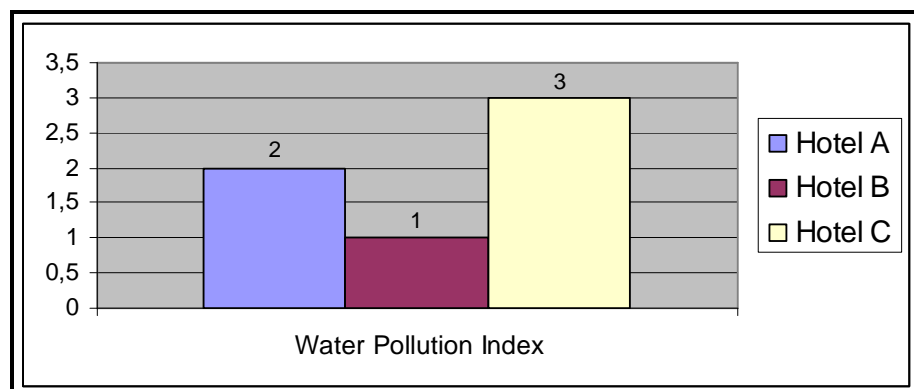
Figure 4.12. The impacts of three hotels according to water pollution index

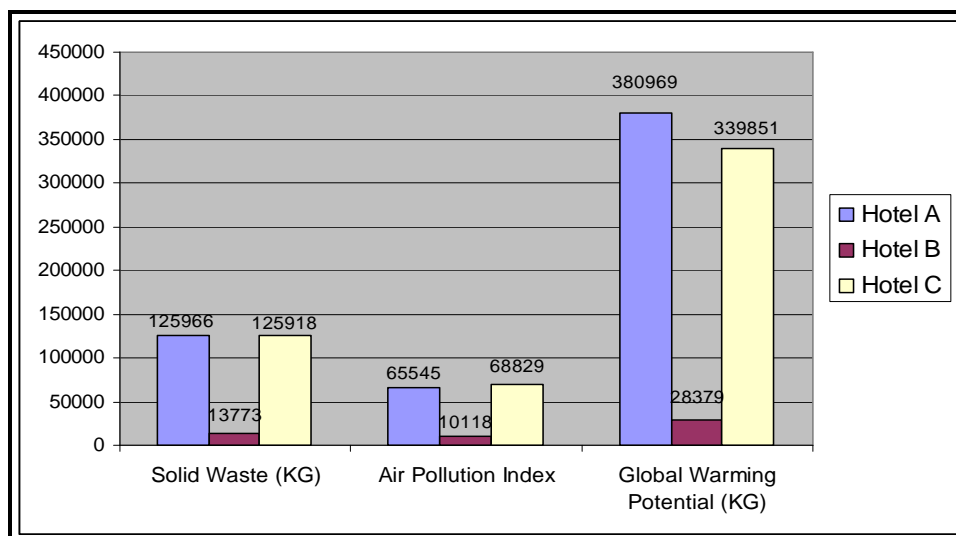
Figure 4.13. The impacts of three hotels according to solid waste, air pollution index and global warming potential.

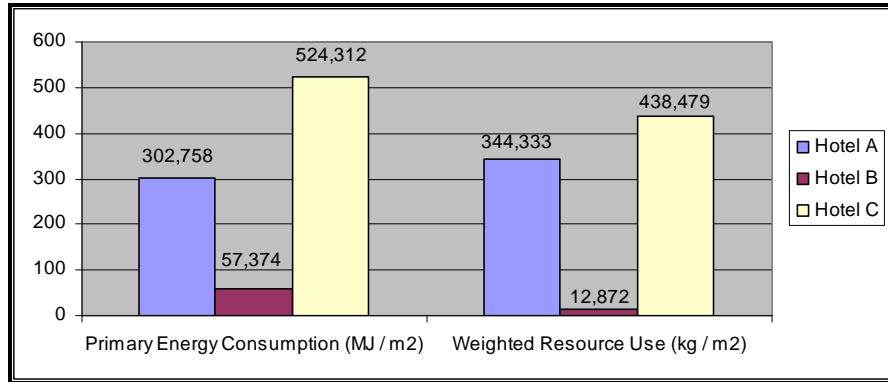
Figure 4.14. The impacts of three hotels per m<sup>2</sup> according to primary energy consumption and weighted resource use.

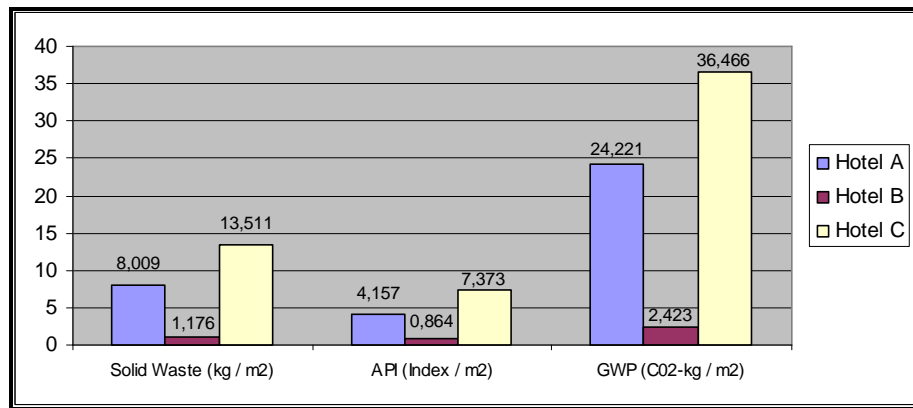
Figure 4.15. The impacts of three hotels per m<sup>2</sup> according to solid waste, air pollution index and global warming potential.

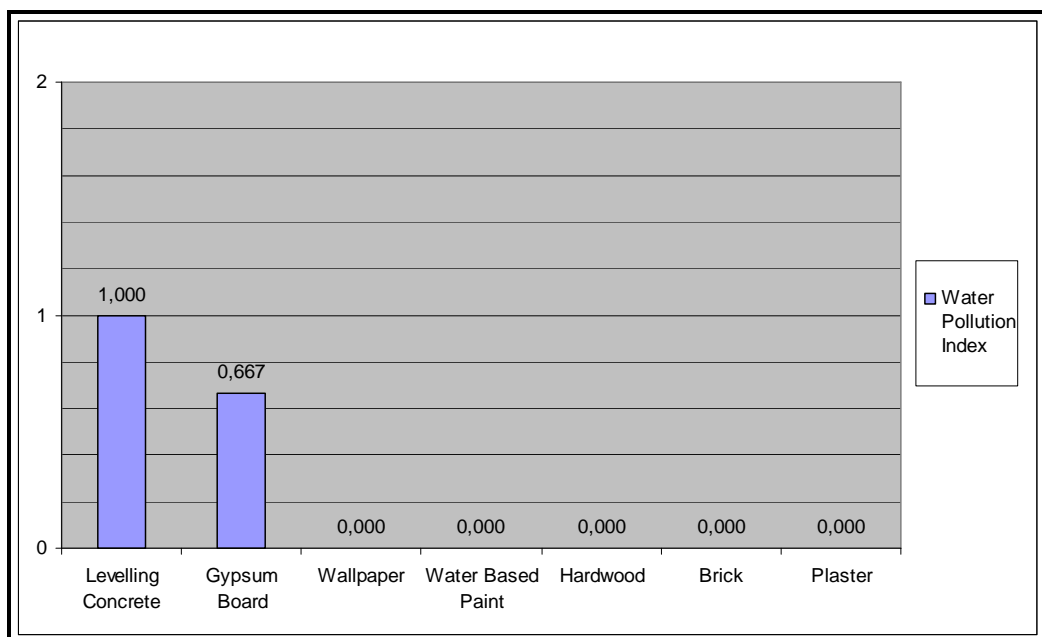
Figure 4.20: Comparison of seven materials according to the water pollution index.

According to Figure 4.20, only levelling concrete and gypsum board created emissions to water. The leveling concrete had the maximum emissions. In Section 3.2.2, specific benchmarks for water pollution due to EPA were given. However, this categorization could not be correlated with the software absolute results. This type of correlation problems were also stated in section 2.3.1 and this was depended on the different data presentation formats encountered in the inventories. The ATHENA Institute did not give any limit conditions about the indicators, only the absolute values of summaries were given such as the amount of each type of emissions to water listed in section 2.3.2; the amount of emission of chlorides, phenols.

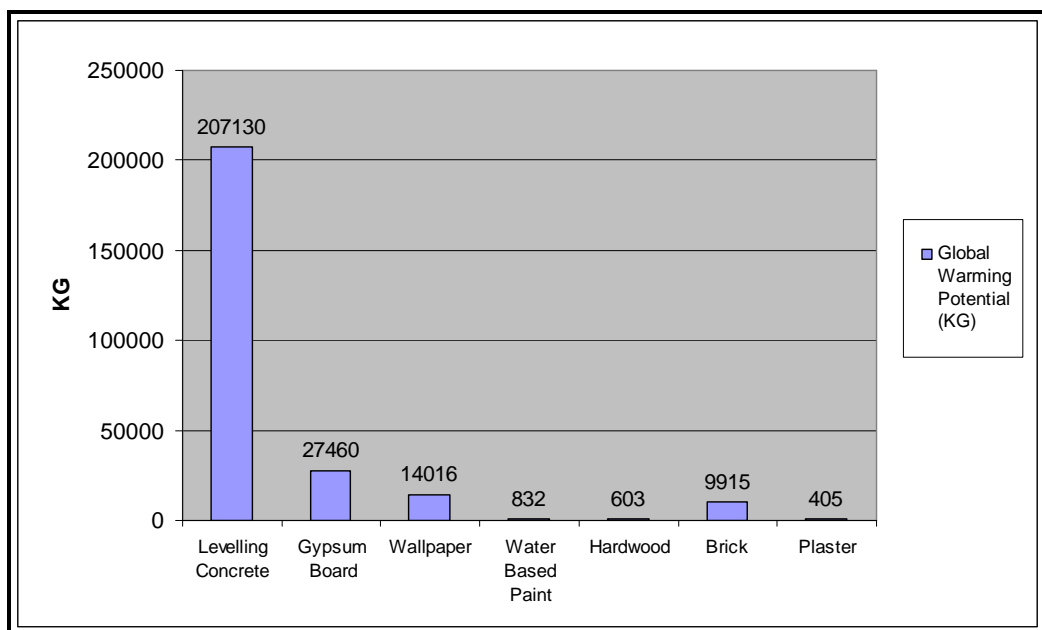
Figure 4.21: Comparison of seven materials according to the global warming potential.

stage which was the reason of that much amount of the greenhouse gas emissions. Plaster was the best choice among these materials listed above for global warming potential; however it caused more weighted resource use seen in Figure 4.22. This indicator becomes very important especially in these days when the main environmental problem is the global warming and its effects.

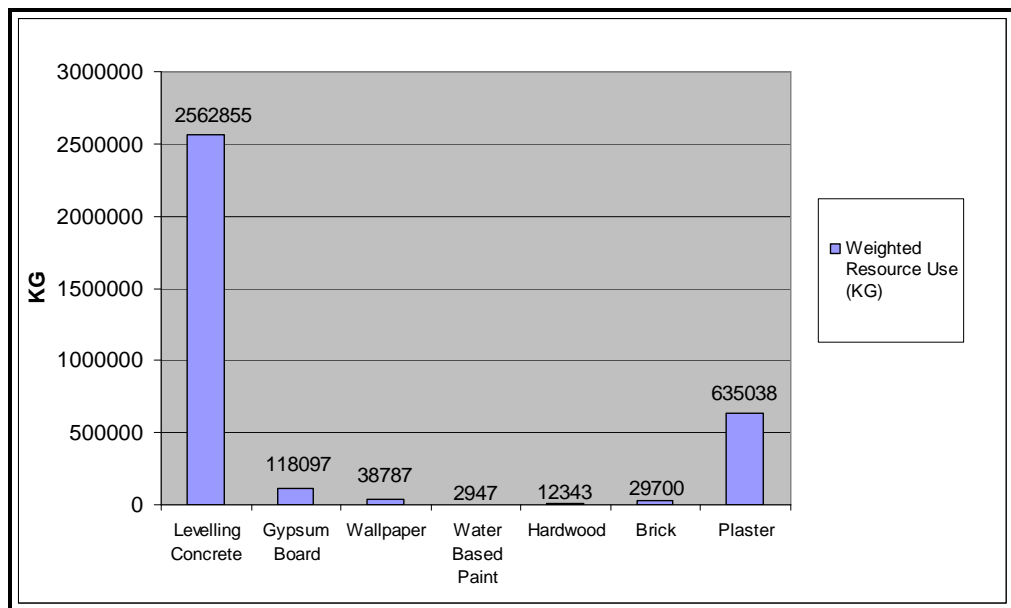
Figure 4.22: Comparison of seven materials according to the weighted resource use.
