M.S. Thesis

# SEISMIC BEHAVIOR OF AN ORDINARY RC STRUCTURE EXPOSED TO CORROSION

İŞIK UNIVERSITY

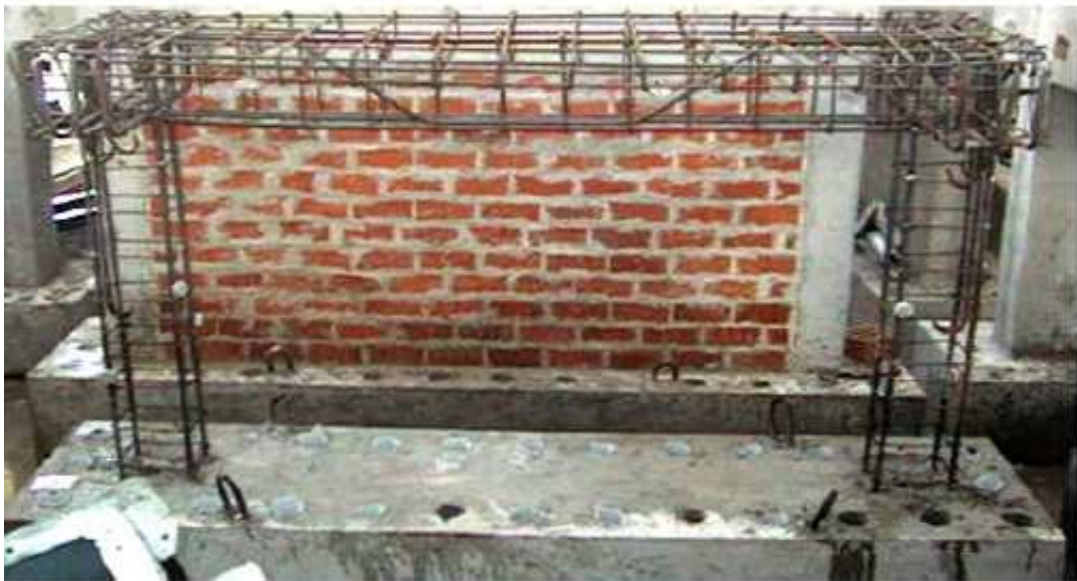
Figure 3.4: The details of frame reinforcement

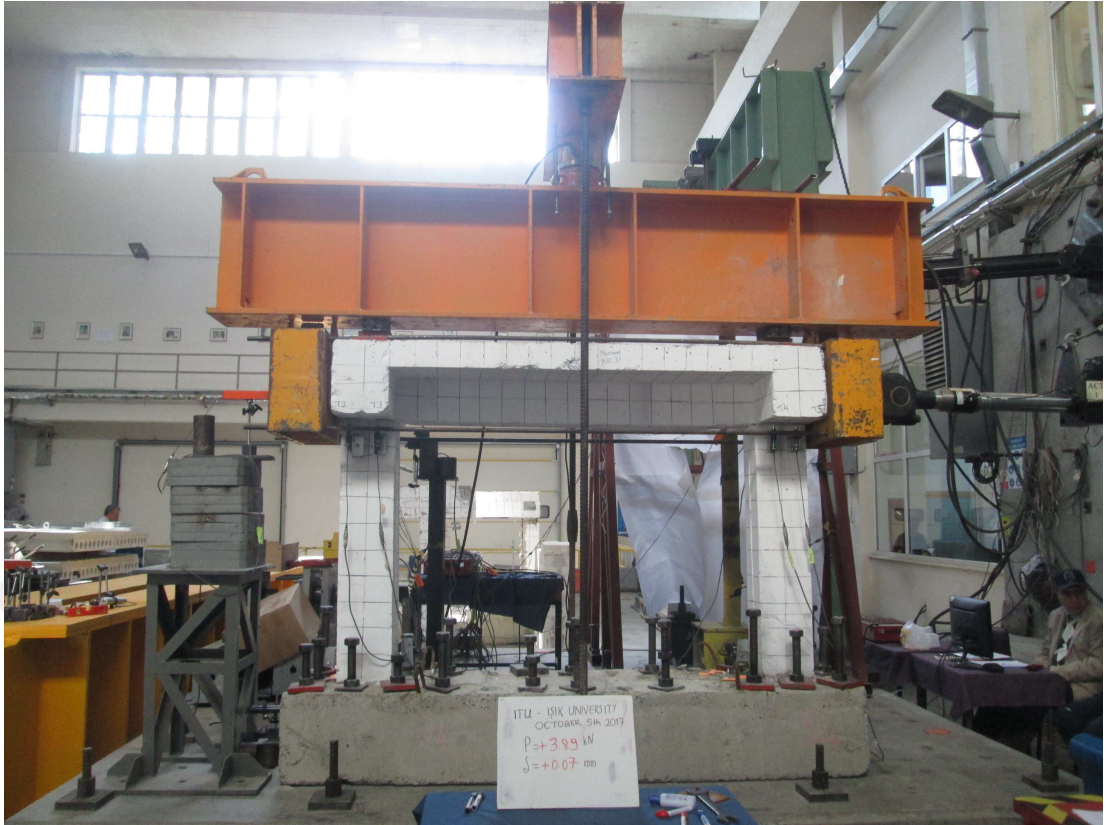
Figure 3.6: General view test setup

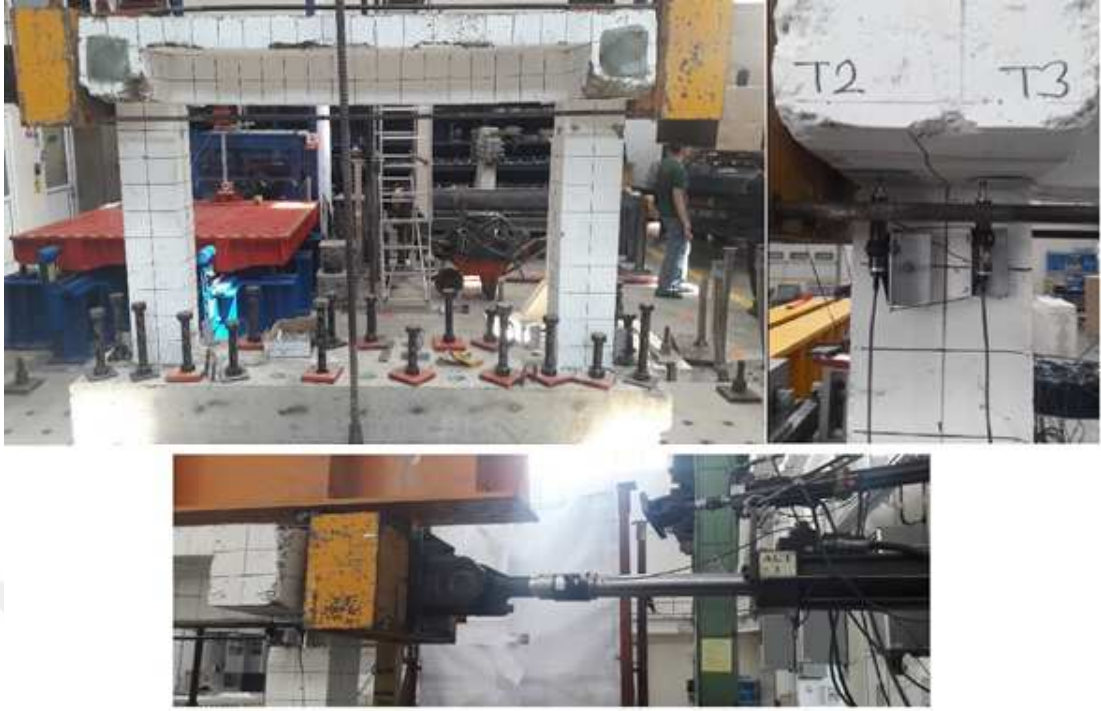
Figure 3.7: Details of setup

Details of the setup is given in following figure (Figure 3.7).

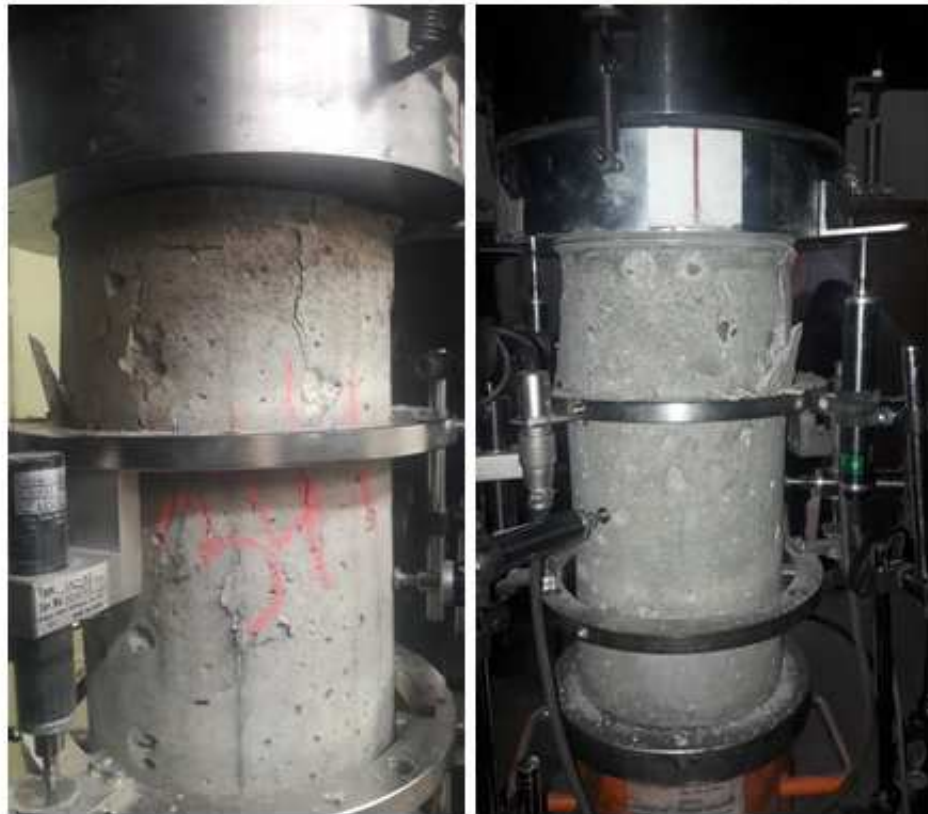
Figure 3.10: Compression test

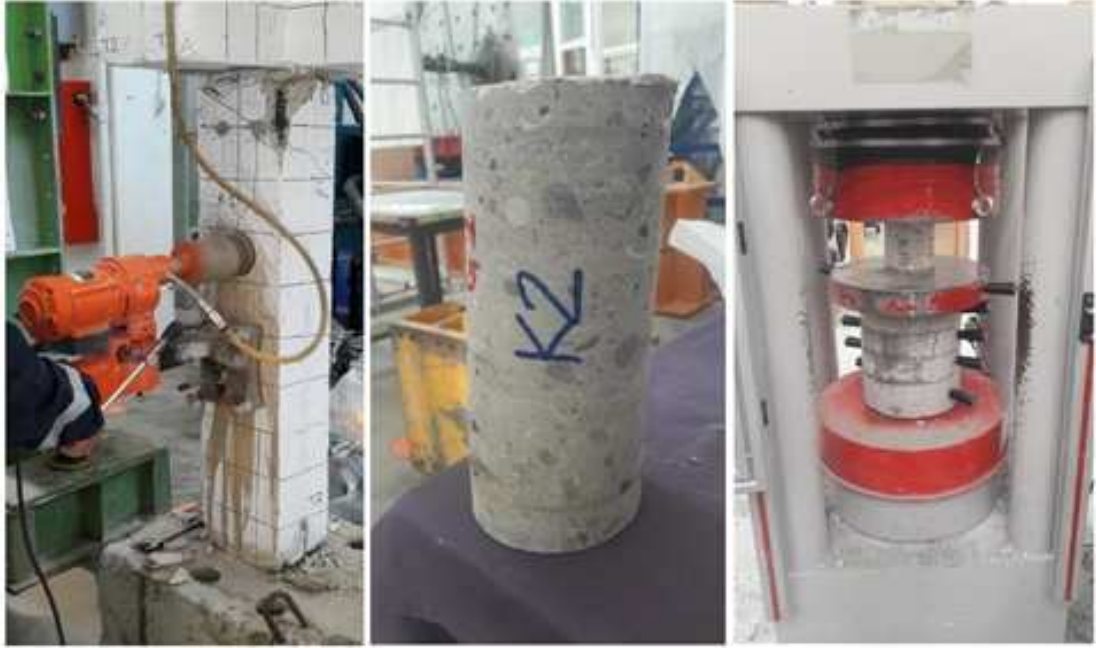
Figure 3.12: Drilling and testing of core specimens

In order to define the mechanical properties of concrete accurately, cylindrical core specimens were taken from columns, beam and slab of the frame. Drilling and testing of the core specimens were performed according to TS EN- 13791 code which specifies the technics for drilling core specimens from hardened concrete, their examination, preparation for compressive test and specification of compressive strength of concrete. After coring, the specimens were tested under compressive force till failure at Construction Materials Laboratory of ITU Civil Engineering Faculty. Details for each core specimen, their compressive strengths and the obtained compressive strength for frame as a result of correlation between compressive test results of core sampling and compressive test results for 15 years old cylinders are given in Figure 3.13. The Figure 3.12 below shows the drilling and testing of core specimen.

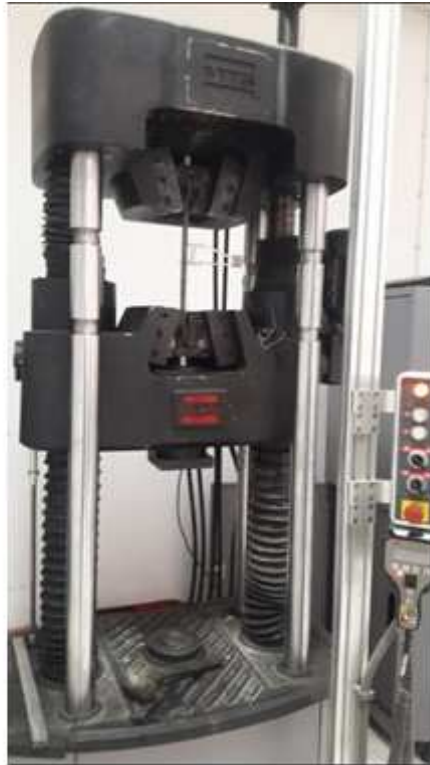
Figure 3.16: Test setup for longitudinal reinforcement

Five longitudinal reinforcing bars that were taken from one column of the frame were cut into eight part totally. Each specimen was tested under increasing tensile force till failure. An extensometer was utilized to obtain the vertical deformation during the tests. The data was recorded using a computerized system of the testing machine. Test set up is given in Figure 3.16 and Figure 3.17. After tests, stress-strain relationship of each specimen derived from the data obtained. Properties of specimens are given in Table 3.4. Tensile properties of the specimens after 15 years given in Table 3.5.

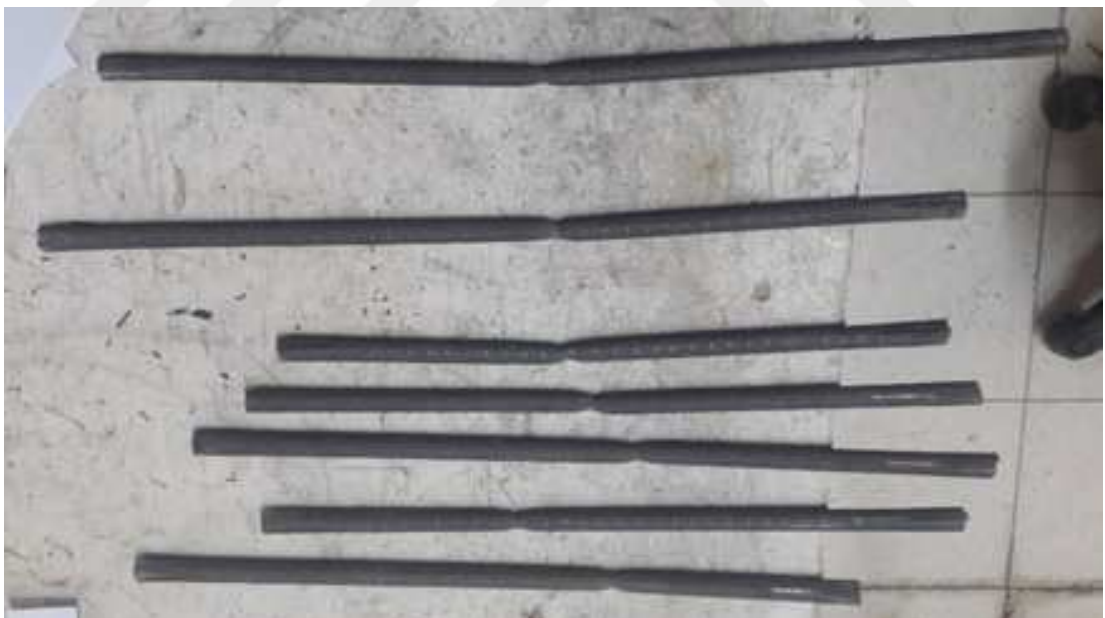
Figure 3.17: Configuration of the steel rebars after tensile test

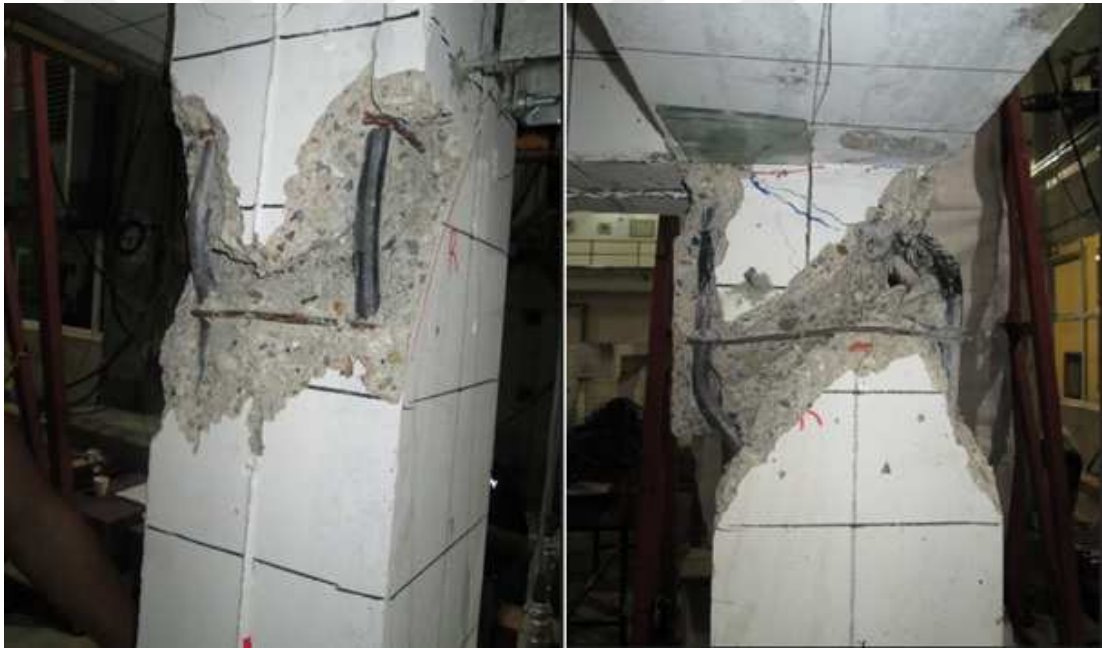
Figure 4.5: Bending and shear failure at right column top end

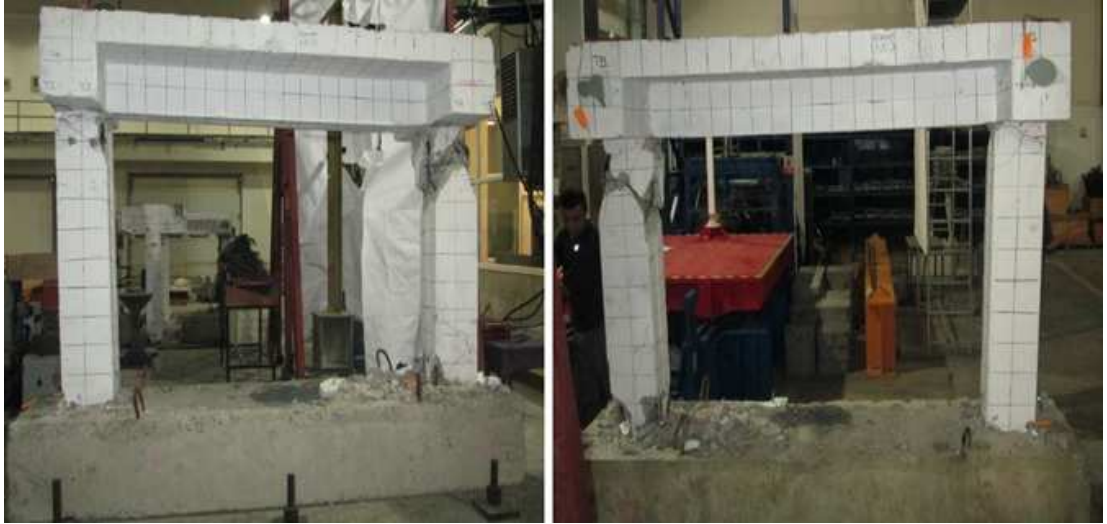
Figure 4.6: Front view and back view of the specimen-A, respectively, at the end of the test

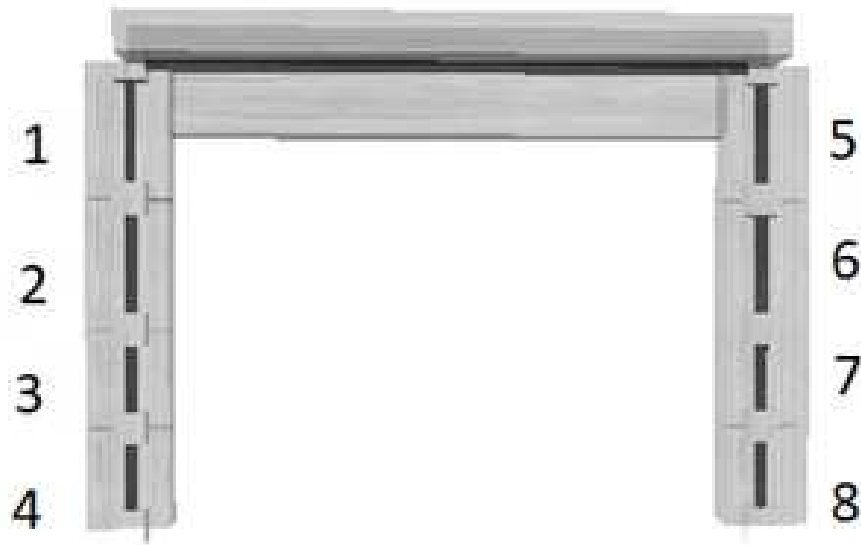
Figure 5.6: Definition of the frame elements in theoretical model used in SeismoStruct

When the nonlinear cyclic analysis is done, SeismoStruct creates a report about damage states of the members. To represent these damage states for the cyclic loading, strain limits were used according to TEC2007 [41]. Figure 5.7 shows the strain limits to obtain damage states of the frame members according to TEC2007 [41]. Figure 5.6 shows how the frame is divided into smaller elements and how these elements are named as numbers to define damage levels separately.
