PRELIMINARY SEISMIC EVALUATION OF HIGHWAY  
BRIDGES IN ISTANBUL

Submitted to the Kandilli Observatory and  
Earthquake Research Institute in partial  
fulfillment of  
the requirements for the degree of  
Master of Science  
in  
Earthquake Engineering

1995

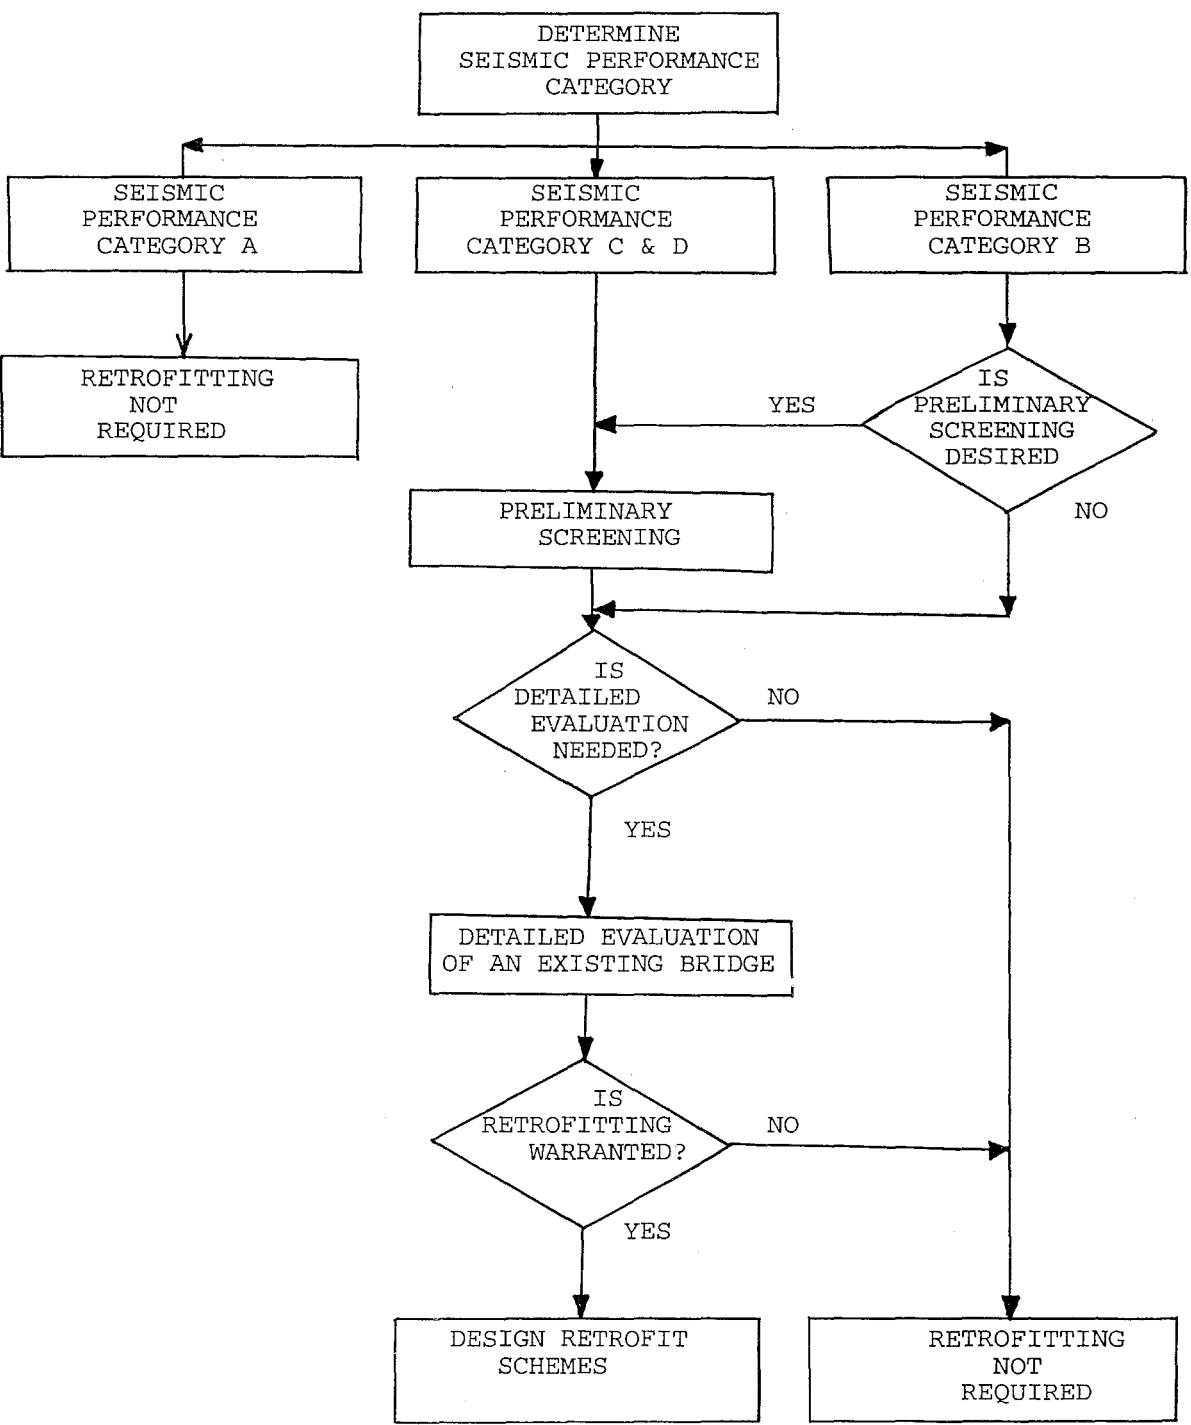
FIGURE 1.1 Seismic Retrofitting Process (ATC, 1983)

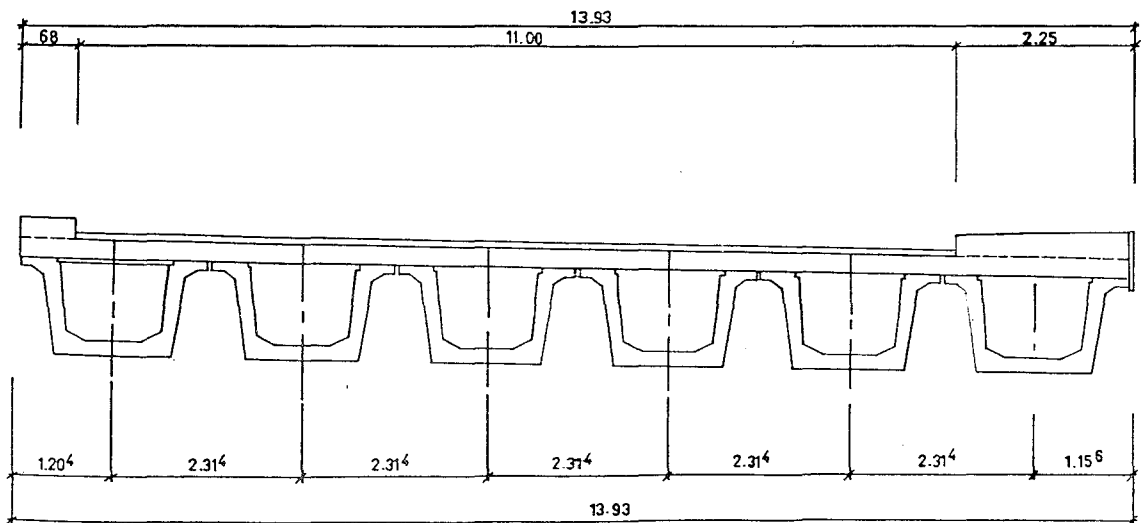
FIGURE 3.3 Typical cross-section of precast prestressed simple supported box beam.

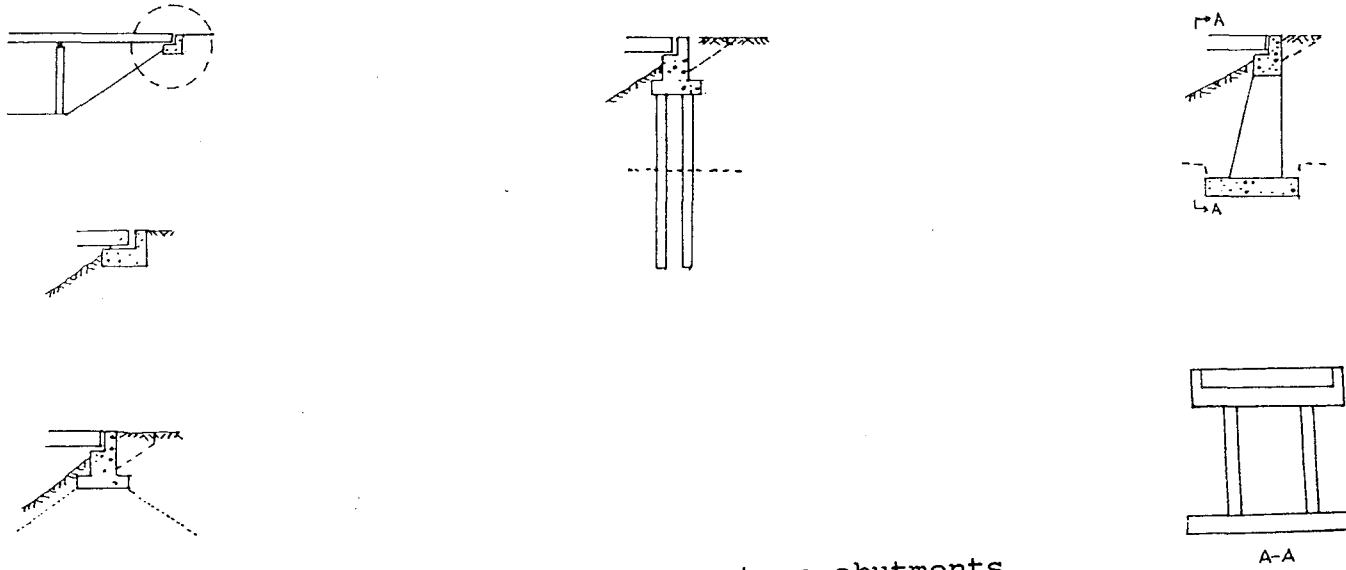
FIGURE 3.5 Open type abutments.

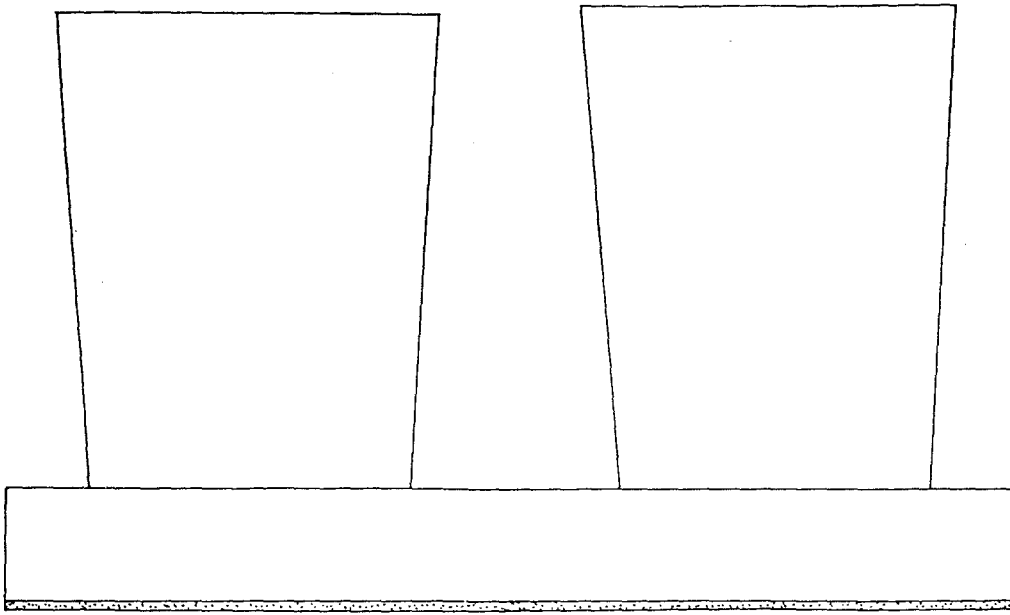
FIGURE 3.6      A typical wall type pier.

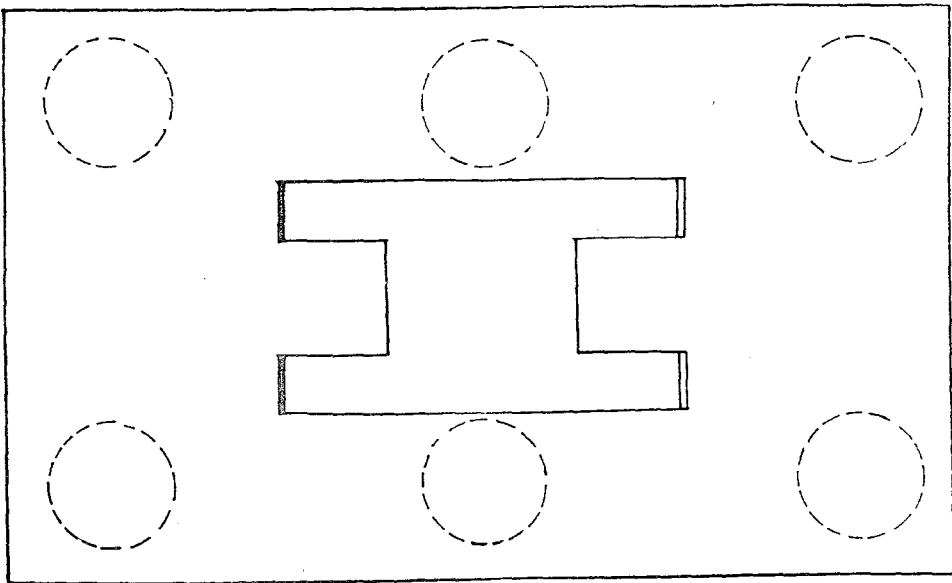
FIGURE 3.7      Plan view of a -H- section column.

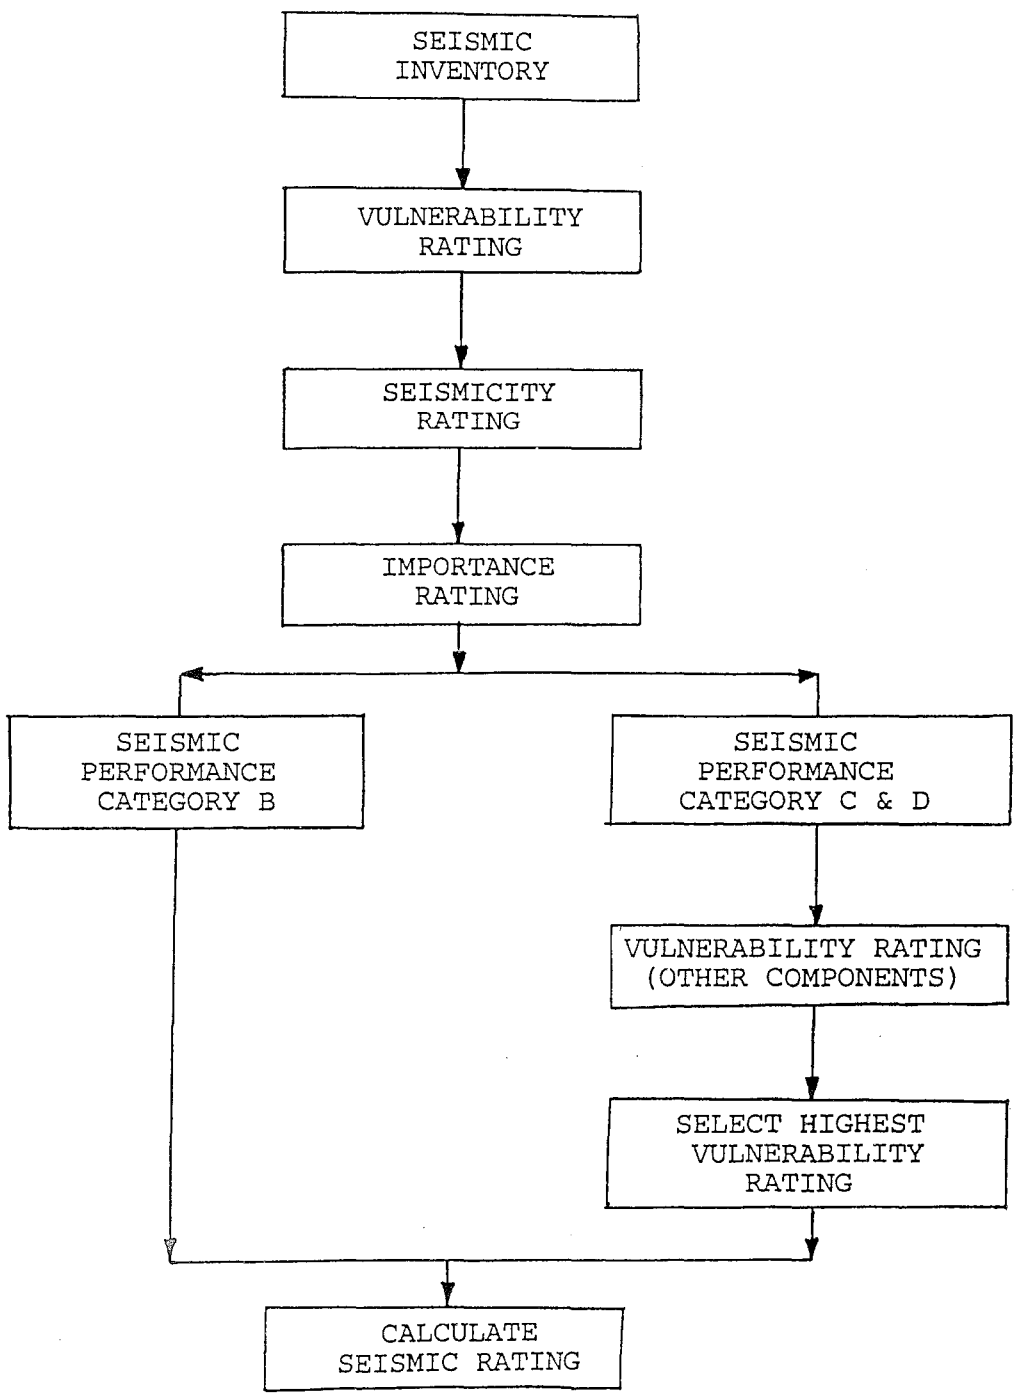
FIGURE 3.9 ATC preliminary screening process.

- 1- Vulnerability of bearings
- 2- Vulnerability of columns, piers and footings
- 3- Vulnerability of abutments
- 4- Liquefaction vulnerability of the bridge site

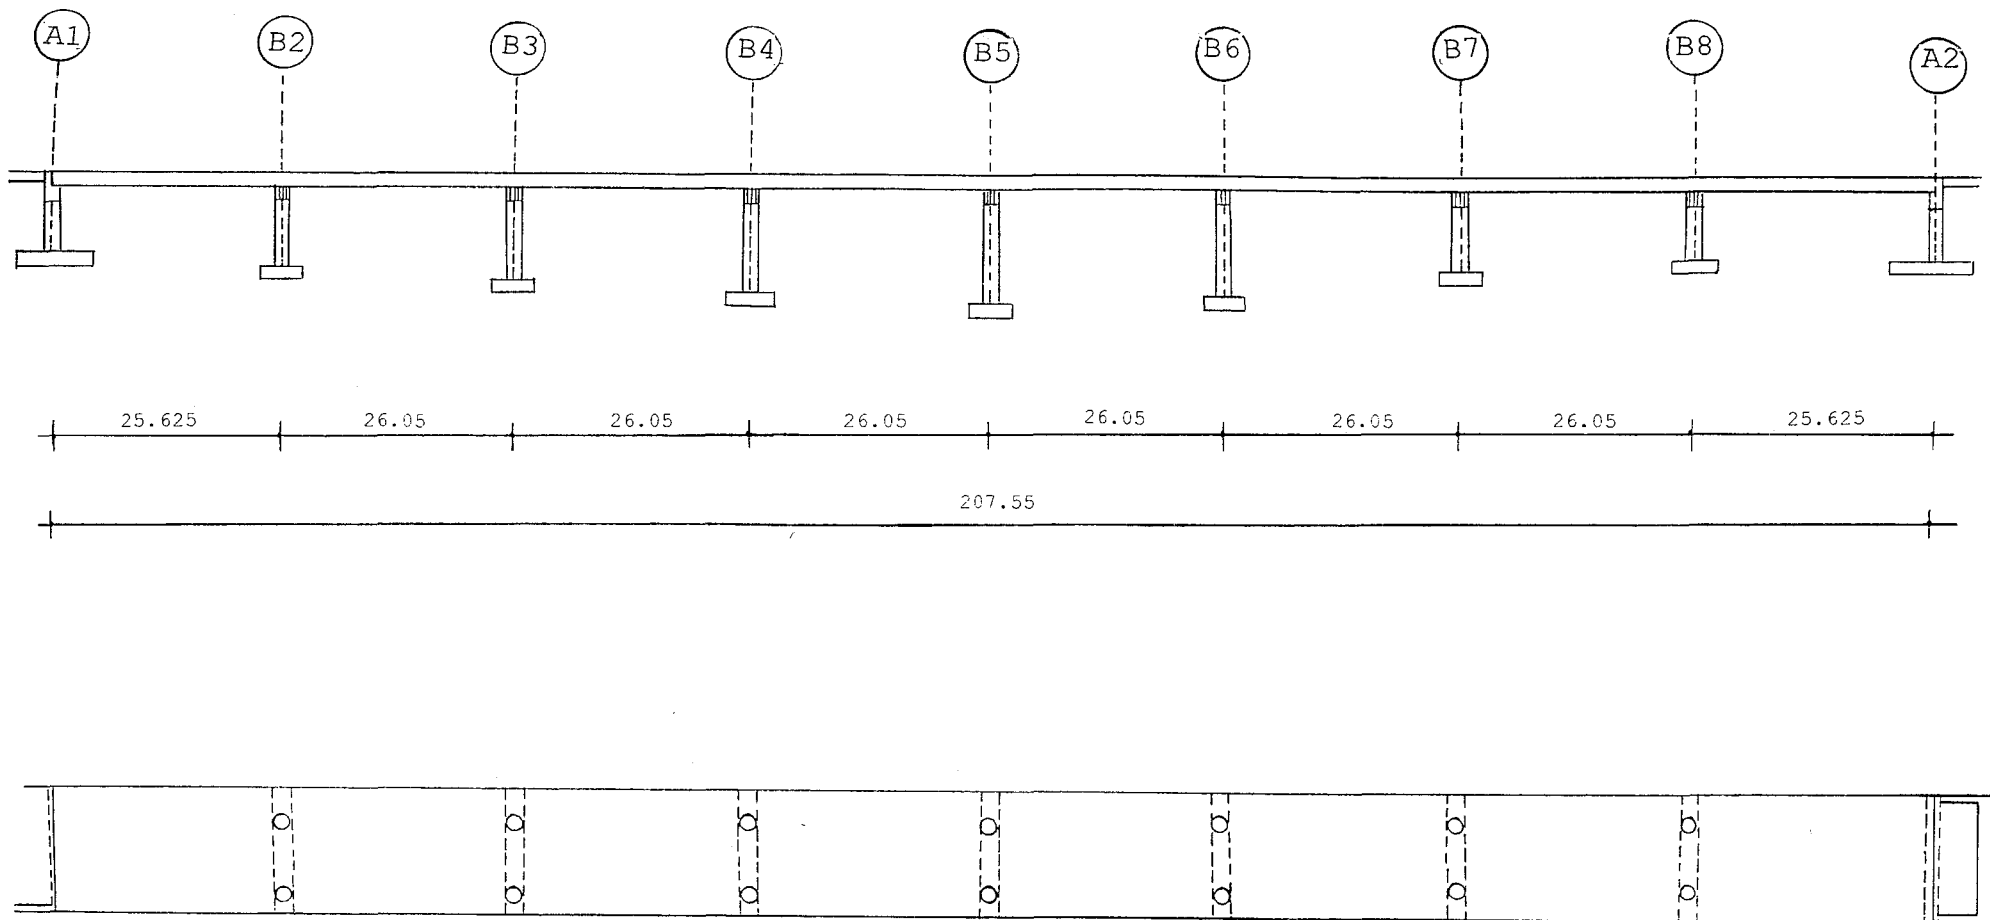
FIGURE 3.14 The basic structural configuration and dimensions of the K1 bridge.

The highway bridges in Istanbul were categorized into 6 in terms of their superstructure properties. As it is clearly seen from the Table 3.4, the majority of the bridges fall into the Category D which is a bridge with a Precast, Prestressed, Simple Supported Box Girder Superstructure. Thus for this case study such a bridge, (K1) was selected on 02 route. The location of the bridge is approximately marked on the map given in Figure 3.13. Total length of the bridge is 207.55 m and it has 8 simply supported spans. The length of the spans are 26.05 m in the mid-spans and 25.625 m in the side-spans. The columns of the piers have circular cross-section with a diameter of 1.65 m and the columns of the abutments have square cross-section with a dimension of 1.5 m. The maximum height of the piers is 12.0 m. The basic structural configuration and dimensions of the K1 bridge are given in Figure 3.14.

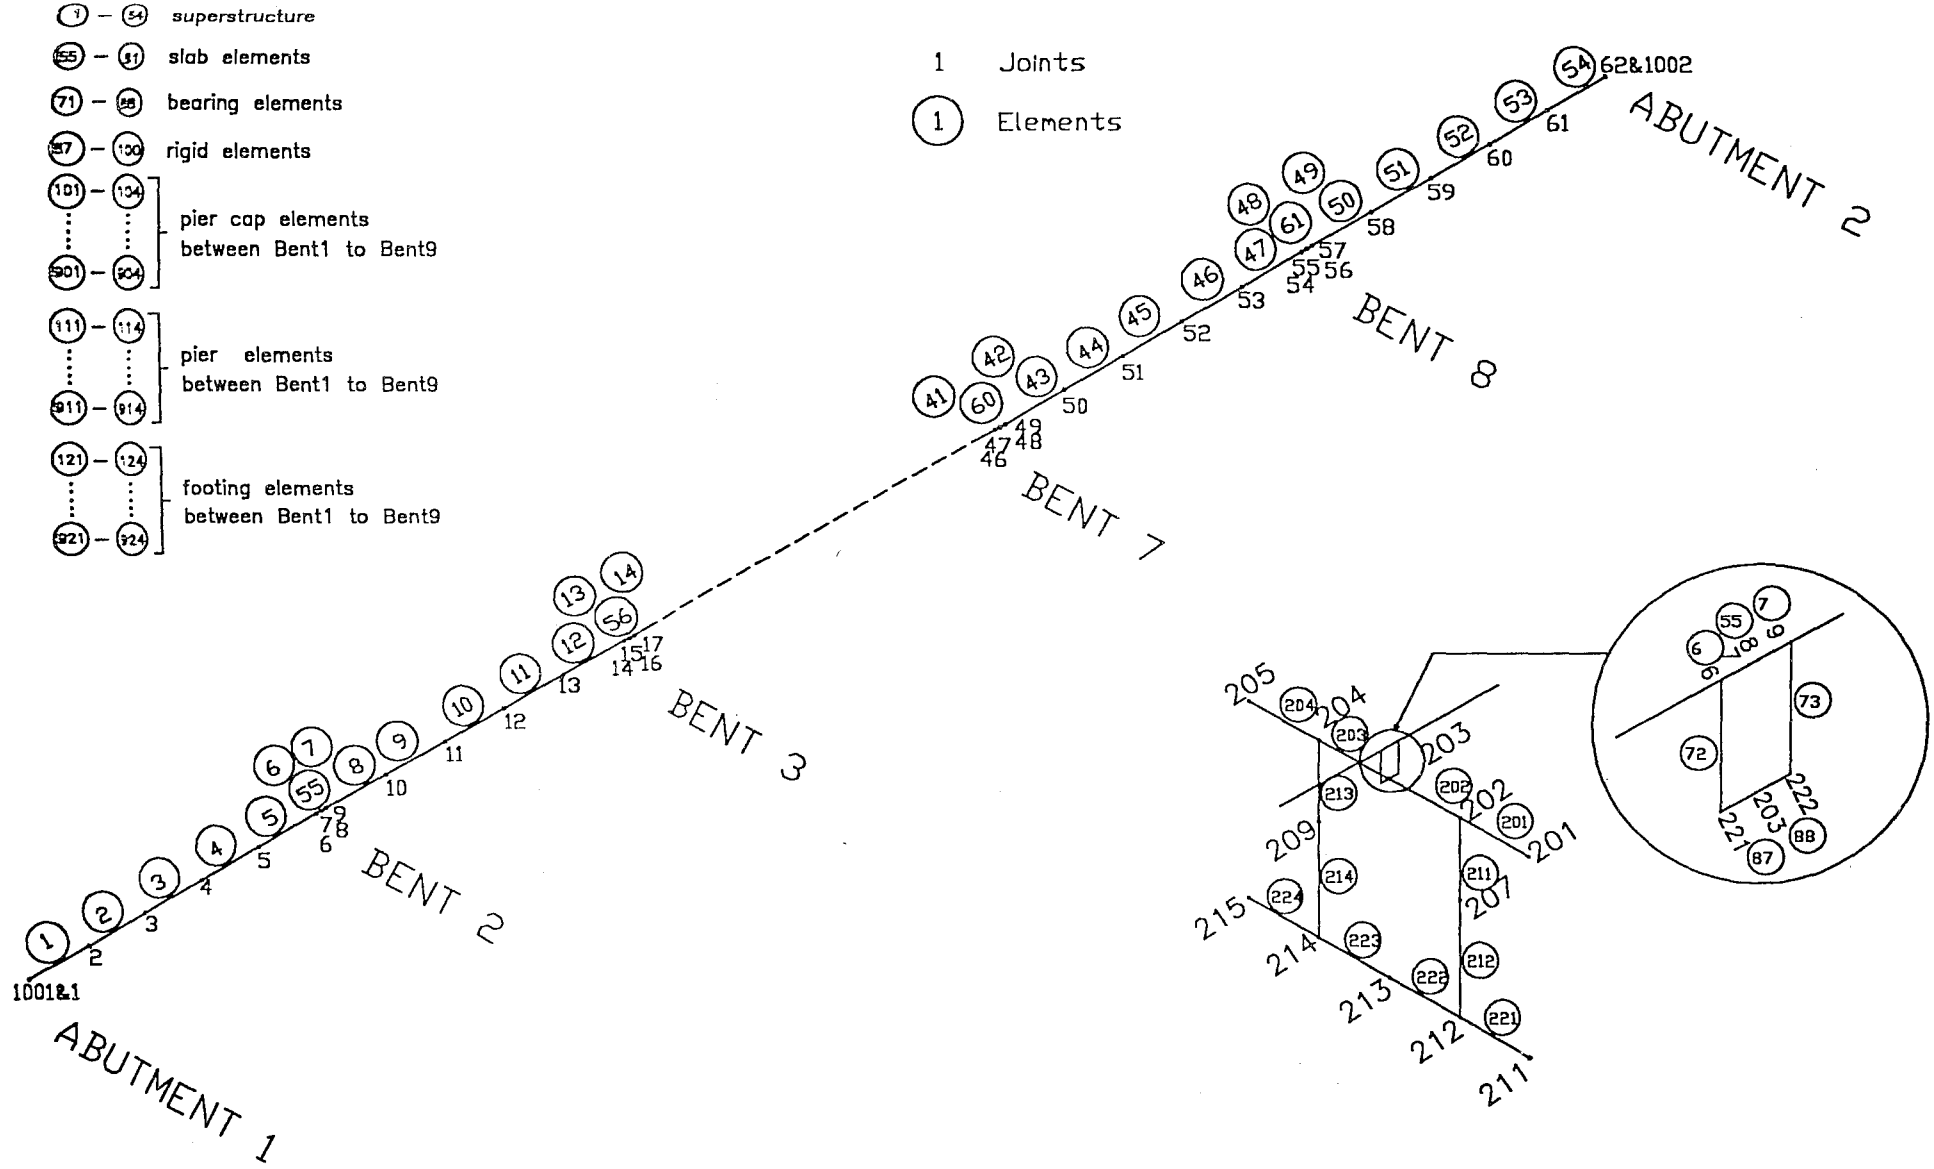
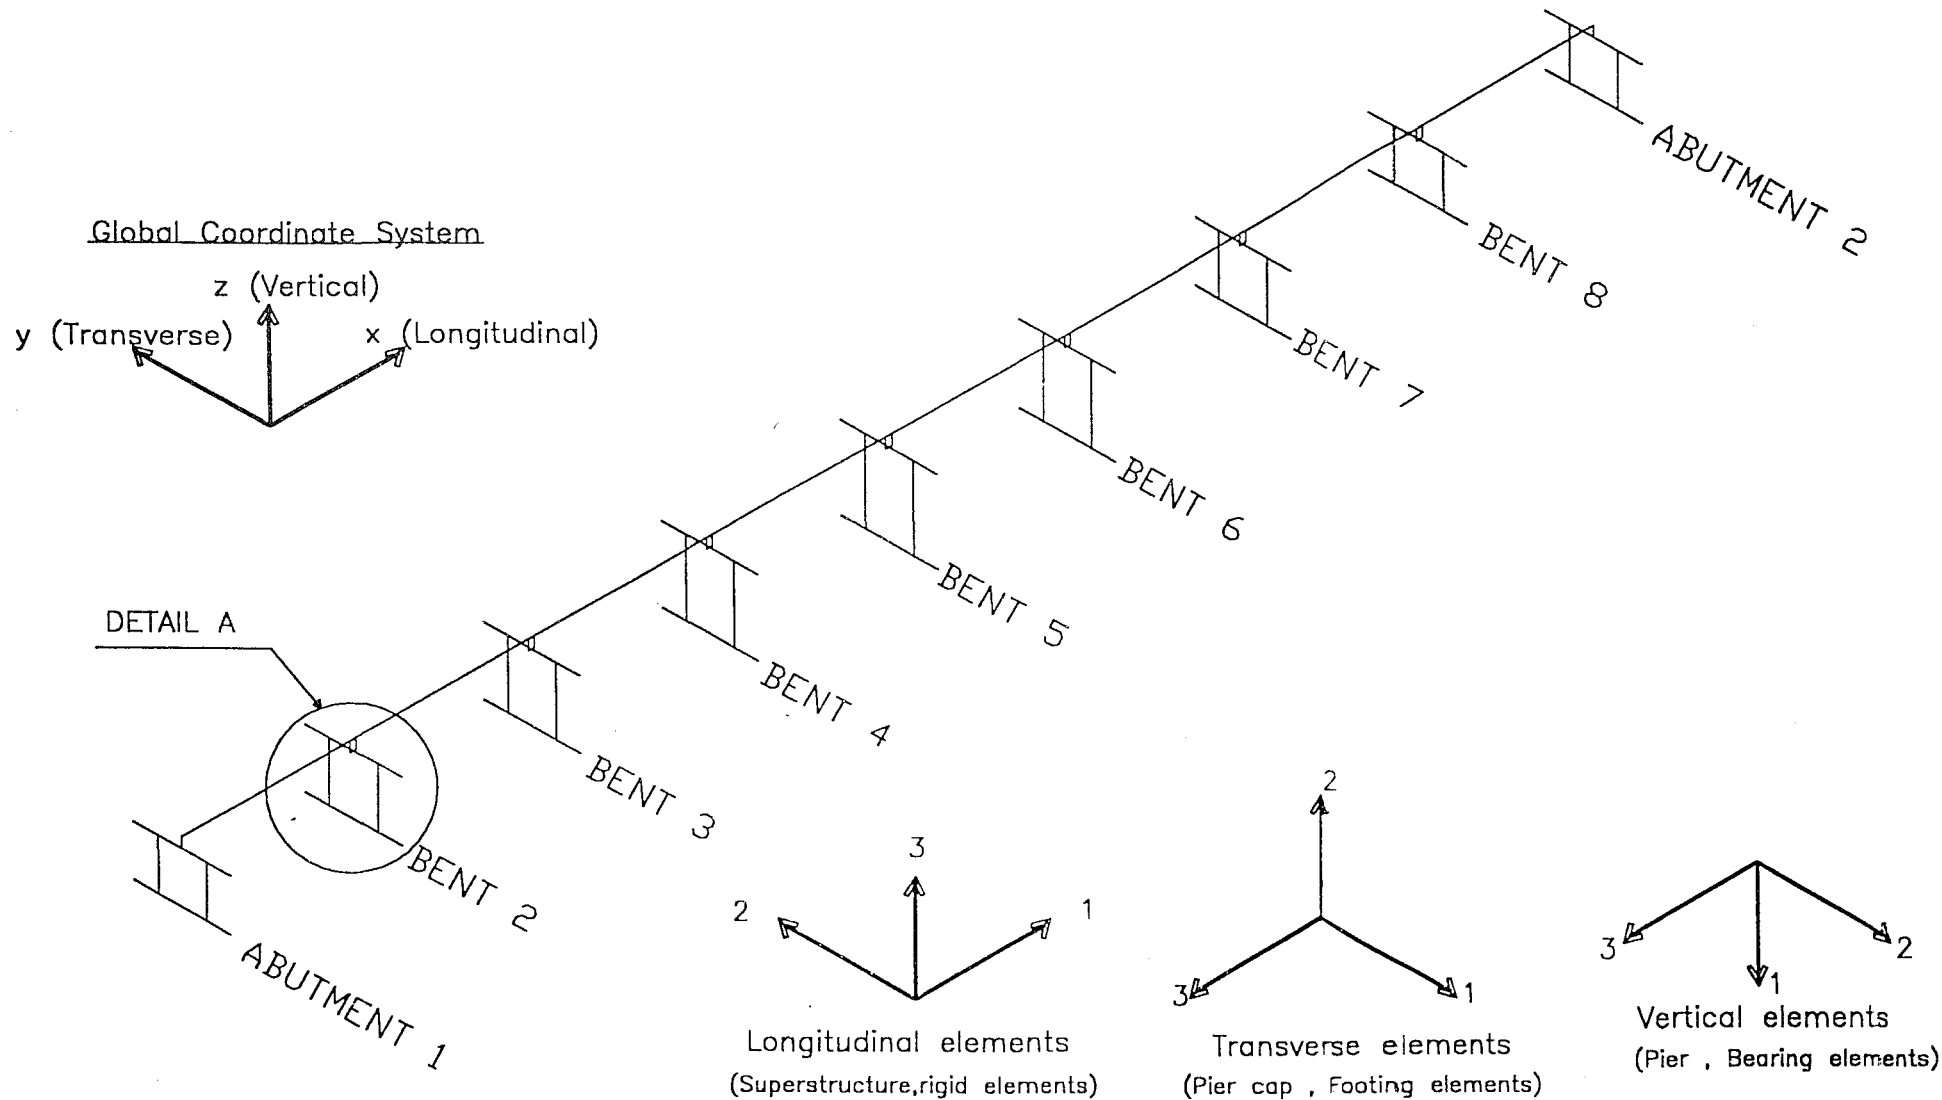
FIGURE 3.15 The frame element model of the K1 bridge.

FIGURE 3.15(contd.) The frame element model of the K1 bridge

**Bearings :** The bearings were modeled as frame elements between the Superstructure and the Pier Cap. The stiffness of these frame elements were assigned as the stiffnesses of the bearings. The top joint of the bearing element was connected to superstructure element and the bottom joint of the bearing element was connected to a stiff-connection element as shown in Figure 3.15 (Detail A).

**Two-Column Bents :** Each column of each bent was separately modeled with two frame elements, running along the centerlines of the columns, as shown in Figure 3.15 (Detail A).

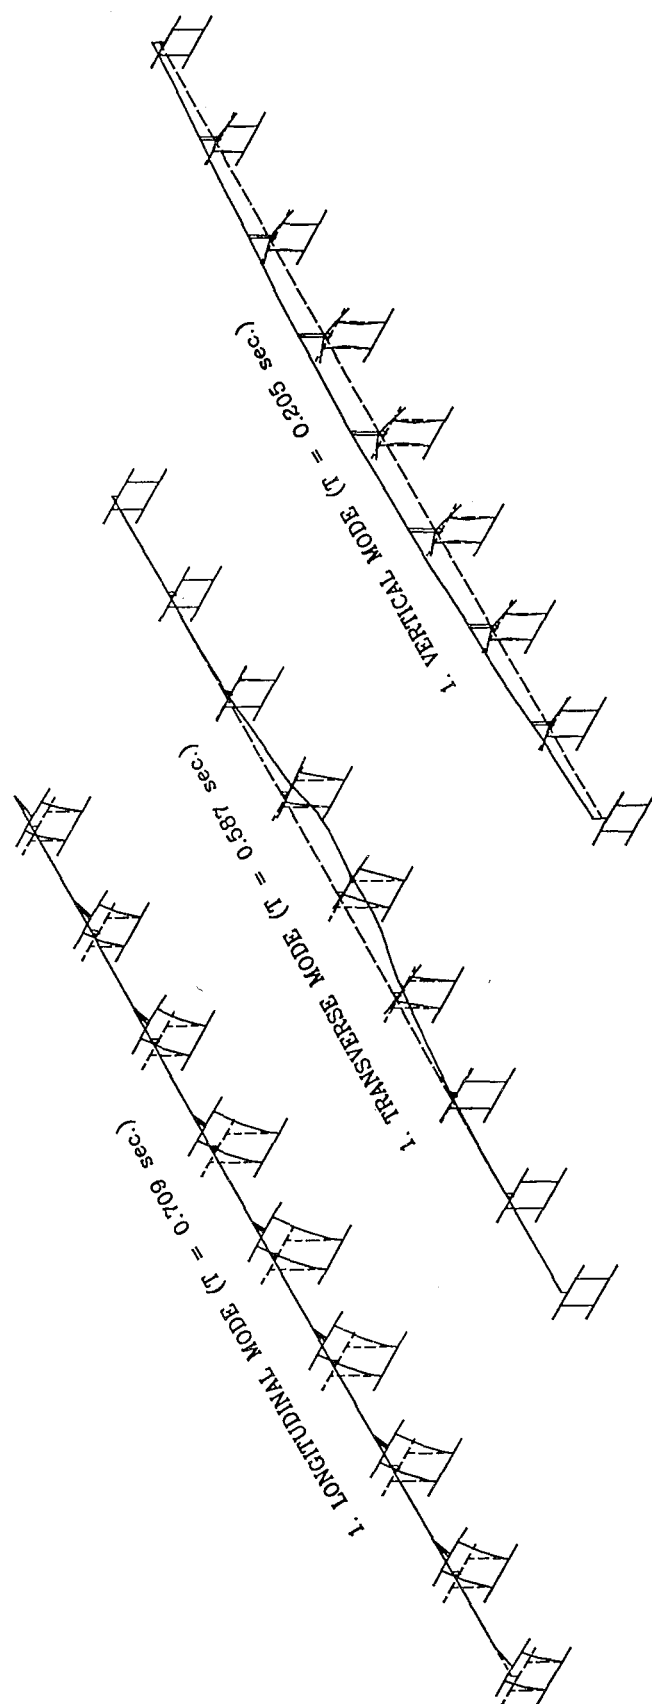
FIGURE 3.16 Mode shapes of the K1 bridge in 3 direction.

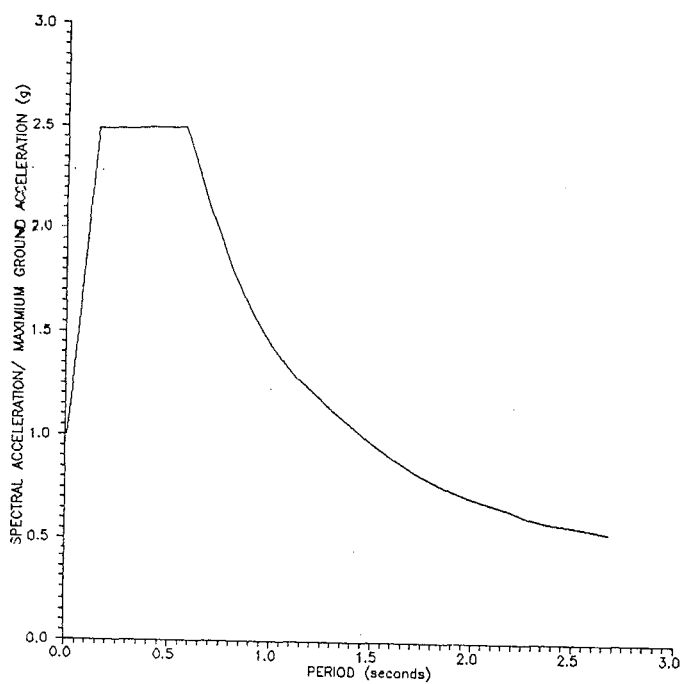
FIGURE 3.17 The AASHTO normalized response spectra.

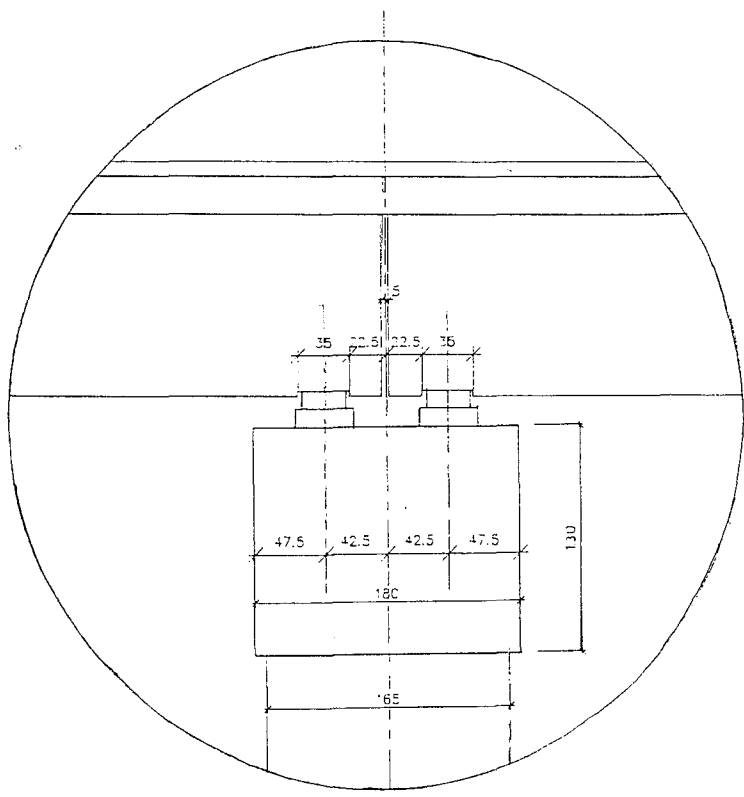
FIGURE 3.18 Support length detail of the K1 highway bridge.

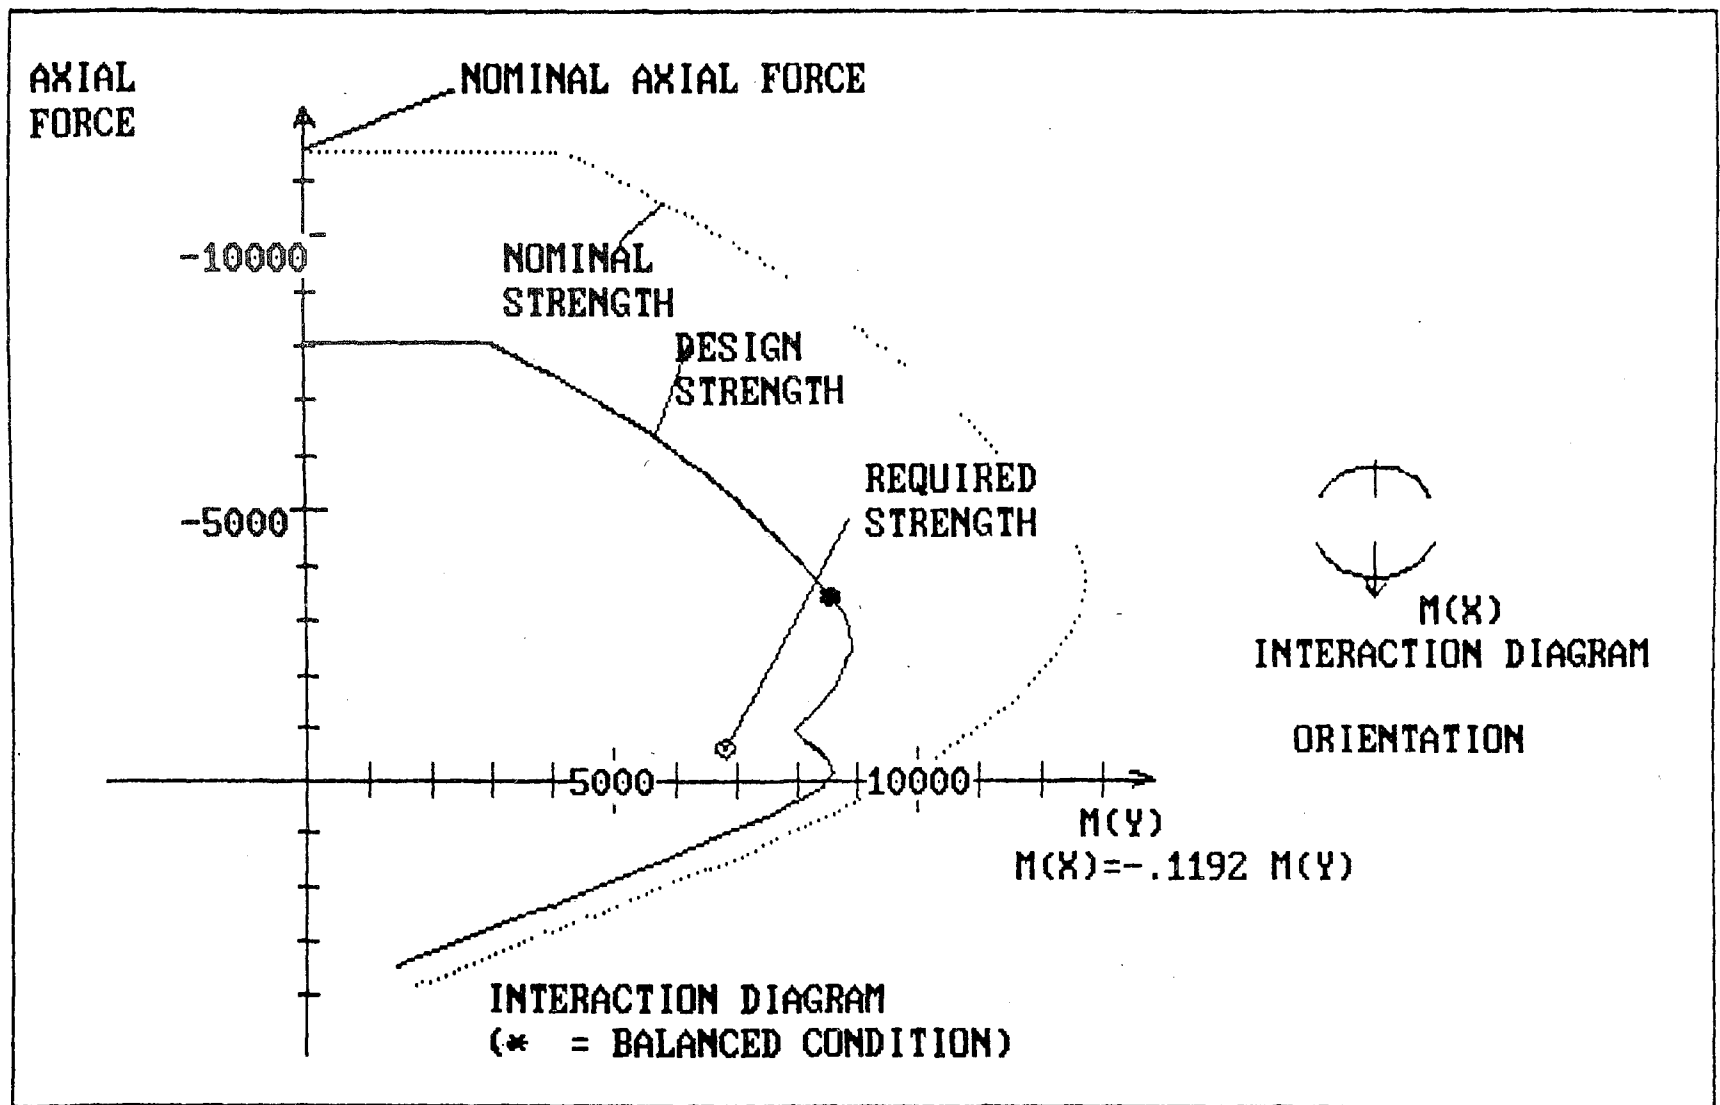
FIGURE 3.19 Interaction diagram of the K1 bridge.

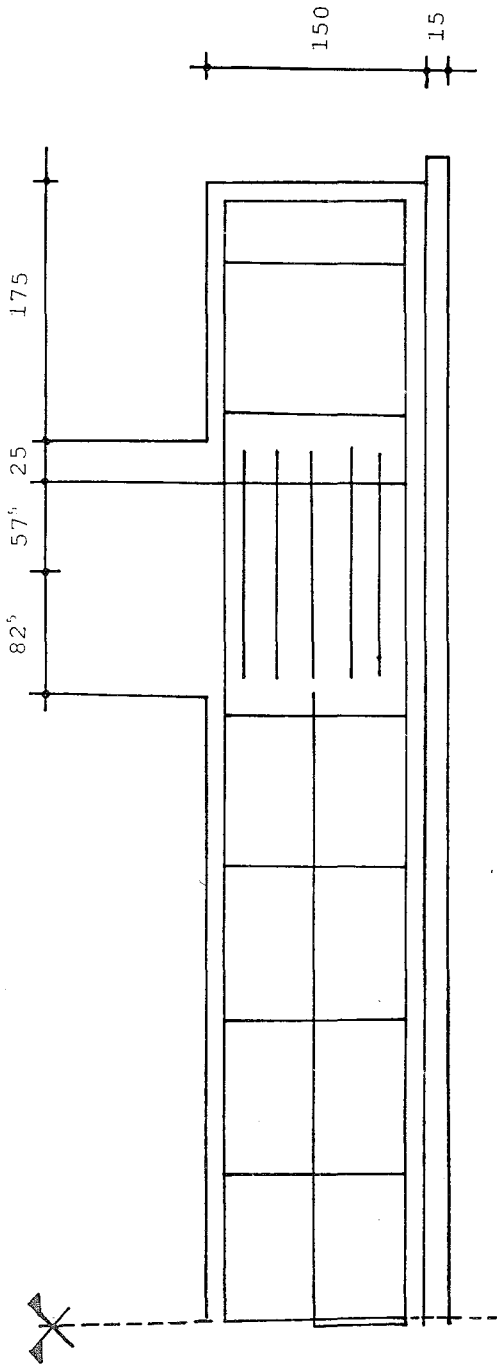
FIGURE 3.20 Cross section view of K1 bridge footing.

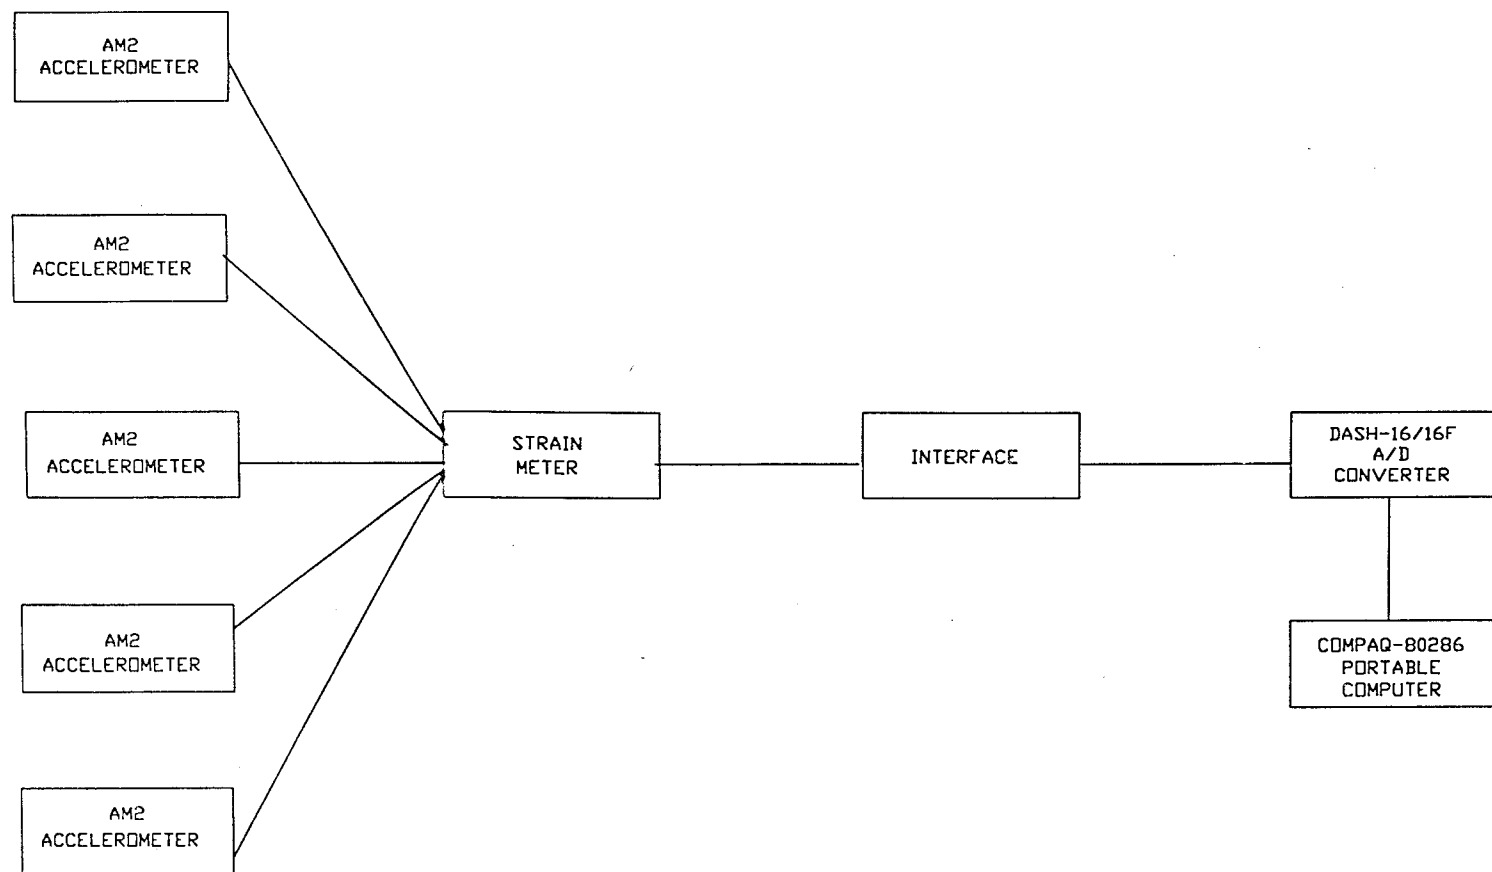
FIGURE 4.1 The main components of the testing equipment

In addition to above, sufficient amount of Cables, an Interface (which transfers the filtered records to A/D converter) and Compaq Portable Computer 80286 were also used during the test.

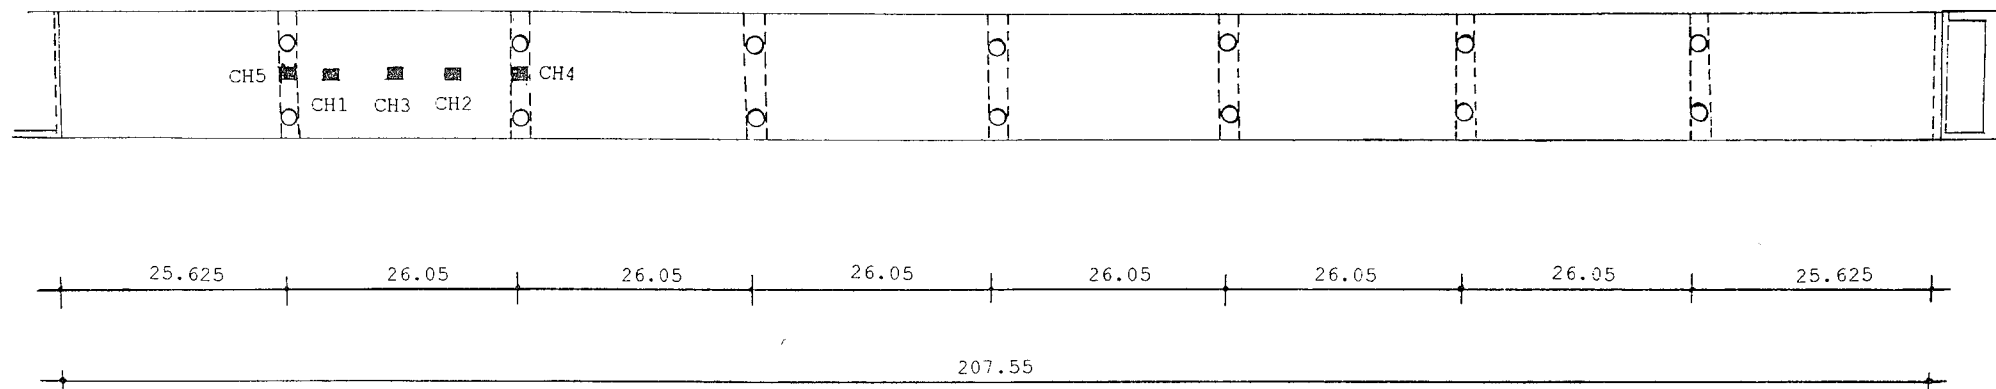
FIGURE 4.2 Location of the accelerometers on the K1 highway bridge.

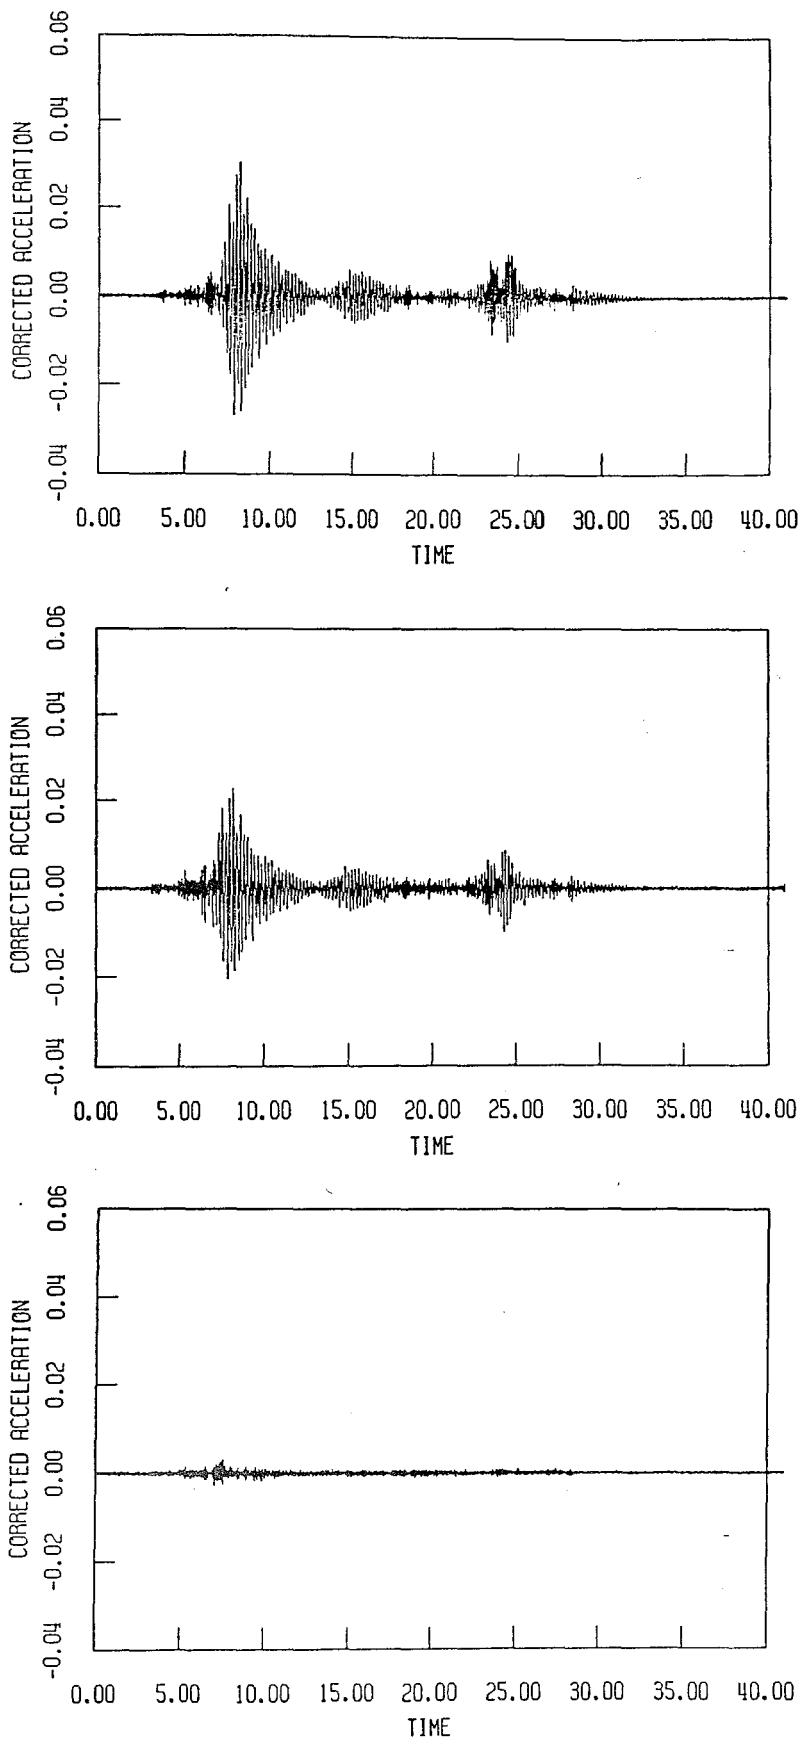
FIGURE 4.3 Corrected acceleration-time histories of test 3 for channel 3, 1 and 5 respectively.

Data processing involves baseline correction, conversion of data from volts to  $\text{cm/s}^2$ , high pass filtering and low pass filtering. Corrected accelerations are shown in Figures 4.3 and 4.4. The F.A.S. of the channels 3,1 and 5 from test 3 and test 5 are given in Figures 4.5 and 4.6. From these plots it is concluded in the vertical direction the natural frequency of the bridge site is at about 4.8 Hz.

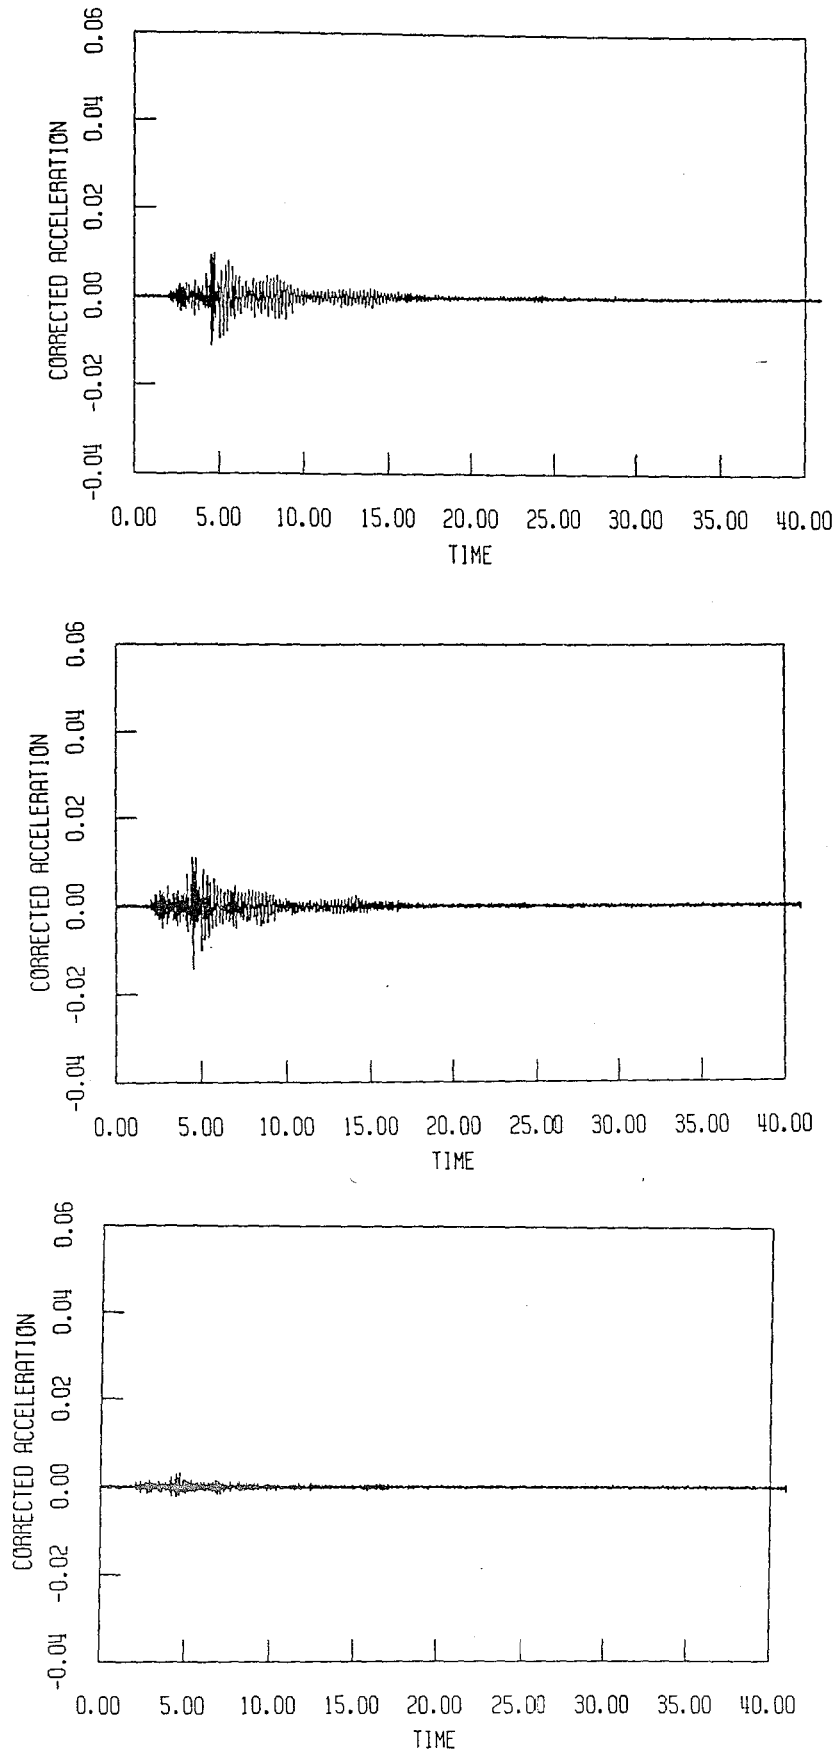
FIGURE 4.4 Corrected acceleration-time histories of test 5 for channel 3, 1 and 5 respectively.
