PRELIMINARY SEISMIC EVALUATION OF HIGHWAY  
BRIDGES IN ISTANBUL

Submitted to the Kandilli Observatory and  
Earthquake Research Institute in partial  
fulfillment of  
the requirements for the degree of  
Master of Science  
in  
Earthquake Engineering

1995

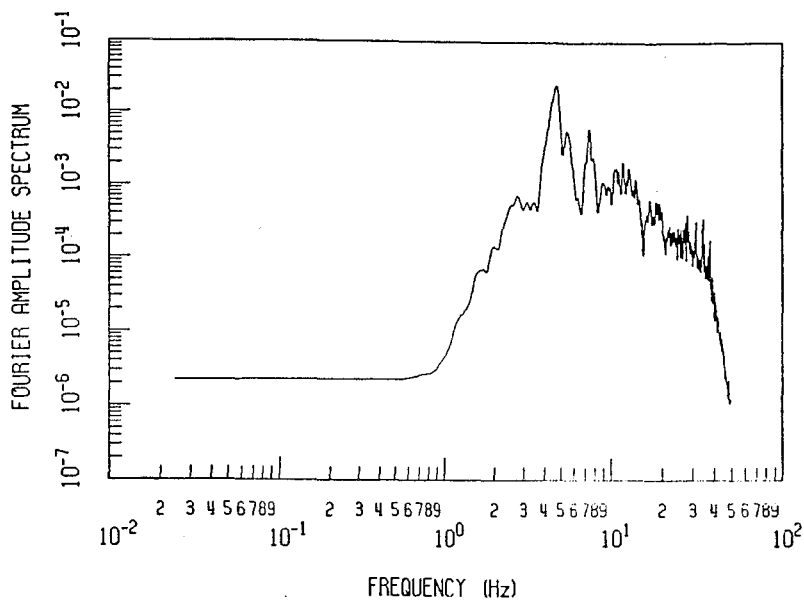
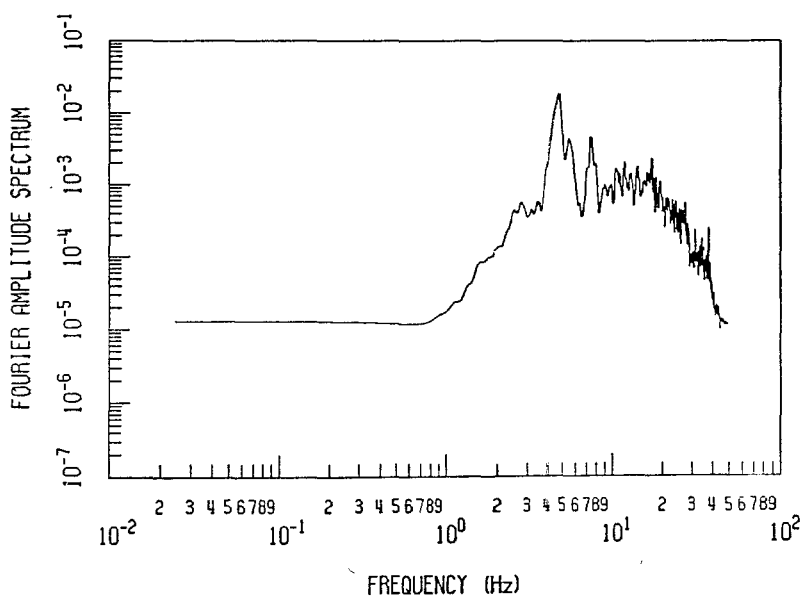
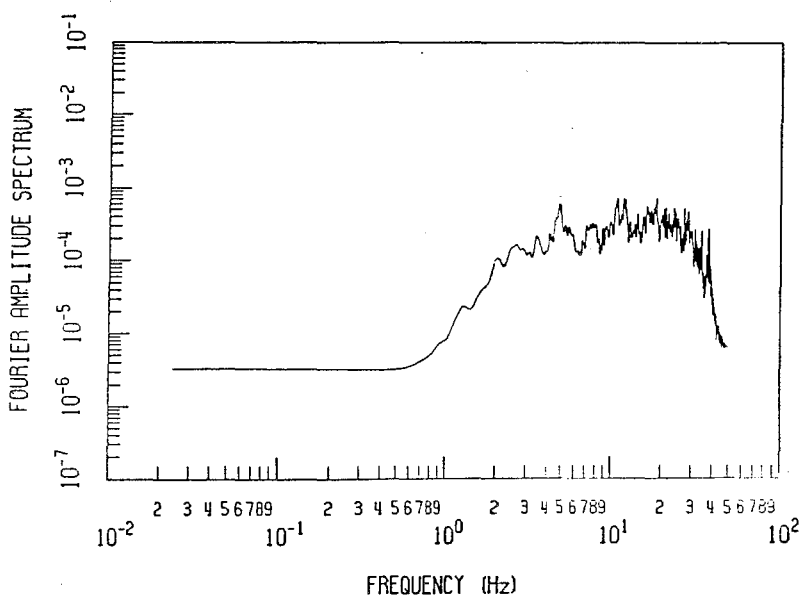
FIGURE 4.5

Fourier amplitude spectrums of test 3 for channels 3, 1 and 5 respectively.

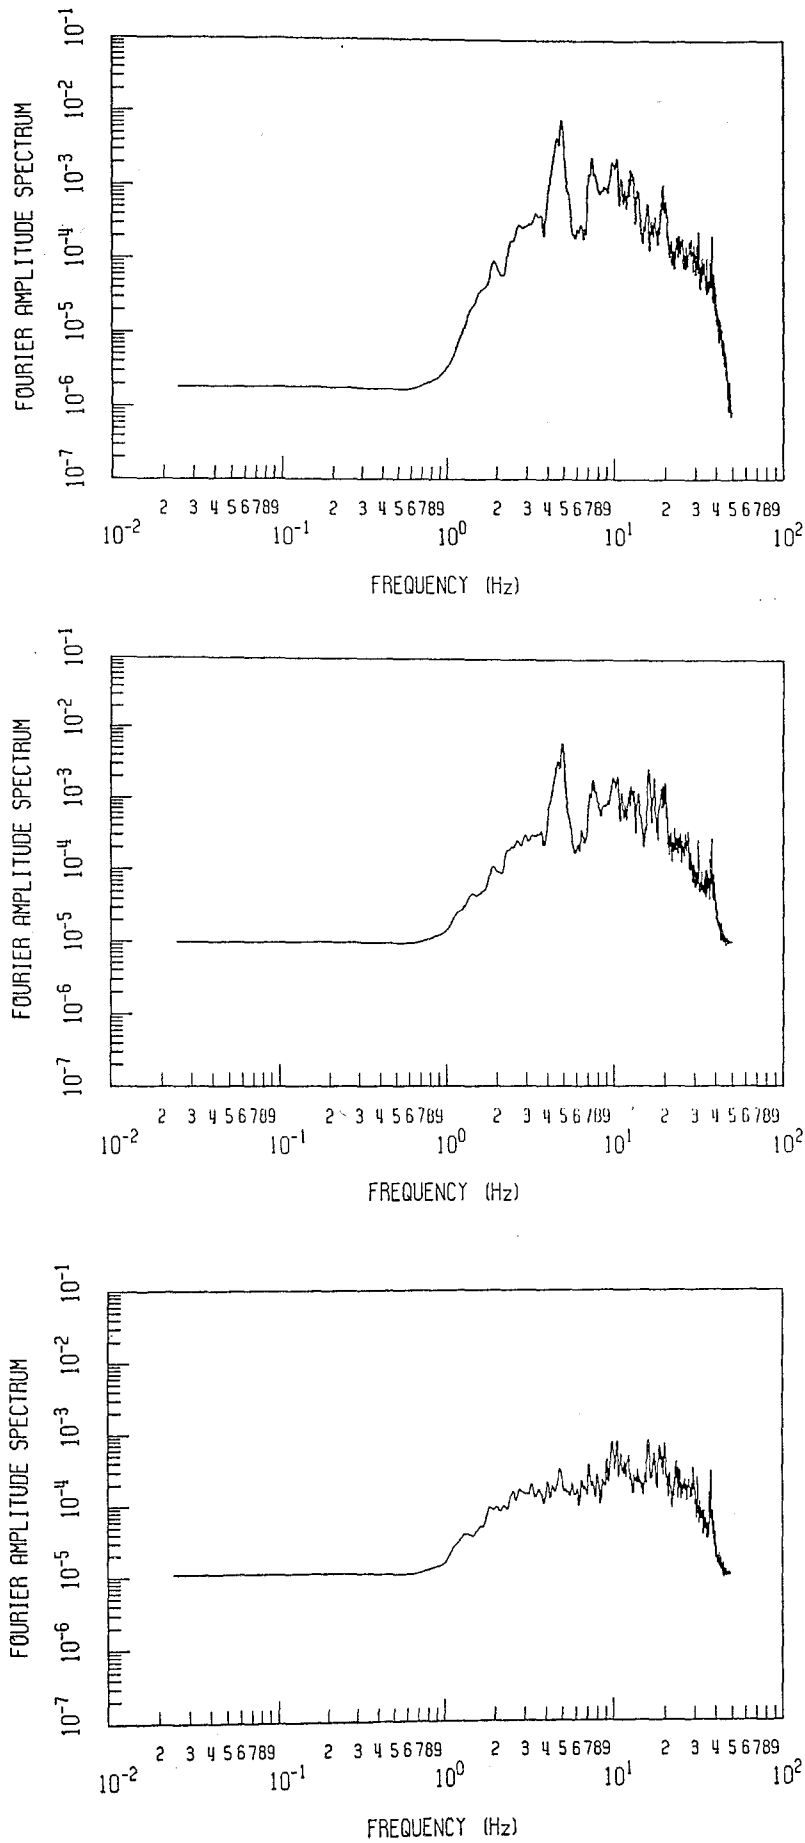
FIGURE 4.6      Fourier amplitude spectrums of test 5 for channels 3, 1 and 5 respectively.

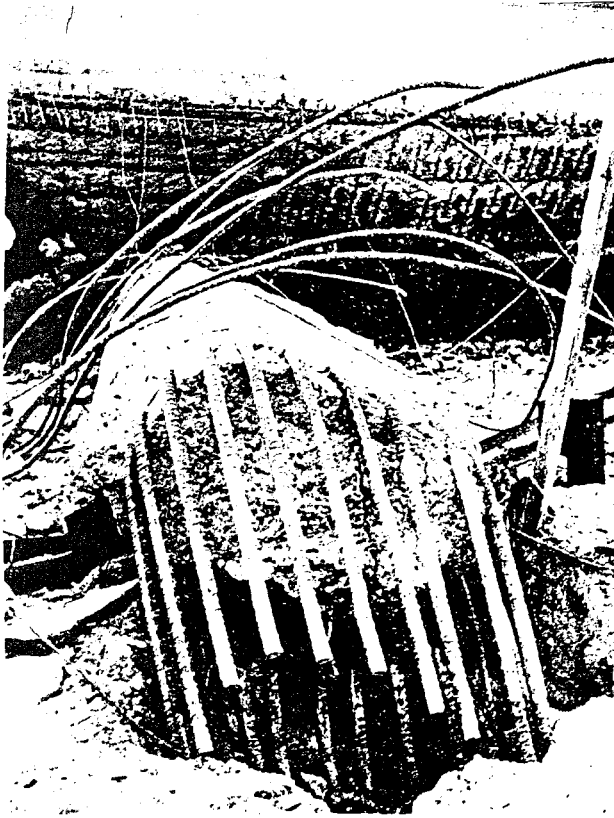
PHOTO B.1 Failure of a column due to insufficient anchorage.  
(San Fernando Earthquake of 1971), ATC (1979).

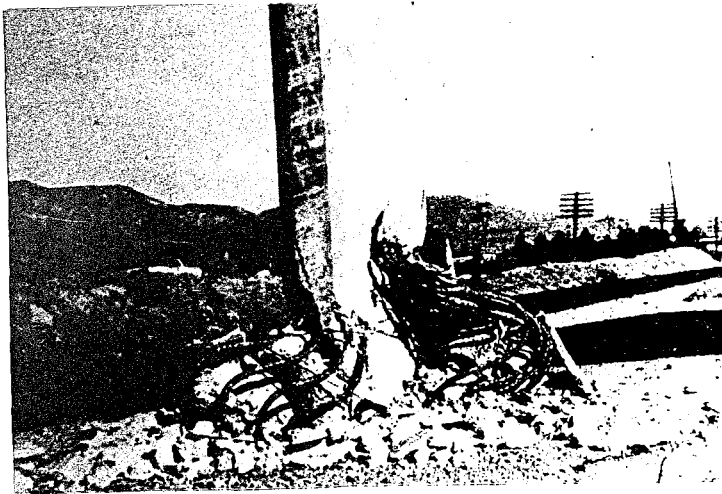
PHOTO B.2 Column Damage. (San Fernando Earthquake  
of 1971), ATC (1979).

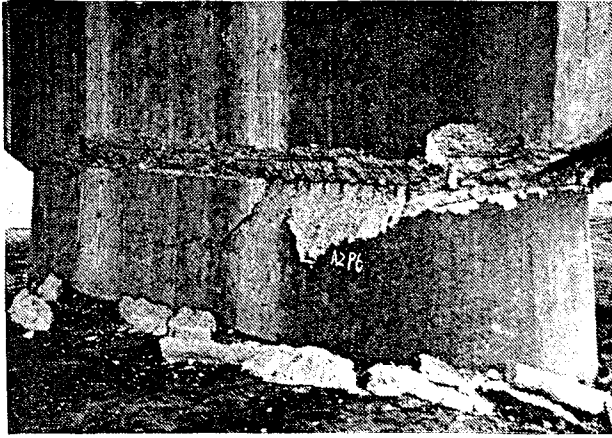
PHOTO B.3 Sendai Bridge, column damage.  
(Miyagi-ken-oki Earthquake of June 12, 1978),  
ATC (1979).

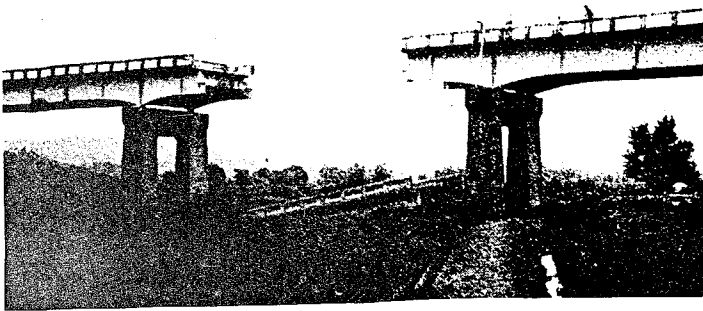
PHOTO B.4 Kin-noh Bridge, fall of suspended girder beam.  
(Miyagi-ken-oki Earthquake of June 12, 1978),  
ATC (1979).

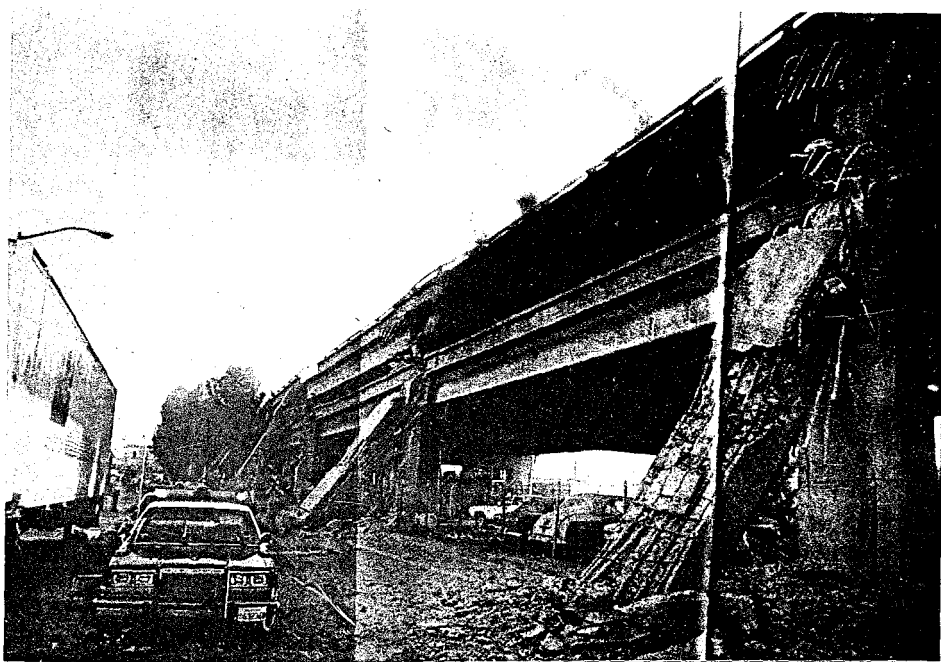
PHOTO B.6 Cypress Avenue (I-880) double deck crossing.  
(Loma Prieta Earthquake of October 17, 1989),  
Time (October 30, 1989).

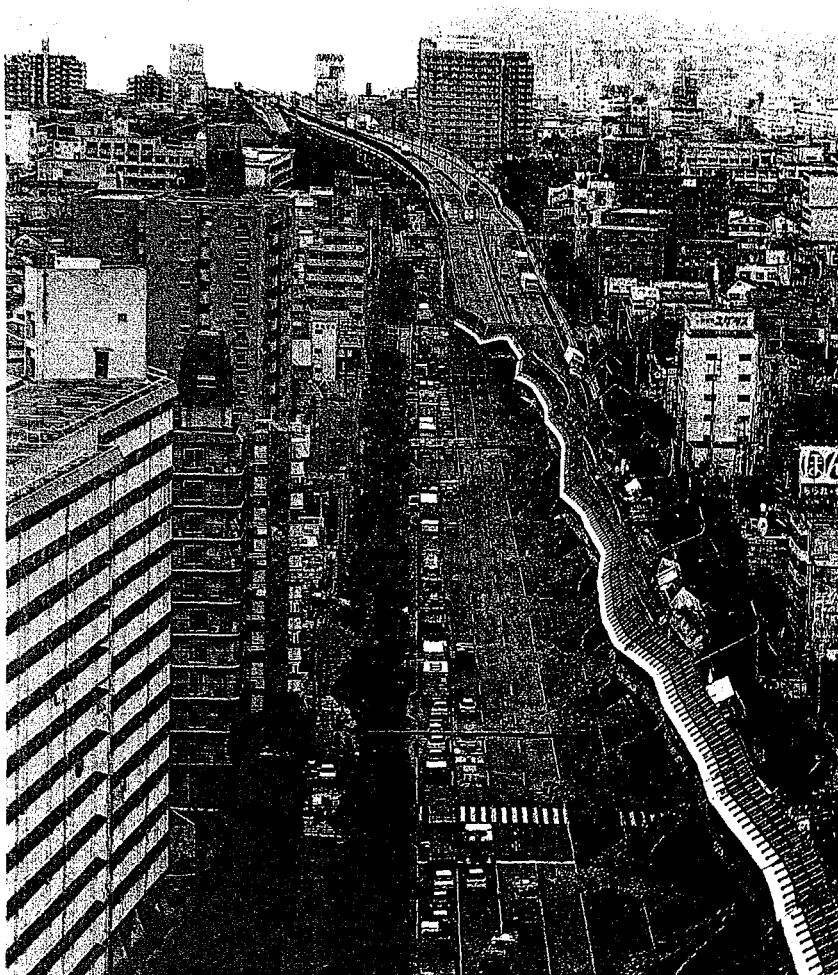
PHOTO B.7 Collapse of Hanshin Expressway.  
(Kobe Earthquake of January 17, 1995),  
(Aydinoğlu N., 1995).

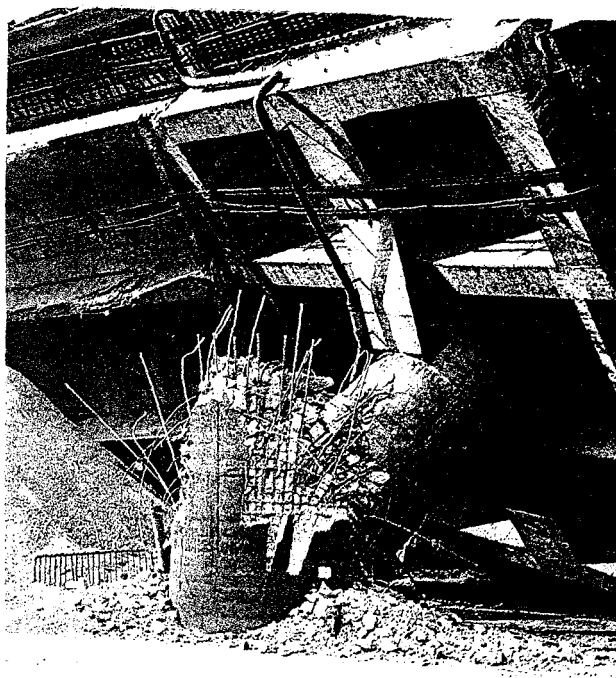
PHOTO B.8 Close view of a broken pier of Hanshin Expressway.  
(Kobe Earthquake of January 17, 1995),  
(Aydinoğlu N., 1995).

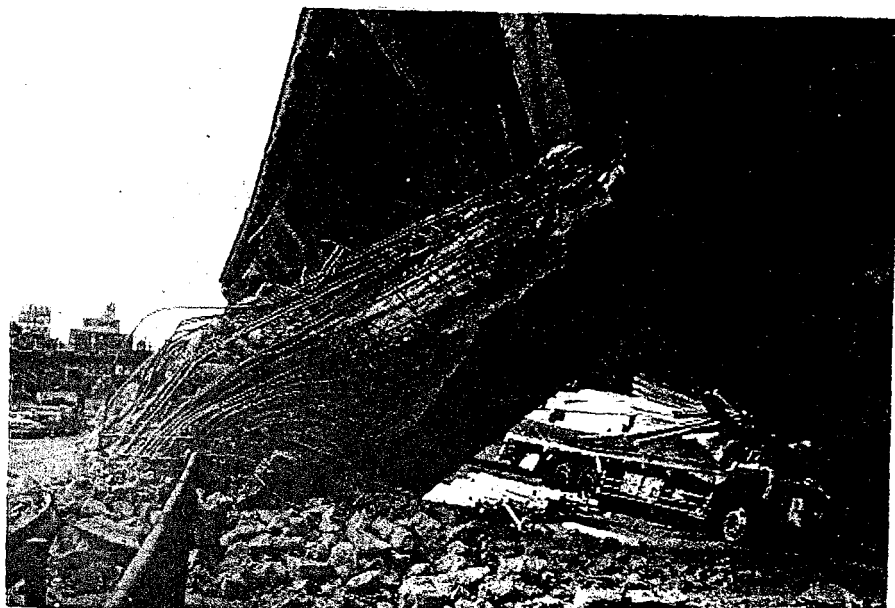
PHOTO B.9 Close view of a broken pier of Hanshin Expressway.  
(Kobe Earthquake of January 17, 1995),  
(Aydinoğlu N., 1995).

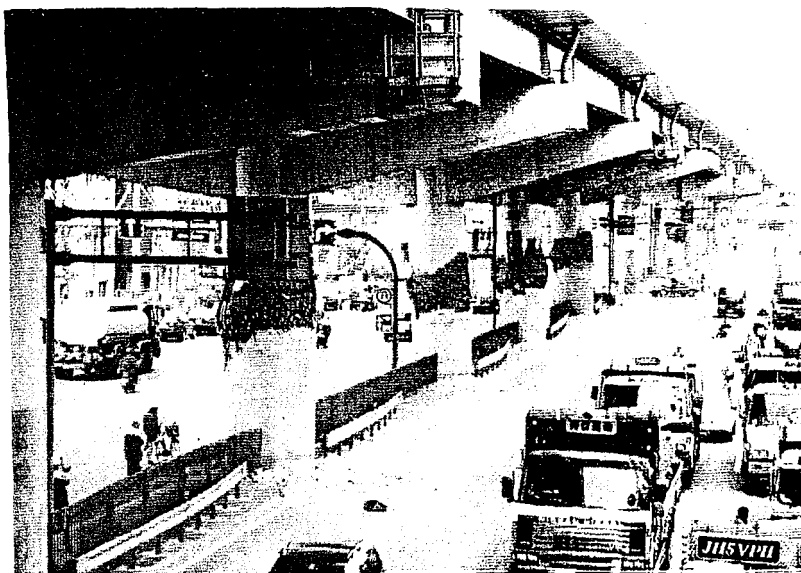
PHOTO B.10 A group of piers on Hanshin Expressway with mid-height damage.

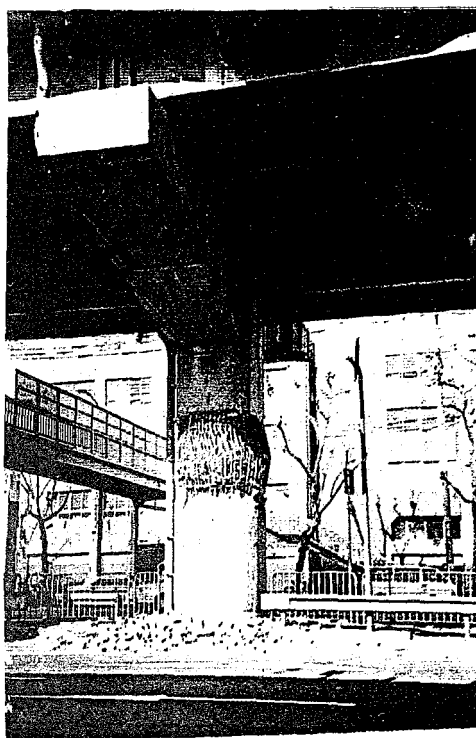
PHOTO B.11 A typical pier on Hanshin Expressway with mid-height damage.

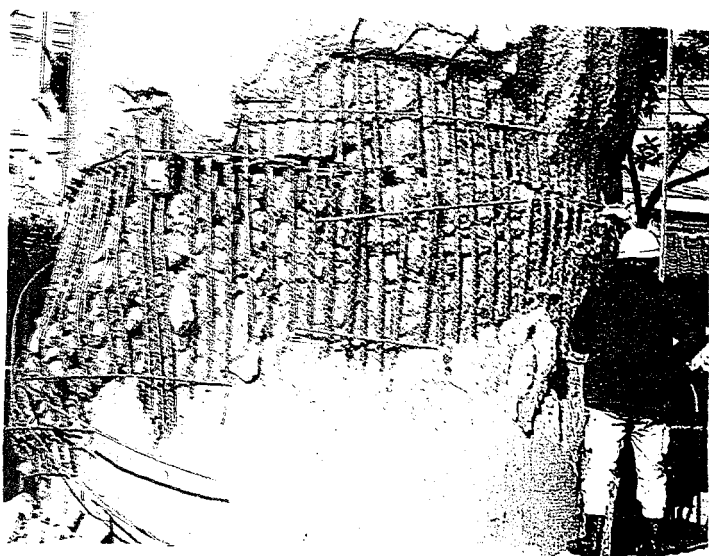
PHOTO B.12 Close view of mid-height pier damage on Hanshin Expressway.

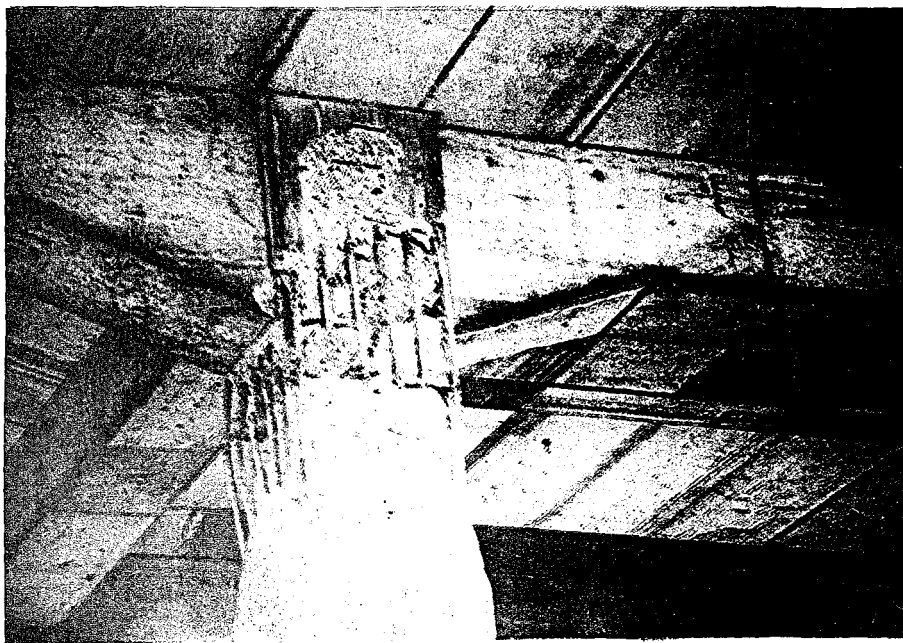
PHOTO B.13 Lack of transverse reinforcement at column-girder joints of Shinkansen Line Bridges.

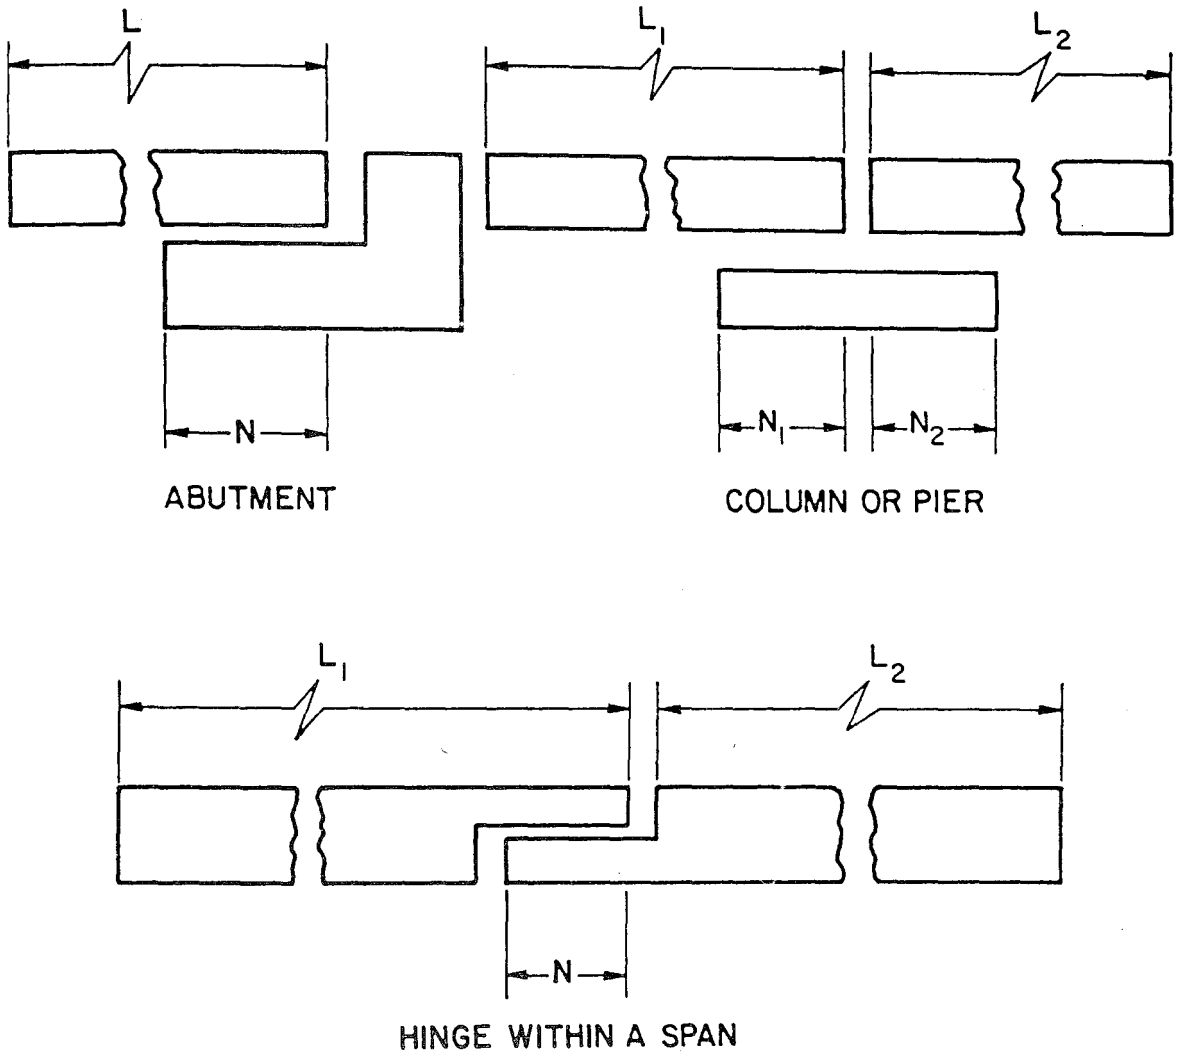
FIGURE C.1      The illustration of the minimum support length.

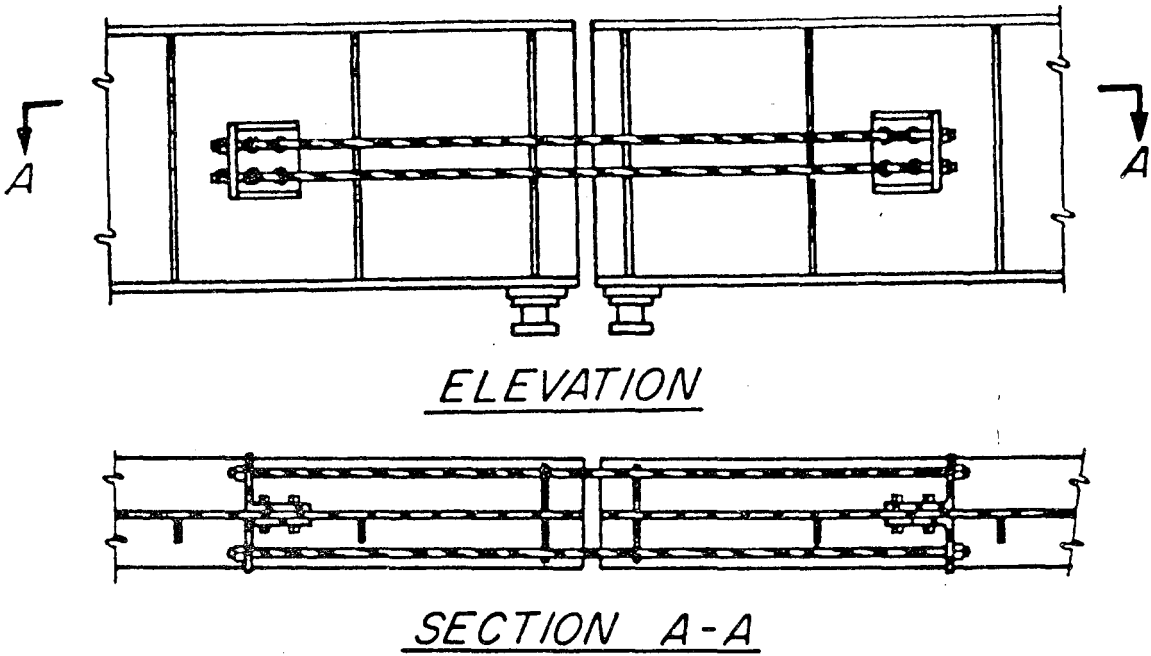
FIGURE G.1 Undesirable restrainer detail (ATC, 1983).

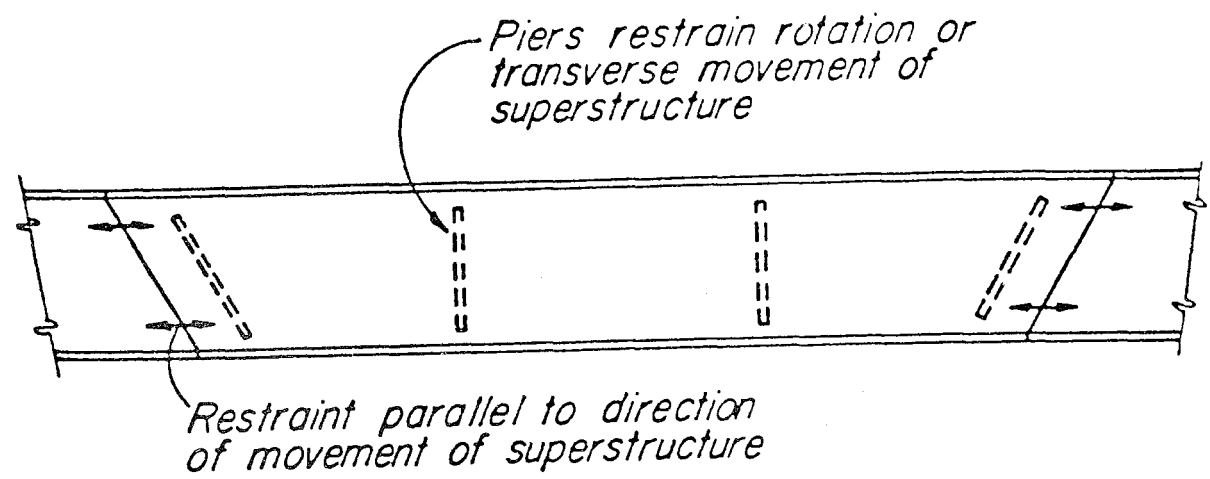
FIGURE G.2 Restrainer orientation-transversely rigid supports (ATC, 1983).

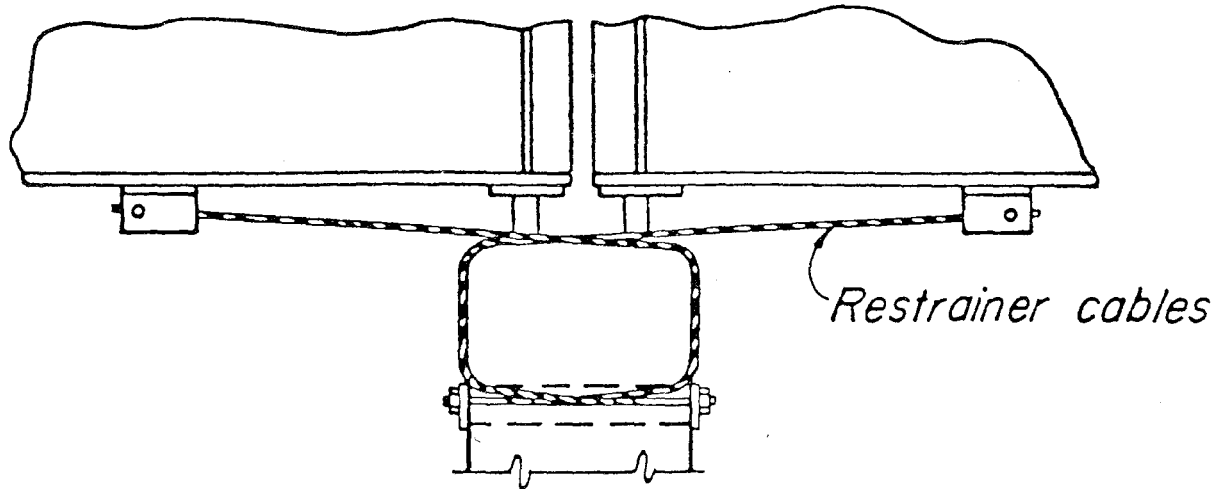
FIGURE G.4      Restrainer at pier-positive tie to pier (ATC, 1983).

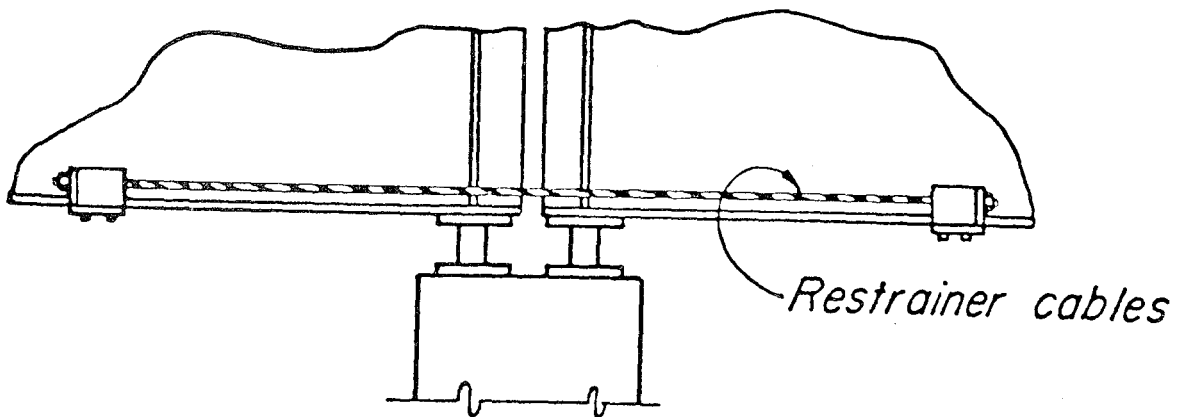
FIGURE G.5      Restrainer at pier-no positive tie to pier (ATC, 1983).

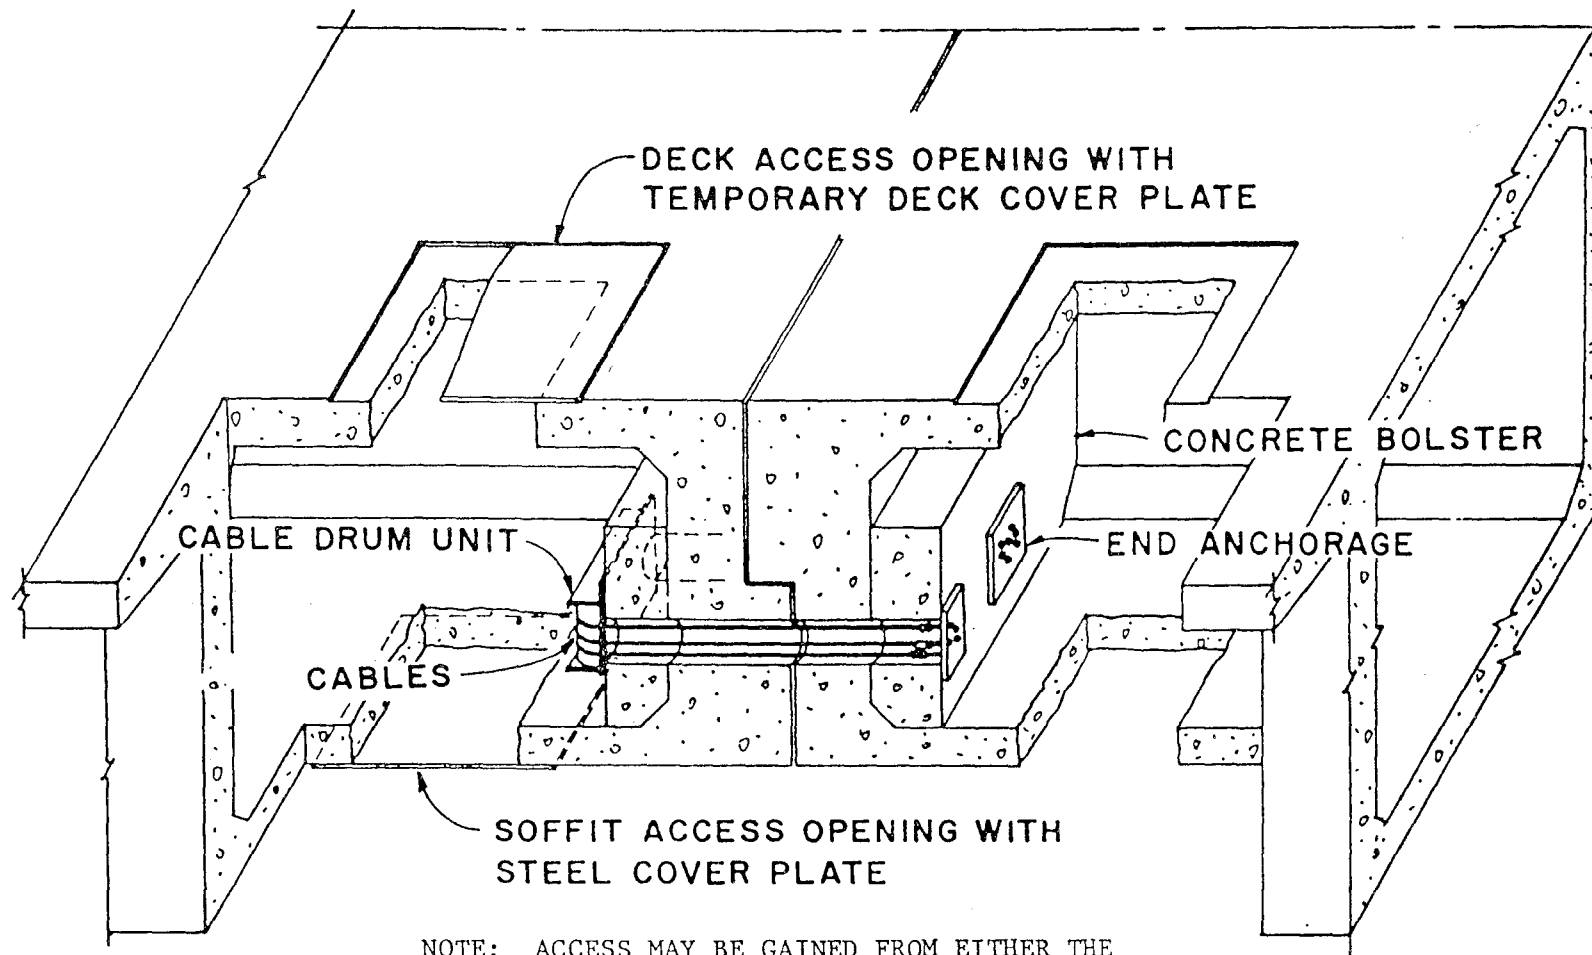
NOTE: ACCESS MAY BE GAINED FROM EITHER THE  
DECK OR SOFFIT BUT NEED NOT BE BOTH

FIGURE G.6 Longitudinal joint restrainer for concrete  
box girder (ATC, 1983).

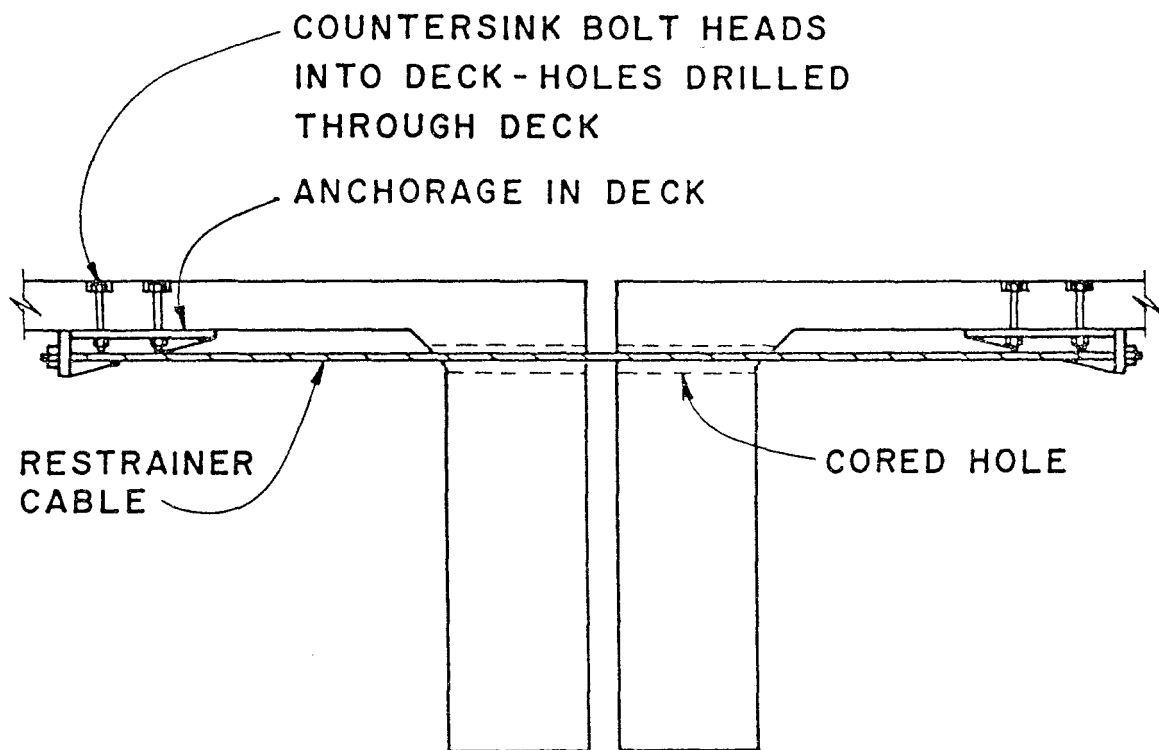
FIGURE G.7 Expansion joint restrainers tied to the concrete deck (ATC, 1983).

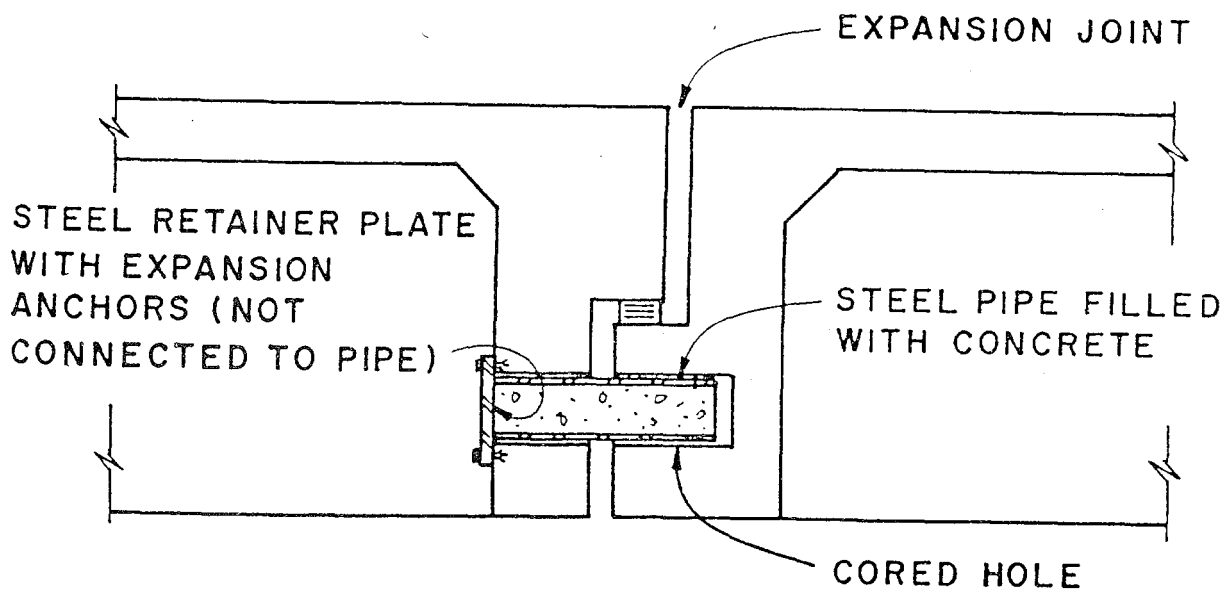
FIGURE G.8 Transverse restrainer retrofit for concrete bridge (ATC, 1983).

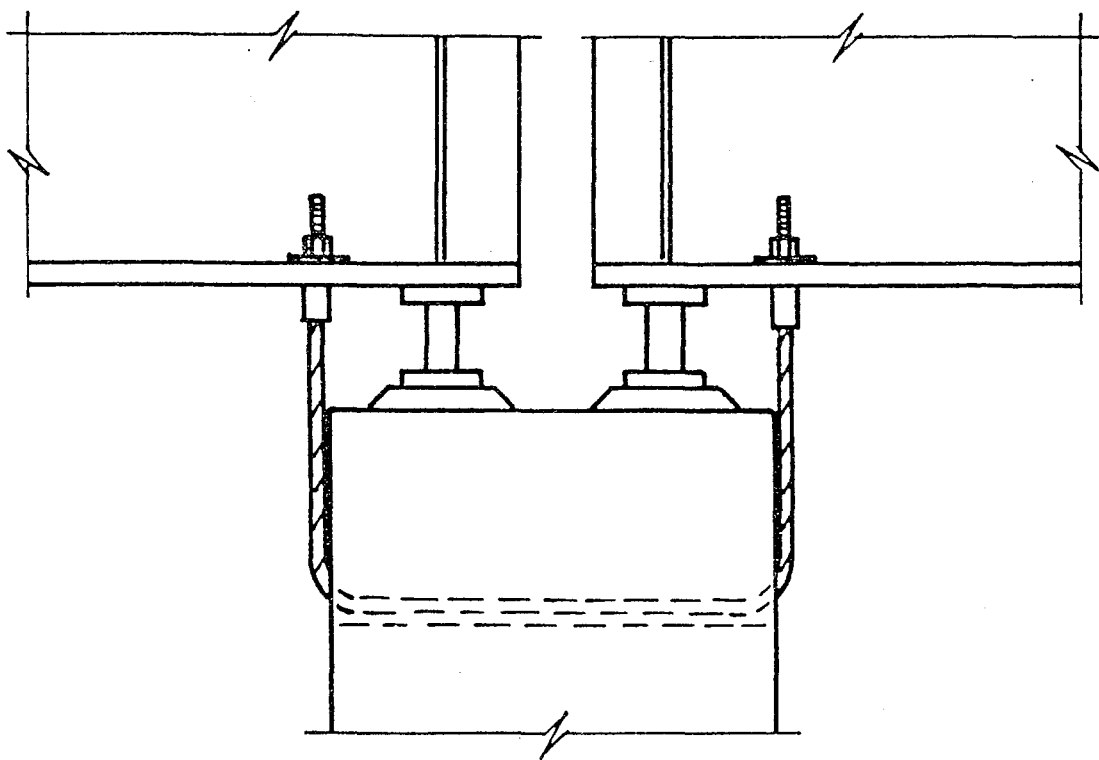
FIGURE G.9 Vertical motion restrainer retrofit (ATC, 1983).

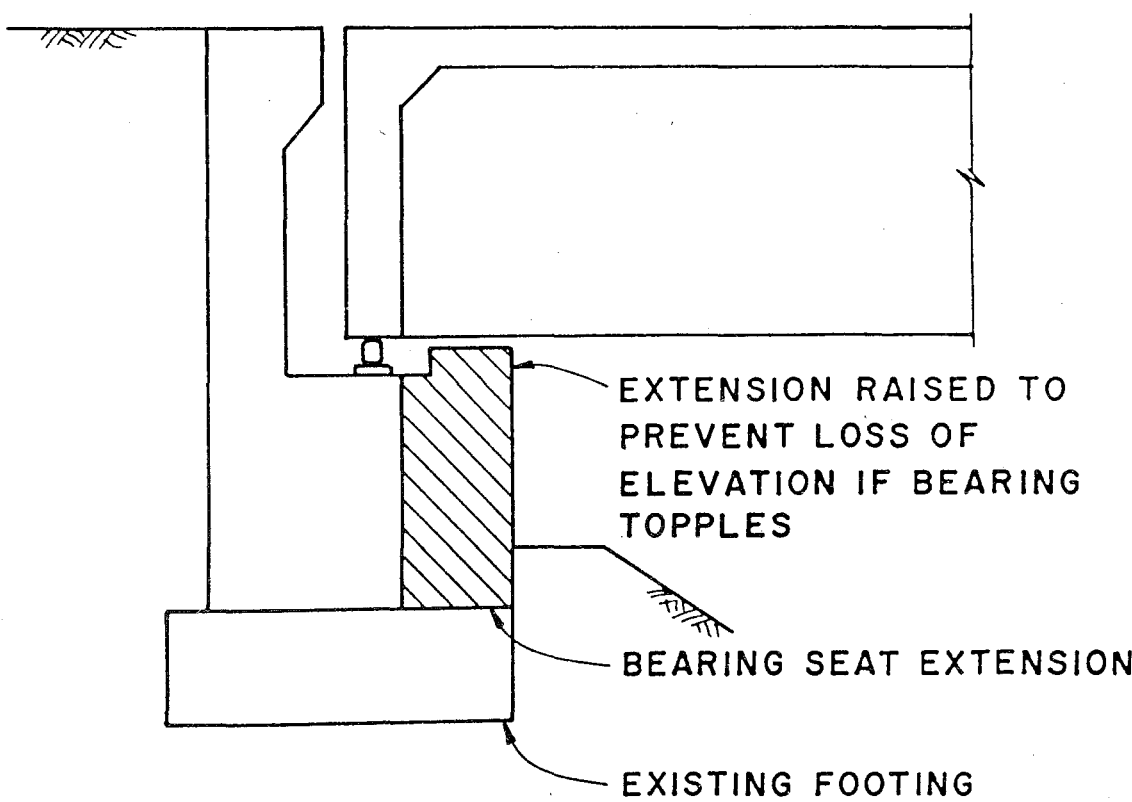
FIGURE G.10 Bearing seat extension at abutment (ATC, 1983).

measure when it is impractical to restrain movement enough to prevent loss of support at the bearings. If possible, at abutments, these extensions should be supported directly on the foundation as shown in Figure G.10.

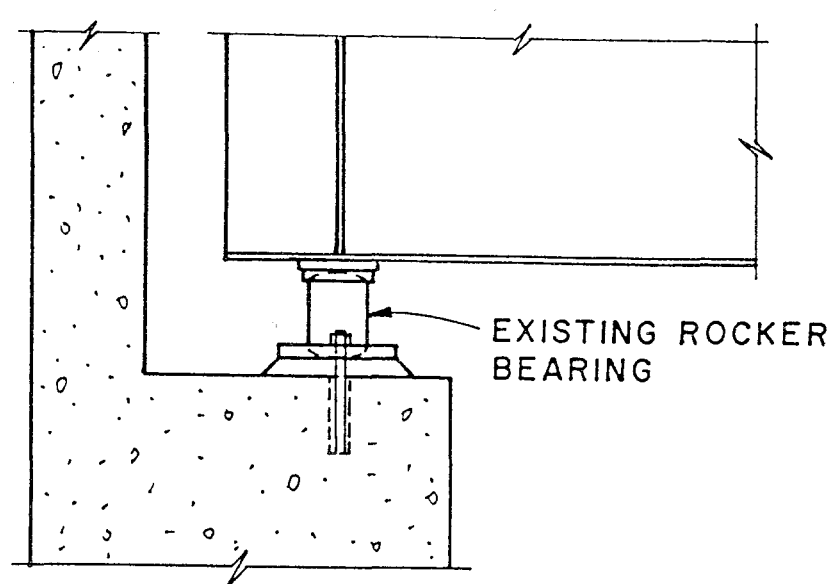
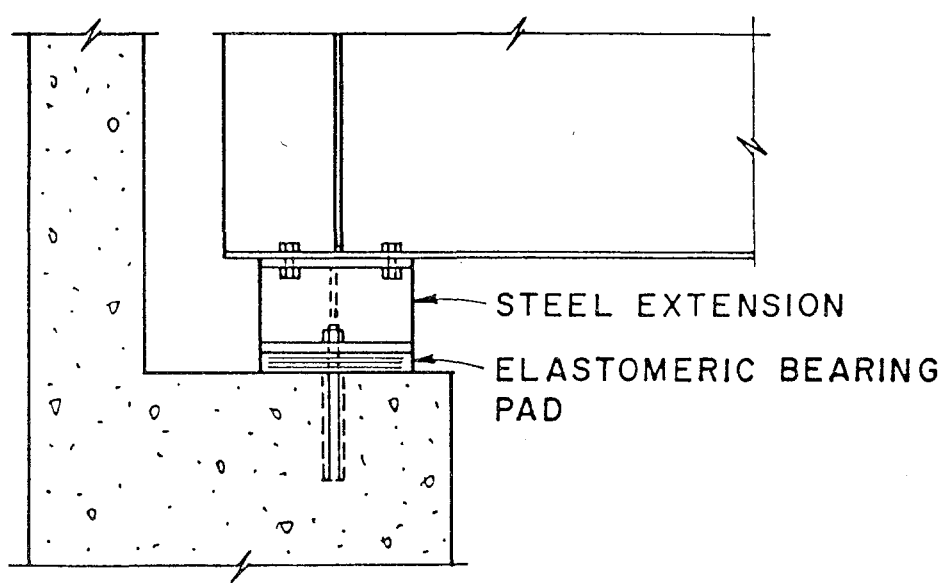
FIGURE G.11 Replacement of rocker bearings-steel extension (ATC, 1983).

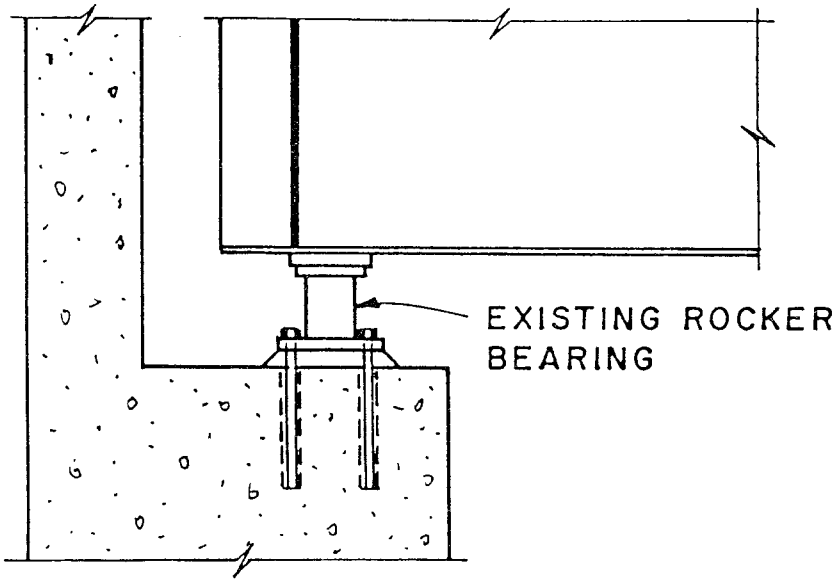
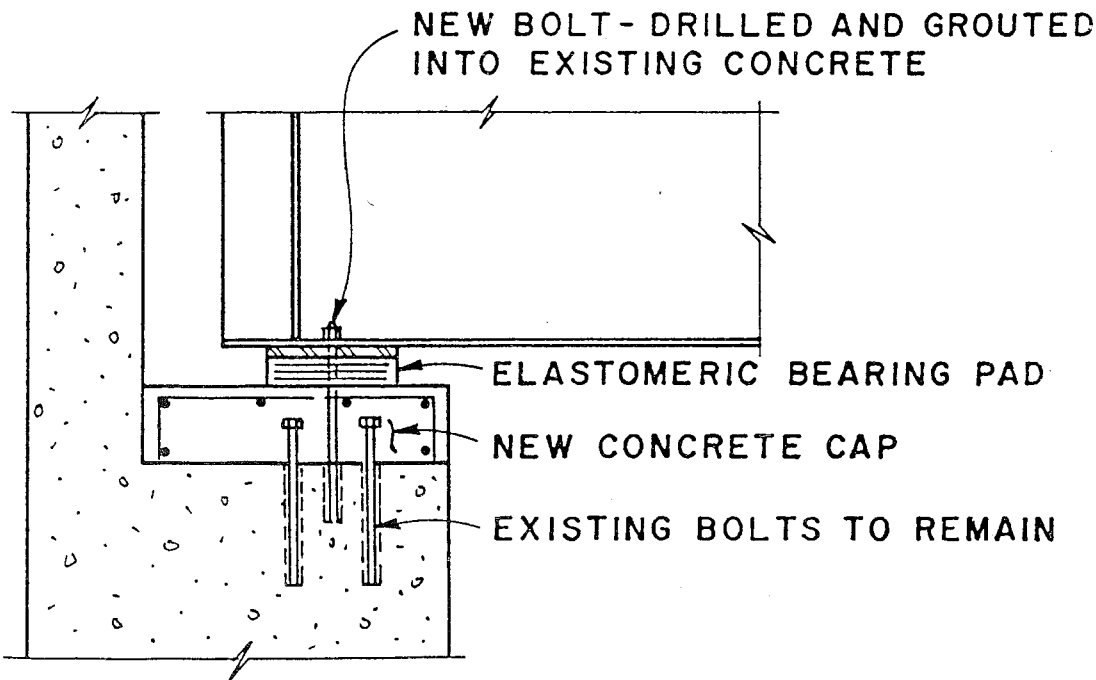
Another possible solution for replacing steel rocker bearings is shown in Figure G.12. In this case a concrete cap is used to build up the elevation difference between a replacement elastomeric bearing and the original high steel rocker bearing. With this method of replacement, the concrete cap can be constructed at a higher elevation between girders to serve as a transverse shear key. In addition, vertical motion restrainers can be anchored in the new concrete cap.

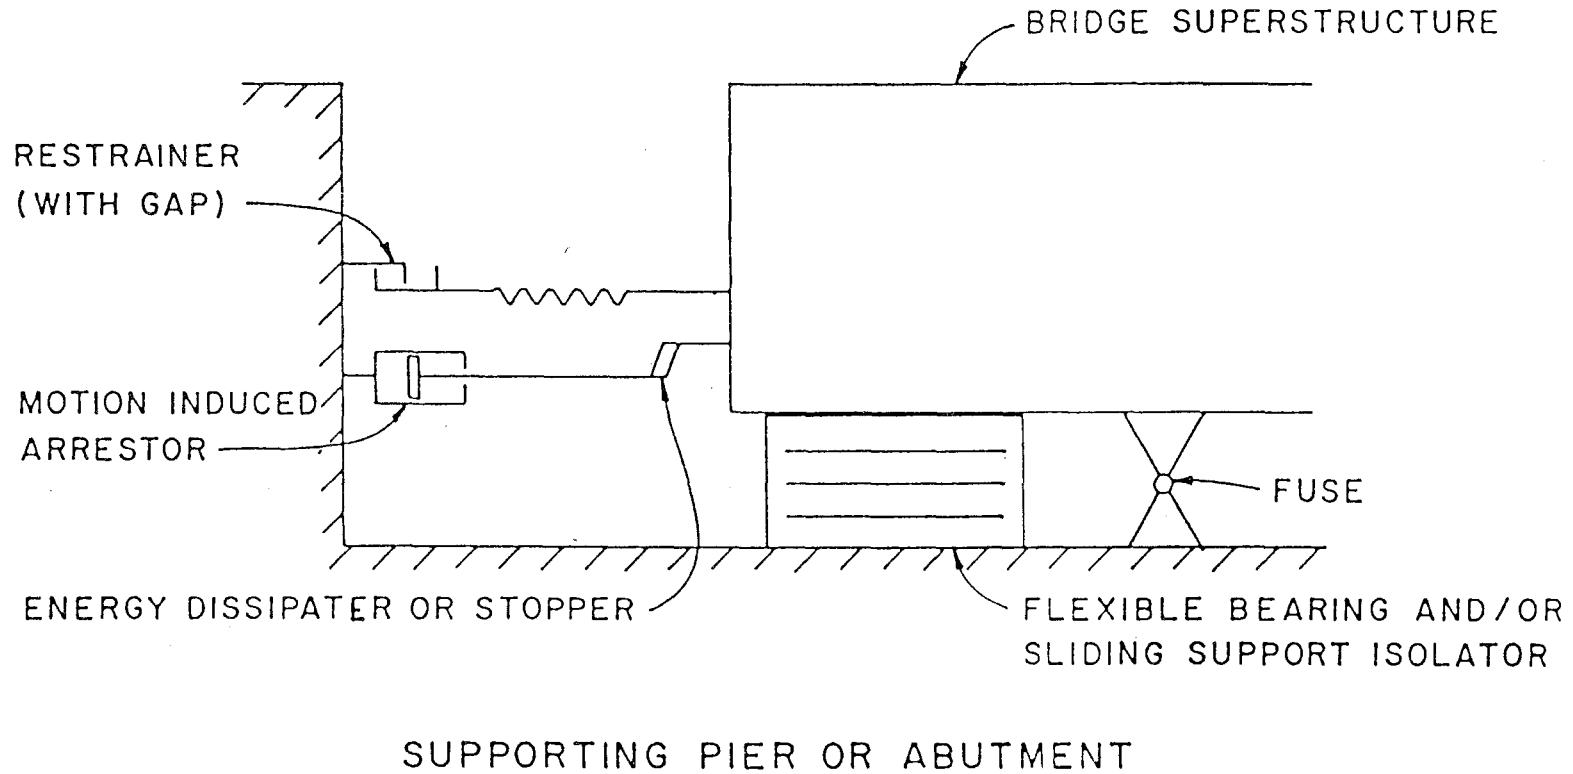
FIGURE G.13 An ideal bearing device (ATC, 1983).

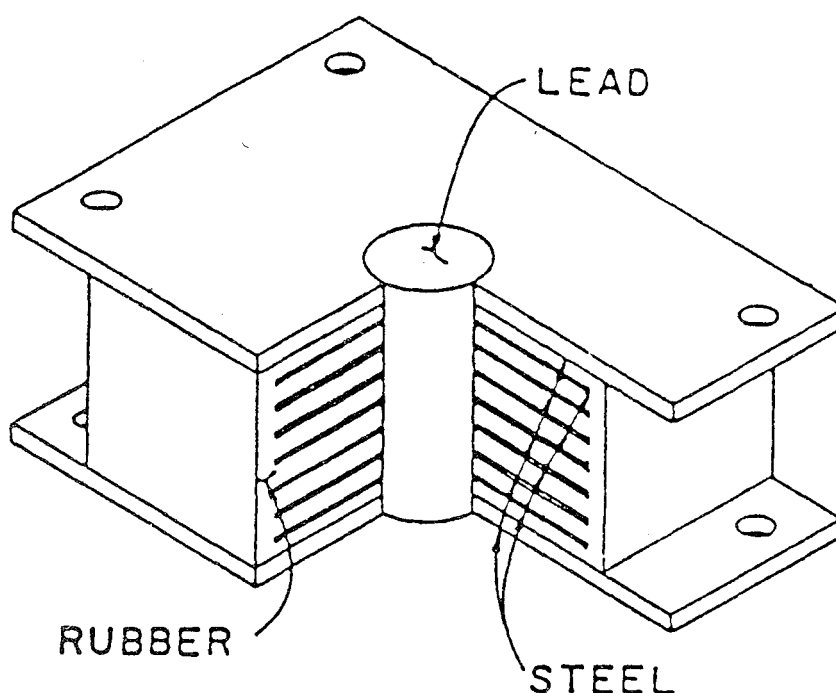
FIGURE G.15 Elastomeric bearing pad with a lead core  
(ATC, 1983).
