PRELIMINARY SEISMIC EVALUATION OF HIGHWAY  
BRIDGES IN ISTANBUL

Submitted to the Kandilli Observatory and  
Earthquake Research Institute in partial  
fulfillment of  
the requirements for the degree of  
Master of Science  
in  
Earthquake Engineering

1995

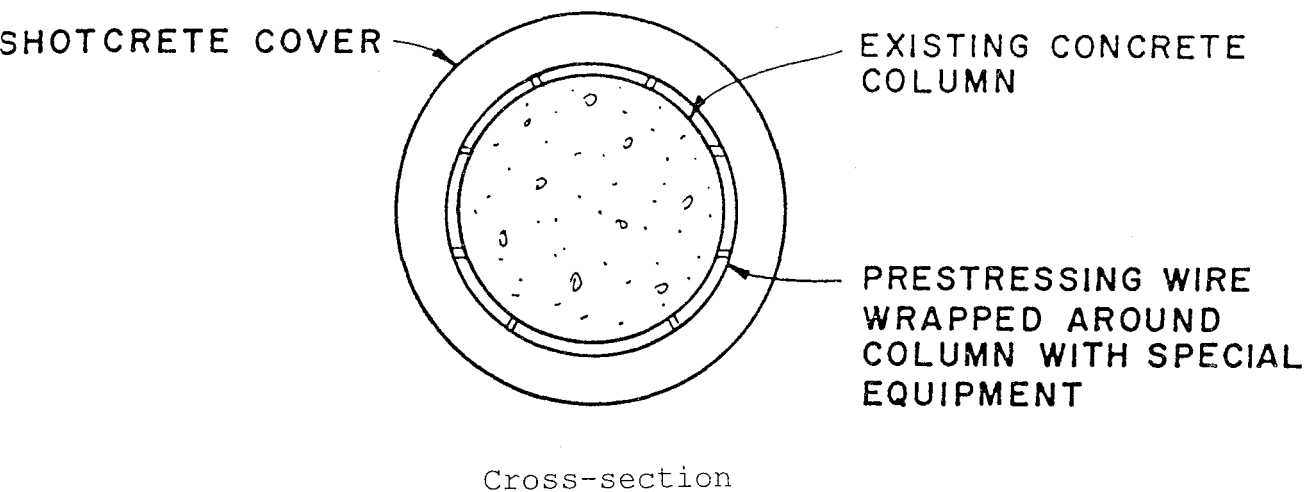
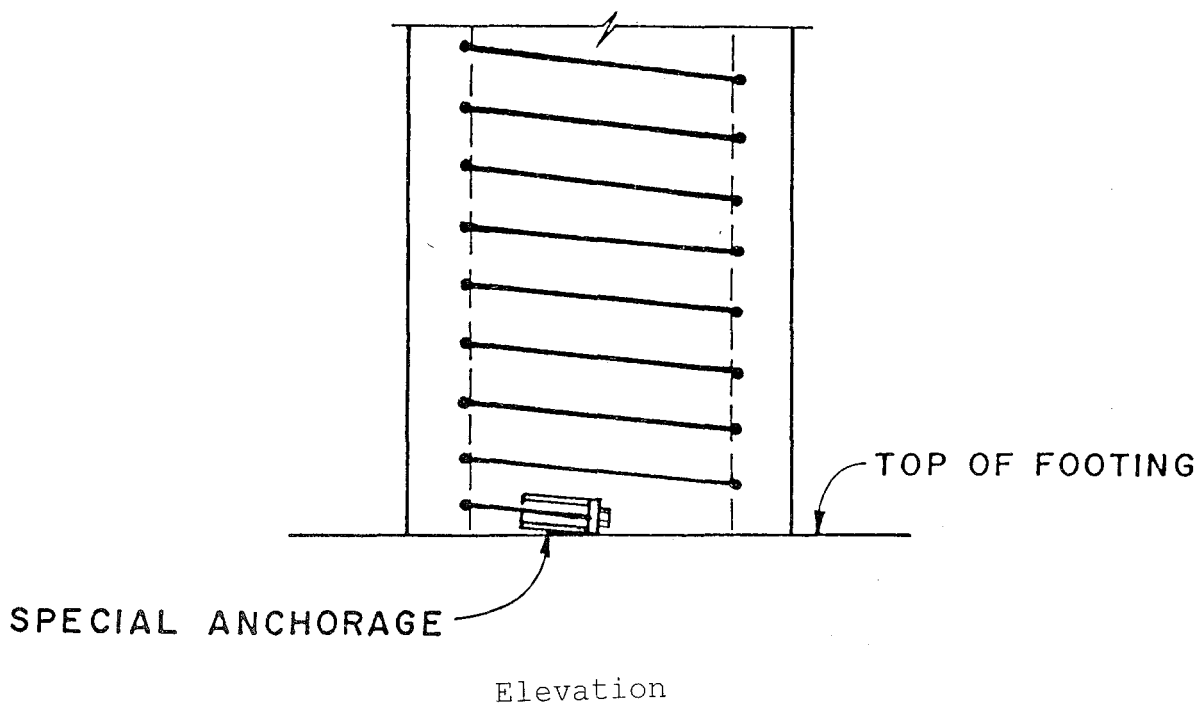
FIGURE G.17 Column retrofit to increase confinement with prestress wire (ATC, 1983).

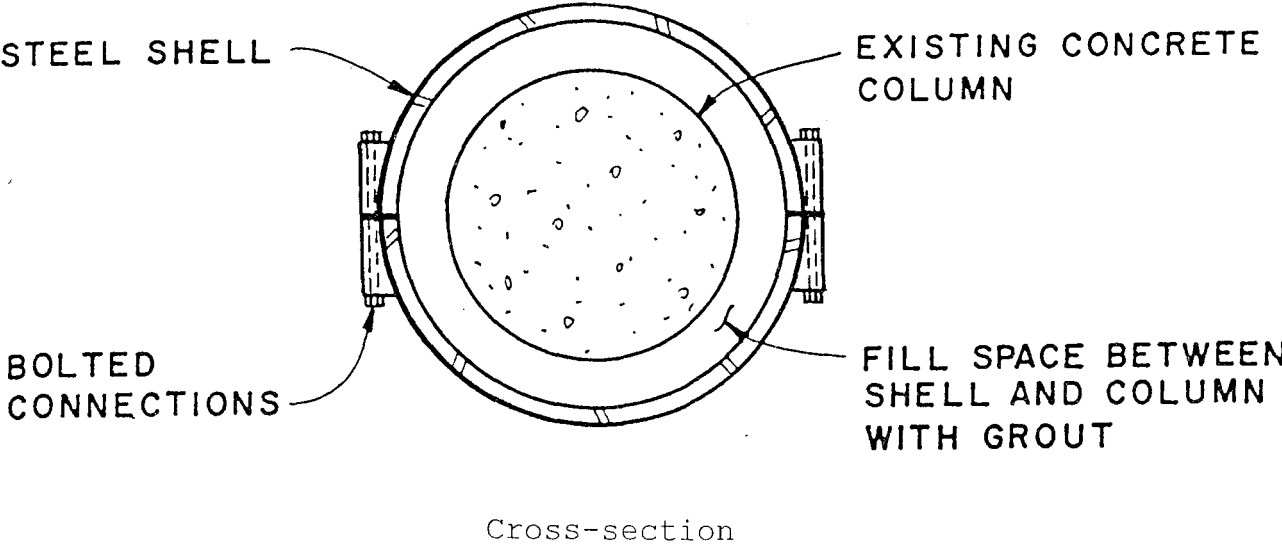
FIGURE G.18 Column retrofit to increase confinement with steel shell (ATC, 1983).

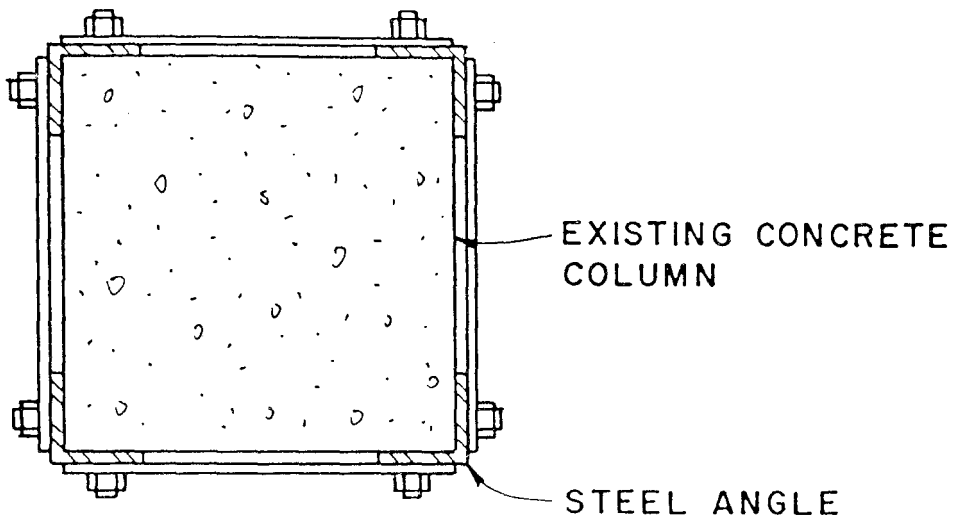
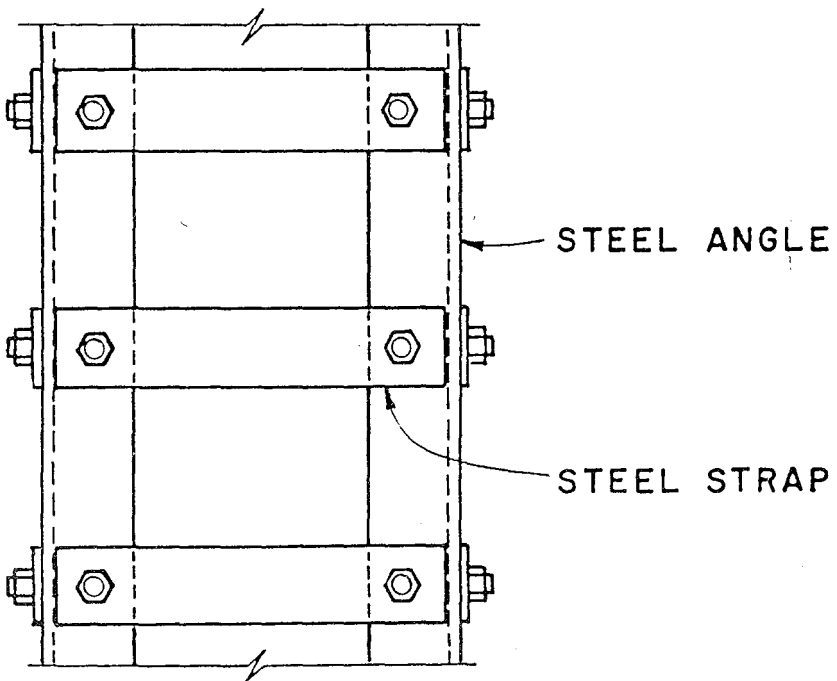
FIGURE G.22 Column strengthening by steel angles (ATC, 1983).

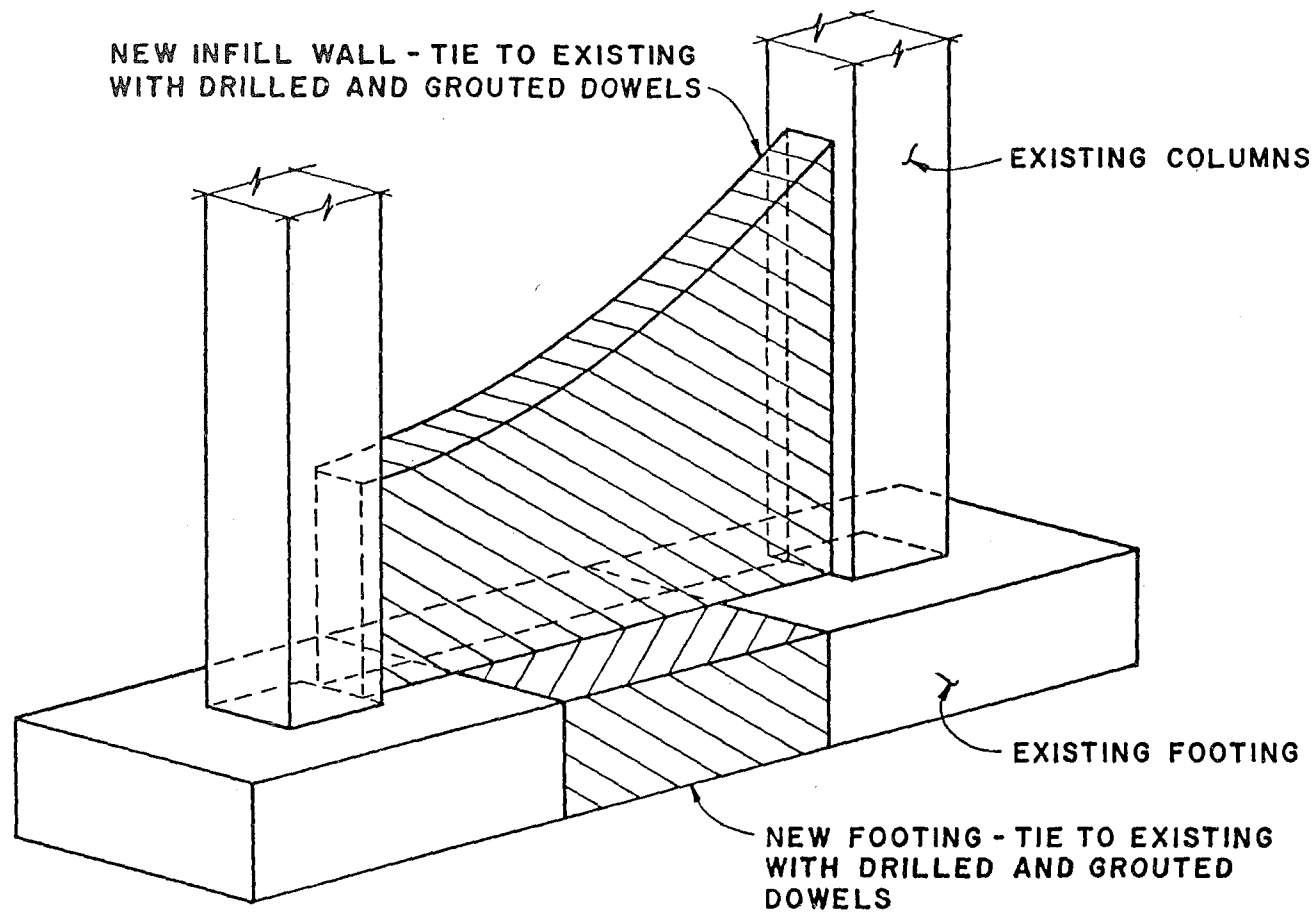
FIGURE G.23 Infill shear wall retrofit (ATC, 1983).

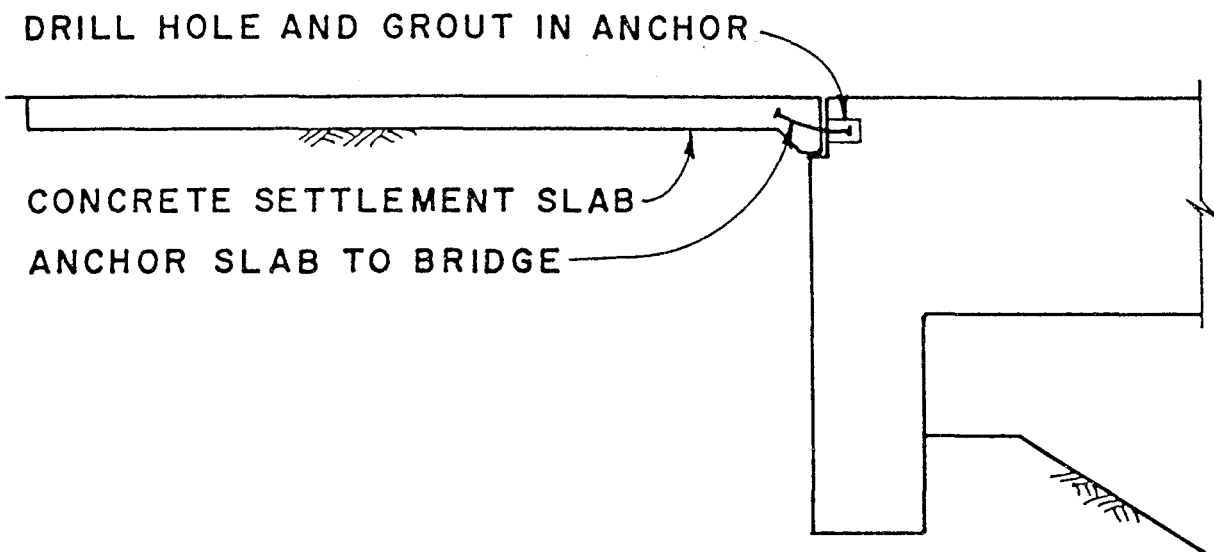
FIGURE G.25 Settlement slab-California style  
(ATC, 1983).

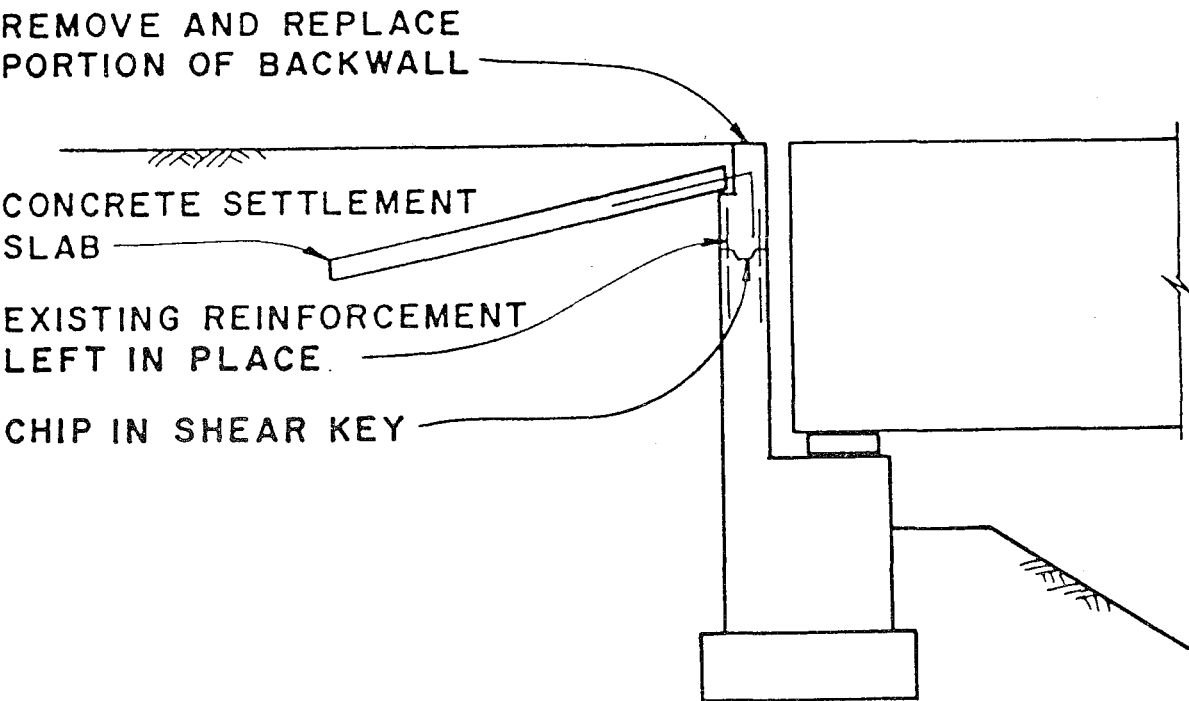
FIGURE G.26 Settlement slab-New Zealand style  
(ATC, 1983).

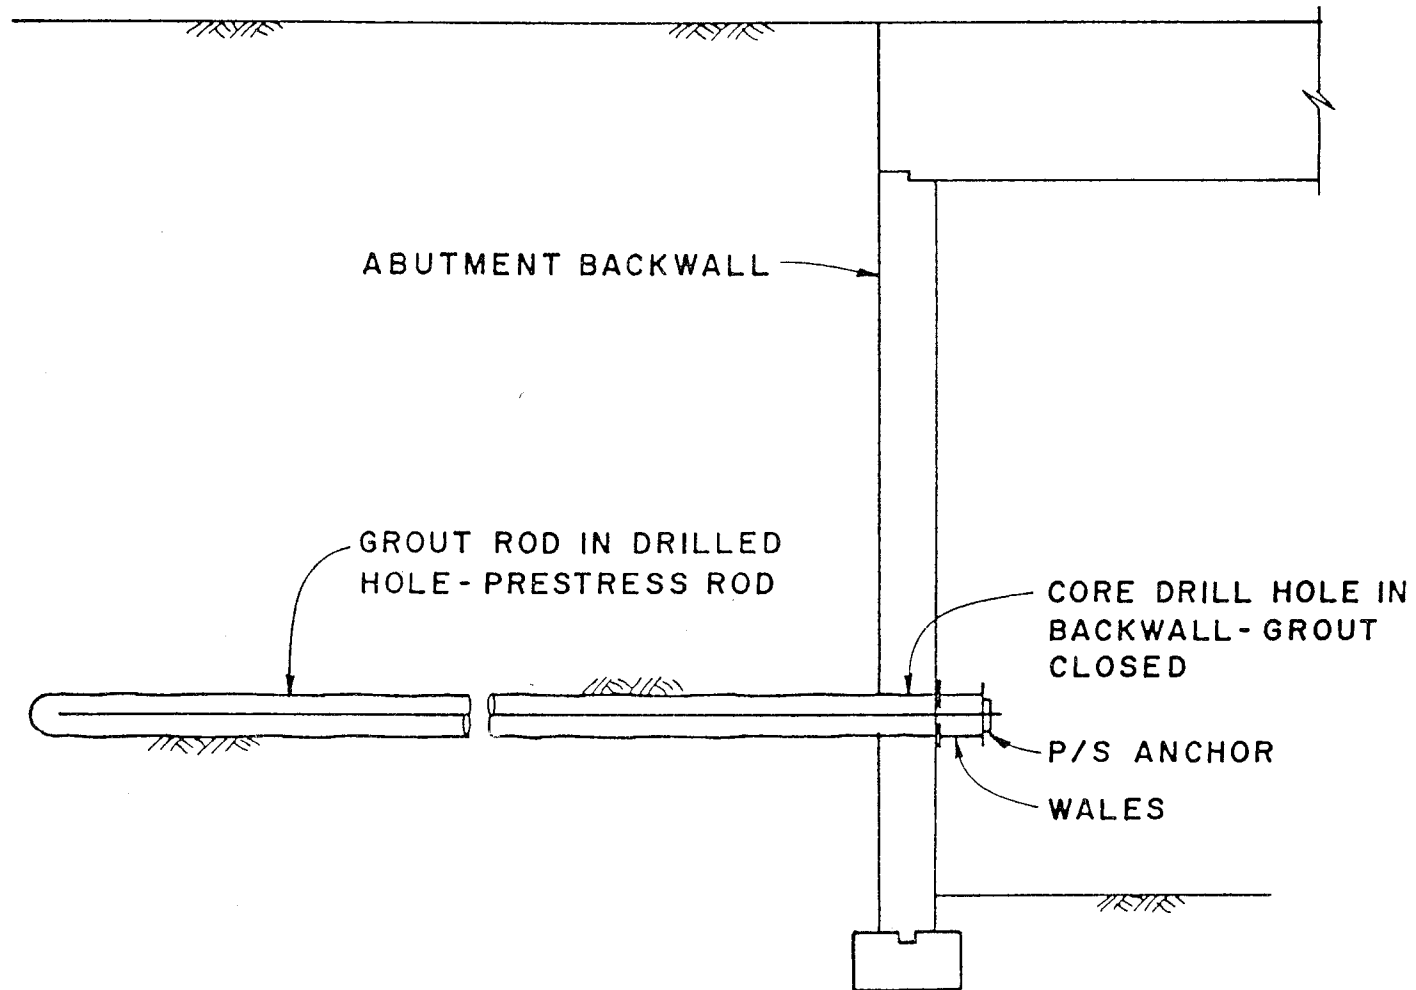
FIGURE G.27 Retrofit of abutment with soil anchors  
(ATC, 1983).

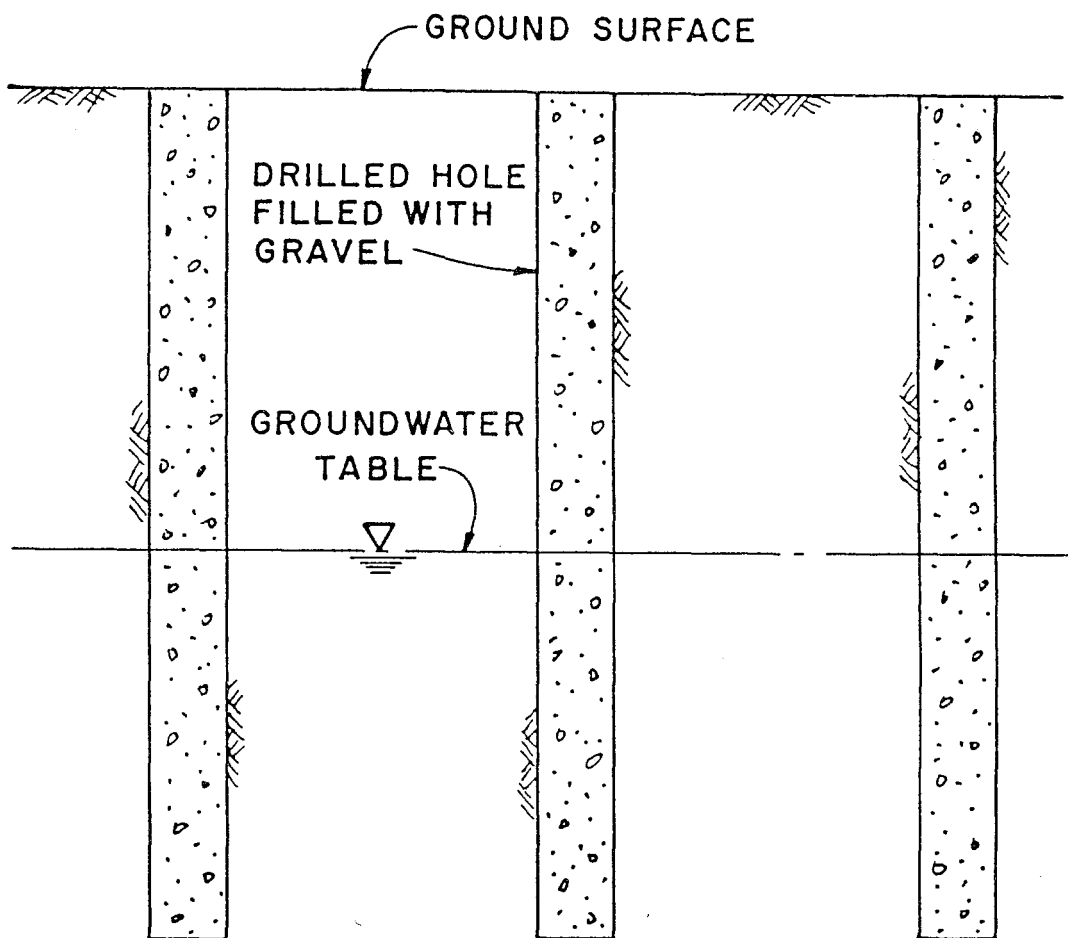
FIGURE G.28 Gravel drain system (ATC, 1983).

A method which improves drainage without disrupting the existing structure is to install a network of gravel drains as shown in Figure G.28. These drains allow water to escape during an earthquake and thus prevent the build-up of pore pressure which can reduce the shear strength of the soil.

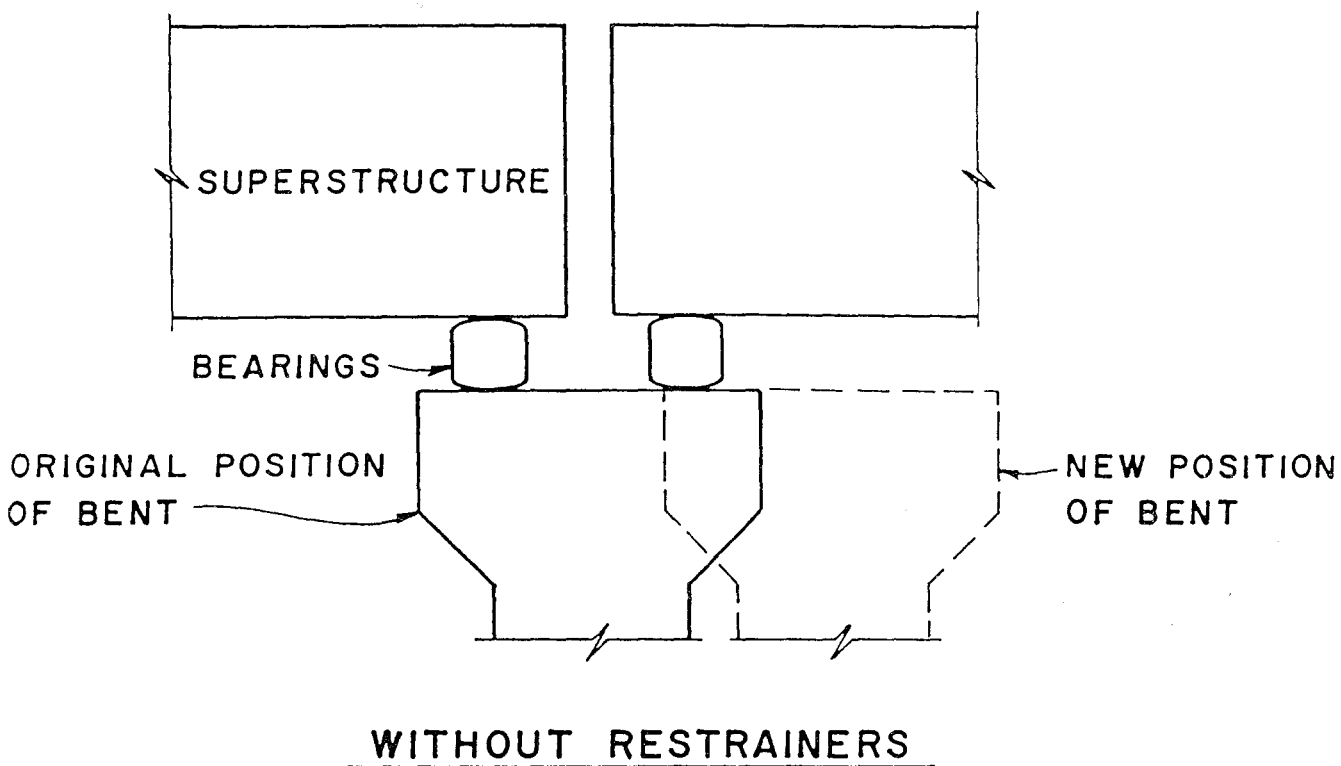
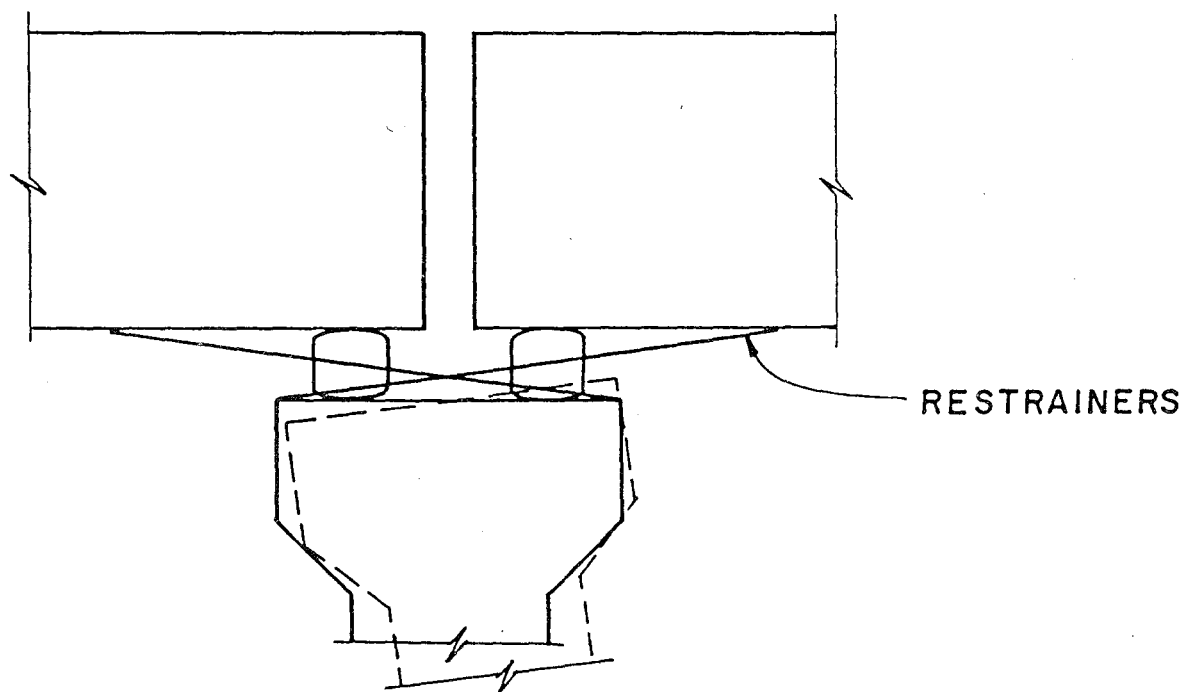
FIGURE G.29 Effects of restrainers at bent during liquefaction failure (ATC, 1983).

Longitudinal restrainers should be provided at the bearings to prevent a loss of support. If bents are not tied to the superstructure, the movements of the foundation can easily pull the support out from under the bearings as shown in Figure G.29. It is preferable to fail the column in flexure rather than to lose this support. Therefore, the superstructure
